Protecting geomembranes from animal damage

By Andrew Mills and Timothy D. Stark

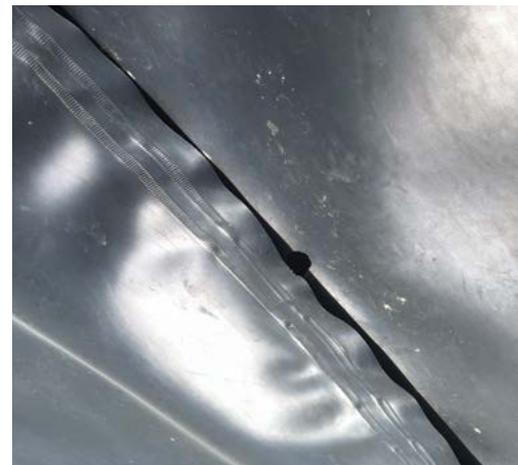
FIGURE 1 Close-up of damage to PVC geomembrane from deer hooves

Resisting animal and insect attacks on geomembranes is an interesting problem. Geomembrane installers and manufacturers have had numerous geomembranes damaged by bears, deer, coyotes, birds, beavers, and ground squirrels (**Figures 1 and 2**). In most cases, the damage is incidental to something else the animal is seeking. Deer damage the liner with their hooves trying to climb out. Bears dig through the liner to try and find something on the other side (organic matter left under a liner in a retrofit, for example). Coyotes burrow under the liner on slopes to create a den that doesn't freeze.

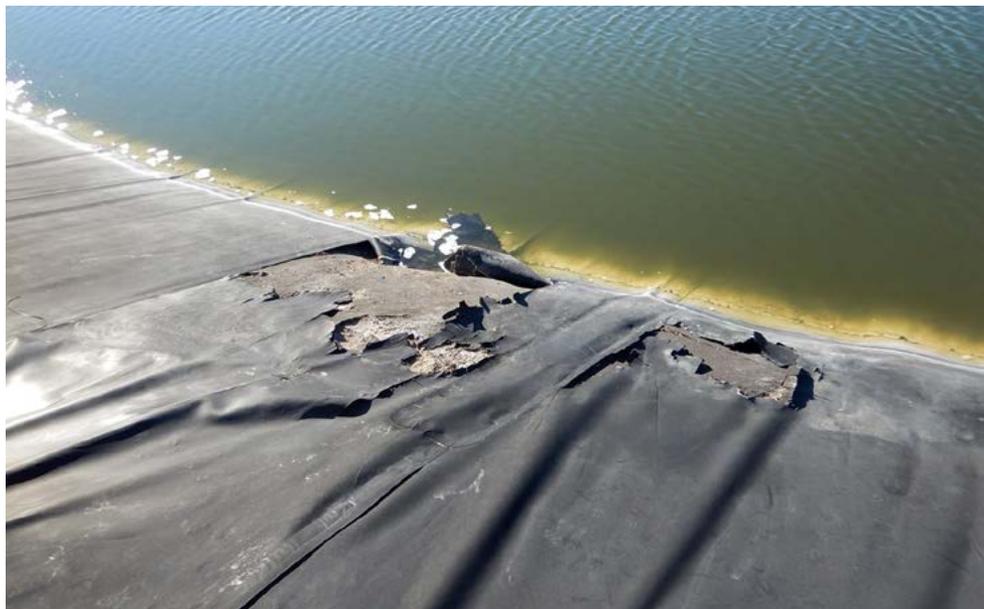
FIGURE 2 Beaver damage to geomembrane liner
