# Rehabilitation of Raw Water Reservoir for Franklin WTP

**Completed reservoir rehabilitation shown now full of water. Inset: Installation of geoweb along the side slopes.**

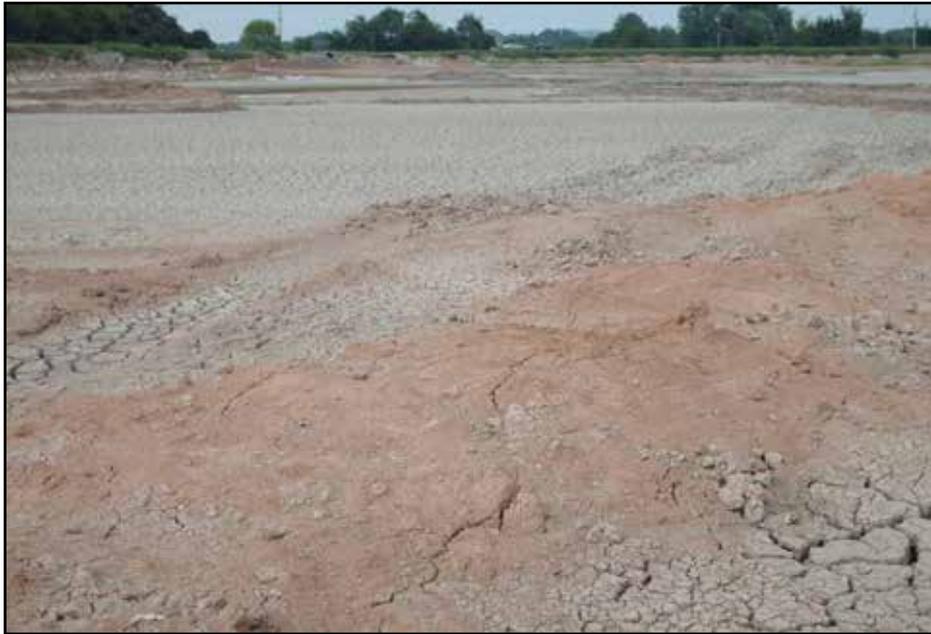
built in the 1950's and during that time the water treatment plant was designed for 1 million GPD. The reservoir served as a source of water during the warm summer months where water was pumped from the Harpeth River. The reservoir was 30 acres in size and designed to hold up to 100 million gallons of water. During the 1960's, the water treatment plant was upgraded to handle 2 million GPD. Over the years, volume within the reservoir was lost due to accumulated filter backwash solids reduc-

ing the capacity to only 80 million gallons. Also, the original clay liner was no longer working and there were continuous leaks in the bottom.

**Top: Reservoir in 2008 after the major drought of 2007. Below: Disposal of filter backwash solids.**

Another means of increasing the capacity of the reservoir was removal of the existing filter backwash solids. There was a significant volume of material due to over four decades of use, with the solids now being diverted to the sanitary system. The filter backwash solids had high levels of aluminum and copper and was considered a “special waste” if taken outside the reservoir, since it was processed. The options were as follows:

The option chosen was to haul the filter backwash solids to a C+D landfill, which required 1,900 dump truck loads or a total of 33,000 cubic yards.

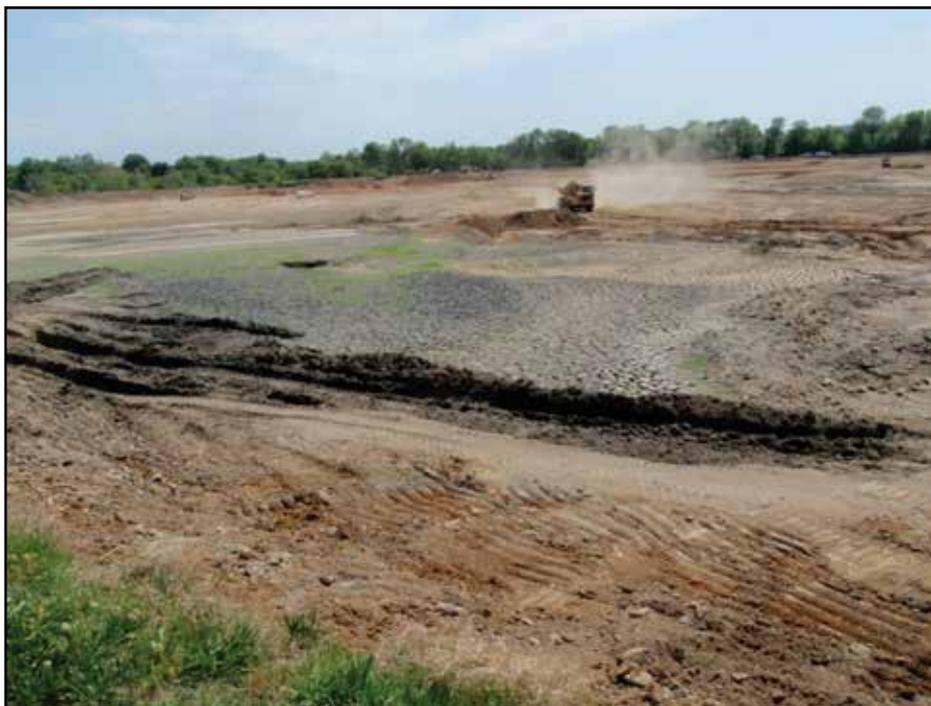
**Resizing of the Reservoir**

AECOM looked at seven alternatives to increase the overall capacity of the reservoir from 80 million gallons to a potential 155 million gallons (see Figure 2). With a combination of raising the spillway 2 feet, raising the berm 8 inches and excavating soil in the bottom, the optimum design volume came to be 105 million gallons (Alternate D). This was based on the estimated grading and modifications cost at \$250,000 and only 1,500 yards of excavation required.

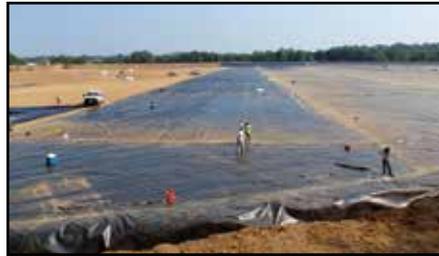
**Geomembrane liner installation.**

Even though the reservoir will be holding “raw water” from the Harpeth River, the facility owner wanted the liner system to be NSF 61 certified for potable water. After one month of fine grading the reservoir bottom, installation of the geomembrane liner started. Since the geomembrane was a heavily reinforced coated fabric with excellent physical properties such as puncture resistance, a geotextile below the liner was not needed.

The EIA-R was prefabricated into panels 90 feet wide by 180 feet long (16,200 SF each). Fabrication of the geomembrane was performed by Colorado Lining International’s New Caney, TX facility and installation of liner and geoweb was by Geosynthetics, Inc. (GSI). A total of 95 prefabricated geomembrane panels were delivered to the job site. This allowed for only 2 field seams per acre required, which dramatically reduced the amount of CQA testing in the field.

A thicker 45-mil reinforced EIA-R was installed on the side slopes since they will experience greater exposure to the elements and a 36-mil reinforced EIA-R was installed on the reservoir bottom. Liner in-

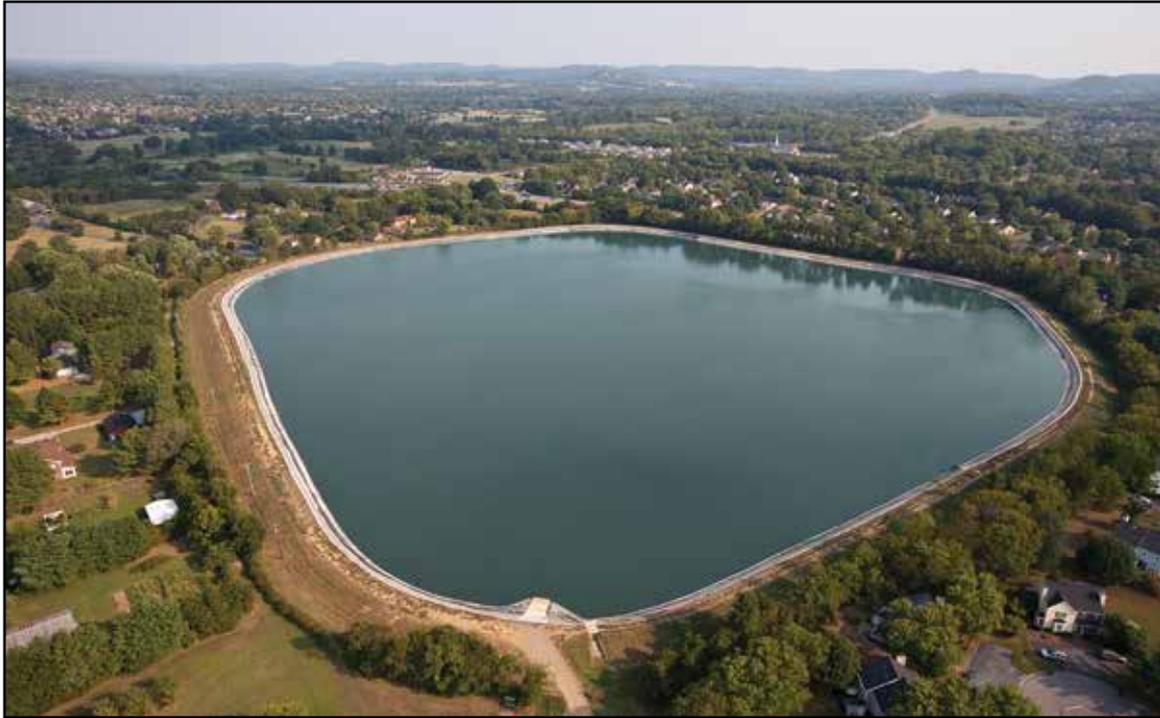
**Aerial photo of the completed reservoir.**

on April 1, 2010. The reservoir was operationally complete in October of 2010, with the final construction cost being over budget by only 1% (\$3,946,762). The general contractor was Summit Construction based out of Nashville, TN. Once completed, the reservoir achieved a total of 113 million gallons of storage which was 8% over the original design of 105 million gallons.
