Local Practices Managing CCRs

Ken Daly, PE

wood.

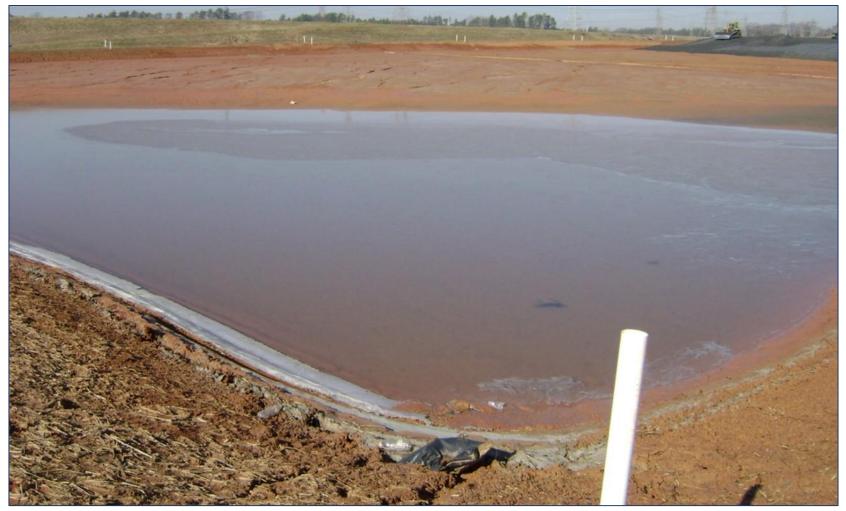
Ash Landfill Sump

Ash landfill circa 2009: Sump blinded by protective cover sedimentation during initial ash filling

- Larger quantity of stormwater runoff from ash and protective cover (unlike MSW landfills)
- Protective cover soil and ash eroding
- Deposited downslope at leachate collection sumps
- Blinded ordinary (MSW-style) sumps and leachate collection system (LCS) corridors

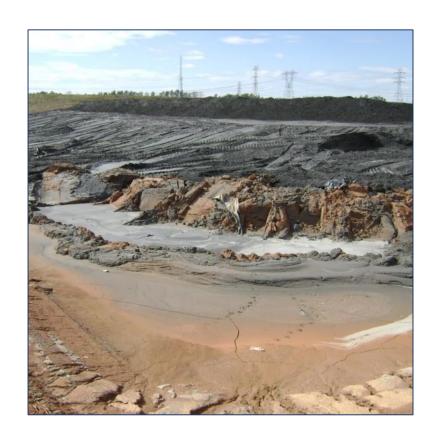
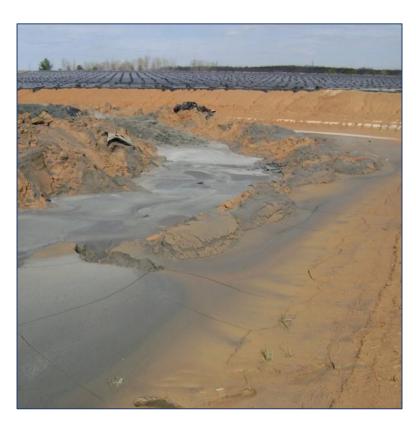
Ash Landfill Sump

Ash landfill circa 2009: Sump blinded by protective cover and ash sedimentation during initial ash filling

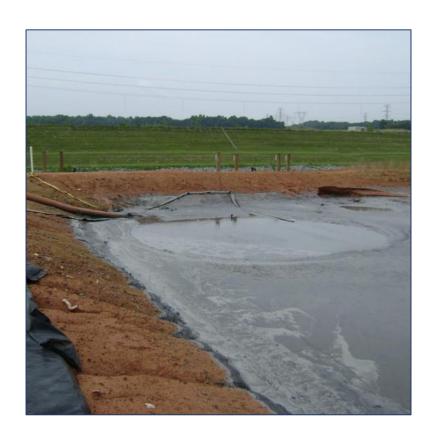
Ash Landfill Sump and LCS Corridor

Ash landfill circa 2009: Sump blinded by ash sedimentation during initial ash filling

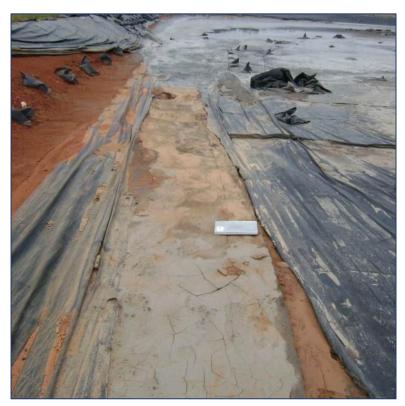
Ash landfill circa 2009: LCS laterals blinded by ash sedimentation during initial ash filling

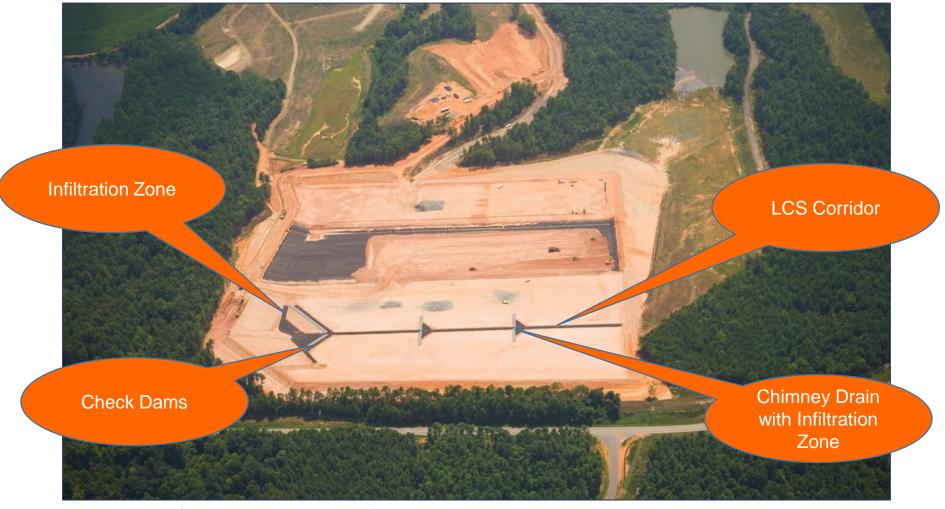
Ash landfill circa 2010: Infiltration zone and chimney drain layout

- Operations Plans
- Grading Plans
- Chimney Drains combination of:
 - erosion and sediment control
 - graded filter design
 - Stormwater design

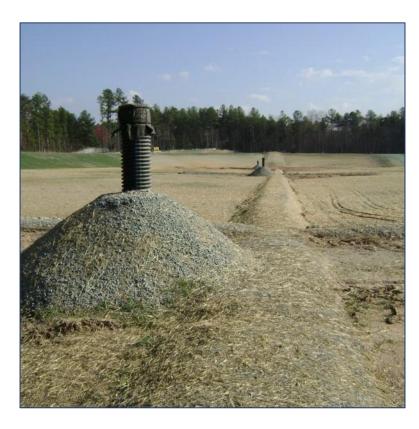
Chimney Drain (left) LCS Corridor center (raised with graded filter)

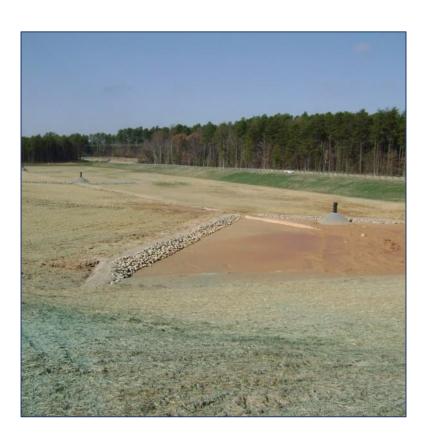
Graded Filters (Check Dams)

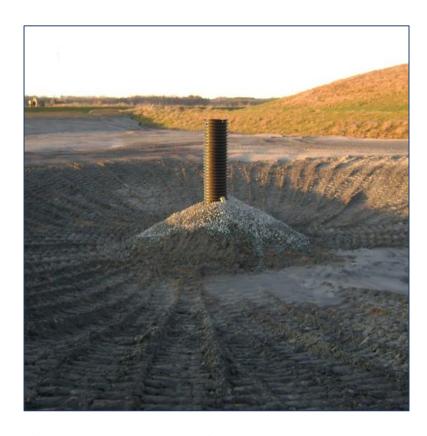
Chimney Drain/Infiltration Zone – No. 57 Stone

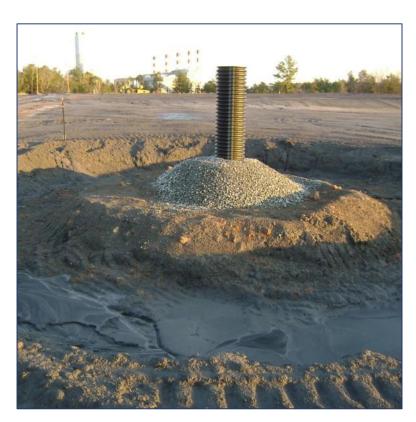
Chimney Drain/Infiltration Zone – No. 57 Stone with Bottom Ash

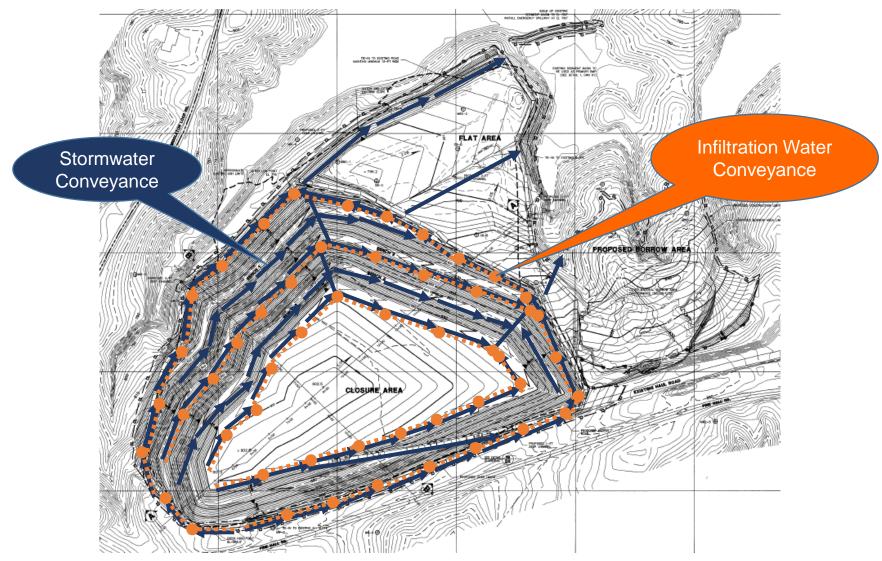
Infiltration water: cover system termination – key trench and outlet pipe (2007 design)

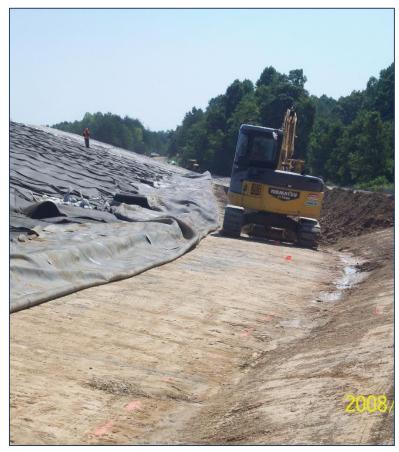
Finished cover subgrade before key trench excavation

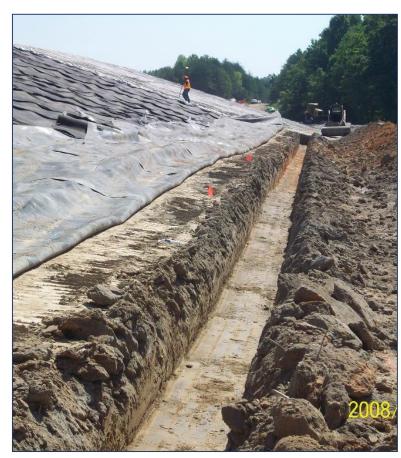
Key trench excavation – "rough" key trench corners

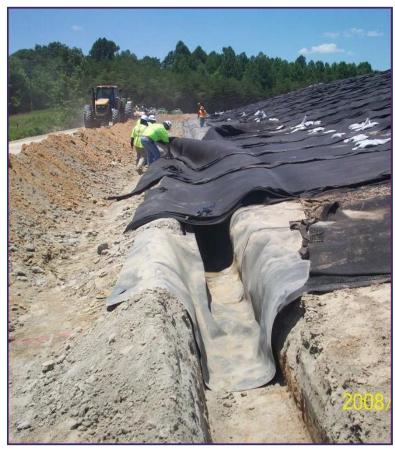
Geomembrane deployed in key trench

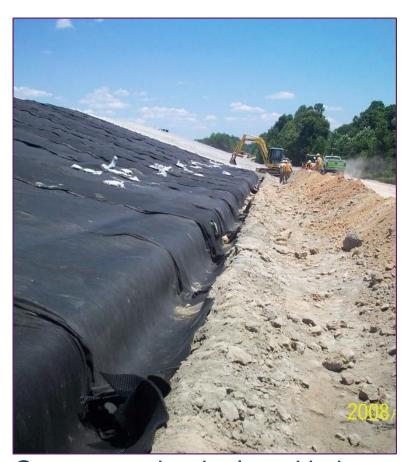
Geocomposite deployed in key trench

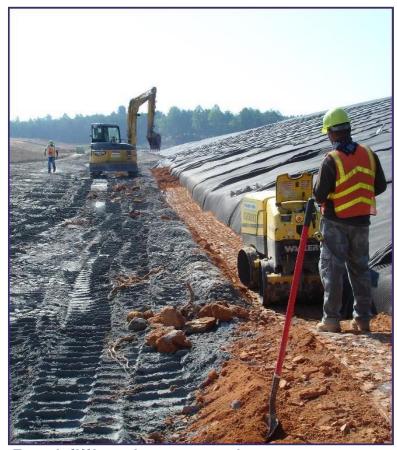
Backfilling key trench: geosynthetic cover to the right; "flat area" (ash) to receive soil cover to the left

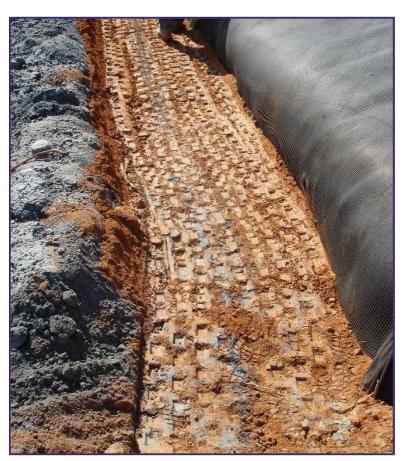
Backfilling key trench

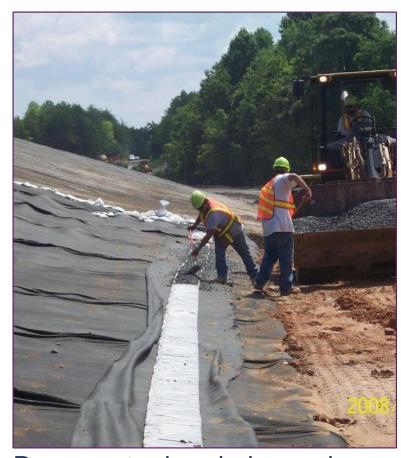
Pavement edge-drain used as panel drain: aggregate and geotextile wrap added

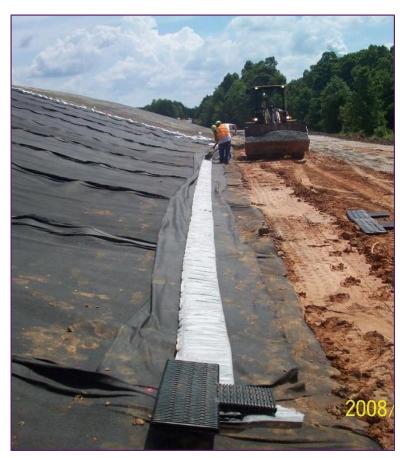
Connection for pipe outlet – spaced 100 ft on center

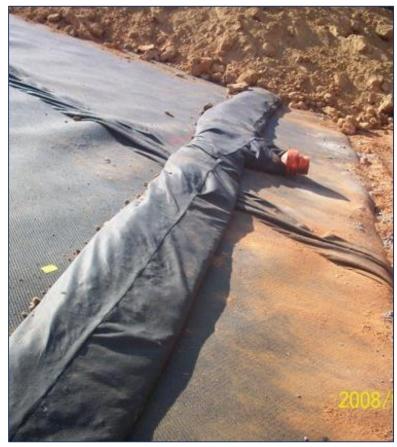
Assembled panel drain (prior to pipe connection)

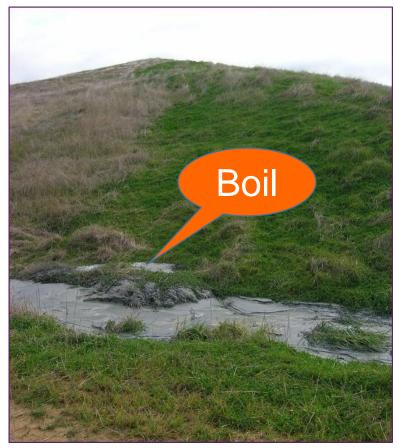
Ash boil (facing southwest)

- Construction completed Fall 2008
- November 2009 boils developed after significant rainfall event

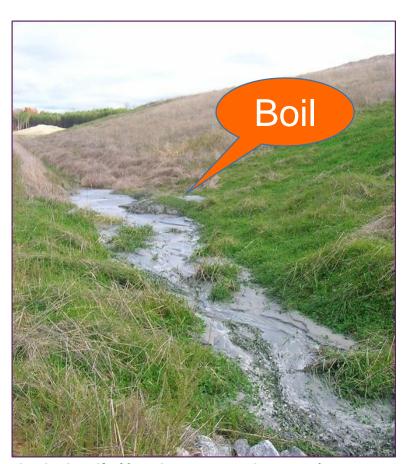
Ash boil (facing southeast)

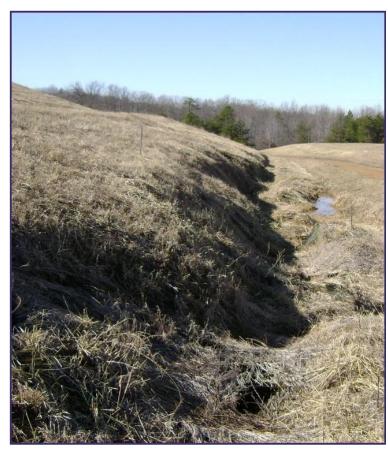
Settlement area (facing north)

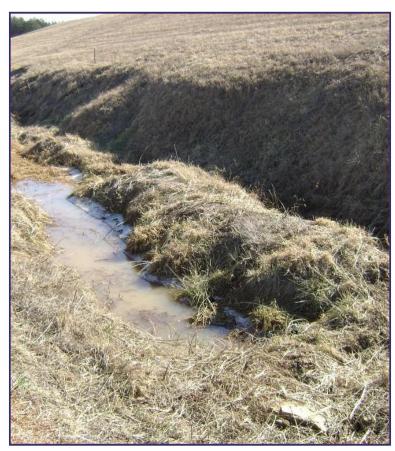
Settlement area (facing south)

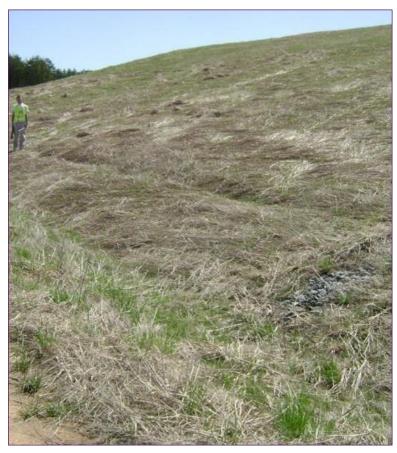
Linear settlement feature

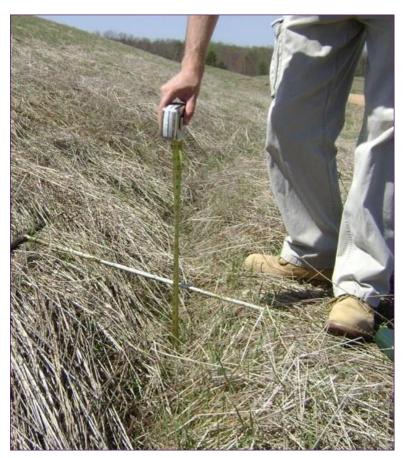
Linear settlement feature – up close

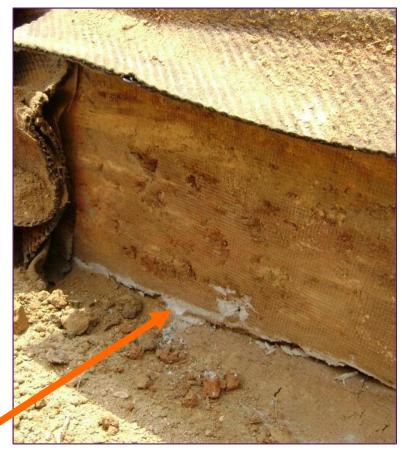
Evidence of water flow and ash transport in key trench side wall

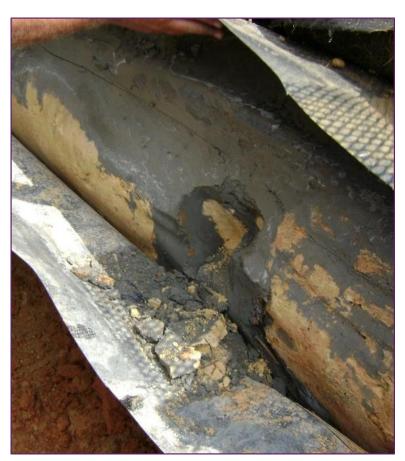
Subgrade void spaces filled with ash at key trench inside crest

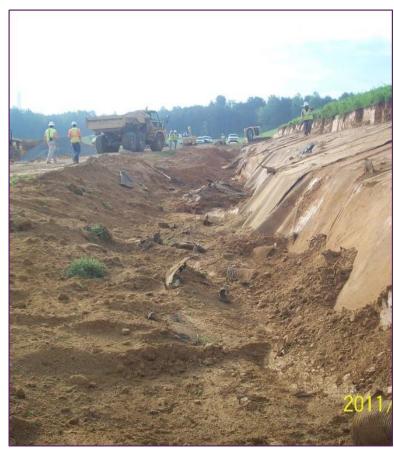
Cover soil removed and geomembrane exposed

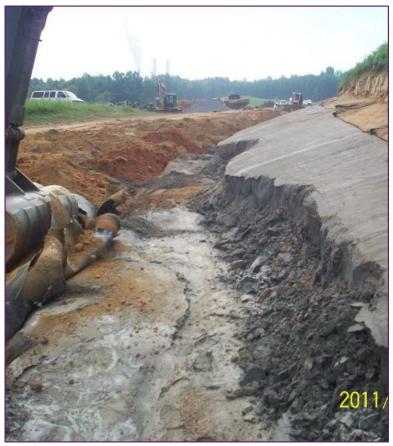
Geomembrane removed – ash loss/undercutting at perimeter exposed

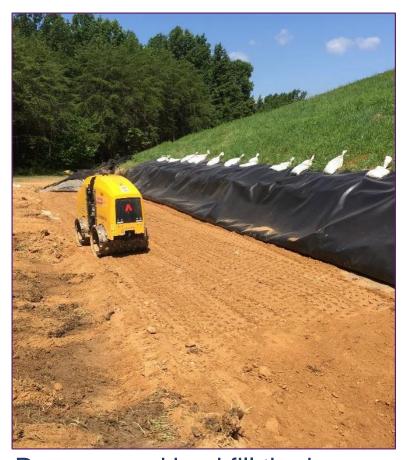
Remove and backfill the key trench – restore subgrade

- 2012:
 - > Boil and linear settlement recurred NW
 - NE stable with clear water discharge
 - > Retrofit NW with additional perimeter drain outlets
- 2015: Boil at NW
- 2016: Retrofit Continuous outlet
 - Geocomposite/aggregate extending to toe
- 2019 Satisfactory performance

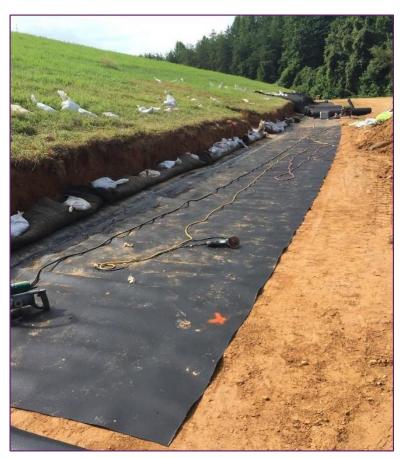
Geomembrane flap – to direct infiltration water to perimeter

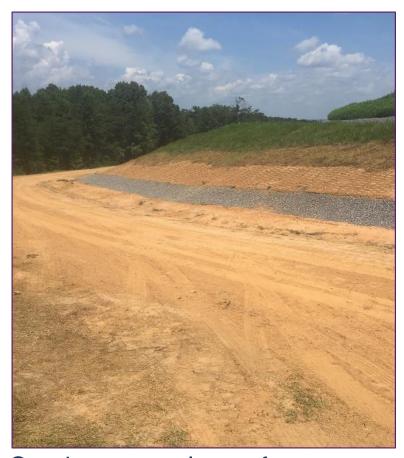
Continuous outlet – after construction (2016)

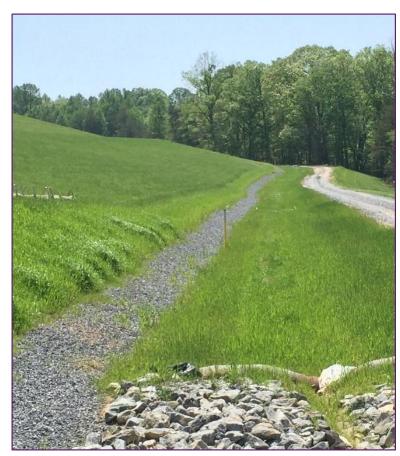
Continuous outlet – April 2017
