**Technical Paper by T.D. Stark, D. Arellano, W.D. Evans,
V.L. Wilson and J.M. Gonda**

UNREINFORCED GEOSYNTHETIC CLAY LINER CASE HISTORY

ABSTRACT: This paper describes a slope failure involving an unreinforced geosynthetic clay liner (GCL) in a municipal solid waste (MSW) landfill liner system. The precise mechanism for the shear movement of the interim slope is not known. However, the significant damage observed in the upper components of the composite liner system suggests that the failure was translatory primarily along the interface between the recompacted soil liner and the overlying hydrated bentonite of the geomembrane-backed GCL. It also appears evident that the slope inclination, slope height, physical characteristics, e.g. high unit weight, of the waste, and possibly the overlying smooth geomembrane/geonet interface played a significant role in the movement. Design recommendations for interface strengths and stability analyses are also presented.

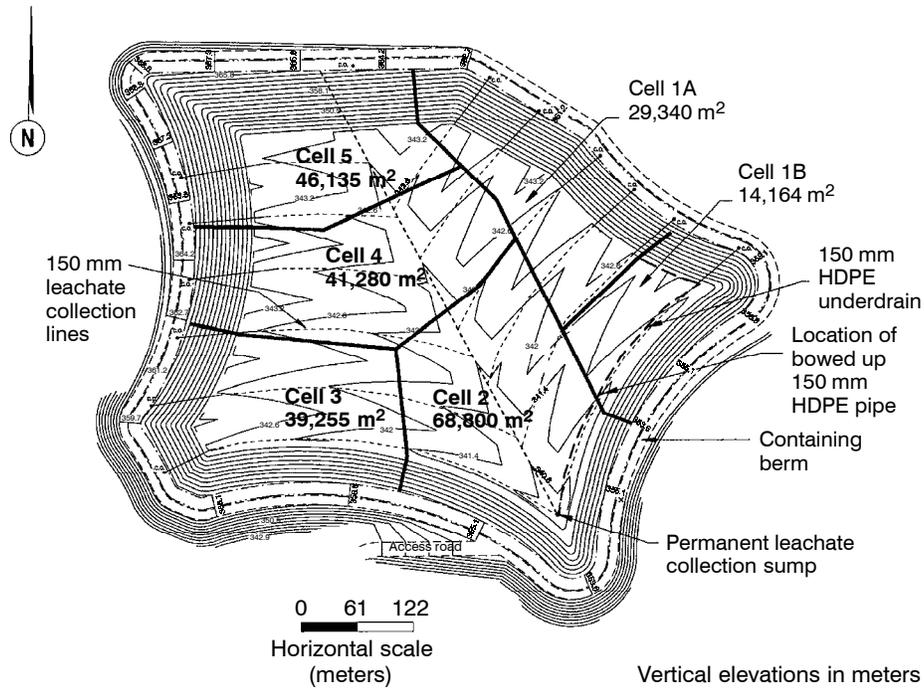
Figure 1. Plan view and cell layout.

Because of the haphazard depositional nature of the existing waste at the site, the lowest cell (Cell 2 in Figure 1) of the new landfill was not built first as is typically done in landfill construction. Instead, the next lowest cell (Cell 1) was constructed initially in an area with no existing waste. Cell 1 was designed with a temporary leachate collection system that was to be utilized until the main leachate collection sump became operational in Cell 2. The temporary leachate collection system was simply a depression of the composite liner system along the boundary of Cells 1 and 2. Figure 2 shows the excavation for the temporary leachate trench after placement of the geomembrane-

In summary, cross section A-A' appears to be the most representative 2-D cross section for the following reasons: (i) it yielded $FS \approx 1$; (ii) the leachate collection pipe shown in Figure 1 moved vertically upward after the protective sand material was excavated from the southern end of the temporary leachate collection trench indicating that sliding was possibly occurring parallel to the pipe; (iii) the geomembrane wrinkles were parallel to the toe of the waste slope indicating that sliding was perpendicular to the slope toe; and (iv) the surficial cracking occurred along the southern portion of the cell indicating movement away from or to the west of the southern containing berm (Figure 1).

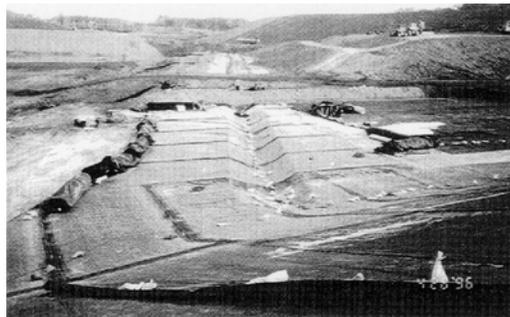
Figure 2. Temporary leachate collection system along the western edge of Cell 1B.

backed GCL. This temporary system was sloped from north to south (top to bottom in Figure 2) with a pump at the south or lowest end. The temporary leachate collection trench varied in depth and width because of the herringbone contour design of the cell floor that it bisected. The trench maintained a minimum 0.9 m thick recompacted soil liner and was lined with a geomembrane-backed GCL (Figure 3). It also maintained a minimum 0.45 m depression in the floor so that a nominal volume of leachate could be

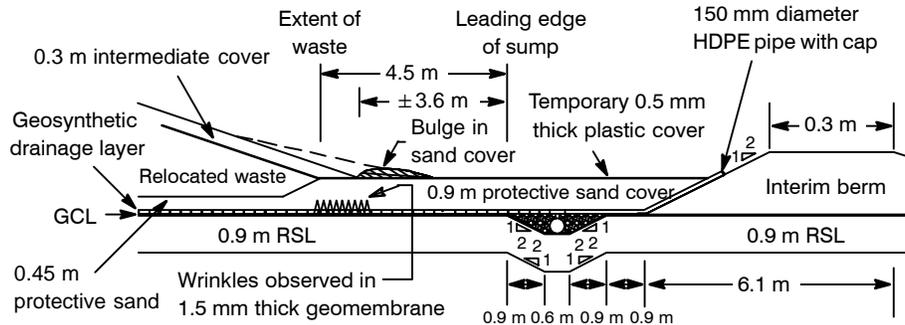
Figure 3. Cell 1 interim berm and temporary leachate collection trench.

collected and pumped. To accomplish this, a perforated pipe and sump pump were placed in the trench and then the entire trench was backfilled with gravel. The temporary leachate collection system would be disengaged when Cell 2 and the permanent leachate collection trench became operational.

On 5 August 1996, cracks in the interim soil cover were observed near the crest of the slope (see cross section A-A' in Figure 5) and near the horizontal limit of waste along the southwestern side of Cell 1B (Figure 6). Figure 6 shows the location of cross section A-A' in Figure 5. The observed cracks were 25 to 75 mm wide and 3 to 12 m long. The cracks exhibited no vertical offset and were characteristic of a horizontal separation. On 5 and 6 August 1996, waste was quickly pushed from the top and face of the waste slope into the void or valley where the haul road existed. This reduced the steepness of the slope and the overall height of the waste. The cracks were monitored using rudimentary methods and did not appear to lengthen, widen, or exhibit differential settlement after the slope was unloaded. It will be shown subsequently that the residual strength of the relevant geosynthetic interface is less than the peak values, which could have resulted in a larger failure due to the process of progressive failure. It is thought that a larger failure did not occur because of the rapid and significant unloading of the slope and the presence of the protective sand layer and the interim berm between Cells 1B and 2 (Figure 3) that provided some passive resistance.

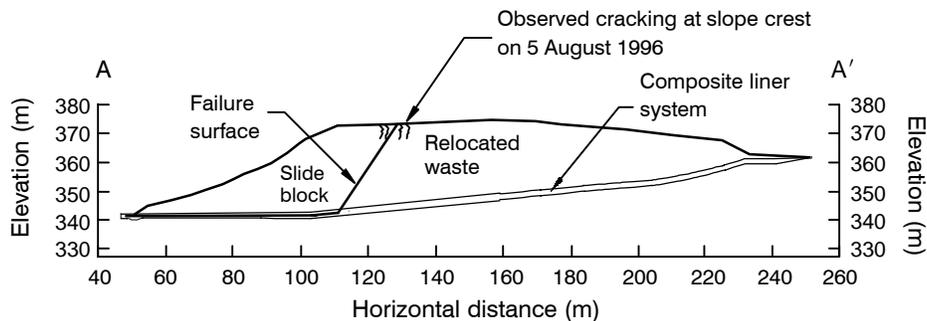
Figure 5. Cross section A-A' in Cell 1B.

After waste removal, several large tears (0.3 to 2 m wide) and numerous small tears (less than 0.3 m wide) were found in the geomembrane portion of the GCL, and two ruptured geomembrane seams were discovered. The large tears were located approximately below where the cracks were observed in the cover soil at the crest of the slope. As a result, an initial failure surface was assumed to extend from the cracks at the crest of the slope, through the relocated waste and geomembrane to the hydrated bentonite, and along the hydrated bentonite/RSL interface to the temporary leachate collection trench (Figure 5).

The large tears observed in the geomembrane after waste removal were located approximately below the cracks observed at the crest of the slope (Figure 5). As described previously, the failure surface was assumed to extend from the cracks at the crest of the slope, through the relocated waste and geomembrane to the hydrated bentonite,

It is anticipated that the slide mass at the toe of the slope moved first and, thus, the analysis should yield $FS \approx 1$ for a failure surface similar to the one shown in Figure 5. A search was conducted to locate the critical failure surface through the waste (Figure 5). This was accomplished by specifying a failure surface along the base of the slide mass that corresponded to the bentonite/RSL interface and performing a search for the critical orientation of the failure surface through the waste using XSTABL.

Using the peak hydrated bentonite/RSL interface failure envelope shown in Figure 9 and the input parameter values presented in Table 1, the failure surface in cross section A-A' (Figure 5) yielded a 2-D FS value of 1.01. The analysis was repeated with the peak smooth GM/GN interface failure envelope instead of the failure envelope for the hydrated bentonite/RSL interface. This analysis yielded $FS = 1.11$, thus, confirming field observations that showed sliding primarily occurred at the RSL/hydrated bentonite interface.

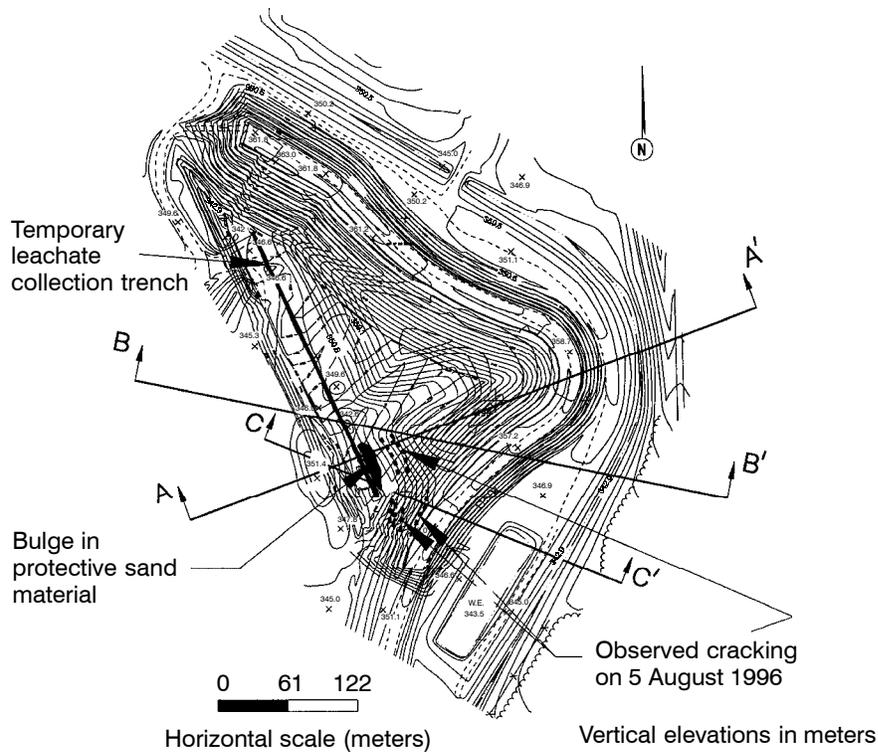
Figure 6. Location of slope stability cross sections.

A number of other cross sections were analyzed. The results from two of these cross sections are shown in Table 2 and Figure 6 presents the location of these two cross sections. These cross sections were chosen because they correspond to the cracking that was observed along the southern edge of Cell 1B. It can be seen from Table 2 that the $FS > 1$ for cross sections B-B' and C-C'. As a result, these cross sections were deemed not critical. In addition, the direction of sliding was perpendicular to the temporary leachate collection trench.

and along the hydrated bentonite and/or smooth GM/GN interface to the toe of the slope. Therefore, it was concluded that the toe of the slope moved towards the temporary leachate collection trench. This sliding occurred prior to excavation of the protective sand cover (Figure 3) because a 0.2 to 0.4 m high bulge was observed in the protective sand cover. After the slide block moved, the geomembrane tore and cracking probably developed at the crest of the slope and along the southwest portion of the slide mass (Figure 6).

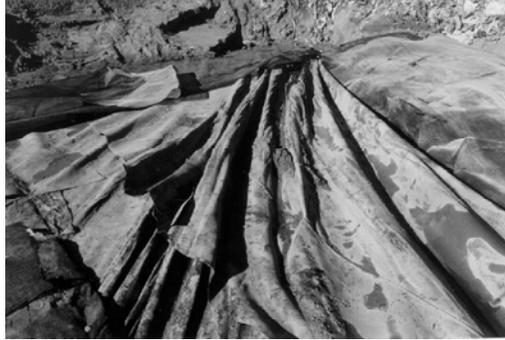
Figure 7. Wrinkles in the geomembrane at the toe of the slope in Cell 1B.

Note: The width of the bottom edge of the photograph is approximately 4 m.

shortly after installation. The size of the wrinkles suggested that other mechanism(s) must have contributed. The wrinkles formed an arc shape (Figure 4) and were parallel to the toe of the waste slope along the western edge of Cell 1B. The wrinkles then were found to be parallel to the Cell 1A/Cell 1B boundary. The exposed wrinkles were approximately 200 to 300 mm high and covered an area approximately 45 m long and 1.2 m wide. It was estimated that approximately 3 to 4 m of geomembrane was wrinkled into the 1.2 m wide strip. After discovering the wrinkles, the temporary collection trench was closed and the protective sand was placed on the geosynthetics.

The remedial measures consisted of welding another layer of the geomembrane-backed GCL over the damaged area. However, in many instances the folds or wrinkles of the damaged GCL had to be flattened to obtain intimate contact between the bentonite of the newly placed GCL and the underlying damaged liner. This was accomplished by cutting the folds open and laying the existing GCL flat onto the recompacted soil liner. This reduced the time that the intact recompacted soil liner would be exposed and possibly damaged by rain water and/or leachate. Approximately 6,070 m² of the 14,164 m² liner system in Cell 1B was damaged.

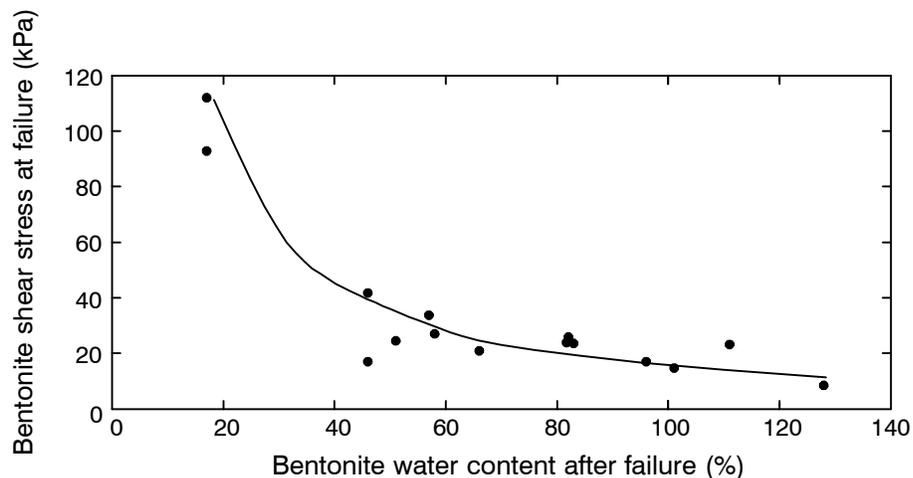
Figure 8. Relationship between bentonite shear strength and water content (data from Daniel et al. 1993).

Figure 8 shows that the peak shear strength of bentonite decreases as the water content increases from the manufactured value of 10 to 15%. More importantly, at a water content between 60 and 80% the majority of the strength loss has occurred. Therefore, the partially hydrated tests resulted in an average water content at or below the transition water content of 60 to 80% while the hydrated tests yielded an average water con-

tent above the transition water content. The field water contents range from 64 to 86%, which suggests that the bentonite had undergone a significant strength loss in the field due to hydration. The field bentonite water content may have been even higher if the bentonite consolidated under the weight of the relocated waste. However, it is anticipated that the amount of bentonite consolidation was small, if any, due to the presence of a geomembrane and RSL.

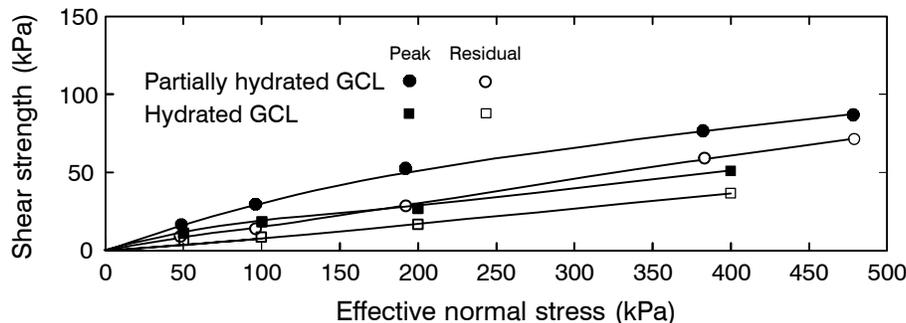
Figure 9. Drained peak and residual shear strength envelopes for GCL/RSL interfaces.

Figure 9 presents the peak and residual failure envelopes from the partially hydrated smooth geomembrane-backed GCL/RSL interface shear testing. The partially hydrated bentonite/smooth geomembrane interface exhibits a peak and residual friction angle of approximately 15 and 9°, respectively. Superimposed in Figure 9 are the peak and residual failure envelopes from the hydrated smooth geomembrane-backed GCL/RSL interface tests. It can be seen that the hydrated tests yield lower peak and residual failure envelopes than the partially hydrated tests. The hydrated bentonite/smooth geomembrane interface exhibits a peak and residual friction angle of approximately 8 and 5°, respectively.

The analysis was also repeated using the partially hydrated bentonite/RSL interface failure envelope (Figure 9). This analysis yielded $FS = 1.36$ (Table 2). As a result, it was concluded that the bentonite on the base of the slide mass was probably hydrated, allowing the slide mass to move toward the temporary leachate collection trench. A hydrated condition was also in agreement with field observations and bentonite water contents measured after waste excavation.

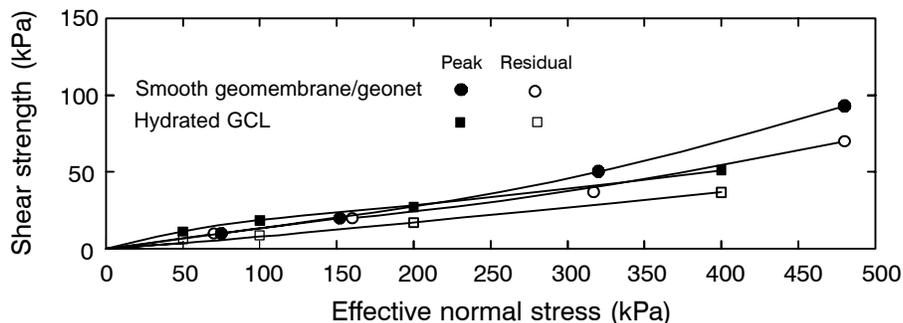
Figure 10. Peak and residual shear strength envelopes for hydrated GCL/RSL and smooth GM/GN interfaces.

Figure 10 presents the peak and residual failure envelopes from the smooth geomembrane (GM)/geonet (GN) interface shear testing. The smooth GM/GN failure envelopes are clearly stress dependent. At normal stresses greater than approximately 300 kPa, the slope of the peak and residual failure envelopes increases. This is attributed to the geonet embedding into the geomembrane and providing some additional shear resistance. Superimposed in Figure 10 are the peak and residual failure envelopes from the hydrated smooth geomembrane-backed GCL/RSL interface tests. It can be seen from Figure 10 that the peak smooth GM/GN failure envelope is below the peak GCL/RSL failure envelope for effective normal stresses ranging from 0 to approximately 225 kPa. The effective normal stress acting on the base of the failure surface in Figure 5

ranges from 10 kPa at the toe of the slope to 440 kPa where the failure surface enters the relocated waste. More importantly, after waste excavation, striations were observed near the toe of the slope on the GM/GN interface whereas the striations on the hydrated bentonite/RSL interface were concentrated behind the slope toe.

Because cross section A-A' was deemed critical, Table 3 presents the FS values corresponding to a residual strength condition and the deformed slope geometry (Figure 13). It can be seen that the hydrated bentonite/RSL interface yields $FS = 1$, which is in agreement with field observations. Momentum effects were not considered in this analysis due to the limited movement and, thus, probable slow rate of movement. As expected, the partially hydrated bentonite/RSL and smooth GM/GN interfaces yielded $FS > 1$, which is in agreement with the FS values in Table 2. A composite residual failure envelope was not applicable because the hydrated bentonite/RSL interface failure envelope is lower for the full range of normal stresses (Figure 10).

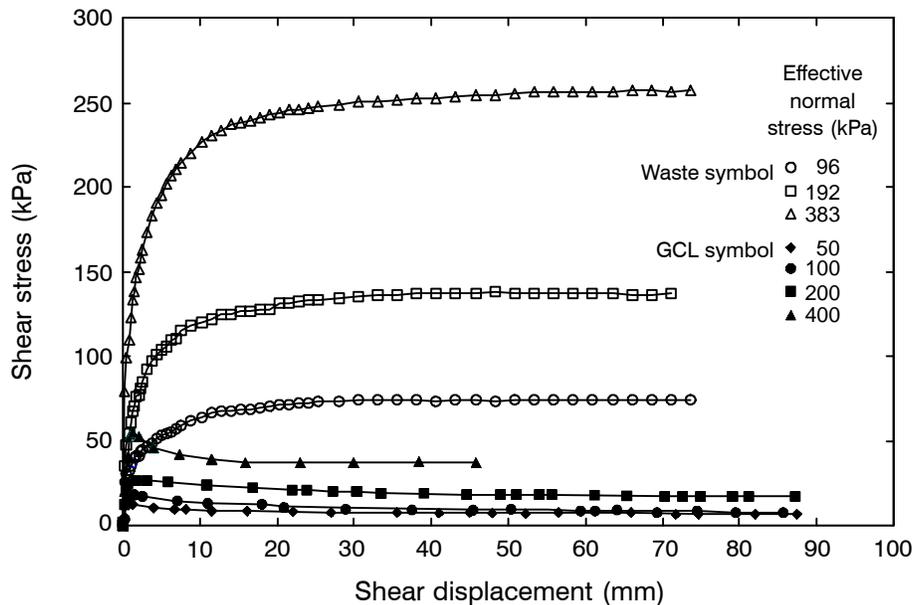
Figure 11. Shear stress-displacement relationships for a waste and hydrated GCL/RSL interface.

The shear strength parameters for the relocated waste were measured by Earth Sciences Consultants, Inc. (1997). Direct shear tests were conducted on reconstituted specimens of the relocated waste. The relocated waste was placed in a 0.3 m by 0.3 m square direct shear box (ASTM D 5321) at a unit weight of 18.5 kN/m³ and a water content of 17.7% to simulate the field placement conditions. The relocated waste specimens were obtained from field samples that consisted of brown sandy clay with approximately 10% waste. It was concluded that a 0.3 m by 0.3 m square specimen was representative of field conditions because the relocated waste contained approximately 10% waste and 90% soil. Three direct shear tests were conducted on the relocated waste at effective normal stresses of 96, 191, and 373 kPa to cover the range of normal stresses acting on the liner system. The normal stresses were applied using pneumatic cylinders and a displacement rate of 0.25 mm/minute was used for the shear testing. The peak failure envelope for the relocated waste was found to correspond to a cohesion and friction angle of 5 kPa and 33°, respectively (Table 1). The shear stress-displacement relationships from these direct shear tests did not exhibit a post-peak behavior after approximately 60 mm of displacement as shown in Figure 11.

It is anticipated that another cause of the development of a post-peak or residual shear strength along a geosynthetic interface is the strain incompatibility between the waste and underlying interfaces. For example, the relocated waste mobilizes a peak shear strength at a displacement 10 to 15 times larger than the displacement at which

the hydrated bentonite/RSL interface mobilizes a peak shear strength (Figure 11). As a result, progressive failure can cause the interface to mobilize a post-peak shear strength before the peak strength of the relocated waste has been mobilized. This is evident from Figure 11 where the peak shear strength of the interface is mobilized at a shear displacement of 2 to 3 mm while the peak strength of the waste is mobilized at a displacement of 30 to 40 mm. At a shear displacement of 40 mm the GCL/RSL interface has mobilized a residual shear strength.

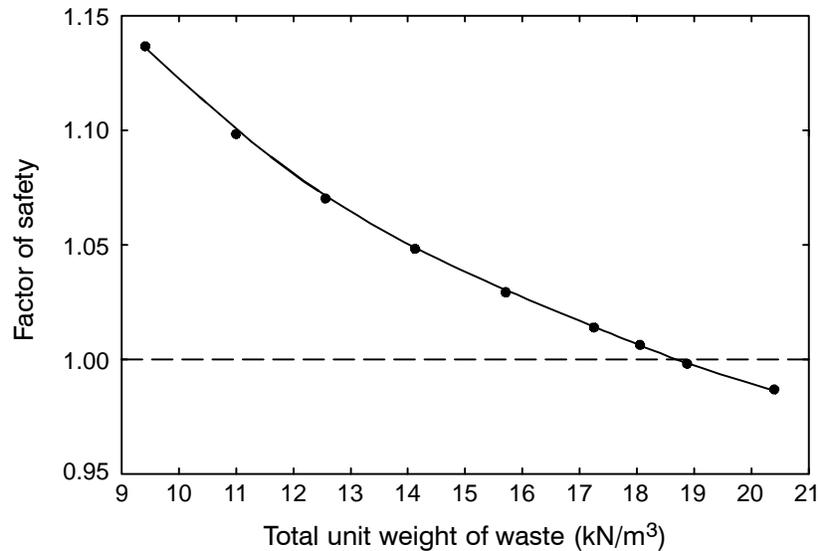
Figure 12. Effect of waste unit weight on factor of safety in Cell 1B.

As mentioned previously, the unit weight of the relocated waste was greater than the new MSW that was being placed in Cell 1A because it consisted of up to 90% soil and was at or near saturation. The effect of unit weight of the relocated waste on the FS value was investigated using cross section A-A', the input parameters shown in Table 1, and the peak failure envelope for the hydrated bentonite/RSL interface. The results of the analysis are shown in Figure 12. It can be seen that even at a unit weight of 9.4 kN/m^3 , $FS < 1.15$ for a waste friction angle and cohesion of 33° and 5 kPa , respectively. Kavazanjian et al. (1995) suggest that new municipal solid waste exhibits a friction angle of 33° and a cohesion of 24 kPa for normal stresses less than 30 kPa . The FS value for a unit weight of 9.4 kN/m^3 and a cohesion and friction angle of 24 kPa and 33° , respectively, is approximately 1.16. Therefore, the slope probably would have been marginally stable even if new MSW, and not relocated waste, was placed in Cell 1B. In summary, it appears

that the steep interim slope (1V:2.5H) and the heavy relocated waste induced shear stresses that exceeded the shear resistance along the critical geosynthetic interface.
