Yeager Airport RSS Failure Case History: Forensic Limit Equilibrium and FLAC Analyses

Stability and Stress-Deformation Analyses of Reinforced Slope Failure at Yeager Airport

Case history on failure of a 67 M tall reinforced soil slope

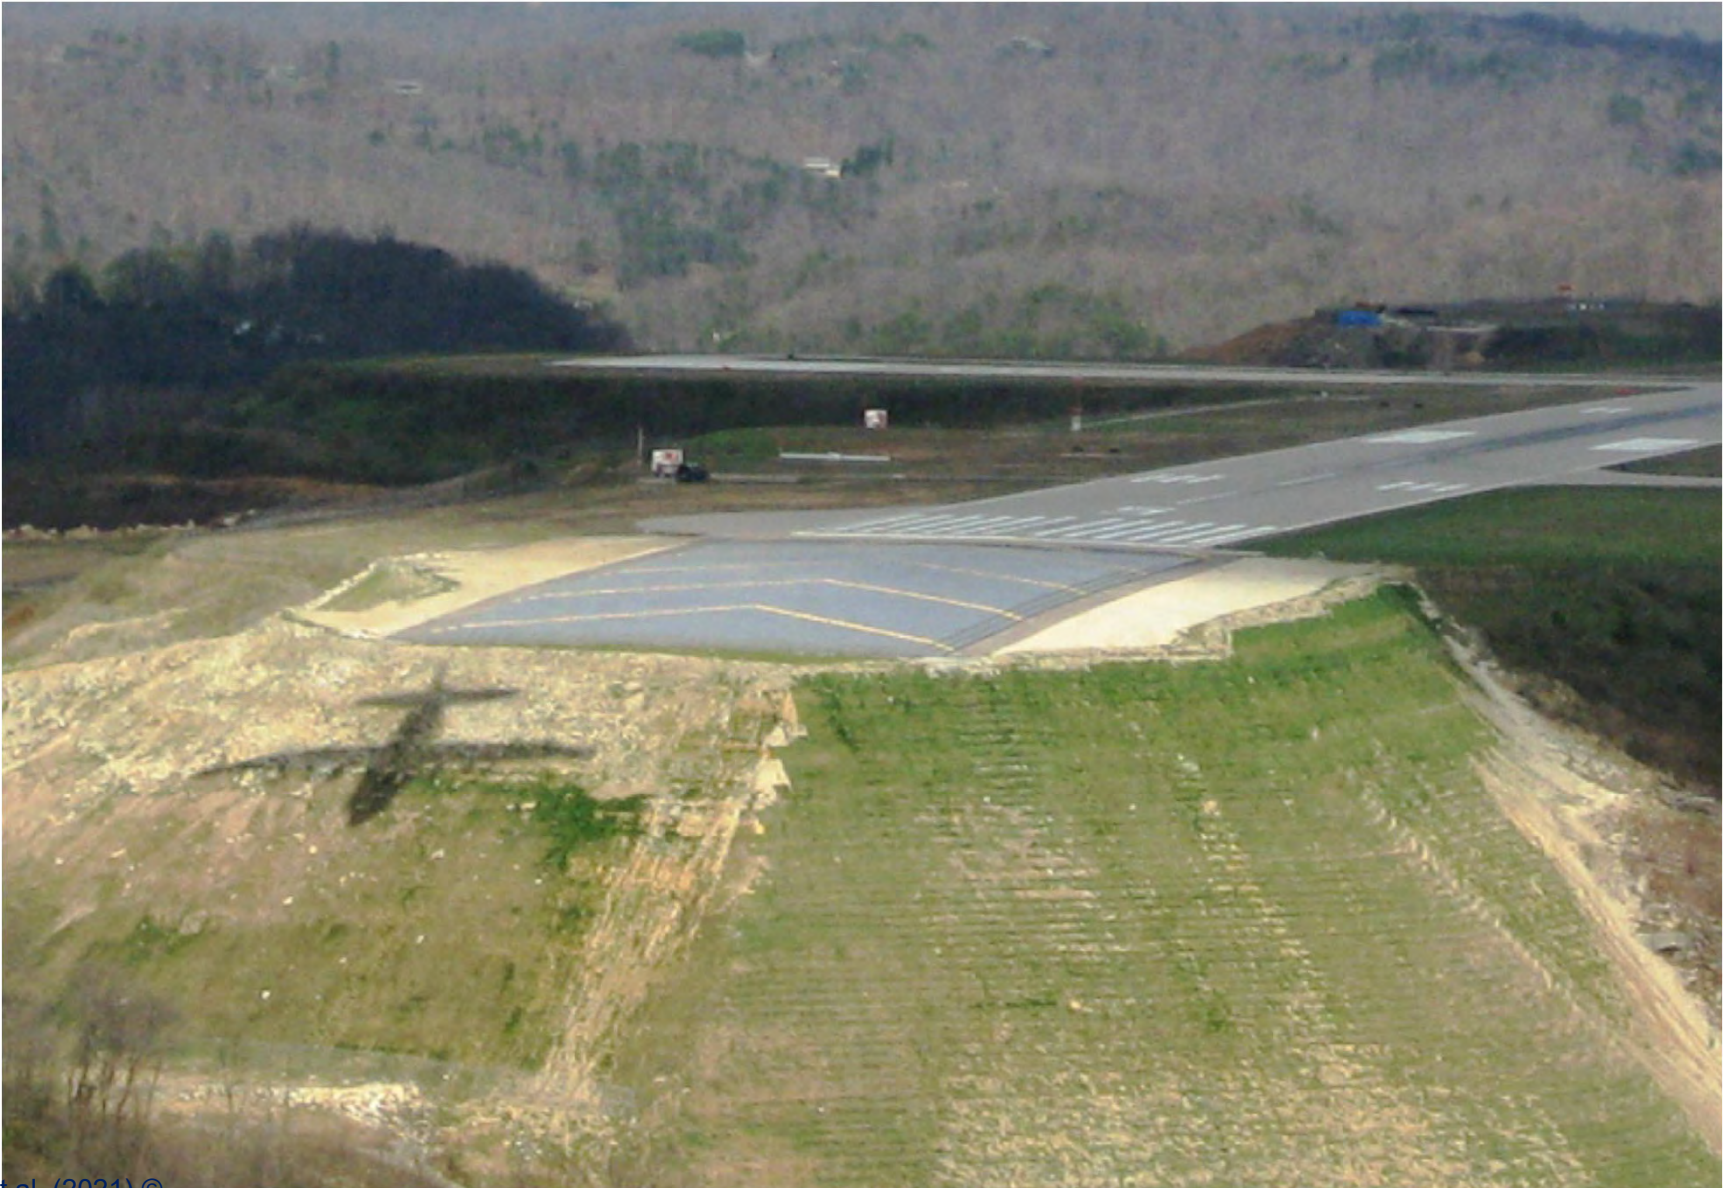
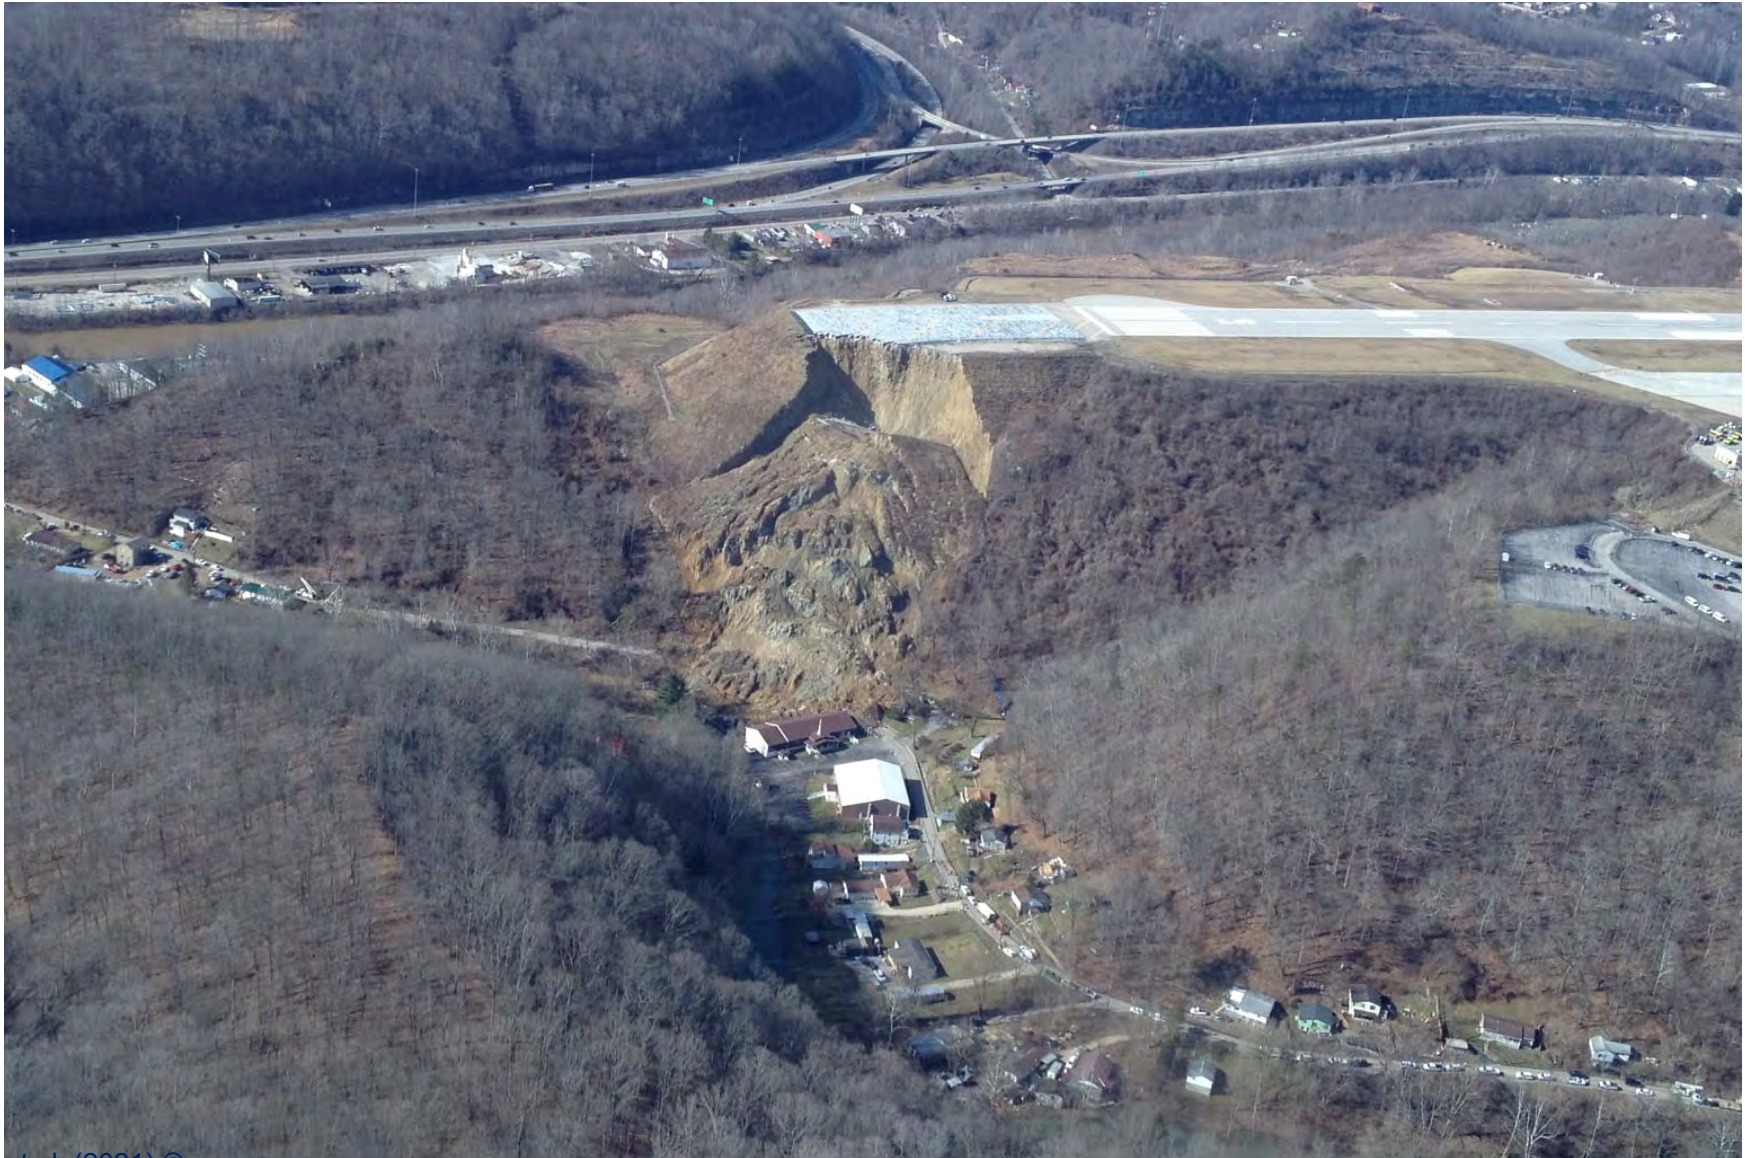
- August 2005 - RSS Construction started
- December 2006 - RSS Construction Completed
- 2010 through 2014 - Shallow slides at base of RSS
- July 2013 - First cracks in EMAS noted
- January 2015 – Settlement of EMAS observed
- March 12, 2015 - Catastrophic failure

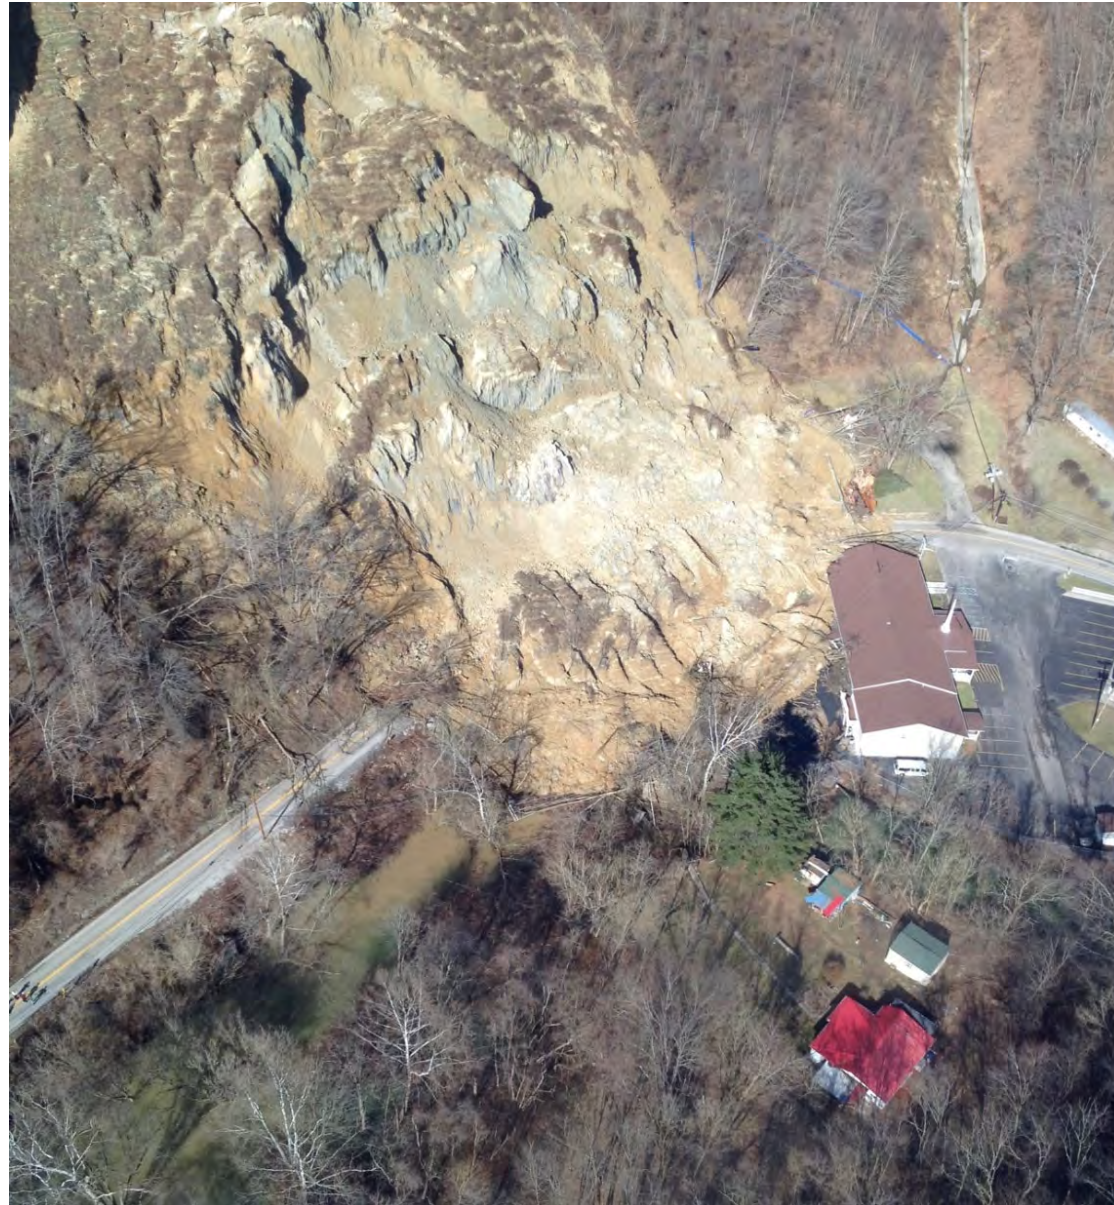
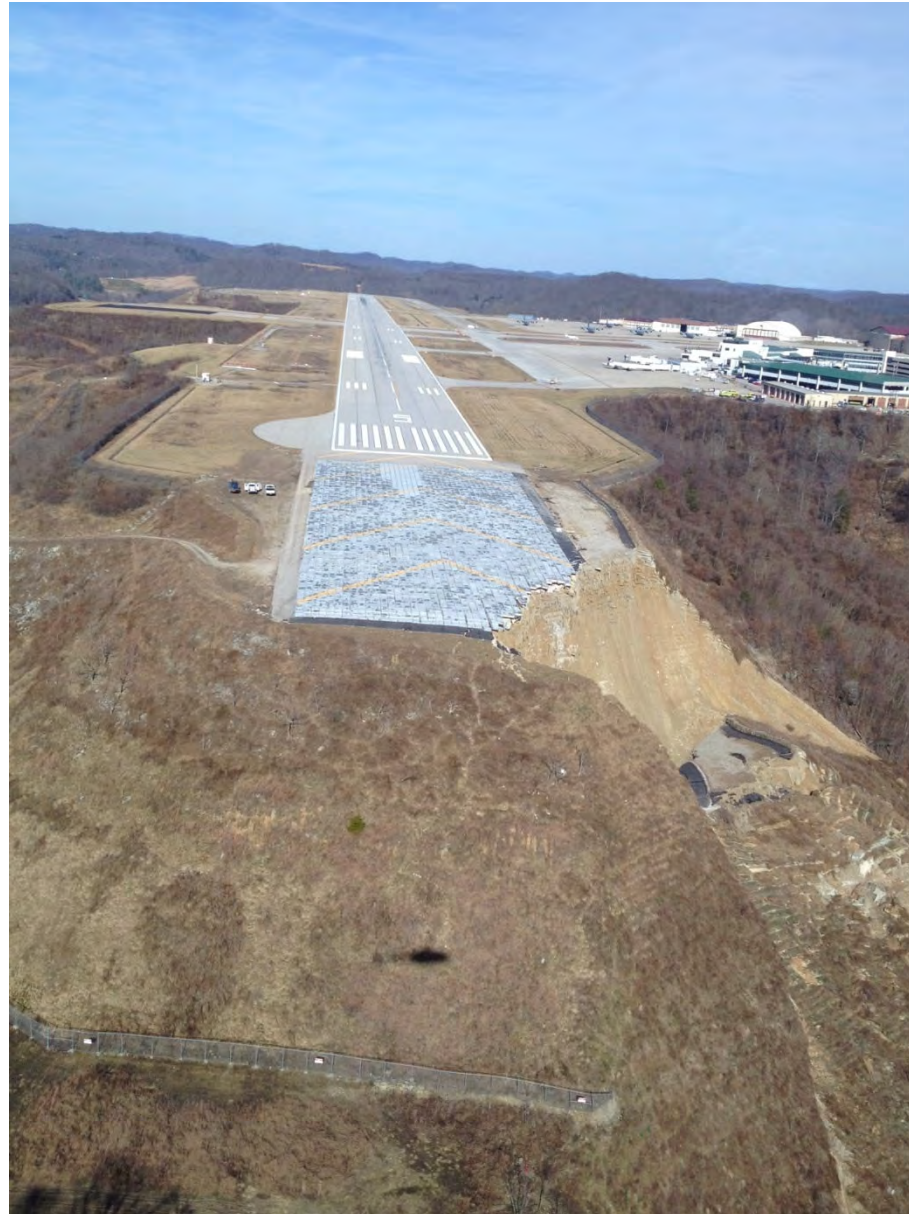
Failure Closed Keystone Drive Below RSS

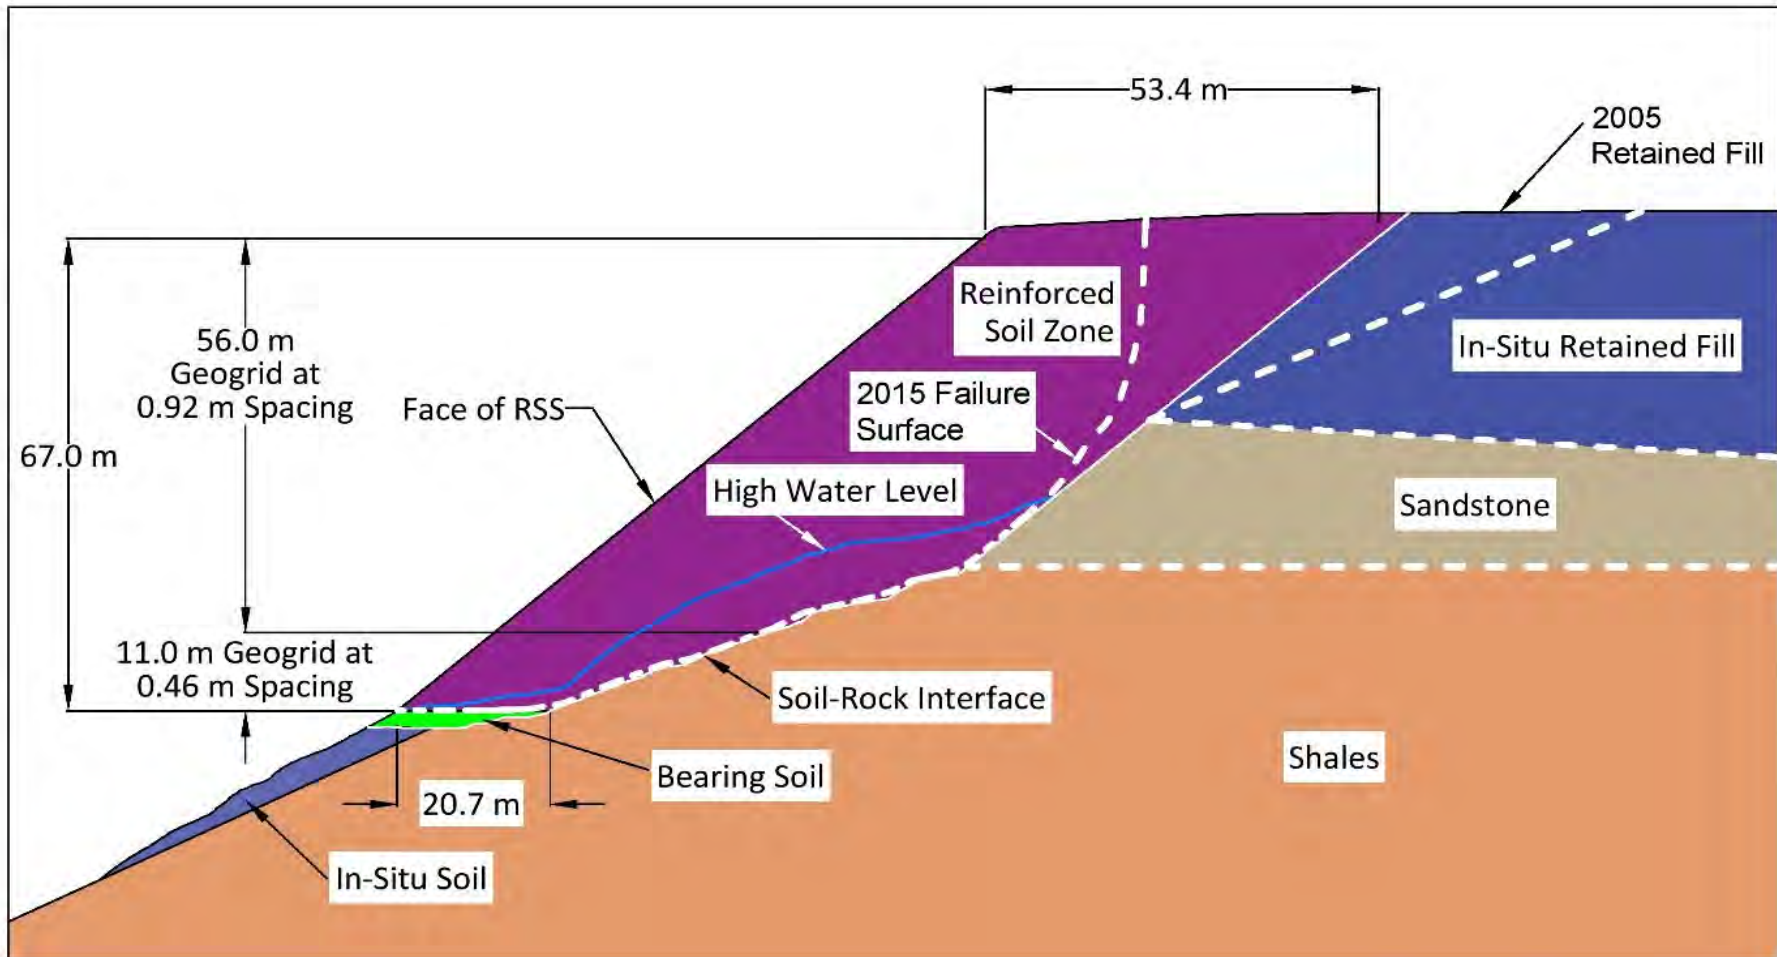
- 250 ft/76.3 m high slope
- 175 ft/53.4 m long geogrid
- 1H:1V

- Compound failure mode
- Failure surface below RSS was along a shale-claystone interface
- RSS collapse occurred after 8 years in-service as shear strength of shale-claystone interface decreased from peak towards the fully softened strength

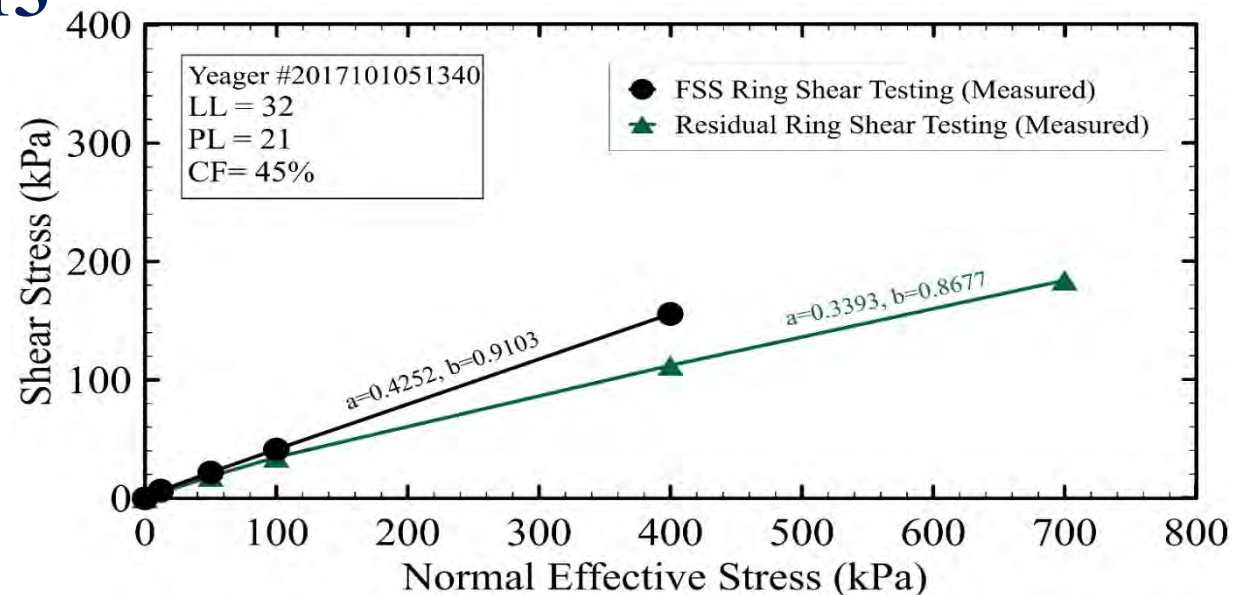
- **LL = 32 – 40**
- **PI = 11 - 19**
- **CF = 45 - 46**

- **FSS = 27 – 21⁰**
- **Residual = 18 – 13⁰**

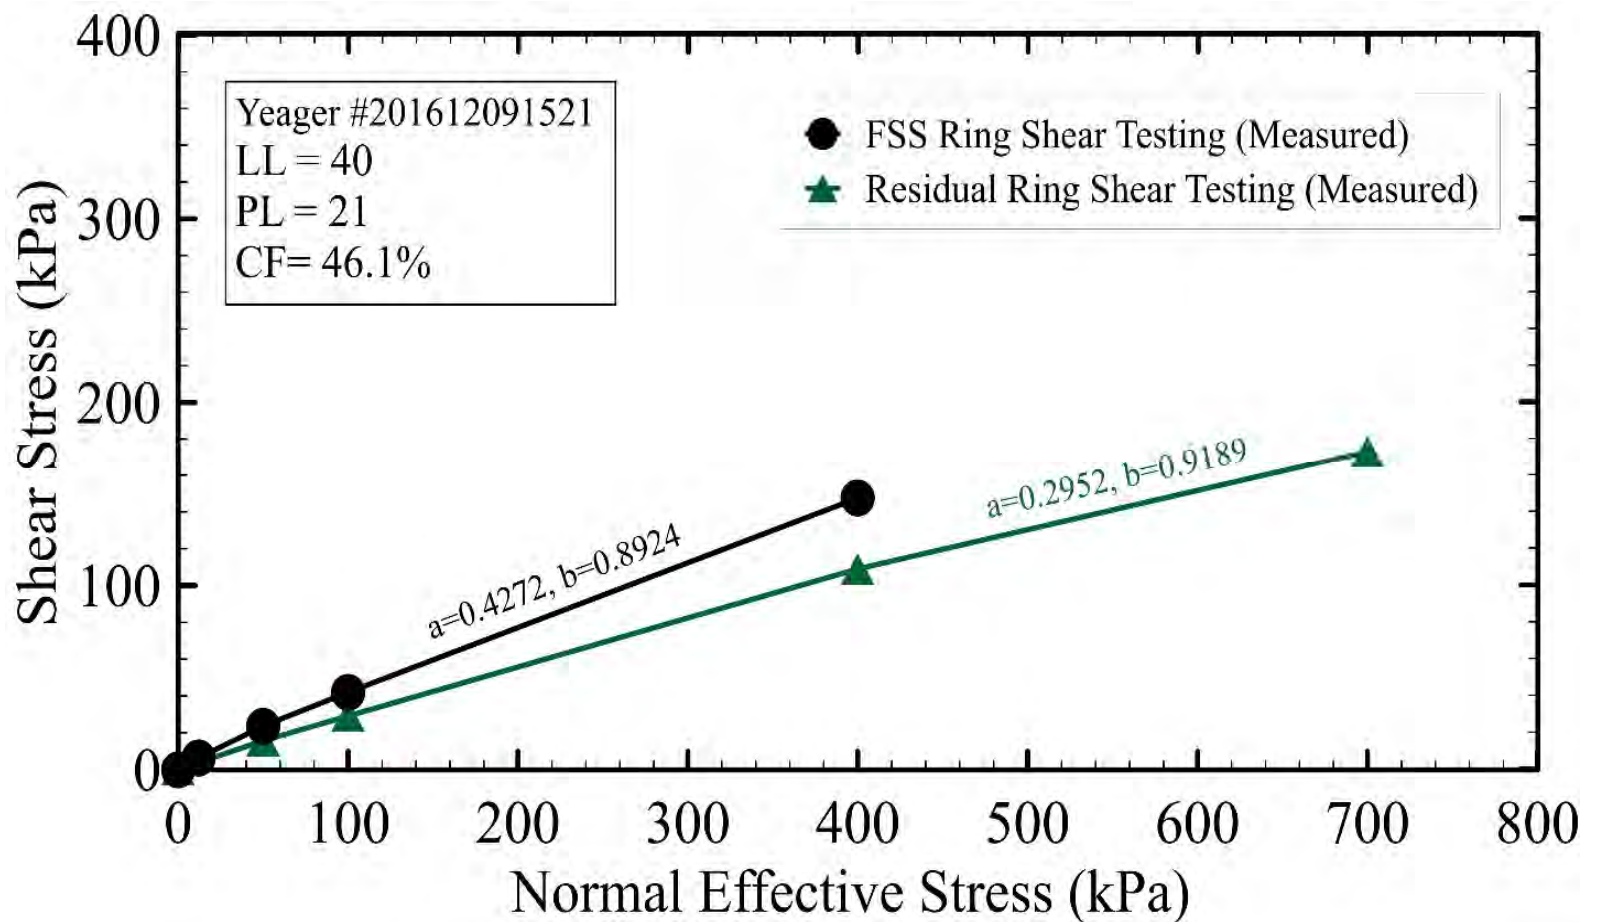
- $FSS = 26 - 20^0$
- $Residual = 17 - 14^0$
- Correlations – Stark and Eid (1997)

Slope Material	Moist Unit Weight γ_{moist} (pcf/kN/m ³)	Effective Stress Friction Angle ϕ' (deg)	Effective Stress Cohesion c' (psf/kPa)
Reinforced Soil Zone	135/21.2	36°	0
In-Situ Retained Soil Zone	135/21.2	36°	0
Bearing Soil at Slope Toe	135/21.2	36°	0
Soil/Rock Interface	135/21.2	Stress-dependent strength envelope	0

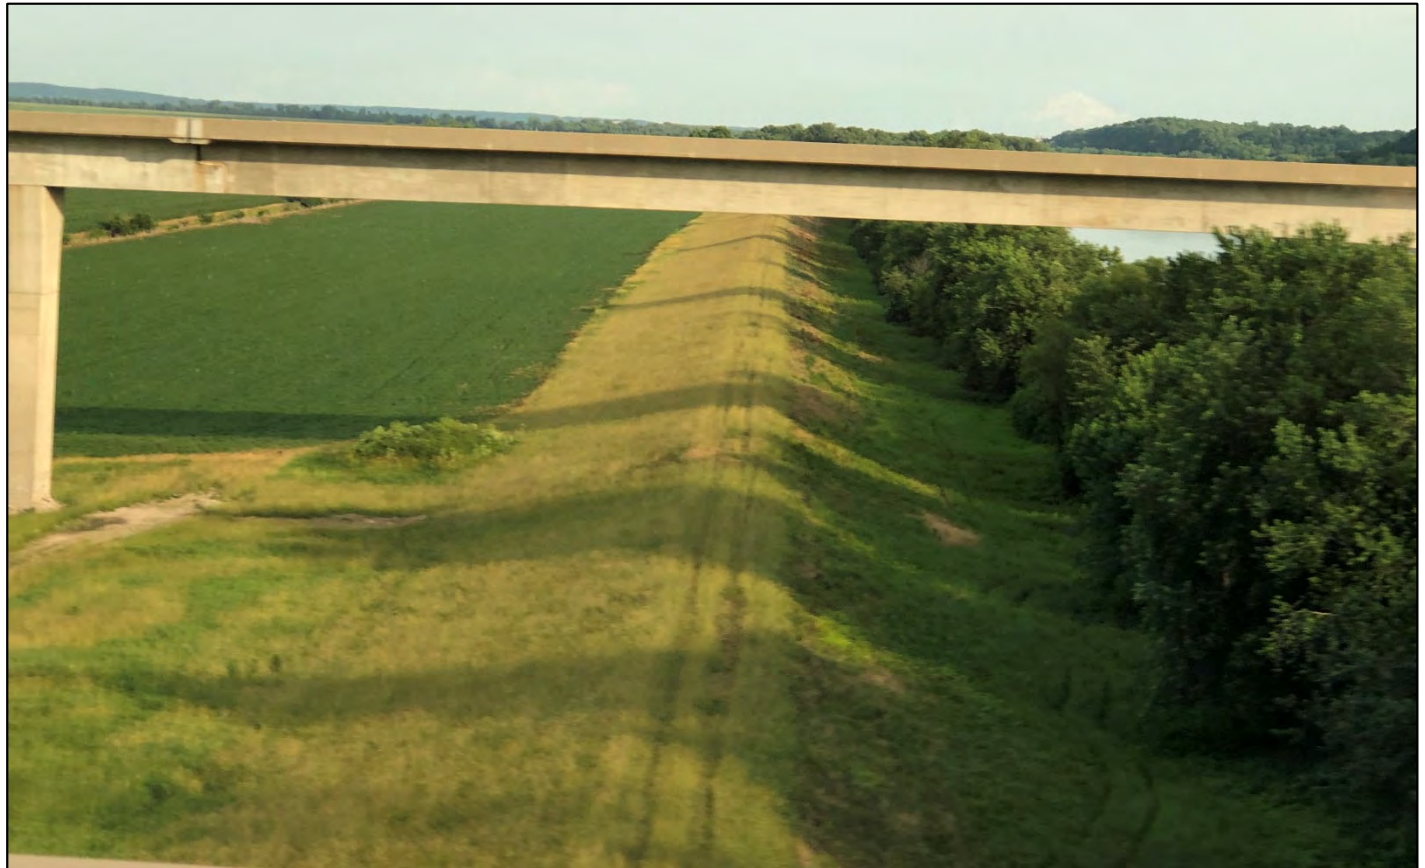
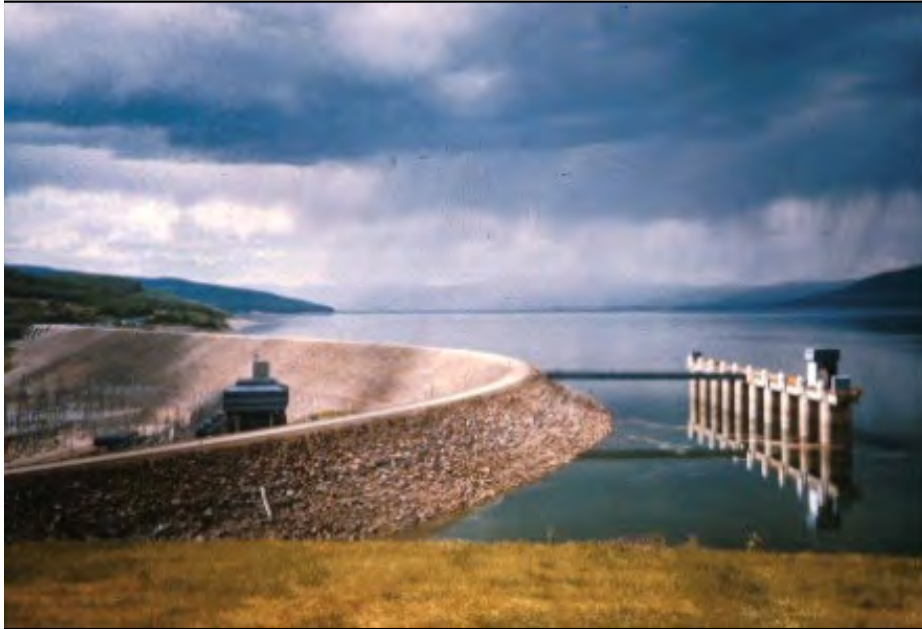
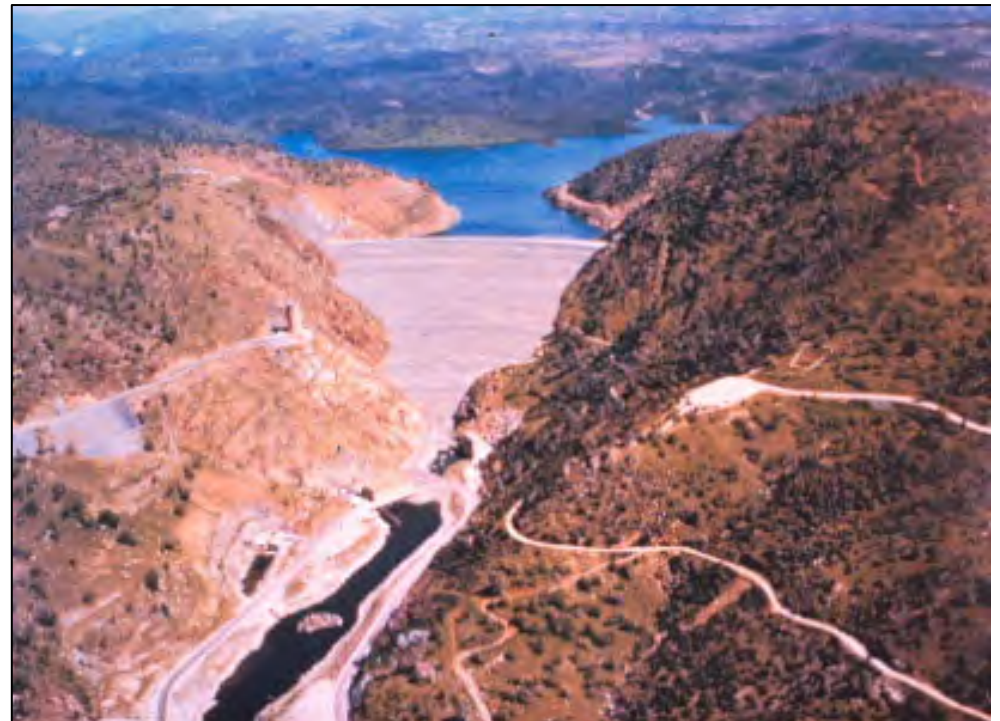
- **2D analyses assume plane strain condition**
- **Slopes are not infinitely wide**
- **3D effects influence stability**

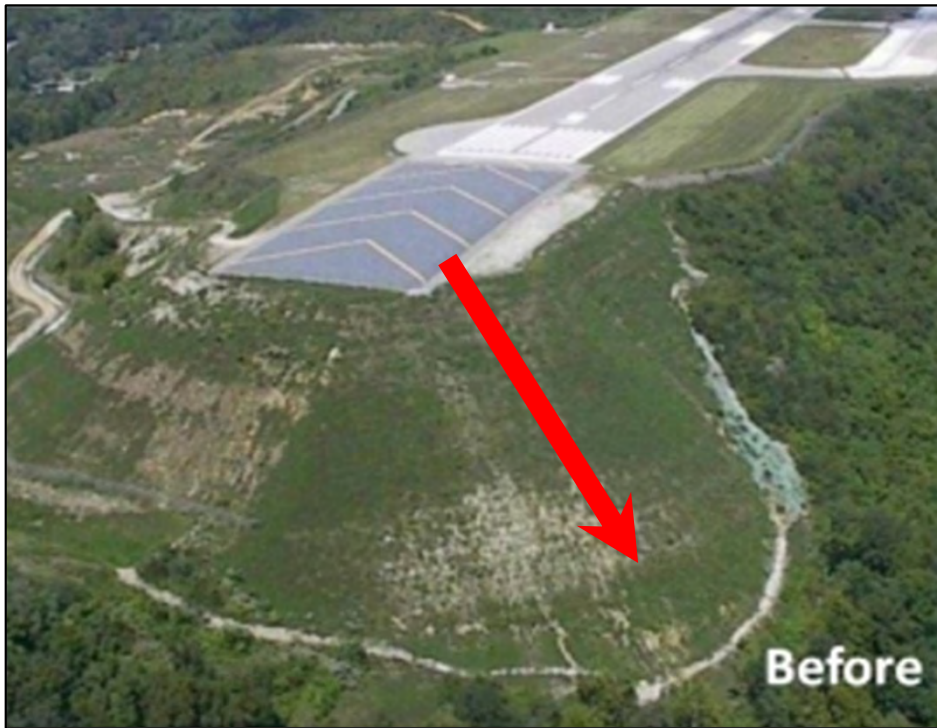
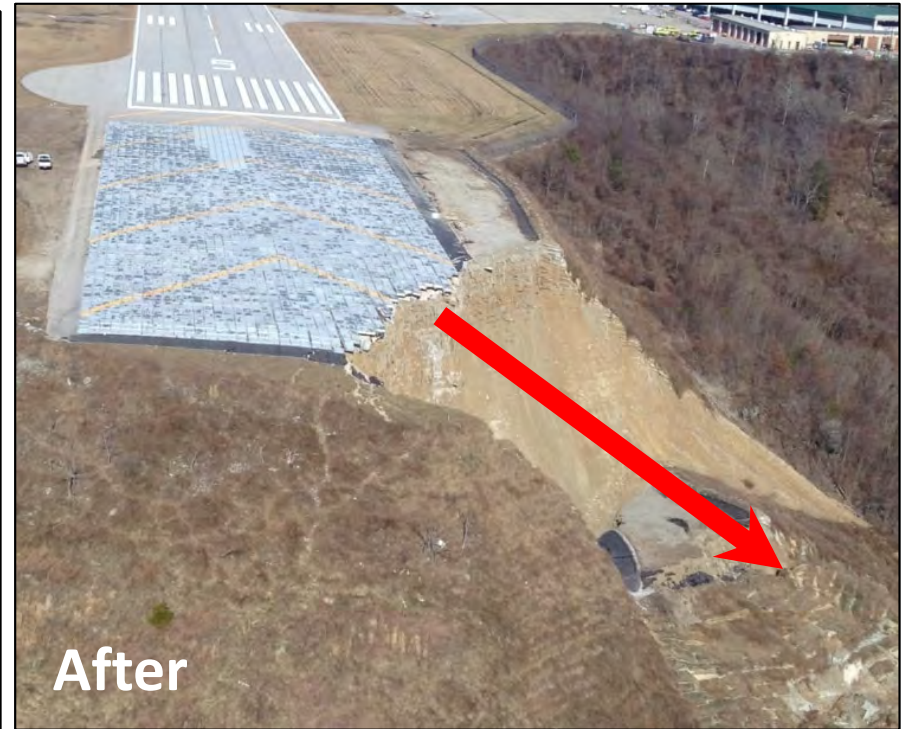
- **Uni-Axial Geogrid**

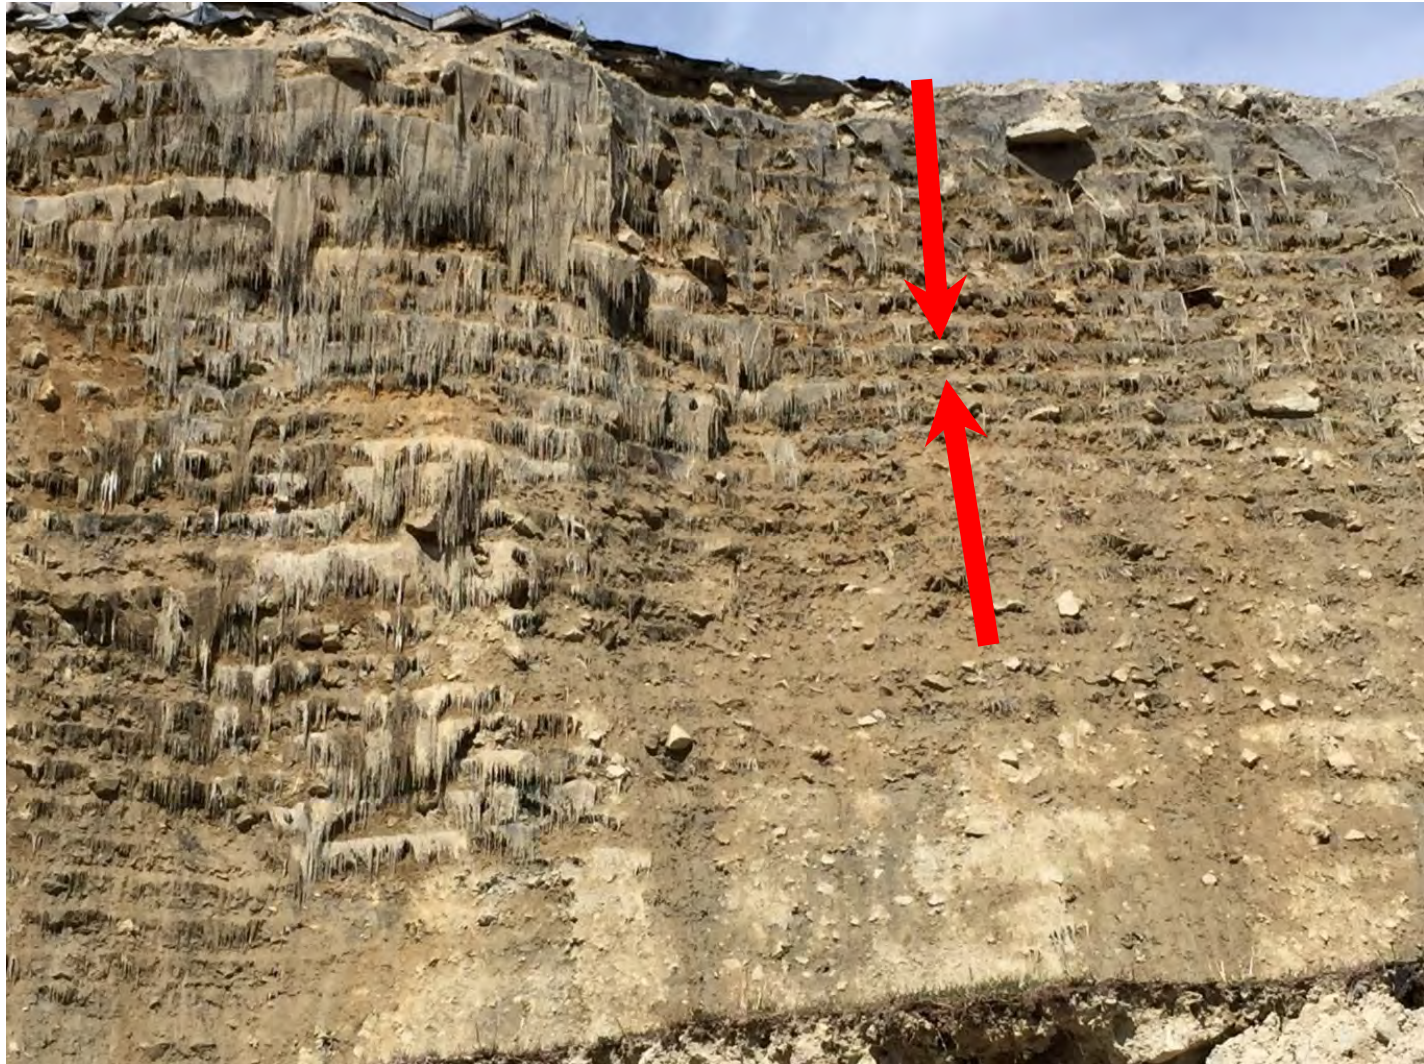
- All 3 ft

- El. 710.0 to 744.5 ft = every 1.5 ft vertically
- Above El. 746.0 ft = every 3.0 ft vertically

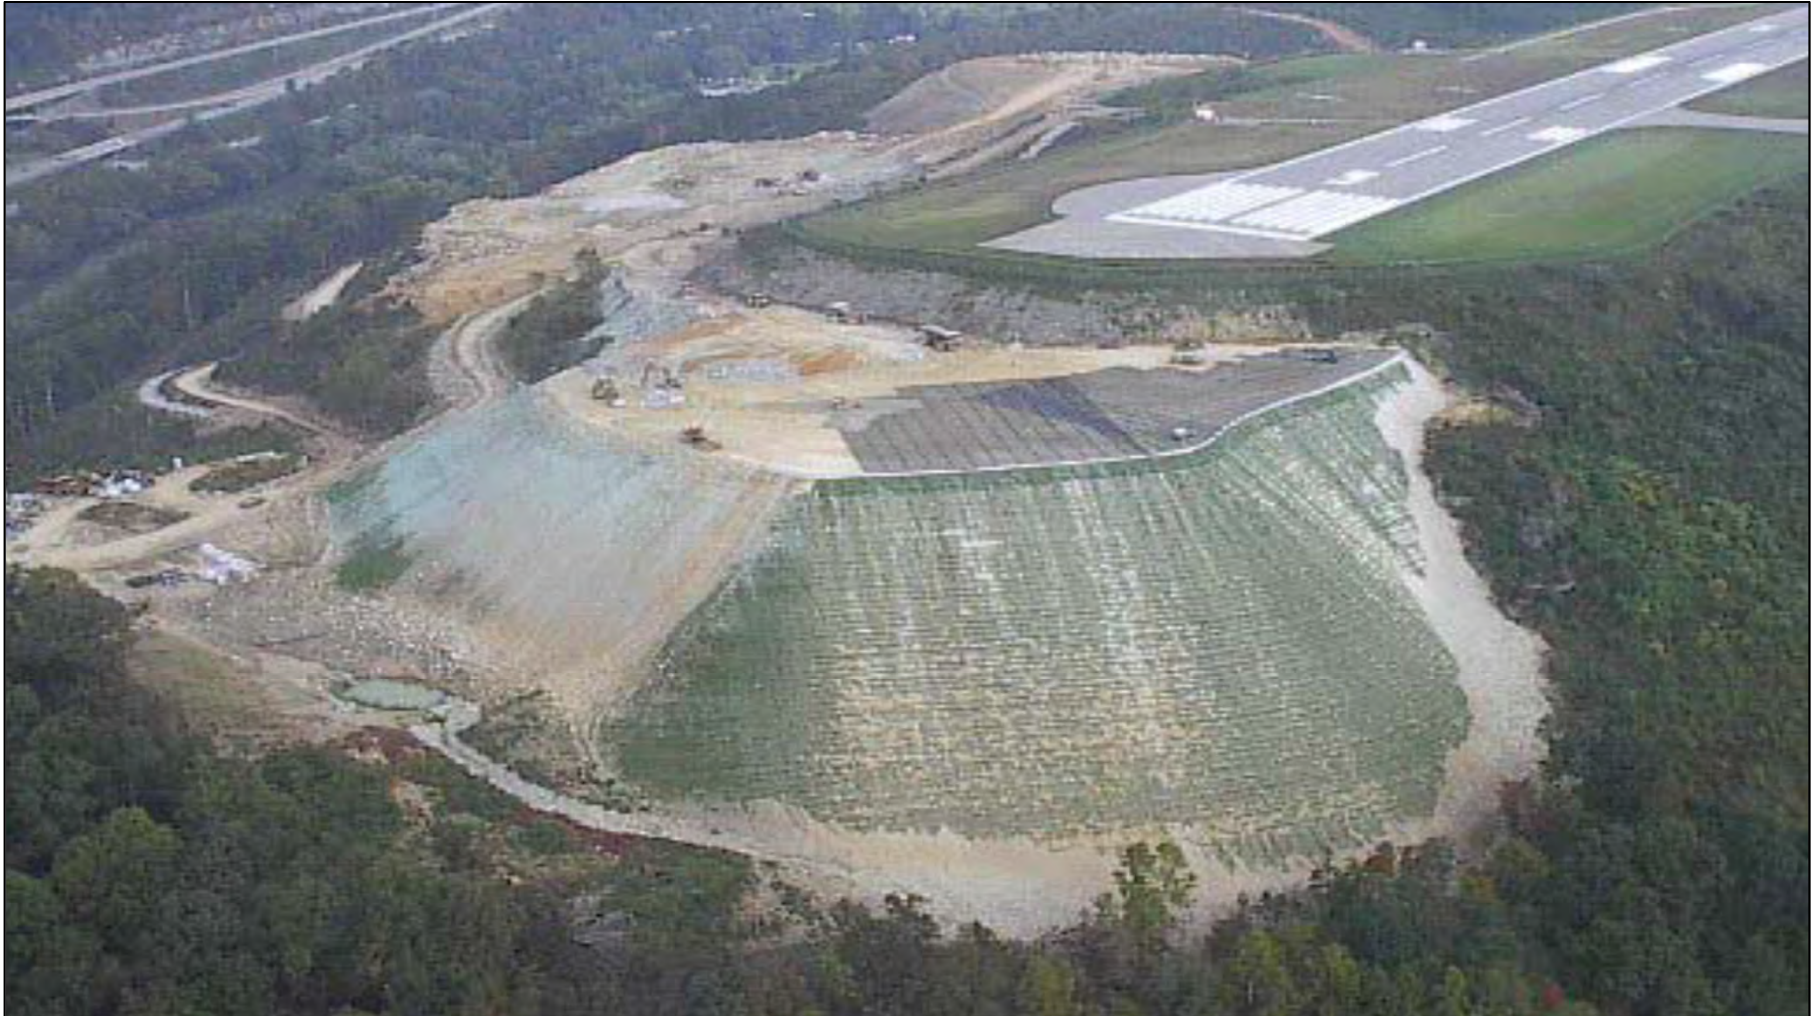
- 90% reduction b/t MD and XMD

- 3D Geometry, Slide Mass, Anisotropy, & High GW

FS 0.95

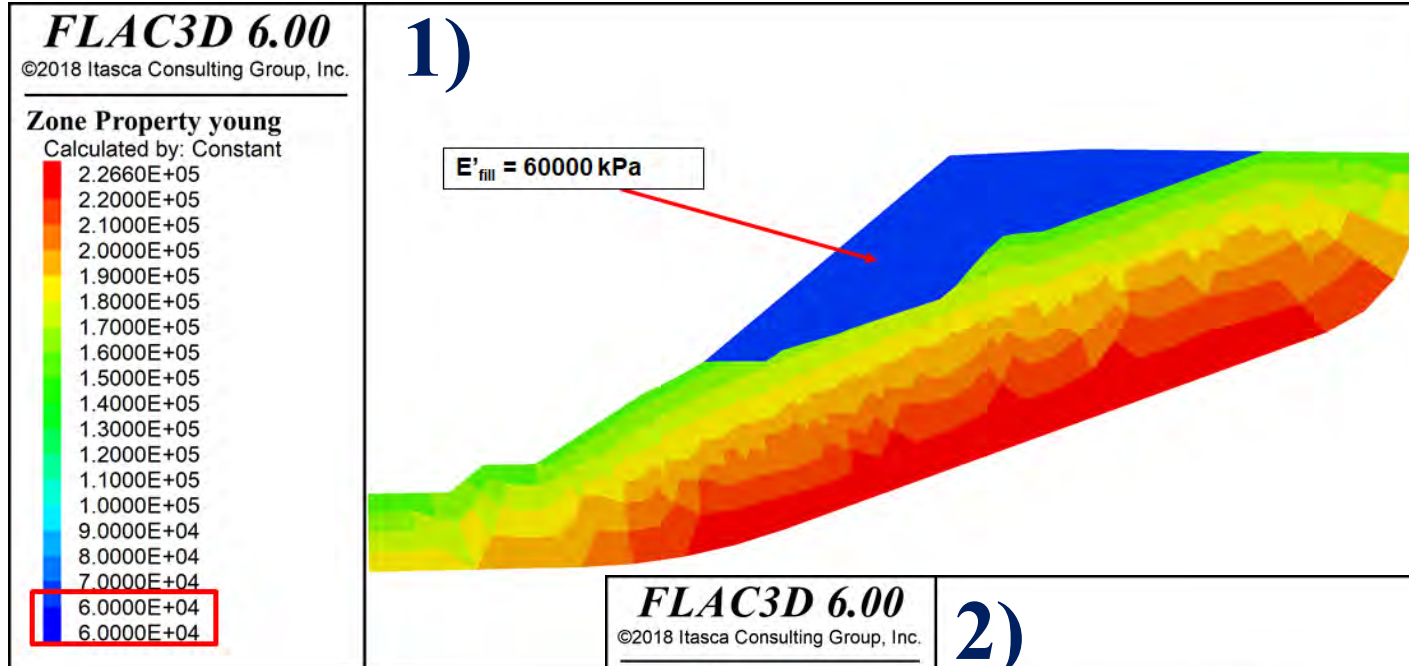
The reason for considering a stress dependent modulus inside the fill is to investigate the potential effect on the stress mobilization pattern in the reinforcement during the strength reduction process leading to significantly different internal (inside the fill mass) shear band formation.

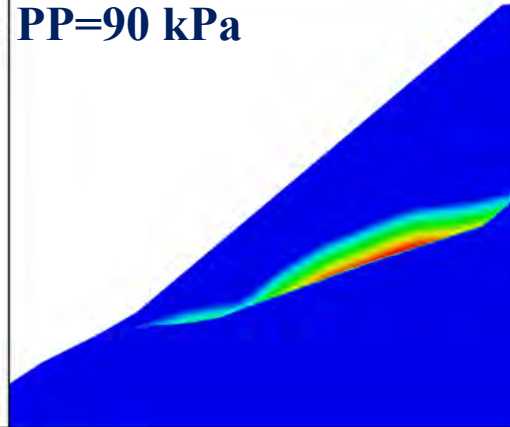
FLAC3D Model – Stage 3a – Exhumed prop, PP=Medium

PP=90 kPa

Zone Gridpoint Pore Pressure

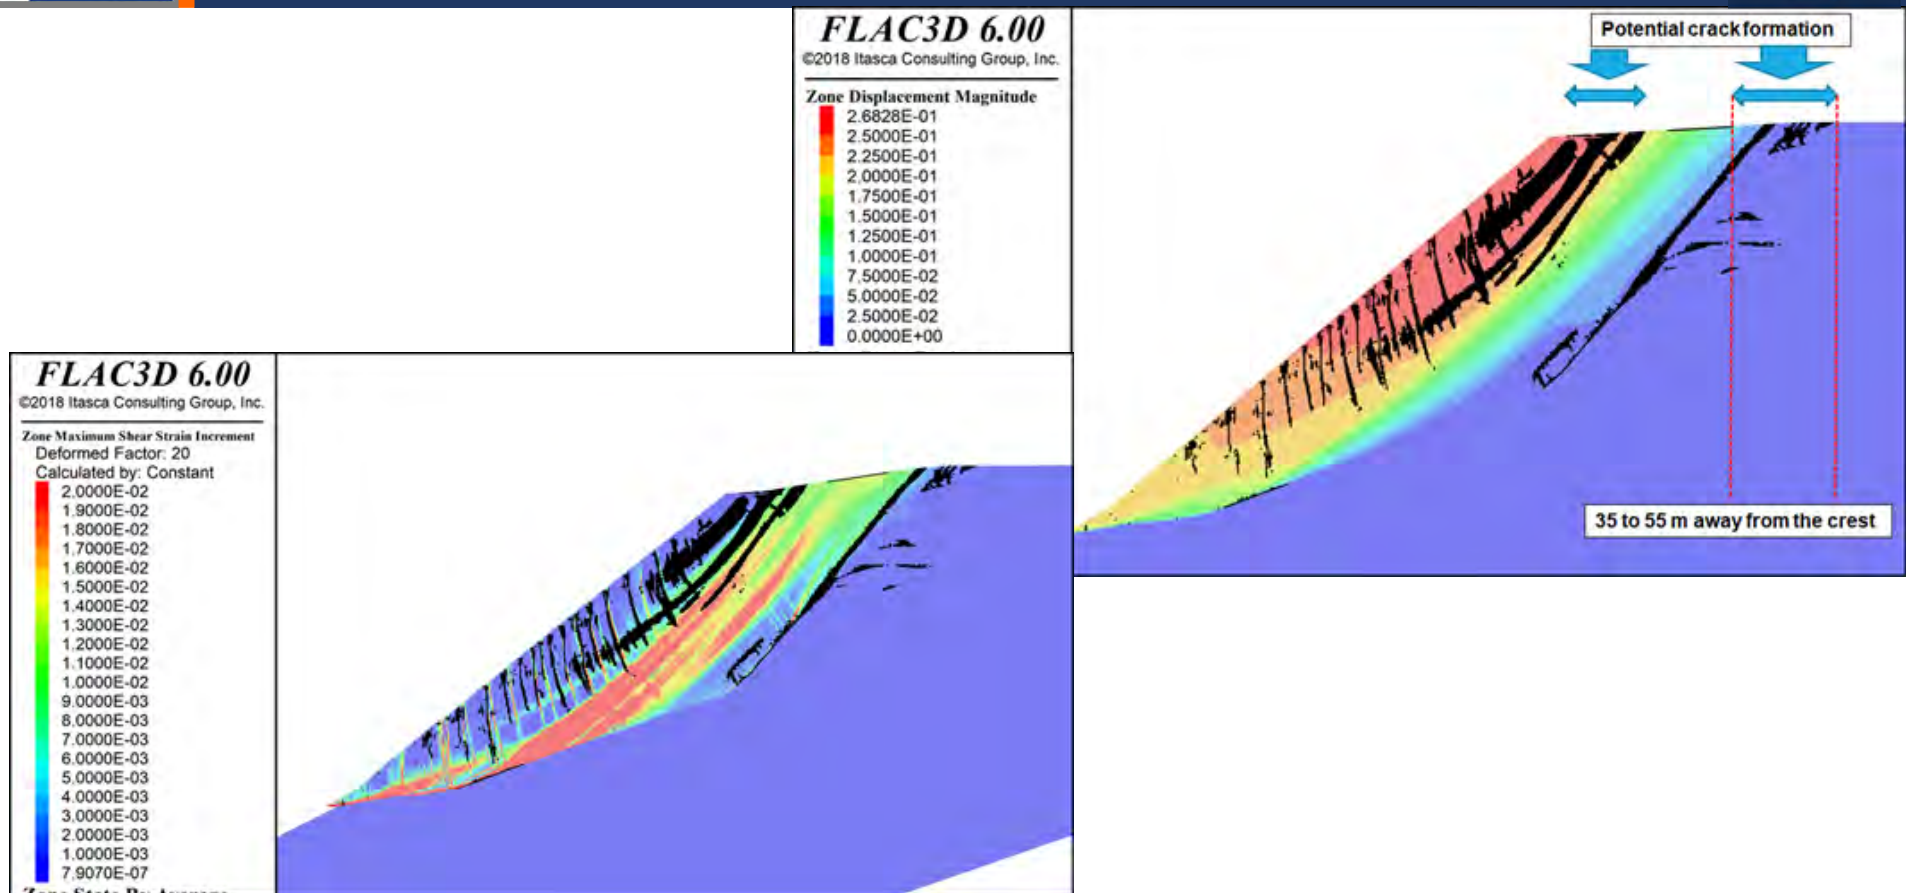
The figure show the shear band location inside the RSS fill overlapped with the incremental displacement field and the shear strains. There is a significant volume of the RSS fill that is already over 2% of shear strain potentially leading to crack formation at the ground surface. The most likely region for crack formation is expected around 35 to 55 m away from the crest in correspondence of section T-T.

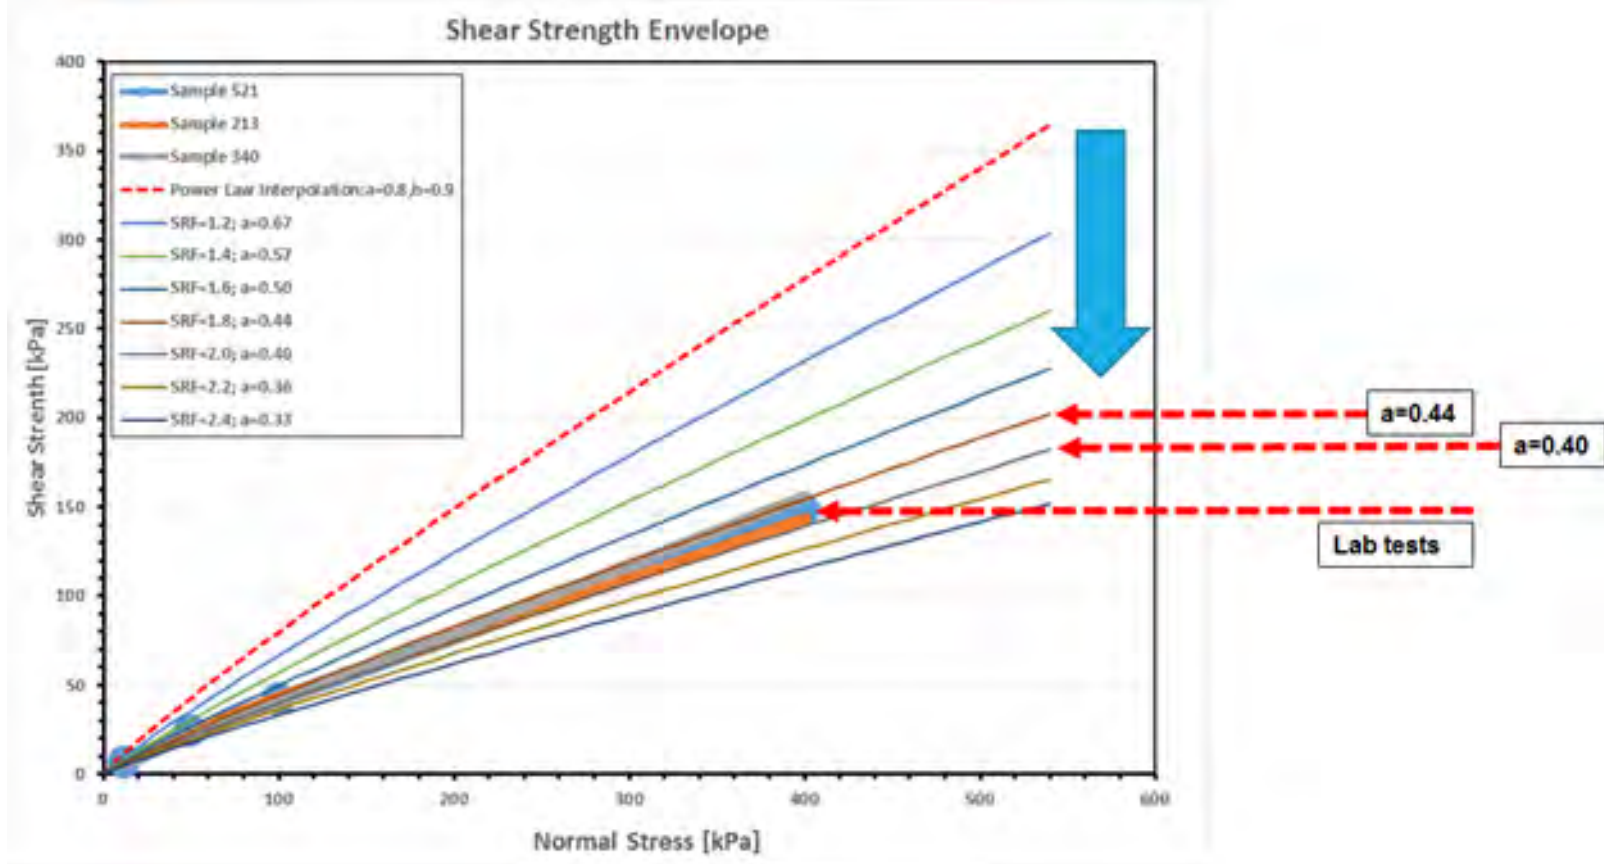
FLAC3D Model – Shear zone strength reduction

The shear zone strength is reduced gradually applying an incremental reduction factor of 0.01 to the paraments a on each step of the process. Initially the SRF is equal to 1 than is incremented in step of 0.01 so that step two has a SRF of 1.01 and so on until failure is detected.
