Yeager Airport RSS Failure Case History: Forensic Limit Equilibrium and FLAC Analyses

Stability and Stress-Deformation Analyses of Reinforced Slope Failure at Yeager Airport

Case history on failure of a 67 M tall reinforced soil slope

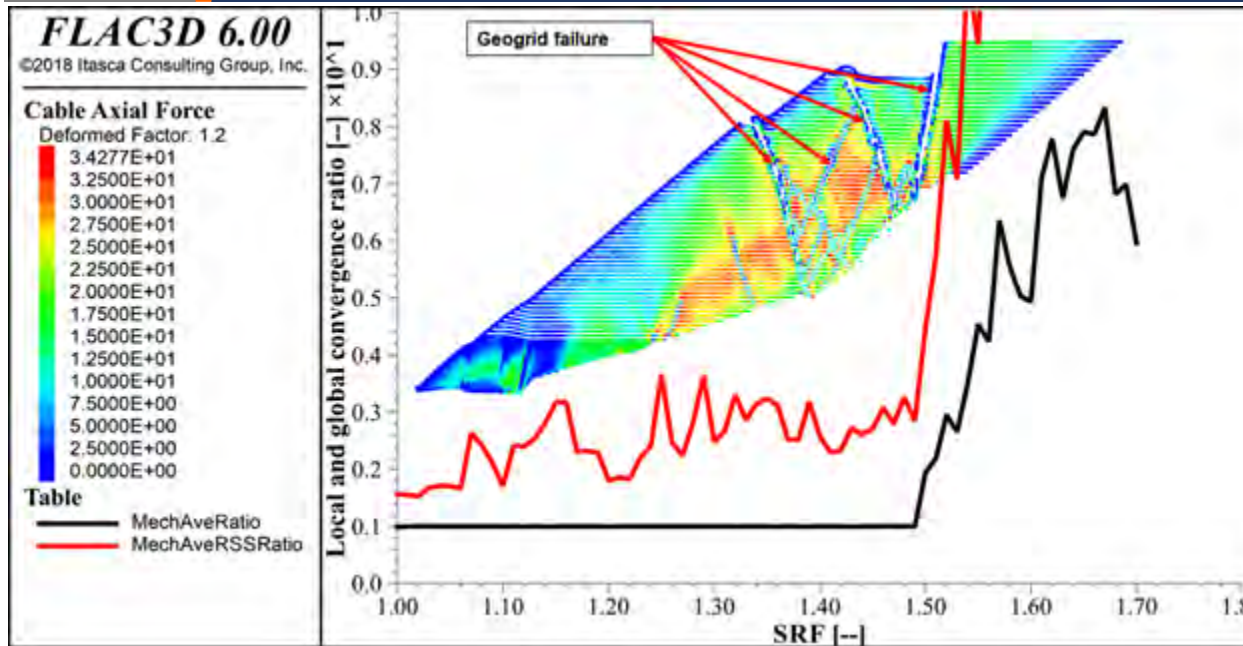
FLAC3D Model – Results – Stage 4-1c – PP=Medium

The model converges up to $SRF = 1.460$ and becomes clearly unstable after. The corresponding a parameter of the strength envelope is therefore:

$$a_{min} = a_{ini}/SRF_{st} = 0.800/1.460 = 0.537$$

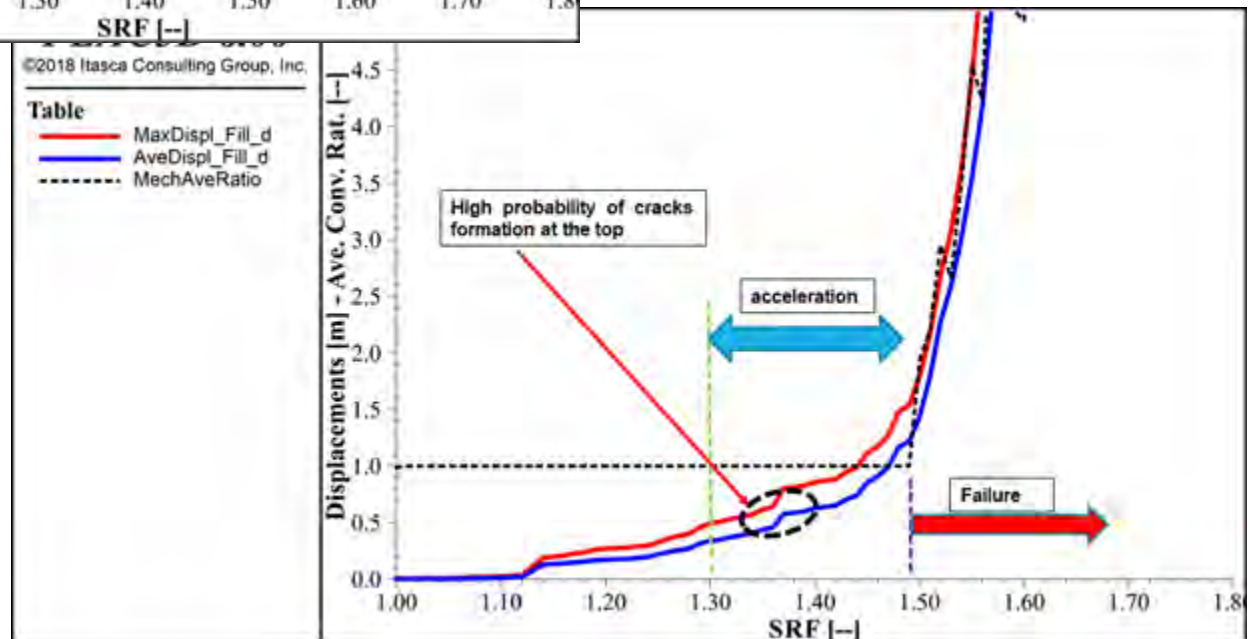
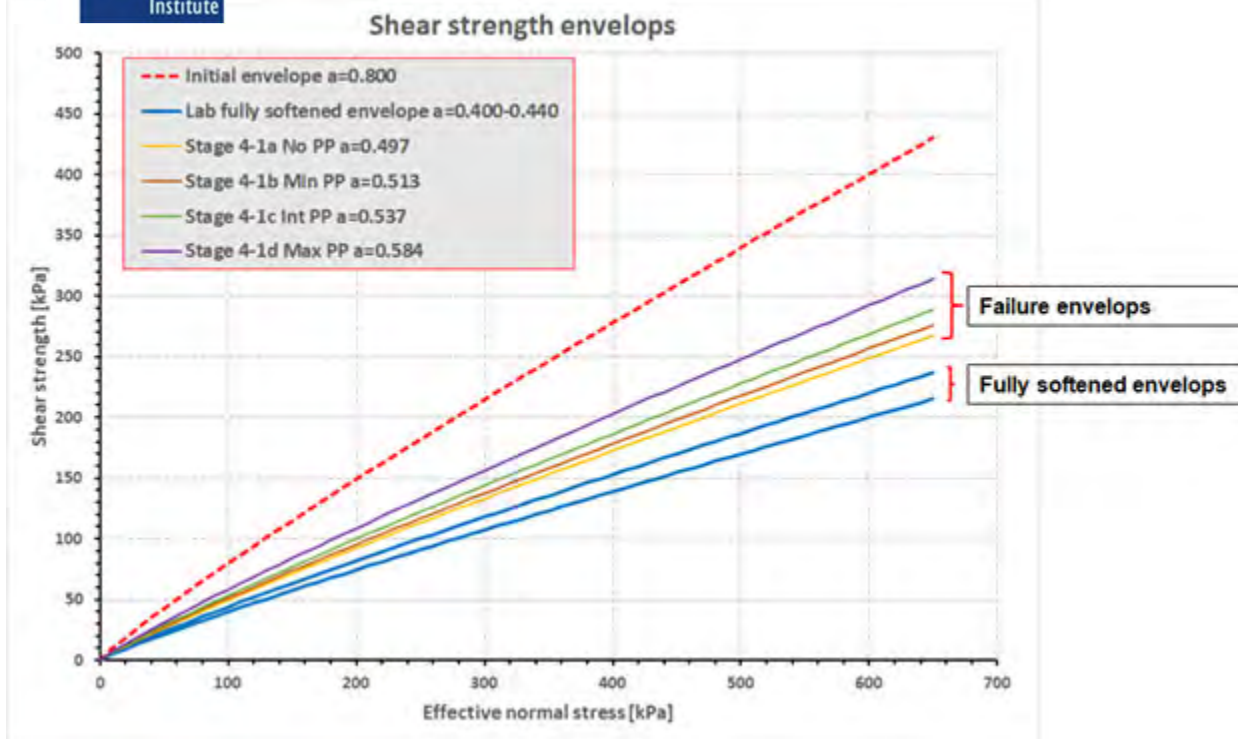
Stage	Pore Pressure	SRF	a
4-1a	No	1.610	0.497
4-1b	Minimum	1.560	0.513
4-1c	Intermediate	1.490	0.537
4-1d	Maximum	1.370	0.584
4-2a	No	1.600	0.500
4-2d	Maximum	1.390	0.576

It is expected to observe lower shear strength from fully remolded samples after a large failure that has determine a significant amount of shearing in the material. Moreover, the analyses presented here are in 2-dimensional conditions while the mechanism in the field is clearly 3-dimensional.

Fully softened $a = 0.42$. $0.42 \cdot 1.3 = 0.55$
