## PVC aquaculture liners stand the test of time

### After three decades of performance, exhumed geomembrane retains strength and flexibility.

By Erik Newman, Fred P. Rohe, and Timothy D. Stark

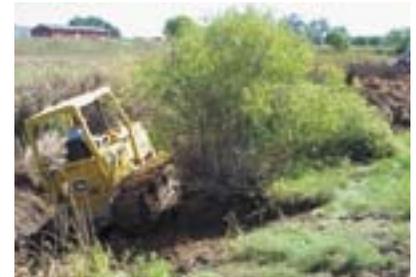
Over time, the ponds became congested with dense, persistent stands of cattails and other vegetation (**Photo 1**). These conditions made many types of experiments impossible. Thus, in preparation for new aquaculture experiments, nine of the ponds were cleared and re-lined in September 2000. This provided a unique opportunity to exhume 29-year-old PVC geomembranes and evaluate their engineering properties. It is important to note that none of the ponds leaked or exhibited any problems during the 29 years of service. The nine ponds were re-lined with 20-mil PVC fish-grade geomembrane liner fabricated in circular panels. Each 11,060-ft.<sup>2</sup> (1,028-m<sup>2</sup>) panel was made of material supplied by Geon Inc. of Burlington, N.J. The new circular panels were fabricated by Environmental Protection Inc., Mancelona, Mich. Woolf Excavating, Kalamazoo, Mich., installed the one-piece liners in ponds 4 through 8, 10, 16, 17 and 18.

**Photo 1:** Willow tree and cattails being removed for geomembrane exhumation.

In one of the ponds a small willow tree was growing about 5 ft. (1.5 m) down-slope of the anchor trench but above the water level. The willow tree was 12 to 15-ft. (3.66 to 4.57-m) tall and had a trunk of 6 to 8 in. (15.2 to 20.3 cm) diameter (**Photo 1**). As the bulldozer operator cleared the soil from the sides of the tree, it was observed that the large tree roots also grew down to the geomembrane, then turned and traveled along the surface of the geomembrane. The main tree roots were 3 to 5 ft. (0.9 to 1.5 m) long, with

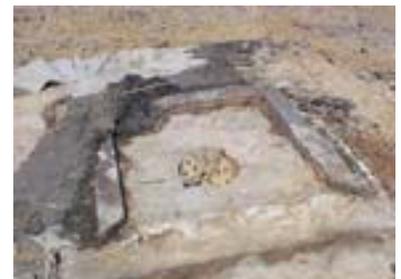
At the center of each pond, an inlet/outlet structure was constructed (**Photo 3**). This structure consisted of a concrete slab, approximately 2.5 ft. x 2.5 ft. (0.76 m x 0.76 m), whose top was level with the liner subgrade. The liner was placed over the concrete, sealed with butyl mastic, and fastened to the concrete using 2-in.-by-4-in. (5-cm-by-10.1-cm) redwood batten strips and concrete nails. This structure and the batten performed well over the nearly 30 years, as indicated by no discoloration of the soil under the PVC geomembrane or around the structure. These observations also indicate that there was little, if any, leakage through the liner in the vicinity of the inlet/outlet structure. In addition, the mastic was soft and flexible after nearly 30 years, which resulted in an effective seal around the nails.

**Photo 3:** Redwood strips surrounding inlet/outlet structure at bottom of a pond.
