MUNICIPAL SOLID WASTE SLOPE FAILURE. I: WASTE AND FOUNDATION SOIL PROPERTIES

By Hisham T. Eid,¹ Timothy D. Stark,² W. Douglas Evans,³ and Paul E. Sherry⁴

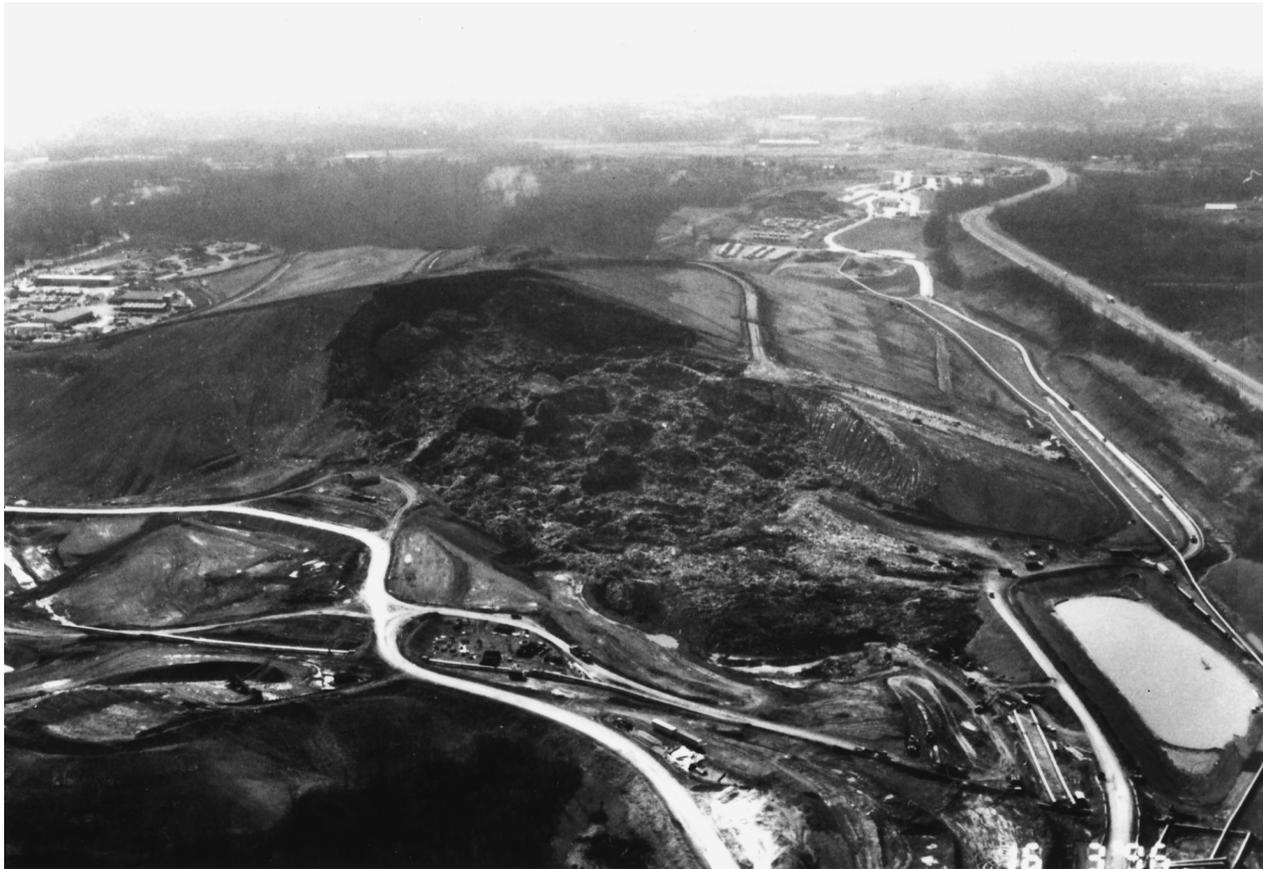
FIG. 1. Aerial View of Wasteslide on March 16, 1996 (Seven Days after Wasteslide)

On March 9, 1996, the largest slope failure in a United States municipal solid waste (MSW) landfill, based on volume of waste involved, occurred (Fig. 1), and it provides the industry with some lessons for the operation, expansion, and stability of existing landfill slopes. The slide involved approximately 1.2 million m³ of waste, making it the largest waste slope failure by a factor of approximately two. The largest previous waste slope failure involved 500,000 m³ in Maine (Reynolds 1991). This paper describes the landfill site and shear behavior of the involved materials.

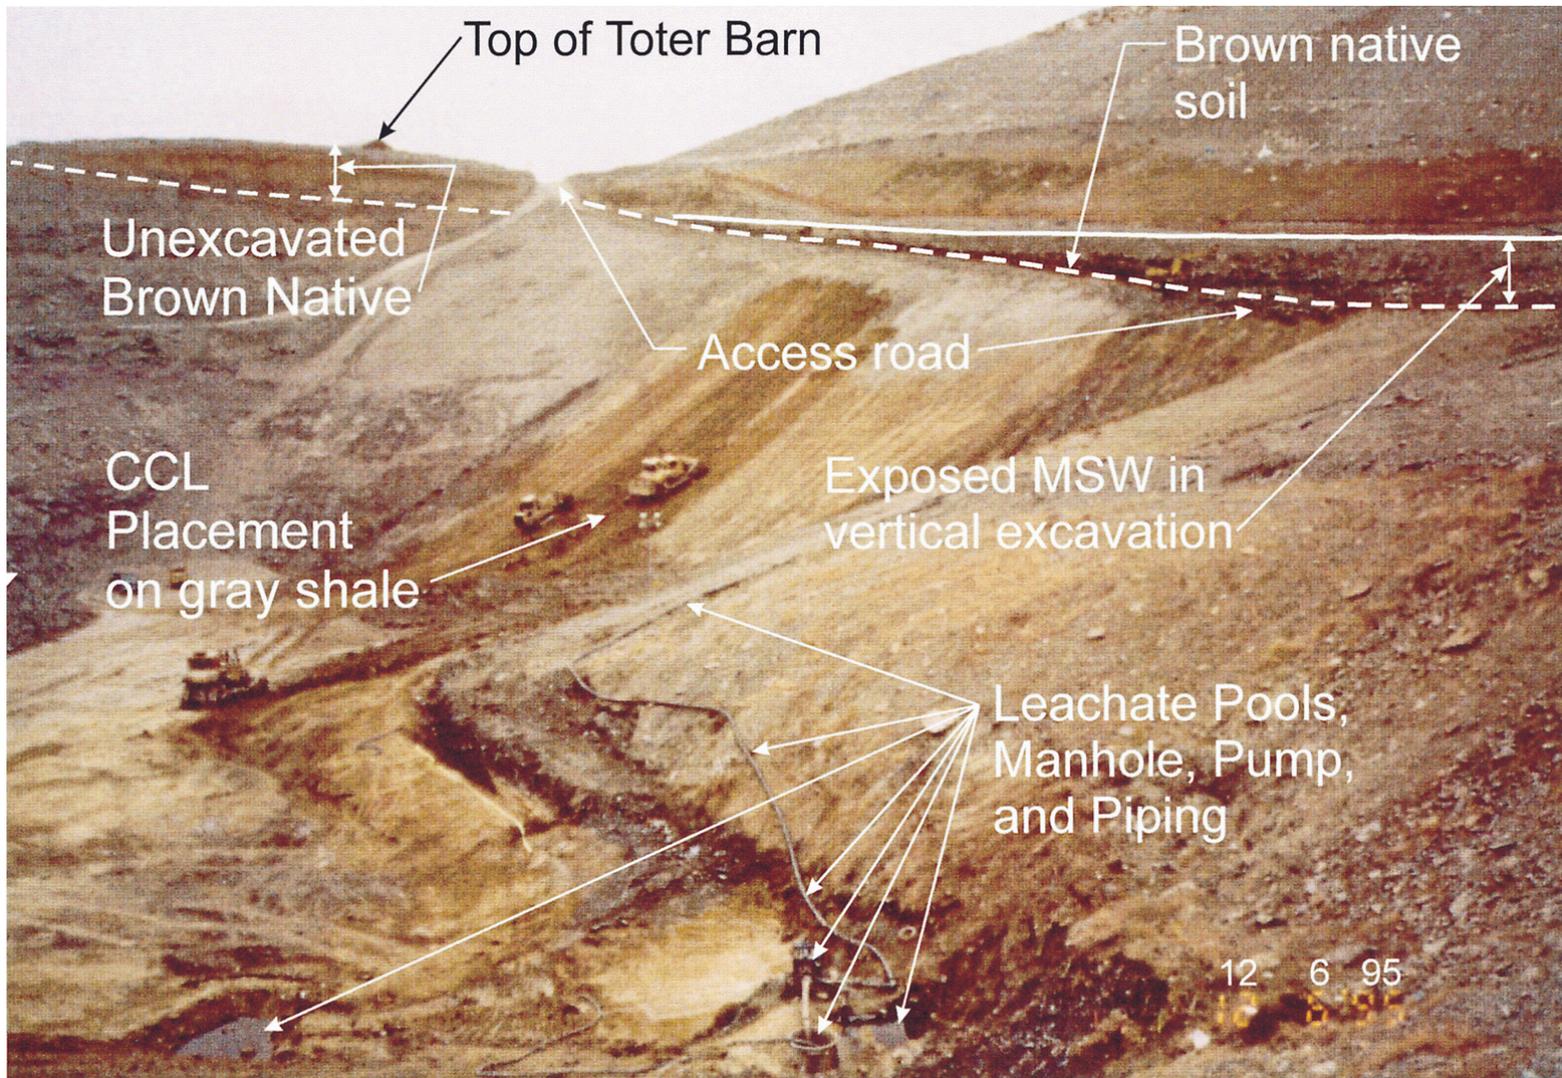
PLATE 1. Construction Activities in Lateral Expansion and Toe of Existing Slope on December 6, 1995 (Note: Equipment for Scale)

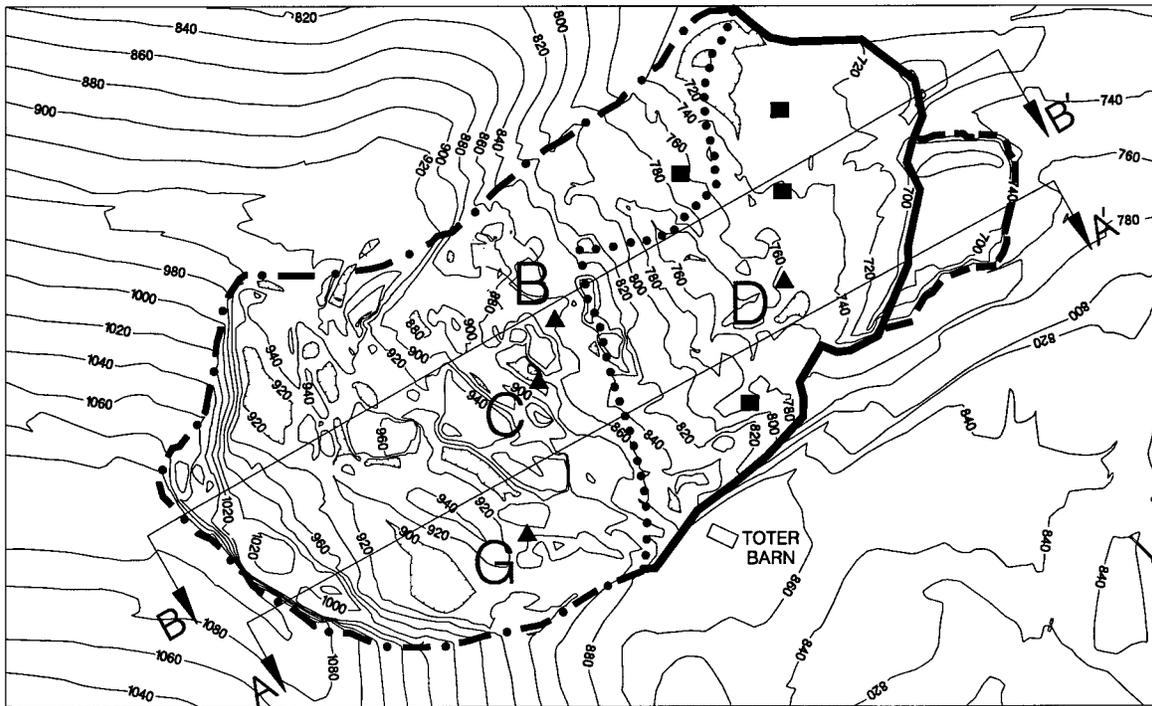
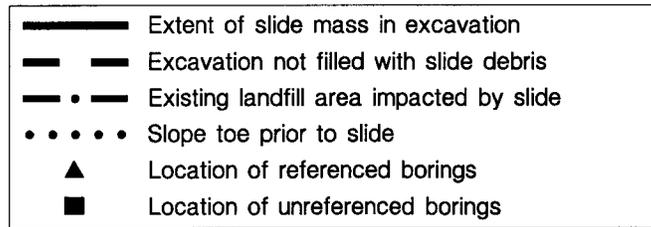
FIG. 2. Plan View Showing Lateral Expansion and Extent of Slide Mass (Contour Lines after Failure)

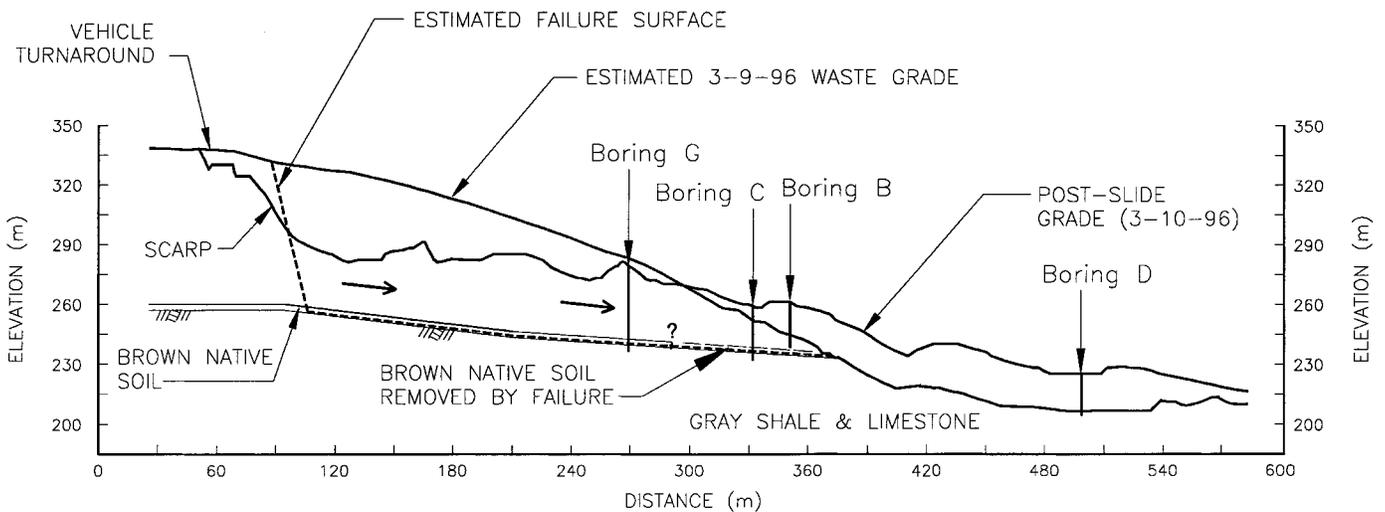
FIG. 3. Slope Cross Section A-A' Showing Slide Mass Geometry and Boring Locations

Based on slope inclinometer data (Fig. 8 in Stark et al. 2000), photographs, and field observations, the failure surface is estimated to have passed through the solid waste at a steep

inclination to the underlying weak, saturated brown native soil (Fig. 3). The failure surface continued in the brown native soil until it daylighted at the vertical face of the excavation at the toe of the existing slope. As a result, the shear behavior of the MSW and brown native soil is investigated herein.

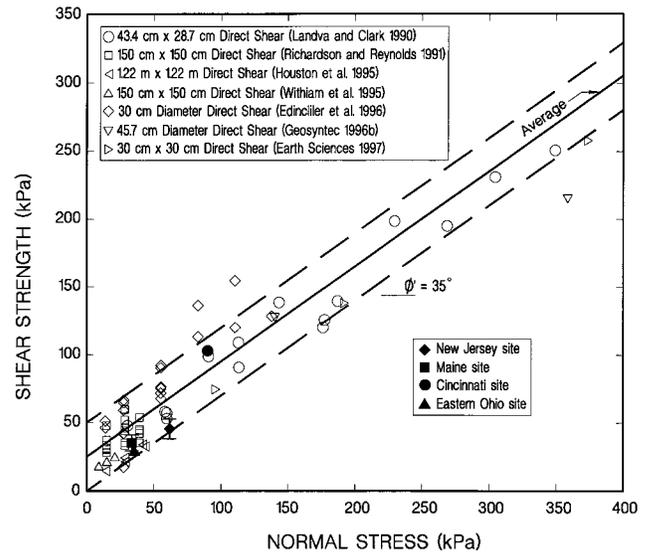
FIG. 5. Summary of Measured and Back-Calculated Data on Shear Strength of Municipal Solid Waste

In Fig. 5, only data from large-scale direct shear tests and back-calculation of failed waste slopes are presented. The other laboratory data were excluded due to the use either of processed [e.g., Jessberger and Kockel (1991)] or simulated [e.g., *Puente Hills* (1984)] waste in the testing program and/or a small specimen size when compared to the maximum particle size of the MSW. Vane shear test results were not included because fairly homogenous material is required to obtain a meaningful result from this test (Jessberger and Kockel 1991). Penetration test results also were not included because no meaningful correlation between MSW shear strength and penetration resistance has been developed (Mitchell and Mitchell 1992). Back-calculated shear strength from plate load tests and test fills was not considered because failure planes were not located, that is, were assumed, which can result in an inaccurate estimate of the shear strength. Back-cal-

The Mohr-Coulomb strength criterion was assumed applicable because the shear resistance of MSW increased with increasing normal stress (Fig. 5). Regression analysis of the data points shown in Fig. 5 suggests that the shear strength of MSW can be defined by a narrow band with an effective stress friction angle, ϕ' , of approximately 35° , and cohesion, c' , that ranges from 0 to 50 kPa. Based on the literature study and back-calculation of field case histories (discussed subsequently), an average c' and ϕ' of 25 kPa and 35° , respectively, may be appropriate for the design of municipal solid waste containment facilities. This combination is slightly higher than combinations published by others, for example, Singh and Murphy (1990), Kavazanjian et al. (1995), and Houston et al. (1995). The lower and upper bounds shown in Fig. 5 could represent the shear strength of MSW that contains more soil, sludge, and/or other soil-like materials (e.g., Eastern Ohio site) and plastics (e.g., Cincinnati site), respectively.

The waste shear strength parameters shown in Fig. 5 are high and indicate a material with high shear strength. The mechanisms that yield high shear strength in MSW are not clear, but the interconnection of the plastics and other materials is probably a contributing factor. This case history, as

To verify the use of the MSW shear strength band shown in Fig. 5, three landfill slope failures were back-analyzed. Two of these landfill failures involve a rotational failure through a soft saturated soil underlying the waste and occurred in Maine (Reynolds 1991; Richardson and Reynolds 1991; and Chilton et al. 1994) and New Jersey (Oweis et al. 1985; Dvirhoff and Munion 1986; and Erdogan et al. 1986). The third case history involves a translational landfill failure along a geosynthetic interface in eastern Ohio (Stark et al. 1998). Nine other landfill slope failures (Stark 1999) were analyzed but not included in Fig. 5 because of *significant* uncertainties in the analysis, such as incomplete geometry, piezometric/leachate pressure, shear strength, and/or subsurface information or stratigraphy. The back-analyses of the three case histories mentioned above are presented in Fig. 5 using the back-calculated shear strength and average effective normal stress acting on the failure surface through the waste. These three case histories are in agreement with the proposed trend lines.

In accordance with Duncan and Stark (1992), the best estimate of ϕ' was used to estimate the corresponding value of c' for the Cincinnati site. This approach appears applicable to internally reinforced materials, such as MSW, because reinforced soils exhibit a higher c' and the same ϕ' as the unreinforced soil (Gray and Ohashi 1983; Maher and Gray 1990). In addition, several laboratory testing programs on MSW have shown that c' is influenced more than ϕ' by the removal of plastics and other materials (Edinçliler et al. 1996; Benson and Khire 1994; Foote et al. 1996). As a result, ϕ' of the MSW at the Cincinnati site was estimated to be 35° (Fig. 5) and then used to estimate the corresponding cohesion from the 30 m high, nearly vertical and unbuttressed portion of the scarp that was stable for approximately eight to nine months until it was reduced by the owner/operator (Fig. 1). Stability analyses, assuming circular and log-spiral failure surfaces from the toe of the vertical scarp through the MSW, were conducted using an average exposed vertical height of the scarp (H) of 30 m, a unit weight (γ) of the waste of 10.2 kN/m^3 , and a ϕ' for the waste of 35° . The resulting values of c' ranged from 38 to 42 kPa. The scarp height was varied from 30 to 60 m in a sensitivity analysis, and the resulting change in cohesion (40 to 80 kPa, respectively) only yielded a decrease in the back-calculated friction angle for the brown native soil of 1 to 2° . Since no fluid was observed exiting the exposed portion of the scarp, fluid pressures were not included in these analyses. Based on these analyses, site-specific values of c' and ϕ' of 40 kPa and 35° , respectively, were used in the stability analyses of the slope failure in the companion paper (Stark et al. 2000). The back-calculated shear strength for the Cincinnati site is also shown in Fig. 5 and plots slightly above the average trend line.

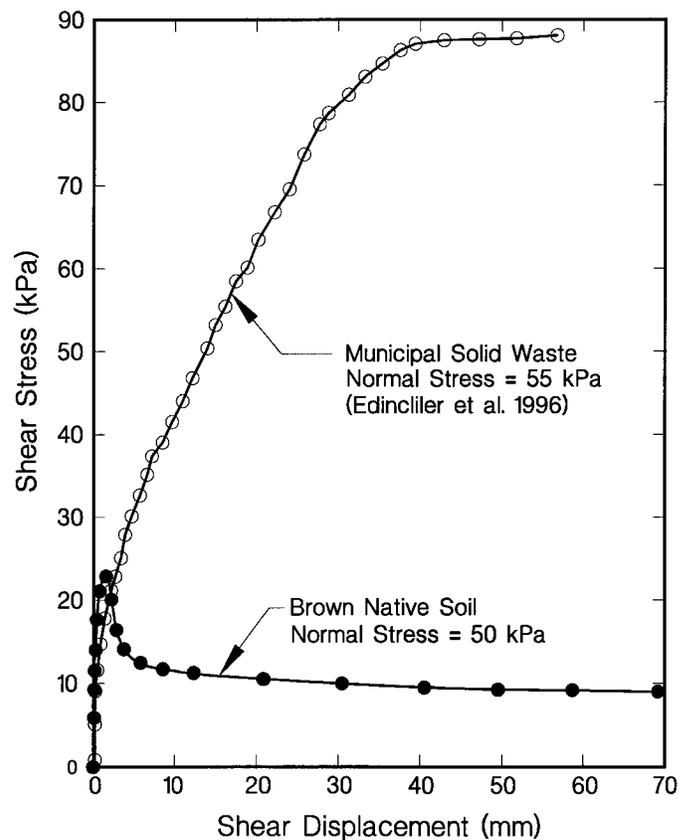
FIG. 6. Shear Stress-Displacement Relationships for Municipal Solid Waste and Brown Native Soil

tive soil can result in mobilization of shear strengths in the MSW and brown native soil that are less than the peak values. A similar conclusion was reached for geosynthetic interfaces (Byrne 1994; Stark and Poeppel 1994) and foundation soils (Mitchell et al. 1995) because of their strain incompatibility with MSW. Therefore, it is important to use MSW shear strength parameters that are strain compatible with the adjacent material(s) in stability analyses. Fig. 6 shows that the peak shear strength of the brown native soil (23 kPa) is mobilized at a torsional ring shear displacement of 2 to 3 mm and then undergoes a postpeak strength loss. The peak shear strength of the waste (89 kPa) is achieved at a direct shear displacement of about 40 mm, and it remains approximately constant at that value for larger displacements. These peak shear stresses correspond to normal stresses of 50 and 55 kPa for the brown native soil and MSW, respectively. As a result, it is conceivable that failure might occur first in the native soil when only a fraction of the MSW peak strength is mobilized. After failure occurs in the native soil, the peak strength of the MSW would be mobilized at a time when the shear strength of the native soil had declined to a value significantly below the peak. Therefore, using a peak strength for both the soil and MSW would be unconservative. Strain incompatibility is most likely when the stress-strain characteristics of the embankment and foundation soil differ markedly, and it results in the percentage of peak strength mobilized in the MSW being smaller than the percentage mobilized in the native soil. Chirapuntu and Duncan (1976) used nonlinear finite-element analyses to show that the reduction in shear strength caused by progressive failure for a foundation soil and overlying embankment can range from 0 to 20% and 20 to 90%, respectively. This might explain the difference between the recommended MSW strength parameters, $c' = 25 \text{ kPa}$ and $\phi' = 35^\circ$, and the fact that vertical waste slopes have remained stable for months to years.

Since vertical MSW slopes have been stable for months to years and the recommended values of $c' = 25$ kPa and $\phi' = 35^\circ$ were verified using field case histories, it may be assumed that only a percentage of the MSW peak strength is mobilized during a slope failure. This may appear contradictory, with the peak strengths from laboratory direct shear tests on MSW plotting in the same range as the back-calculated values in Fig. 5. However, this is attributed to sample sieving/sorting and specimen reconstitution processes removing some of the in-situ interaction/interlocking between the various pieces of waste and yielding a laboratory peak strength that is lower than the in-situ value.

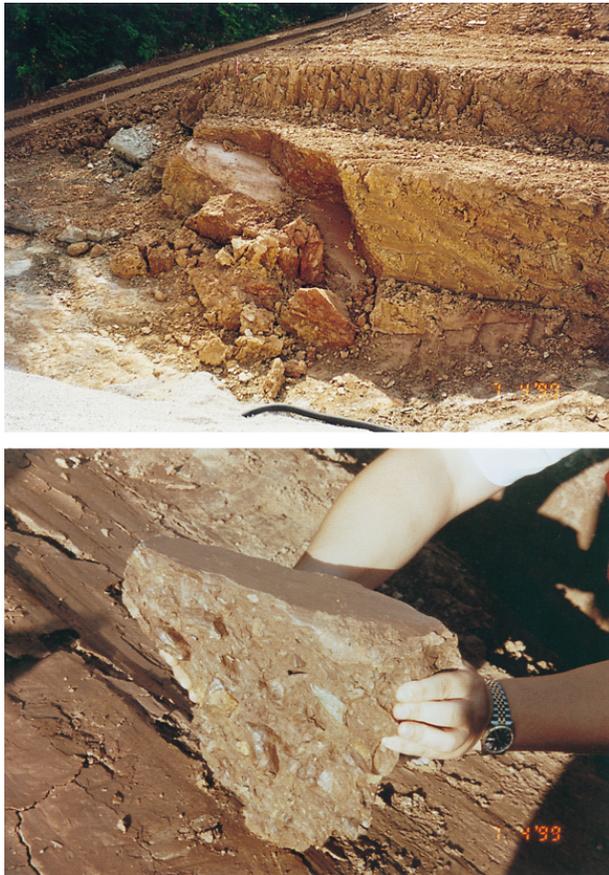
PLATE 2. Failure Surface along High-Plasticity Layer at Ohio Site: (a) (Top) Failure Surface Overview; (b) (Bottom) Failure Surface Closeup

colluvium during remediation resulted in many failures along well-defined and continuous high-plasticity layer(s) [Plate 2(a)]. It can be seen that the weak layer extends away from the exposed failure surface almost parallel to the pipe in the foreground. Plate 2(b) shows a closeup of the weak layer exposed in Plate 2(a), and it is important to note (1) the thin and plastic nature of the failure surface/zone, and (2) the many rock fragments adjacent to but not in the failure surface. The same sorting of rock fragments from the weak layer was observed in other locations and also reported by Skempton

(1985). As a result, only the layer of high-plasticity material, and none of the rock fragments, should be included in laboratory shear and index test specimens. The failure zone material in Plate 2(b) all passed the U.S. Standard Sieve No. 40.

Field observations suggest that the potential failure surface will follow the weakest (i.e., most plastic) material. In addition, field case histories, such as the site shown in Plate 2, suggest that these weak layers can be present over a large percentage, or maybe all, of the failure surface. Therefore, use

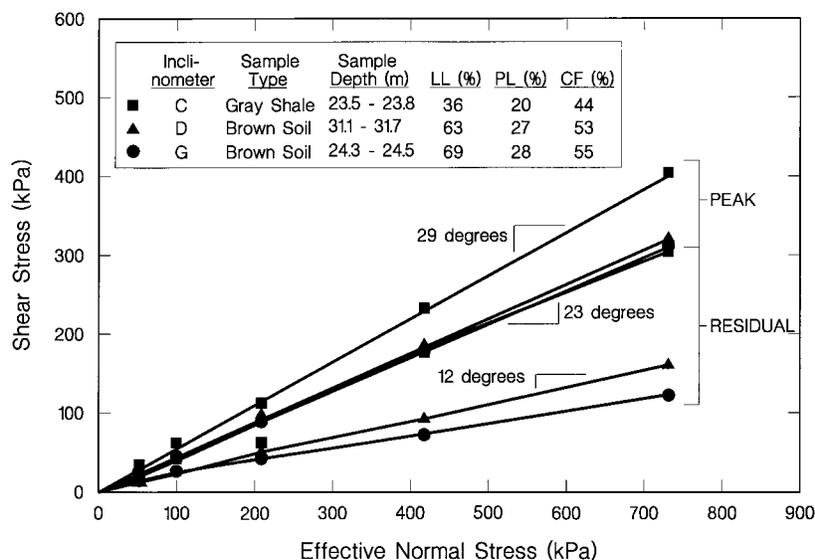
FIG. 7. Drained Peak and Residual Failure Envelopes for Brown Native Soil and Gray Shale

The fully softened friction angle for the gray shale also was estimated from ring shear tests and corresponds to 29°, which is in agreement with the correlation, that is, 27 to 30° for effective normal stress of 50 to 400 kPa, respectively, proposed by Stark and Eid (1997).

Fig. 7 also presents the residual failure envelopes for the brown native soil obtained in Borings G and D and the gray shale directly underlying the waste in Boring C. In accordance with Stark and Eid (1994), the drained residual failure envelope for the brown native soil in Boring G is stress dependent and may be approximated with a friction angle of 10° to represent the shear strength at the range of applied stresses. The empirical correlation proposed by Stark and Eid (1994), which relates liquid limit (LL), clay-size fraction (CF) (<0.002 mm), and effective normal stress to the drained residual friction angle, yields a residual friction angle of 10 to 12° for effective normal stresses of 100 to 700 kPa for the brown native soil from Boring G. It can be seen that the brown native soil from Boring D yielded a higher residual friction angle (12°) than that of Boring G. The gray shale exhibits a lower plasticity and a much higher residual friction angle (23°) than the brown native soil. These data also suggest that sliding occurred through brown native soil and not the gray shale.
