# Lake Forest reservoir relining and floating cover

By Brian Fraser, MBA, Douglas Hilts, P.E., and Robert Emmons

Geosynthetic floating covers provide a highly sustainable and economical method of protecting and treating fresh and potable water. They are designed to protect fresh water from environmental contamination while eliminating water losses due to evaporation. Case in point is the Seattle Public Utilities, Lake Forest potable water storage reservoir. The reservoir was first built in 1962 as an open-top, concrete-lined 60-million-gallon (227-million-l) containment facility for potable water storage.

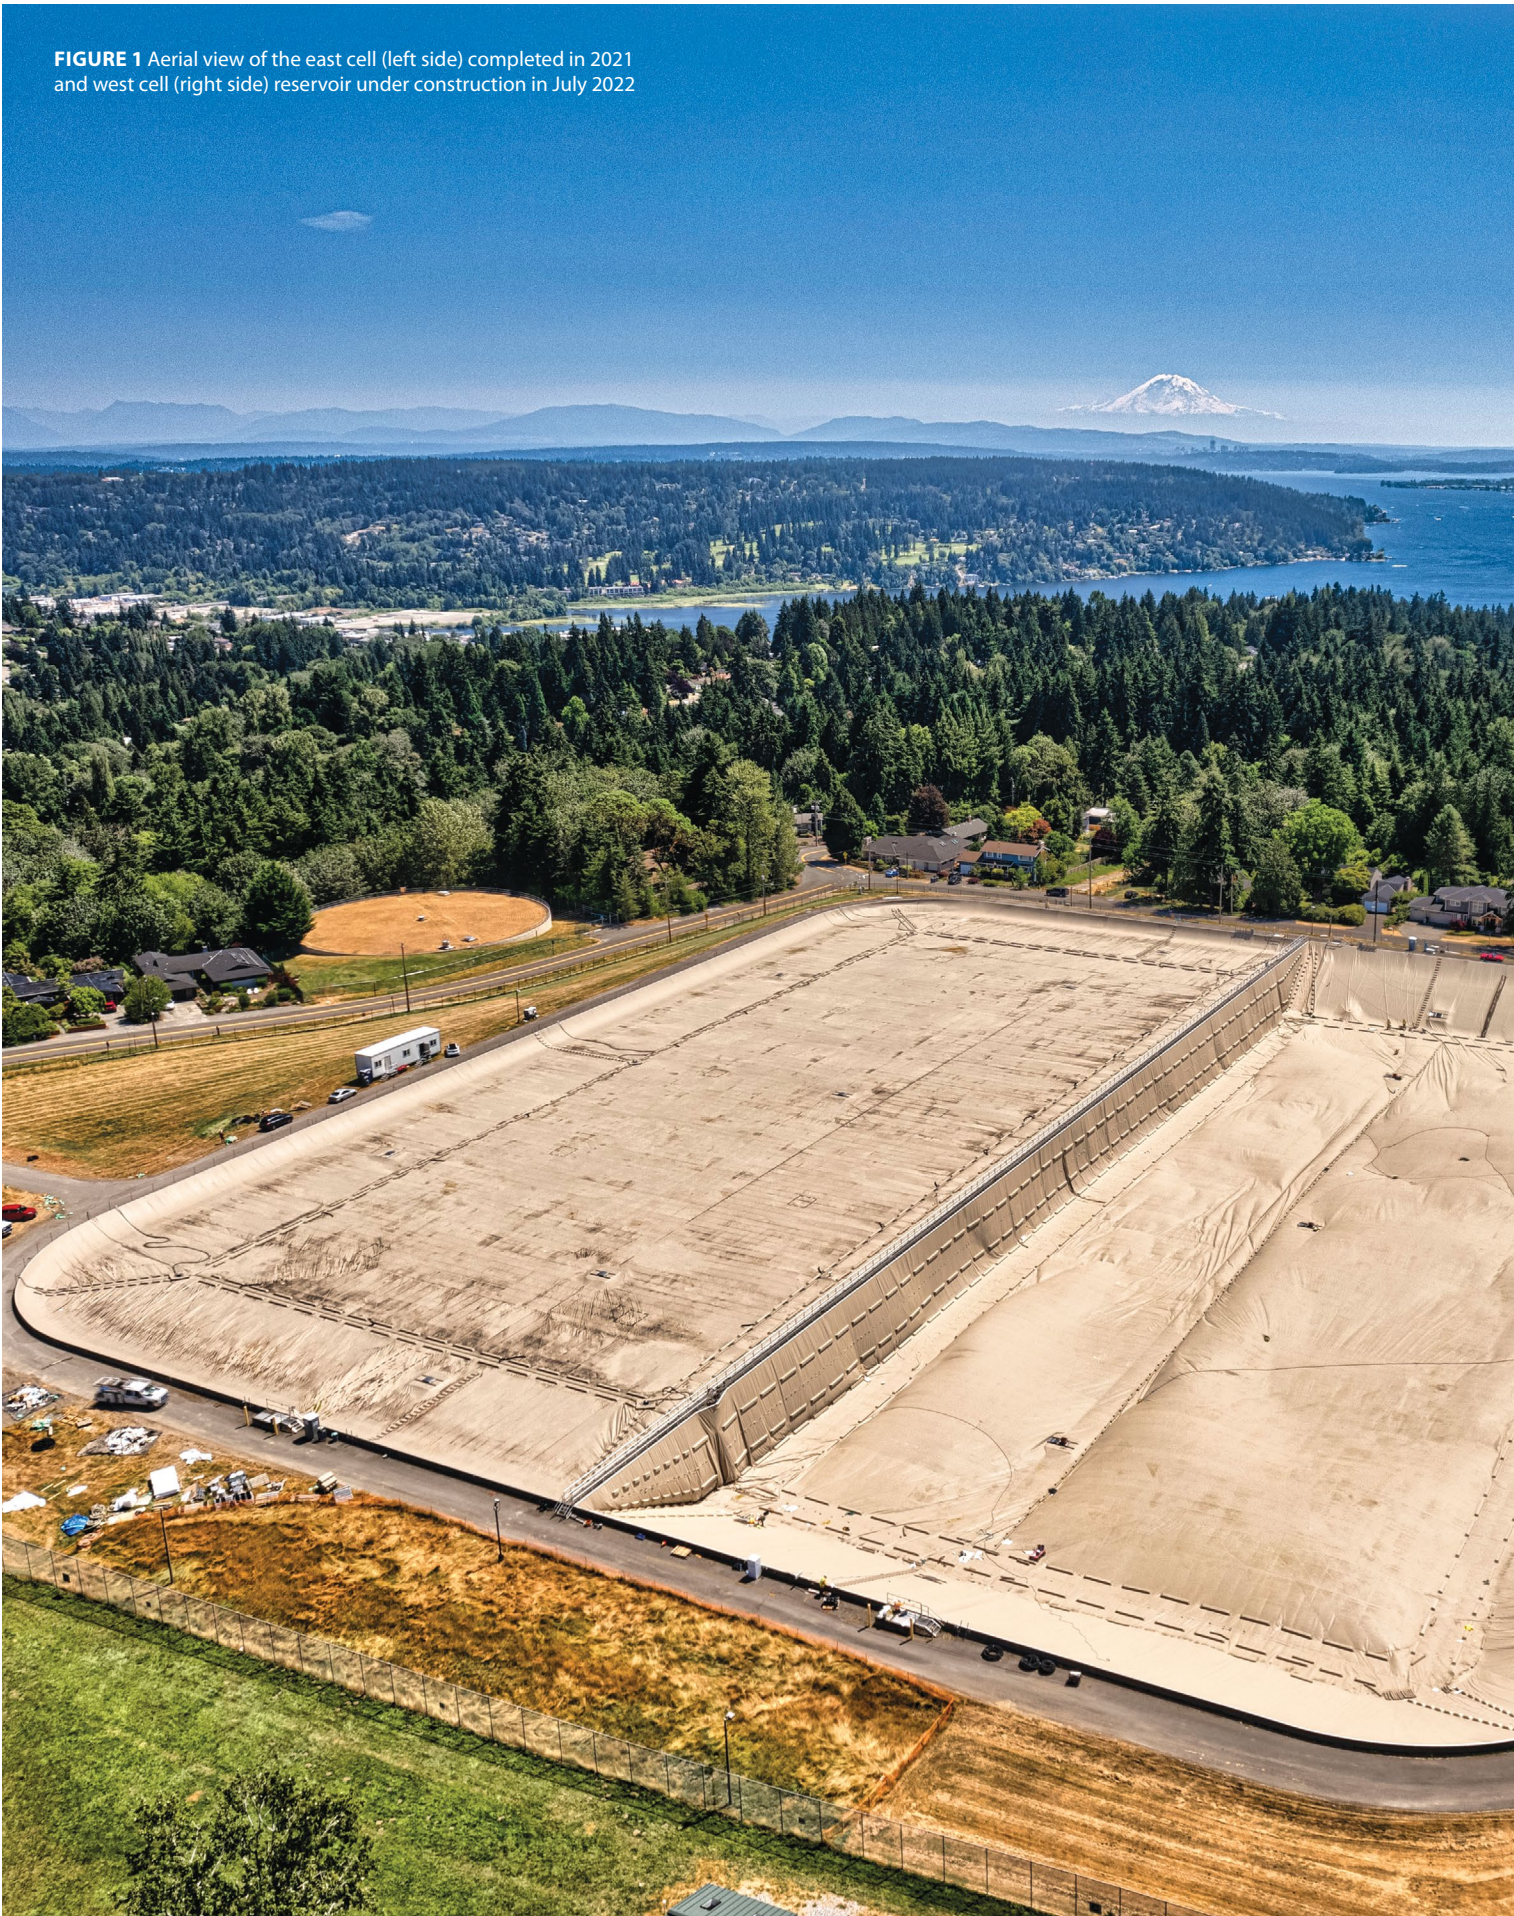
**FIGURE 1** Aerial view of the east cell (left side) completed in 2021 and west cell (right side) reservoir under construction in July 2022

In May 2021, phase 1 construction began on the new replacement geomembrane liner and floating cover system for the east cell of the Lake Forest reservoir and was completed in September 2021. Phase 2 included the installation of a new geomembrane liner and floating cover system on the west cell. This construction was completed September 2022.

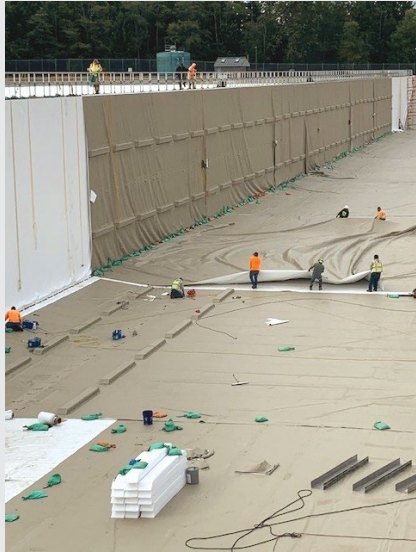
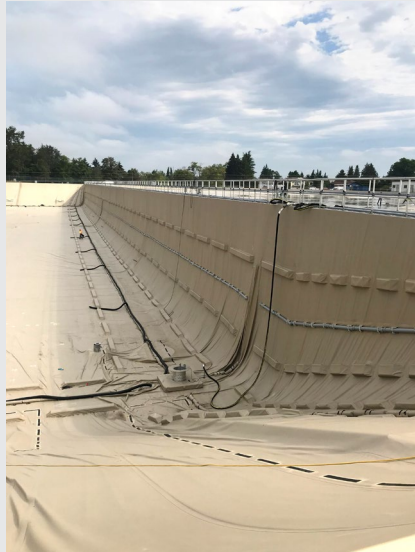
**FIGURES 2–3** Installation underway of double trough system on 28-foot divider wall

engineer selected a weighted tension cover system. This system uses a series of designed troughs in conjunction with surface floats and ballast weights to supply the required cover tensioning, provide buoyancy in the floating cover and create rainwater collection troughs to drain surface water adjacent to the vertical divider wall. To handle the additional material slack developed in the floating cover from the 28 foot (8.5 m) vertical divider wall during the different reservoir operating levels, a special double trough system was designed and installed. The installation required that large custom-size panels be fabricated in the factory. These panels then needed to be lifted onto the vertical wall on-site to be vertically welded together. The joining of the panels required 3 inch (7.62 cm) wide field seams. The perimeter parapet wall required each fabricated panel to be lifted above the wall for deployment of the factory-produced panels and anchorage to the top of the perimeter wall. The geomembrane liner was anchored at the base of the perimeter wall and the floating cover was anchored to the top of the perimeter wall. The mechanical attachment consisted of stainless steel concrete anchors and stainless steel batten bars with rubber gasket material. The welding on-site was done primarily by thermal wedge and performed in compliance with the Geosynthetics Research Institute GM19 standards, and engineers specified field factory and seam strength requirements.

The weight tensioned floating cover system in both reservoir cells also required various additional appurtenances including access hatches, air vents, access stairways, double material over existing concrete stairs on slope and a pump surface water removal system. **Figure 2** shows the installation of the divider wall trough system on the west cell. **Figure 3** shows the east cell wall

trough system in application at close to full operating level of the reservoir.

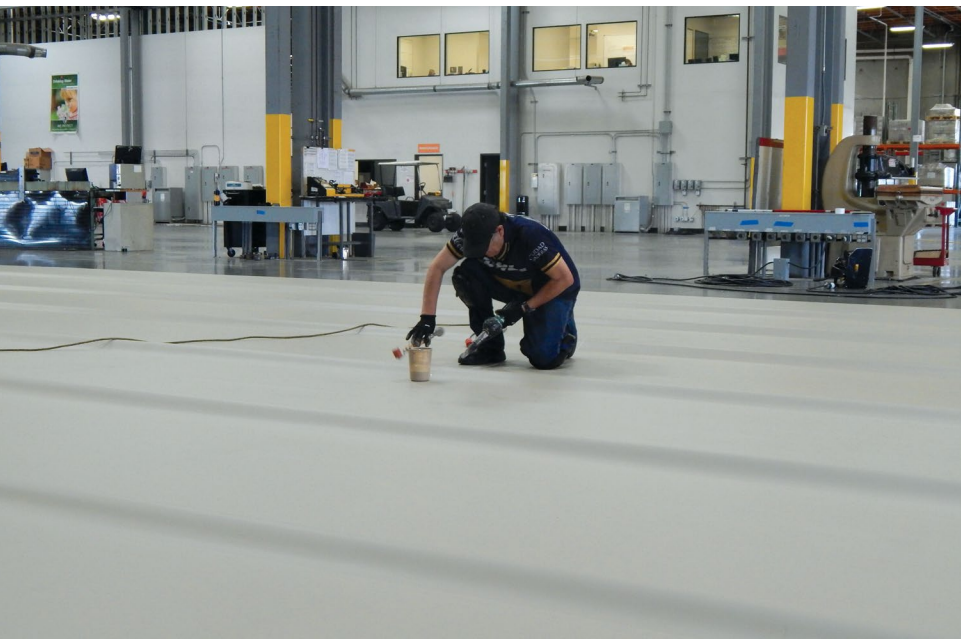
**FIGURE 11** Factory fabrication of CSPE panels in Lakeside, Calif. plant

The Lake Forest reservoir required substantial prefabrication of the geomembrane liner, floating cover and appurtenances. The project required approximately 850,000 square feet (79,000 m<sup>2</sup>) of prefabricated geomembrane panels. This included a large amount of custom-sized fabricated panels to address the divider wall and various curves and slopes of the reservoir. The prefabrication

of the geomembrane liner, cover and components resulted in substantial reduction in the amount of required field welding, construction time and installation cost. Prefabrication typically results in a major reduction of installation time and construction cost. We estimate that the prefabrication of the liner and cover system reduced field welding time by over 50% on the Lake Forest project. This was also important considering the highly inclement weather conditions typically experienced in the Seattle and Puget Sound region of western Washington.

The Fabricated Geomembrane Institute (Stark et al. [2020]) has previously compared factory and field-welded thermal geomembrane seams for a large off-stream water reservoir project. This comparison showed that factory-welded seams exhibit higher seam peel and shear strengths, less variability and more consistency than field-welded thermal seams. The compiled test results showed that factory seams are about 10% stronger than field seams. Factory fabrication can typically result in about 75% fewer field seams on a project.

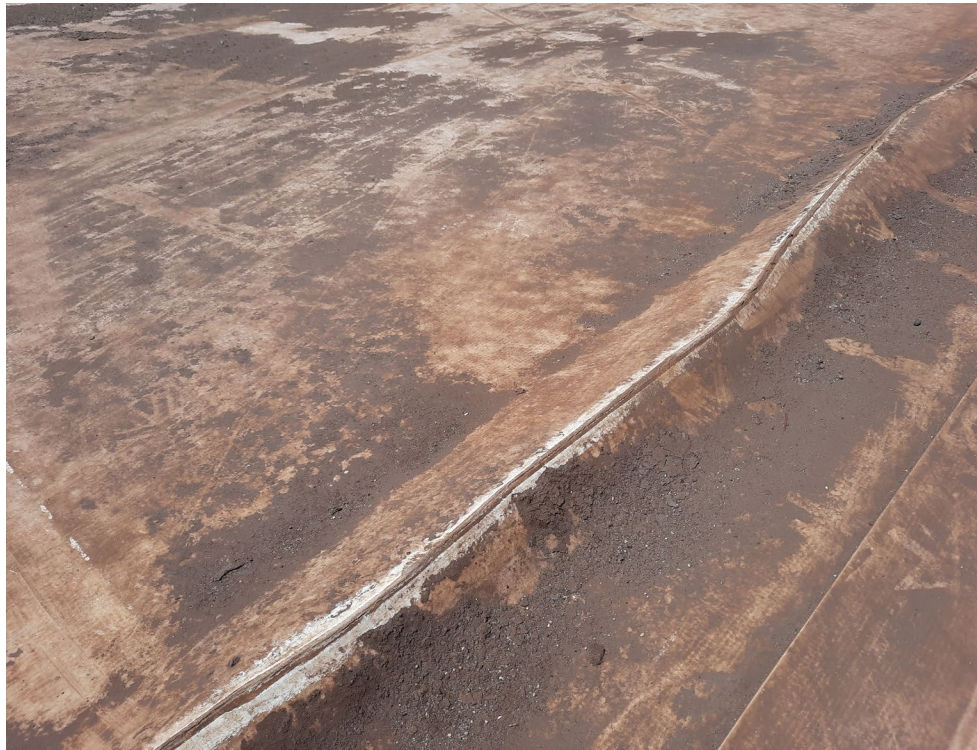
**FIGURES 12–13** Surface cracks found in the RPP liner material folds and creases

The material selection process was a very important factor for the geomembrane liner and floating cover portion of the project. The owner has reported leakage and the existing reinforced polypropylene (RPP) material was showing signs of stress cracking and premature degradation. This included various cracks located around folds and creases (see **Figures 12** and **13**). Unfortunately, the extent of damage on the geomembrane liner could not be fully determined until the reservoir was taken out of service and the floating cover system was removed. The type of cracking in the material folds is often associated with multiple factors including prolonged UV exposure, continuous exposure to chlorine used for potable water disinfection and stress concentrations at upstanding folds resulting from hydrostatic pressure. Chemicals used for disinfectants in municipal water treatment include chlorine and chloramines and can function as accelerators in breaking down or leaching out the protective antioxidant packages of protective antioxidant packages in various polyolefin and PVC geomembrane-based formulations resulting in environmental stress cracking and premature material failure (Mills 2011).
