A Maintenance Supervisor Dies When He Falls off a Ladder into a Hot Water Tank

California Case Report: 07CA005

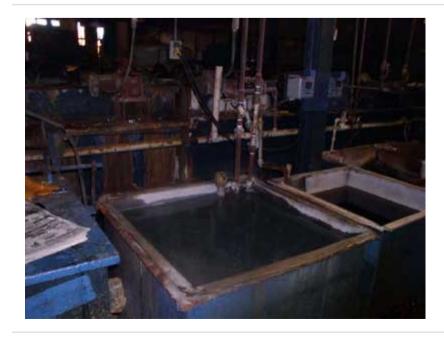
The site of the incident was the tank area of a metal finishing company. The hot water tank the victim fell into was three feet deep with a water temperature of approximately 160 degrees Fahrenheit. The tank was used for rinsing off parts that had been dipped in other chemical or acid tanks, and was not covered. On the day of the incident, the victim was responding to a service call involving a possible electrical short circuit in a dryer. With the help of an apprentice worker, the victim secured an extension ladder adjacent to the hot water tank in order to gain access to the conduit located above him. The victim used a 20-foot extension ladder with a 250-pound capacity that was manufactured in 2006. The victim ascended the ladder to the eighth or ninth rung and reached beyond the rails of the ladder to remove the cover plate on the conduit. He was about to check the wires with an electrical tester when he told the apprentice to go to the supply room for a part. It is not known if the victim slipped or received an electrical shock that may have precipitated his fall into the hot water tank. Other employees witnessed the victim exiting the tank by himself after approximately 10 seconds.

Exhibit 2. The tank filled with hot water.

Recommendation #1: Ensure vats and tanks are safeguarded by grates or covers whenever work occurs above them.

Discussion: The tank involved in this incident was not covered to prevent objects or individuals from falling into it. When employees are required to work directly above open tanks, employers should ensure that the top of the tank is covered with a grating or grille with openings no larger than two inches and of sufficient strength to hold the weight of anything that may fall on it.

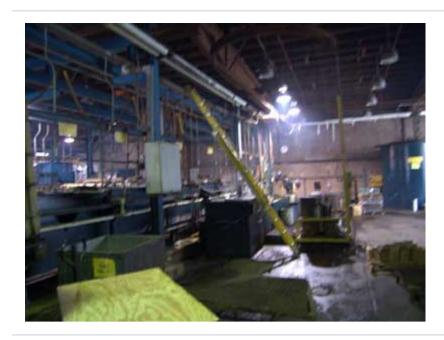
Discussion: The use of a ladder limited the work area of the victim to an arm's length on each side of the ladder. In order to reach the conduit, the victim needed to maintain his balance while holding the ladder with one hand. Although the fall was not witnessed, it is likely the victim lost his balance by attempting to exceed a safe reach. The use of mobile scaffolding or another type of work platform such as a scissor lift would have provided a stable work surface and enabled the repairs to be completed safely.

Exhibit 3. The incident scene with the ladder in place.

Recommendation #3: Ensure that employees use a safe method to gain access to elevated work areas.

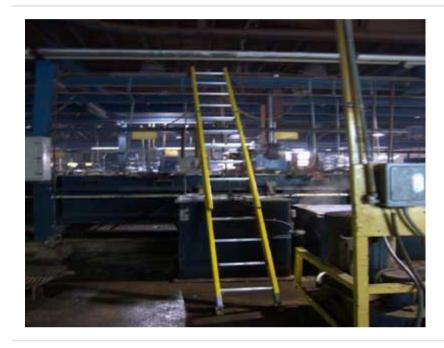
Exhibit 4. Alternate view of the ladder secured in place.
