# A Construction Laborer Was Run Over By A Front-End Loader

Investigation: # 02CA010

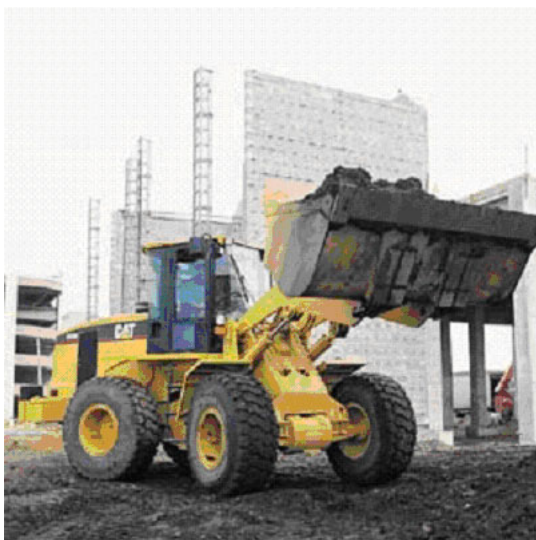
Exhibit 1. Picture of an articulating front-end loader similar to the one involved in the incident.

The site of the incident was a rectangular shaped 60,000 square foot dirt lot that was being renovated for the building of a new warehouse. The victim and his employer were sub-contracted to prepare the foundation for this new building. The equipment involved in this incident was an articulating front-end loader. The loader had a back-up alarm, but it was not working at the time of the incident. The loader's right rearview mirror was also missing. On the day of the incident the victim was functioning as a grade checker and the signalperson for the front-end loader. The other piece of equipment on the lot was a water truck used to moisten the dirt and keep the dust level down.
