**SUBJECT:** Two Laborers Die from Hydrogen Sulfide Exposure in a Confined Space at an Organic Waste Recycling Facility

**SUMMARY**  
**California FACE Report #11CA008**

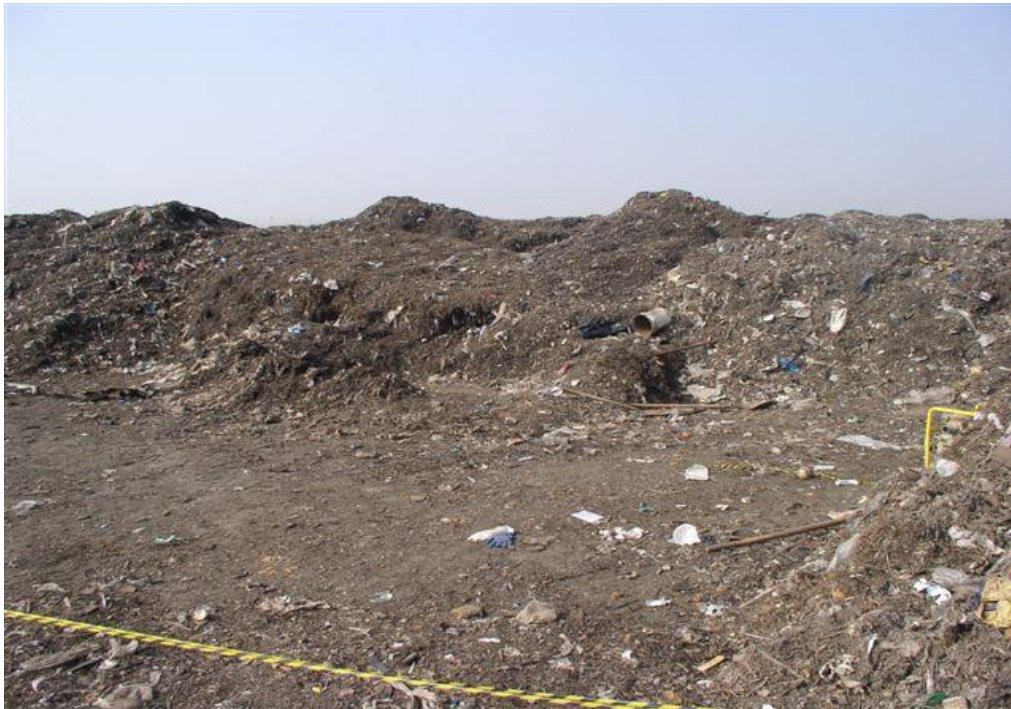
**Exhibit 1. The incident scene.**

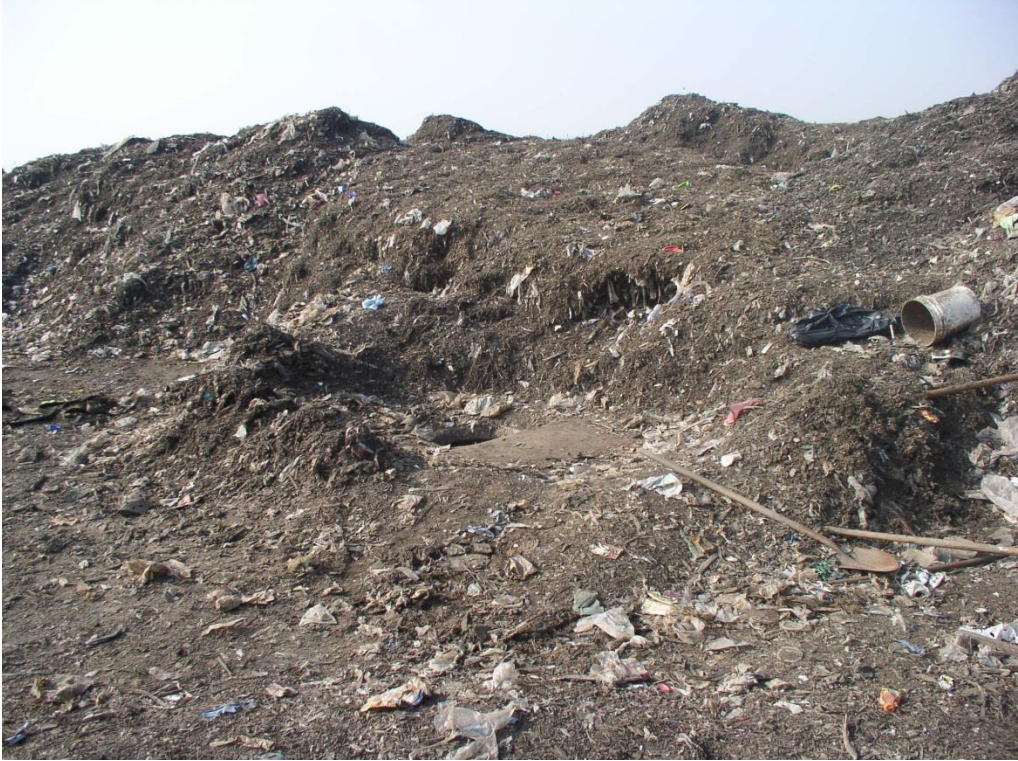
The drainage system consisted of 24-inch diameter drainage pipes strategically angled beneath the soil and 14 vertical shafts (manholes) ranging in depths of 4 to 10 feet and 36 inches in diameter. Each of the vertical drainage shafts was covered with a solid metal plate. The vertical shaft involved in this incident was 10 feet in depth, six feet in diameter at its base, and had three drainage pipes leading in and one pipe exiting toward the catch basin.

**Exhibit 2. The shaft opening.**

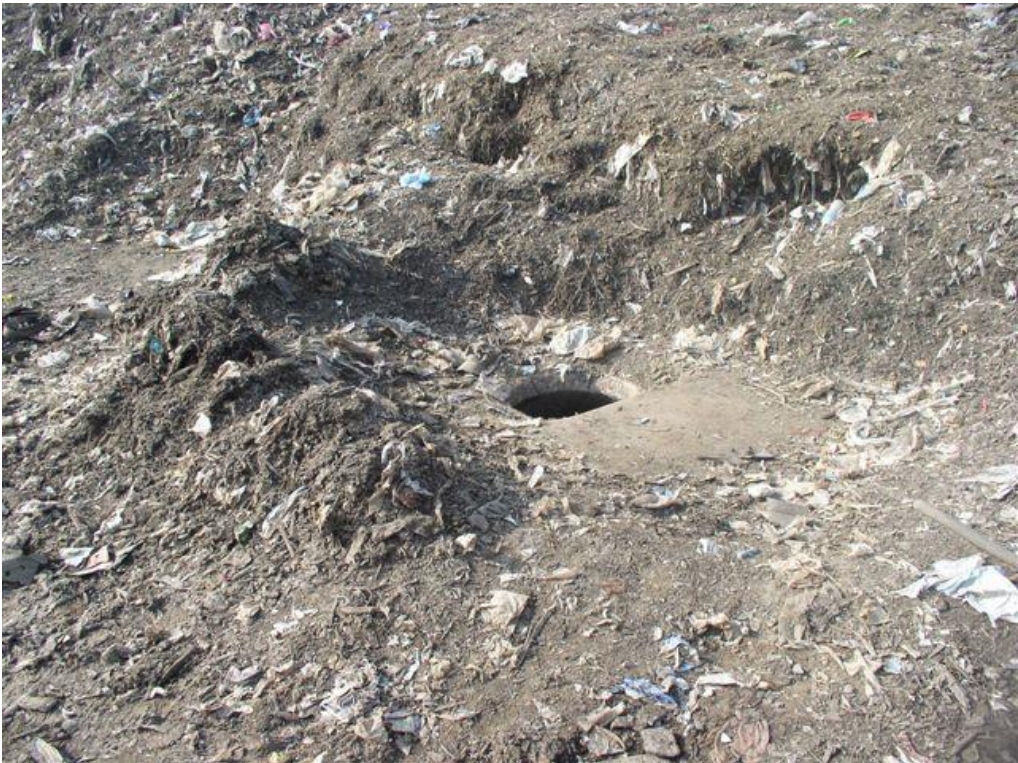
**Exhibit 3. The shaft opening.**

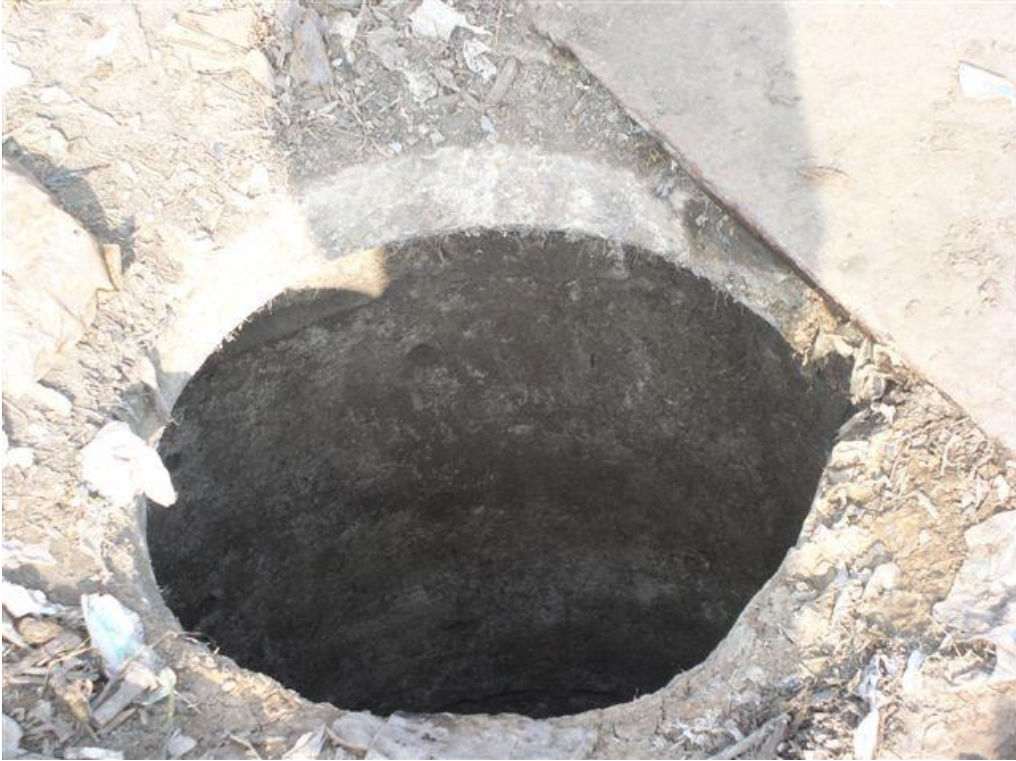
**Exhibit 4. A close-up of the shaft opening.**

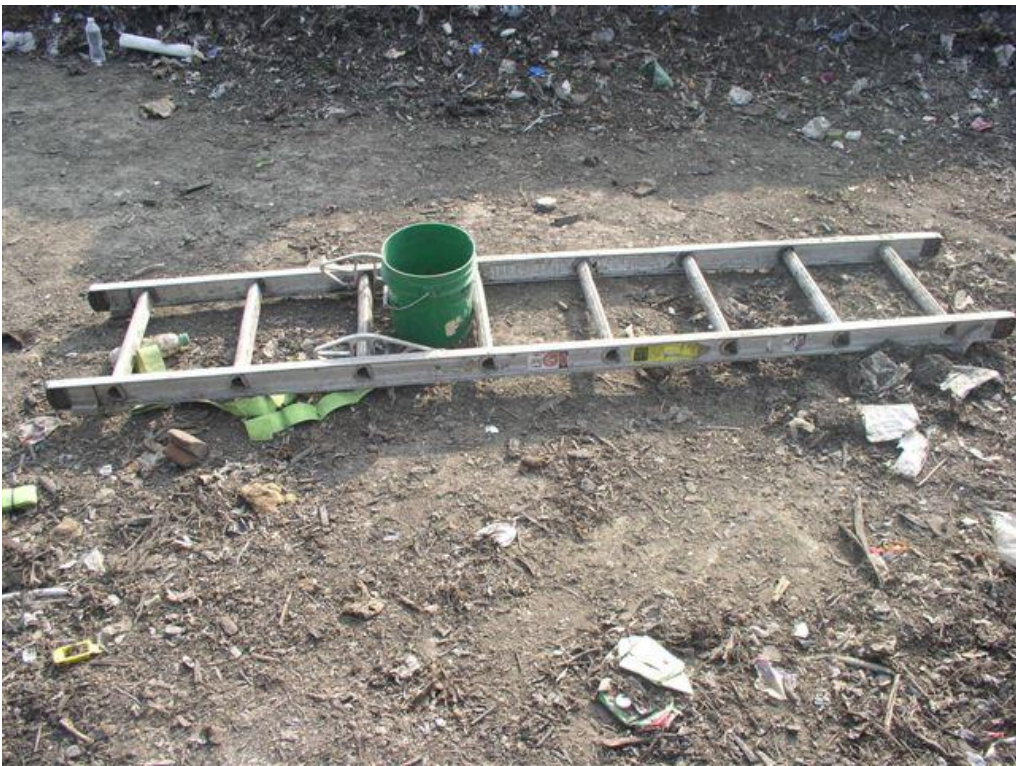
On the day of the incident, the workers were taking turns spraying water from the high pressure hose. All three took turns sitting on the edge of the shaft and directing the water stream to the bottom of the shaft. This proved unsuccessful in cleaning out the hole, so they placed an eight-foot ladder into the shaft. The 16-year-old victim was standing on the ladder inside the shaft to aim the spray of water. The 22-year-old victim witnessed his brother collapsing into the shaft, went down the ladder to rescue him, and then was overcome himself. The third employee looked down the shaft; saw both co-workers unresponsive and called for help. The fire department arrived at the incident scene and determined that hydrogen sulfide was present. The rescue team entered the shaft wearing self-contained-breathing-apparatus (SCBA) to rescue the victims. The 16-year-old was pronounced dead on arrival at the hospital, and the 22-year-old survived for two days before he was taken off life support.

**Exhibit 5. The ladder found in the shaft opening.**

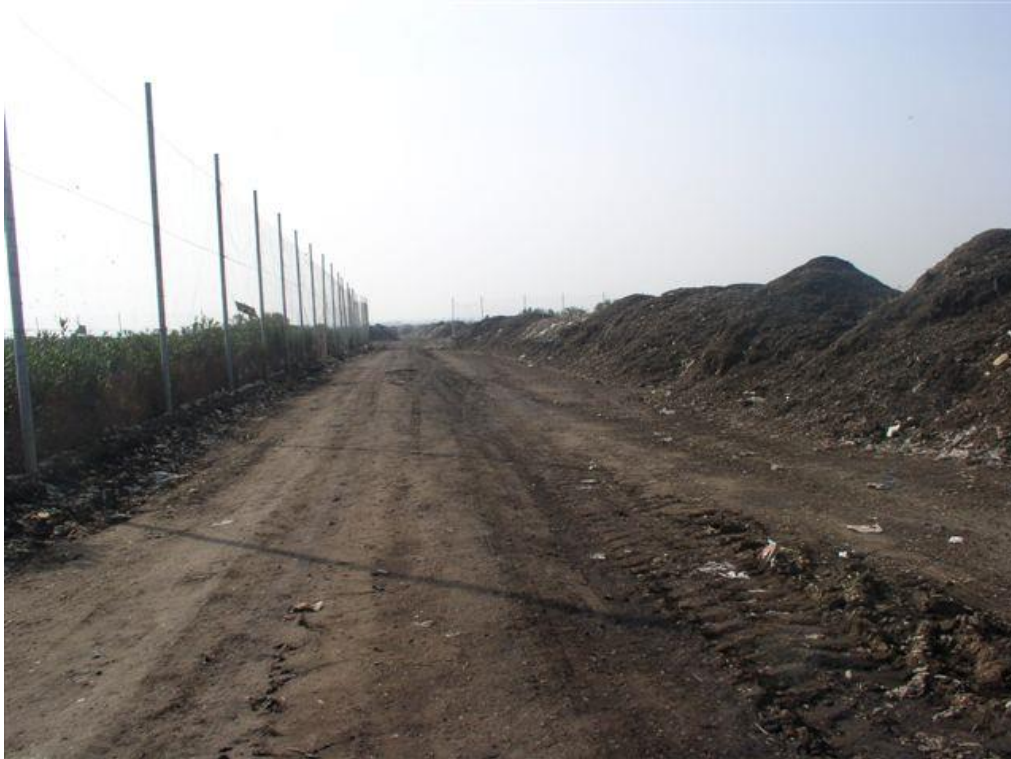
The incident occurred on a multi-acre organic waste recycling facility where organic materials from commercial and residential sites were turned into compost. Organic materials were piled into large wind rows (a long row) and treated with water and chemicals to speed biodegradation. A storm drain system below ground carried water and debris to a catch basin on the property.

**Exhibit 6. The wind rows of compost at the recycling compound.**
