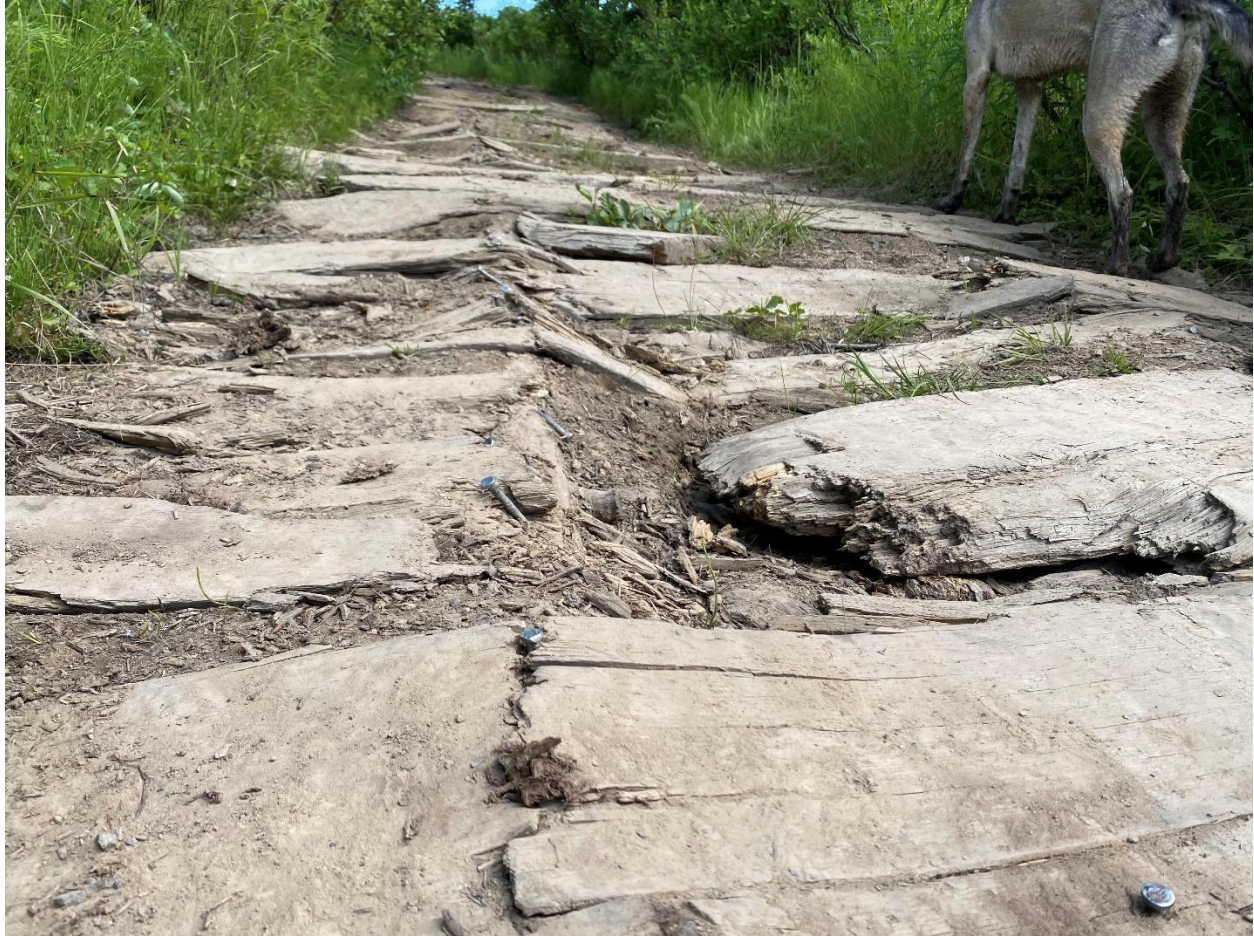
Photo 1: A close-up of the degraded Boardwalk Trail that users avoid. Big nails are sticking up everywhere, which stops both horse riders as well as ATV users. July 2022.

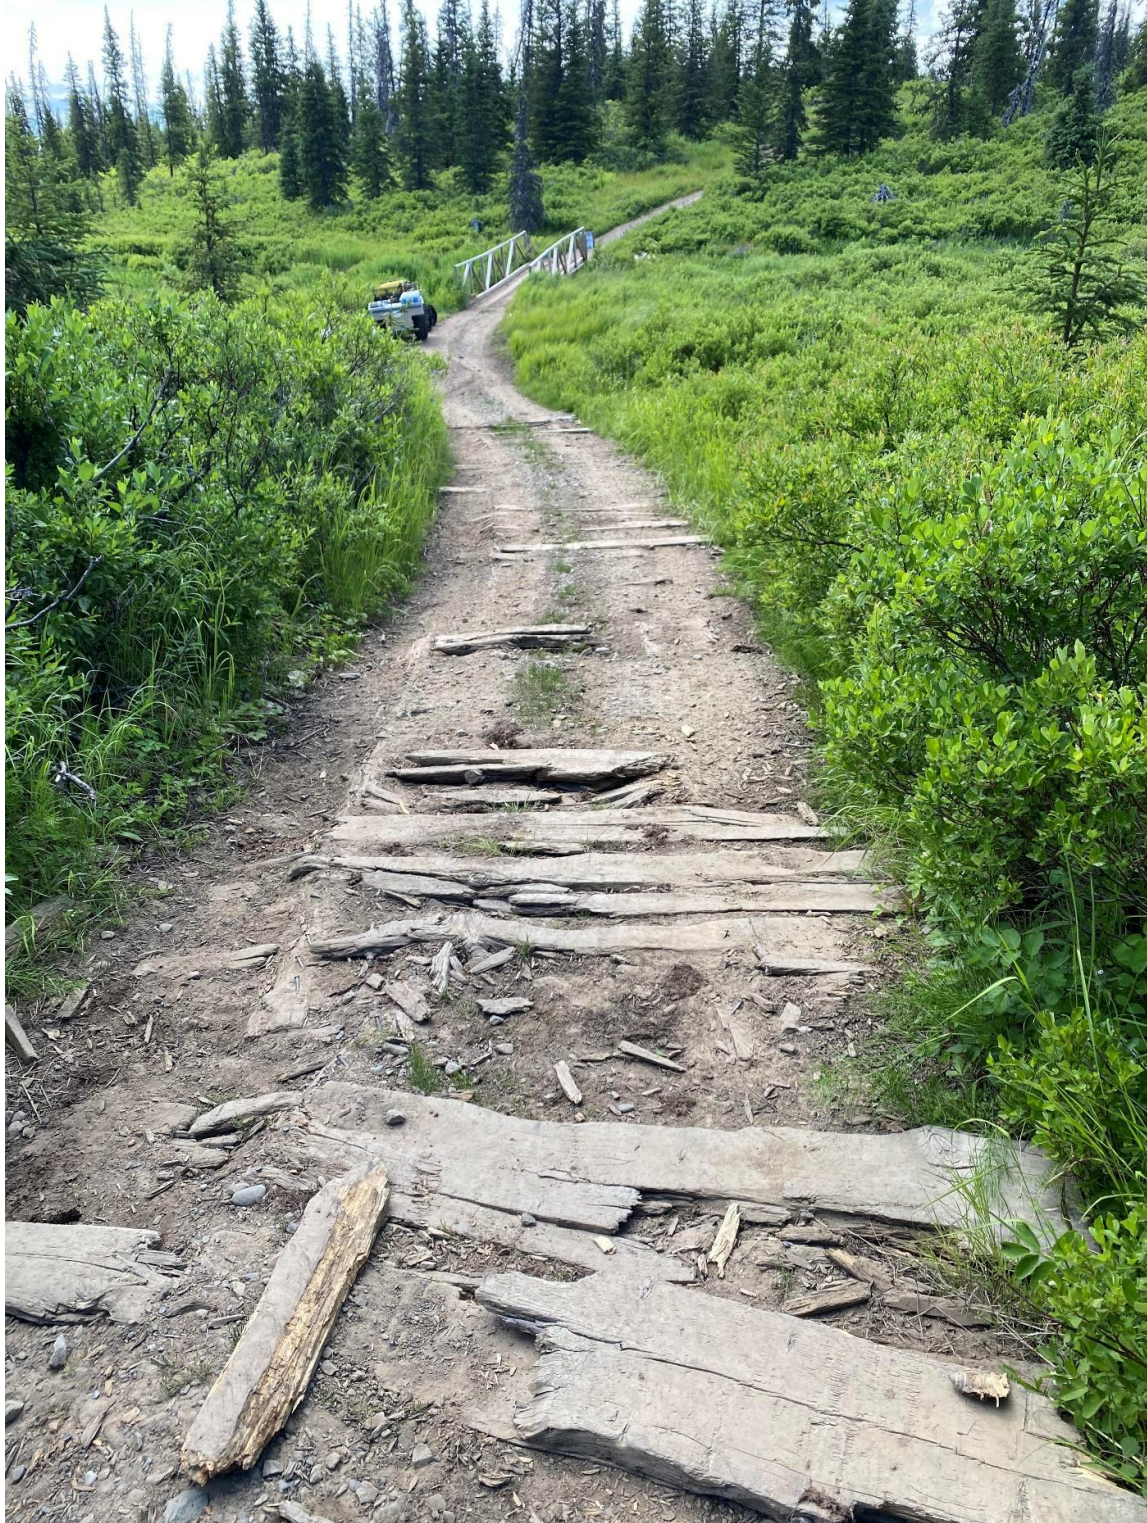
Photo 2: Moose Creek bridge on Boardwalk Trail looking west from the beginning of the 1.4 mile severely degraded section that is shown in photo 1.

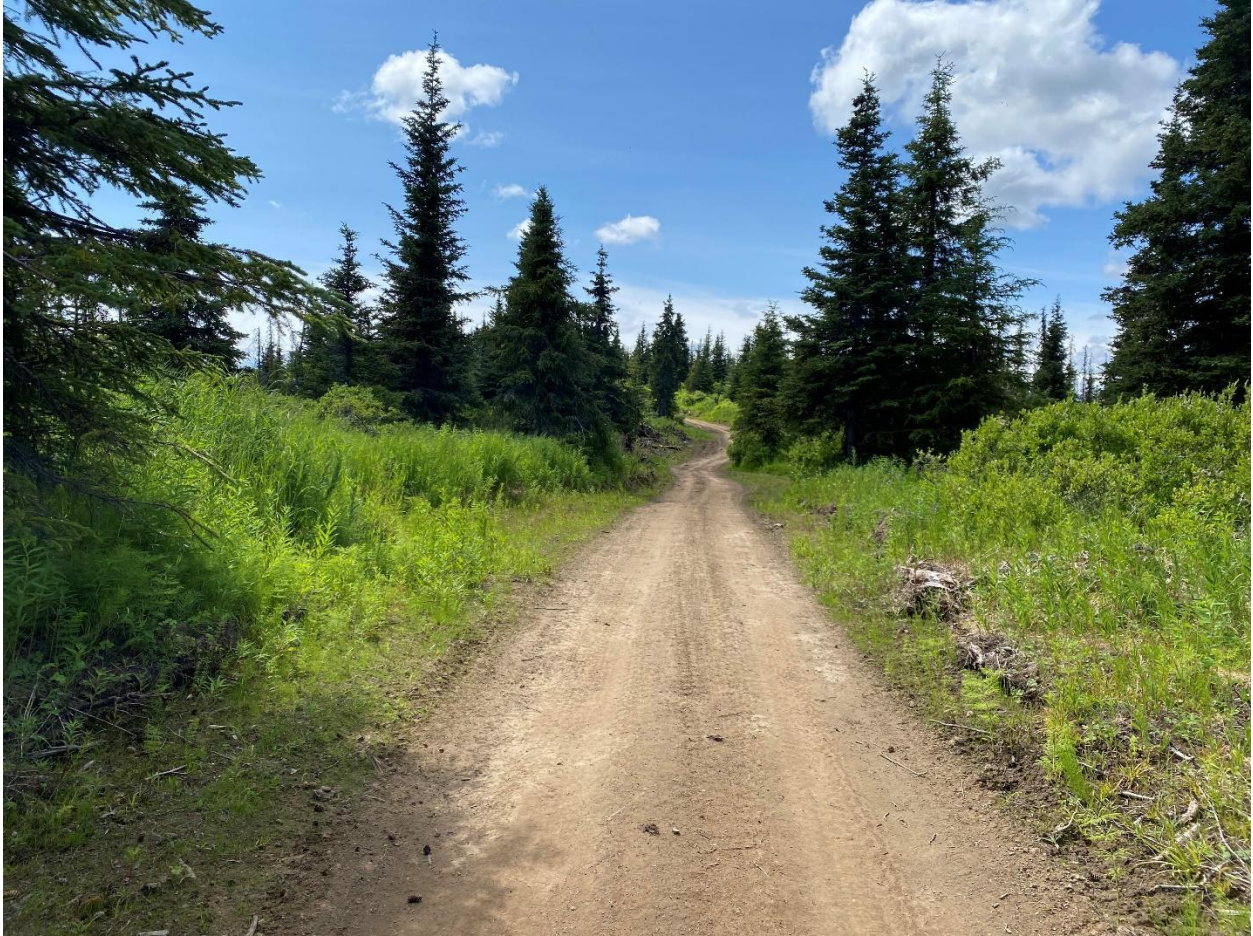
***Photo 3:** The portion of the Boardwalk Trail between the parking lot and the Moose Creek. This section was partly rehabilitated in 2021.*

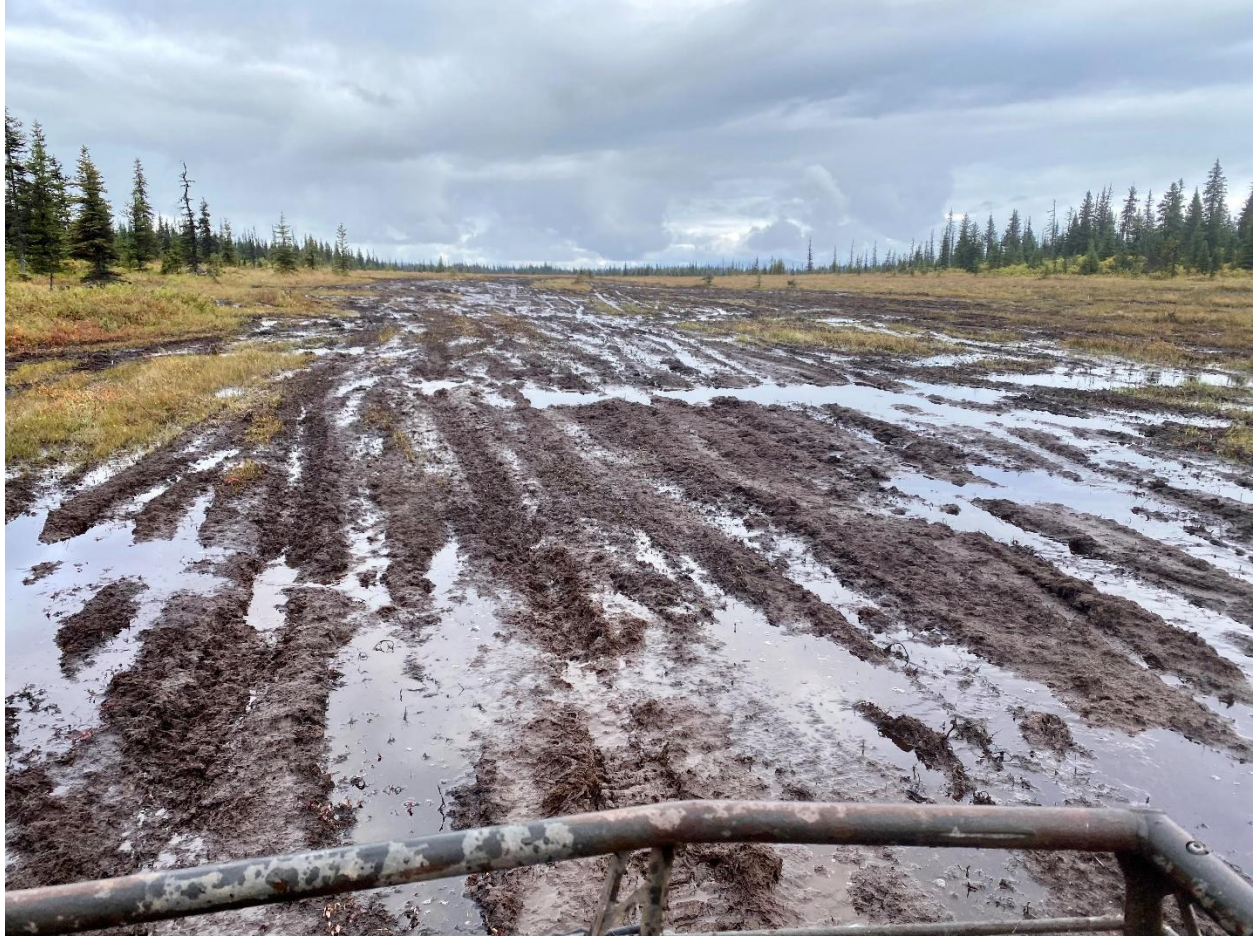
Photo 4: *ATV users are not using the Boardwalk Trail east of the Moose Creek bridge and are instead driving out onto the wetland, which has seen severe damage. This photo is from early September in 2022 before the 2022 moose hunting season (the damage increased with all traffic related to moose hunting).*

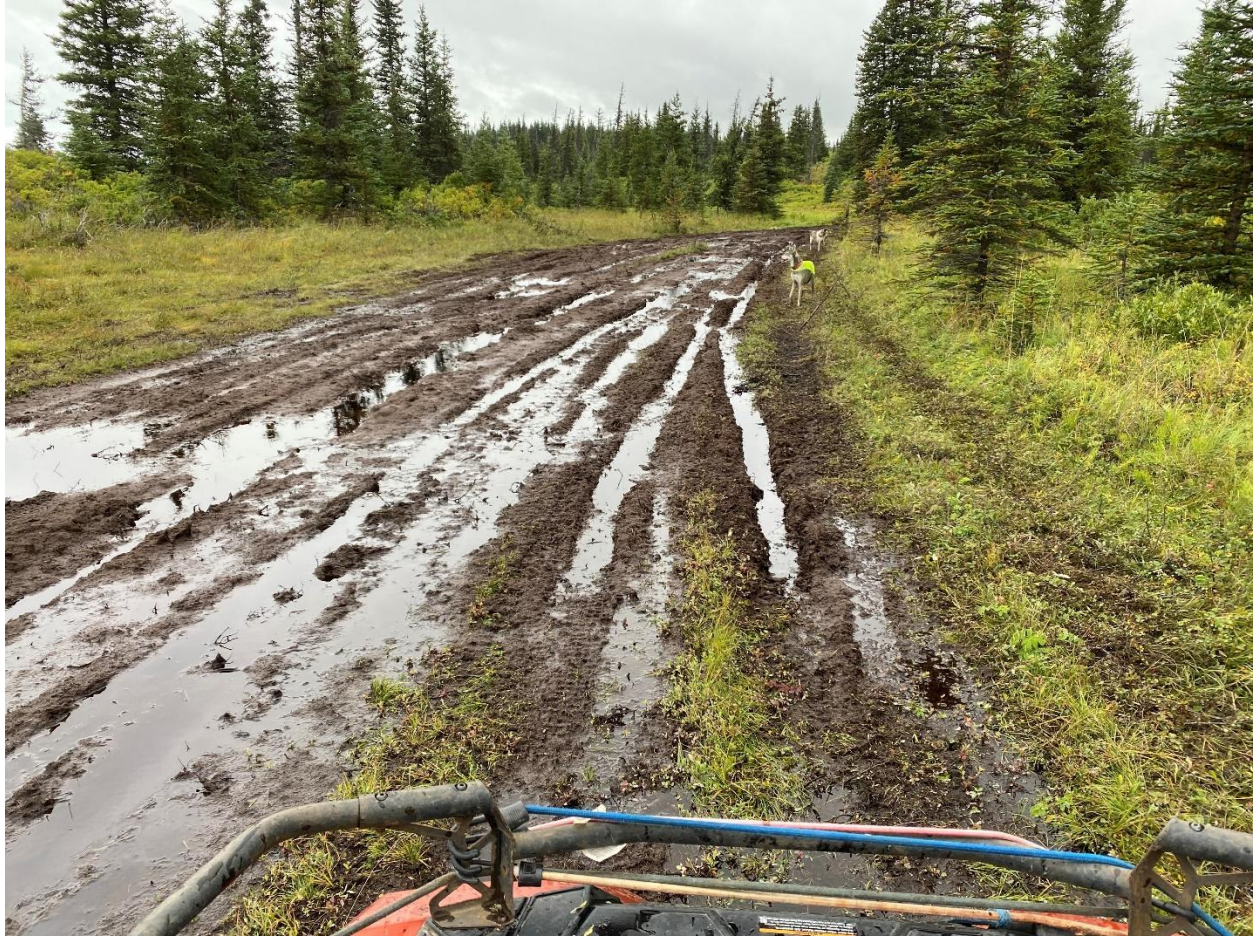
Photo 5: *The small valley of Moose Creek in the distance (looking west) and the beginning of the wetland damage caused by ATV drivers abandoning the Boardwalk Trail just east of Moose Creek due to the extremely poor condition of the trail east of the Moose Creek bridge .Photo in early September 2022 prior to the start of the moose hunting season.*
