# **Norwegian Pilot 2**

## **A6 Evaluation and final report**

NordicWay 2

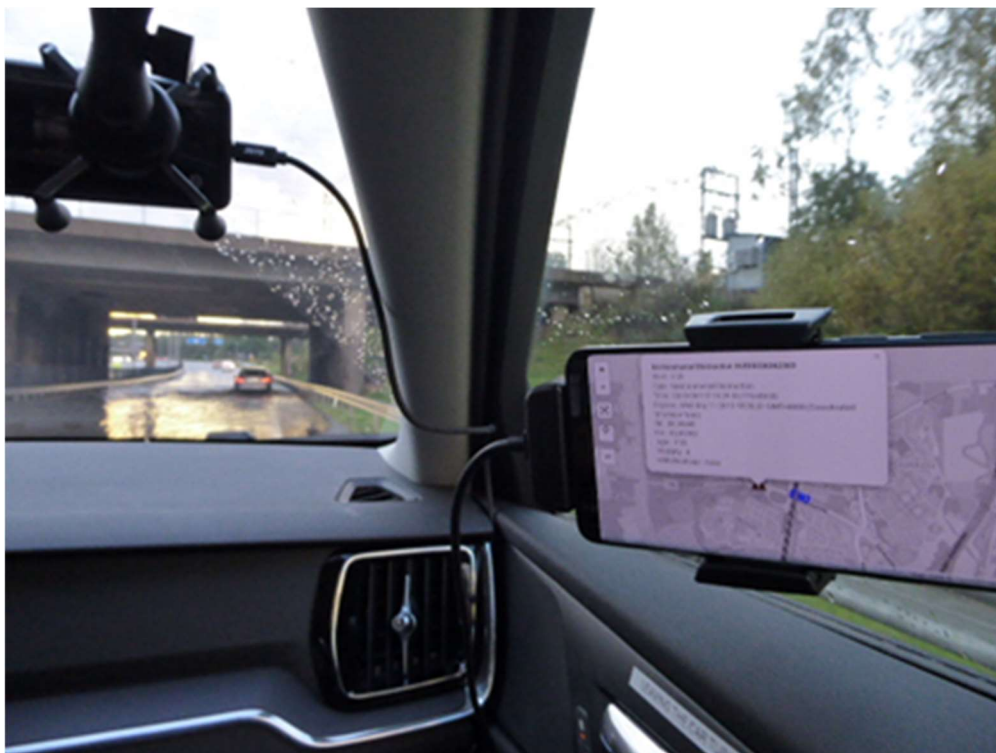
**Figure 3 Environmental obstruction warning issued by the Finnish TMC over the interchange**

Figure 3 documents that we received an environmental obstruction message over the interchange just east of Helsinki. As the picture shows there was flooding in an underpass. This message was sent from the Finnish TMC and received by the interchange node in Norway where it was extracted, put on a map and sent to the vehicle. We saw the message early on and could have made a detour if we wanted to, but we were also curious about what the message meant in real life. Hence the tour also provided a vessel for testing messages passed over the interchange.

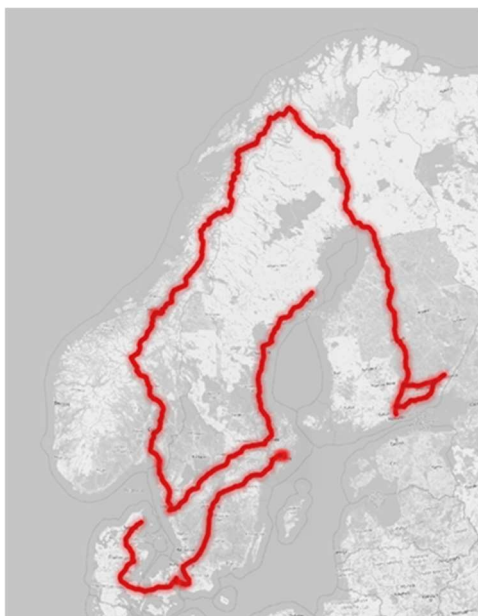
**Figure 7** The actual route driven of the NordicTour

Figure 7 shows the actual route driven on the NordicTour. The additional stretch from Gothenburg and up the east coast of Sweden was the second part of the NordicTour. The second part took place mid-March 2020. This was supposed to get extra data on semi winter conditions. The expedition only got halfway up Sweden before the team was called back to Norway since Norway was closing its borders due to Covid-19 pandemic.

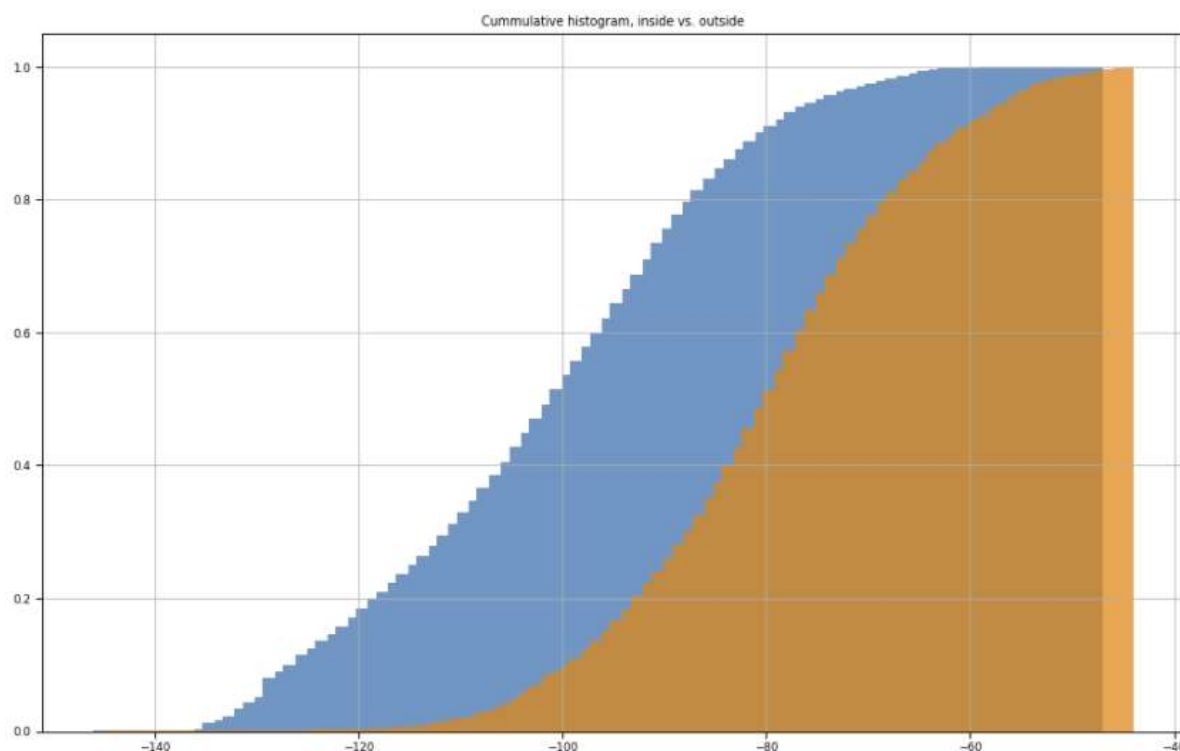
**Figure 12 Signal strength inside the vehicle and outside the vehicle on 4G**

The main take away from the logging is that antenna on top of the vehicle provides a much stronger reception than units inside the car. And the difference is quite staggering. Figure 12 shows a cumulative histogram of received signal strength from the device inside the vehicle and the antenna on the roof.

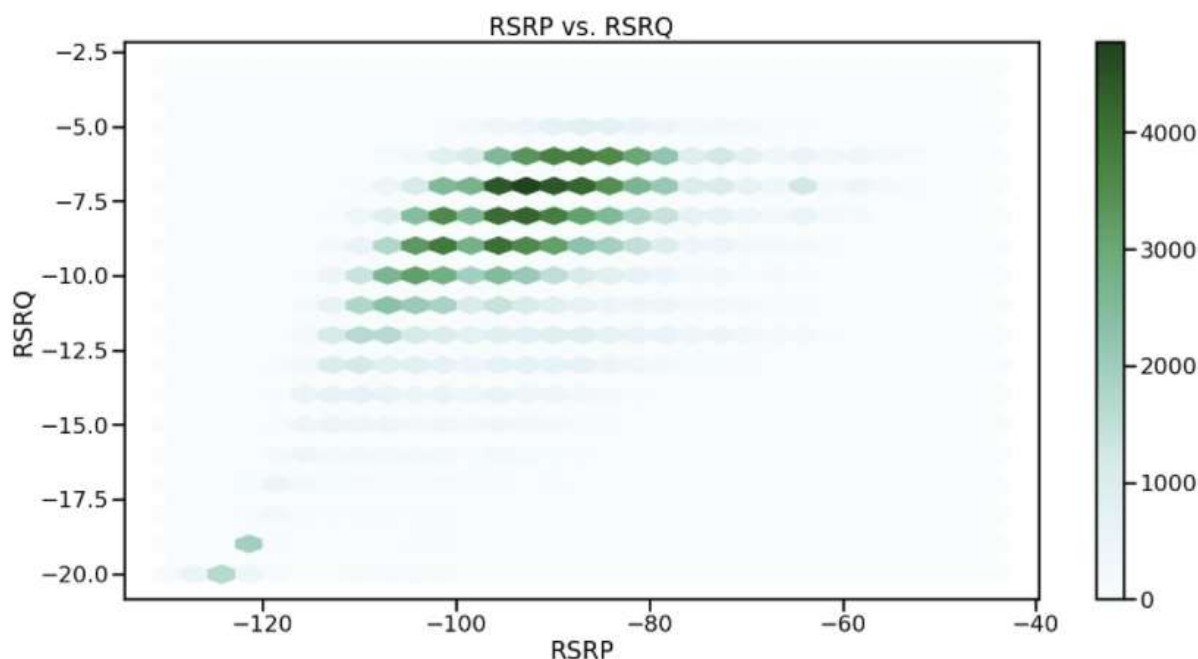
**Figure 13 Hexbin plot of RSRP versus RSRQ for Tablet**

To investigate throughput, one needs to add one additional parameter, RSRQ Reference Signal Received Quality. The combination of RSRP and RSRQ are among other parameters used by the UE to choose base station or cell. Figure 13 shows a scatter plot of RSRP vs. RSRQ for the Tablet inside the vehicle. The closer to the upper right the better the connection is. When the Tablet had LTE coverage it also had a decent RSRQ, typically better than -10dB.

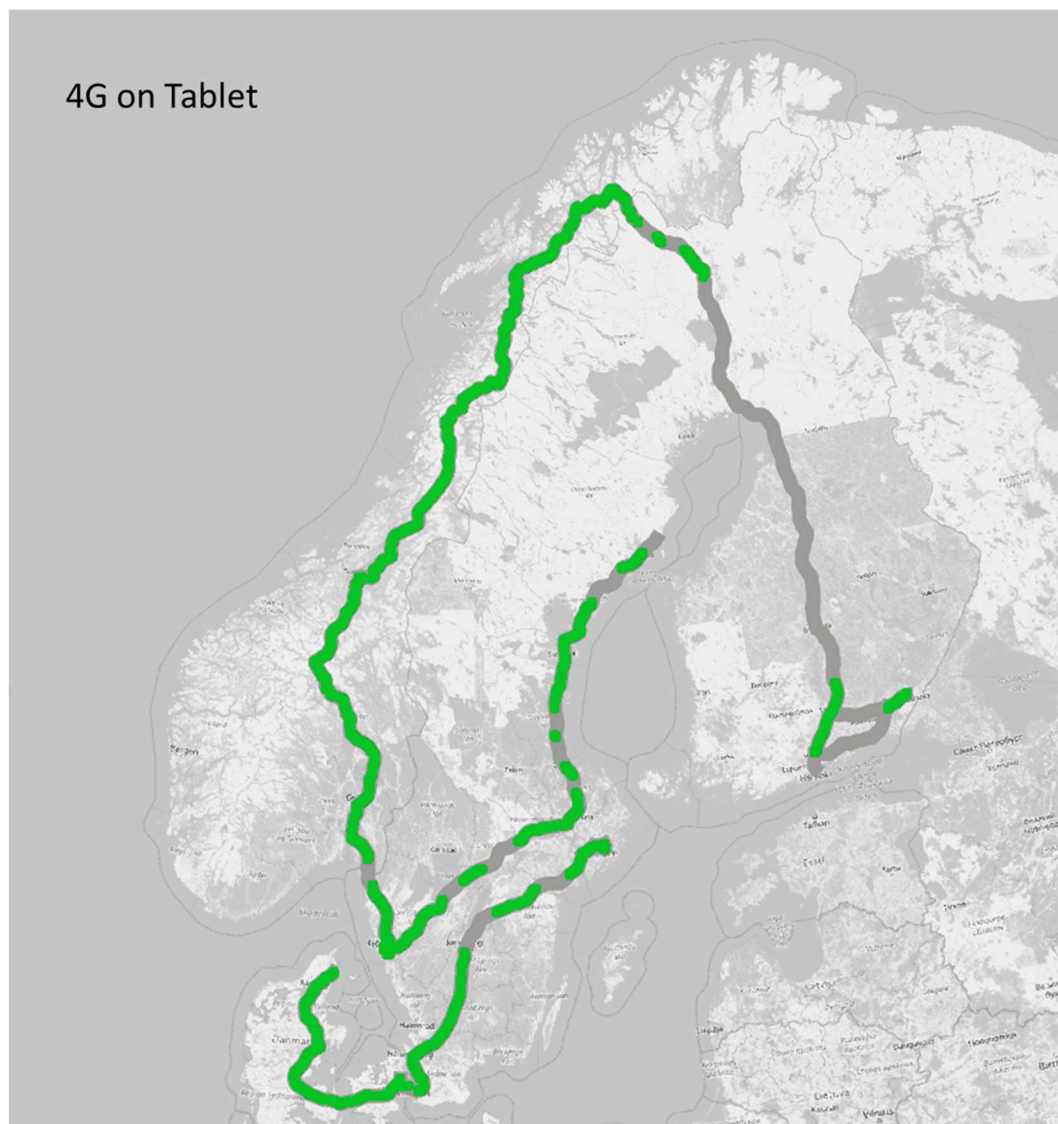
**Figure 14** 4G network connection to Tablet

The data collected was also geo referenced for simpler understanding of where the issues are. Visualizing the vast amounts of observations is challenging as the datapoint will overlap when creating maps. To make sure that one does not lose information due to visualization issues three figures have been created, one for each technology. The dark grey line shows the route driven and the colours shows what technology the tablet had available at any time. Figure 14 shows where the Tablet was using the 4G telco network. The green spots indicate where the vehicle had 4G reception, the map does not say anything about the quality of the reception – only that the Tablet was using 4G. Figure 15 shows where the Tablet was using the 3G network. Here one can see that there are spots in Norway where 3G is used. This was expected as the 3G networks in Norway are being shut down by the two main operators<sup>23</sup>. The main reason for shutting down these networks is to “give room” for 5G networks. It is also projected that the 2G network will be shutting down soon, most probably in 2025 in Norway<sup>4</sup>. The status of 3G and 2G in the other Nordic countries was not explored in this study. But from the data one can clearly see that both Sweden and Finland still have large 3G coverage. Hence the fall back from 4G is to 3G rather than 2G as is the case in Norway since the technology is not available to a large extent.

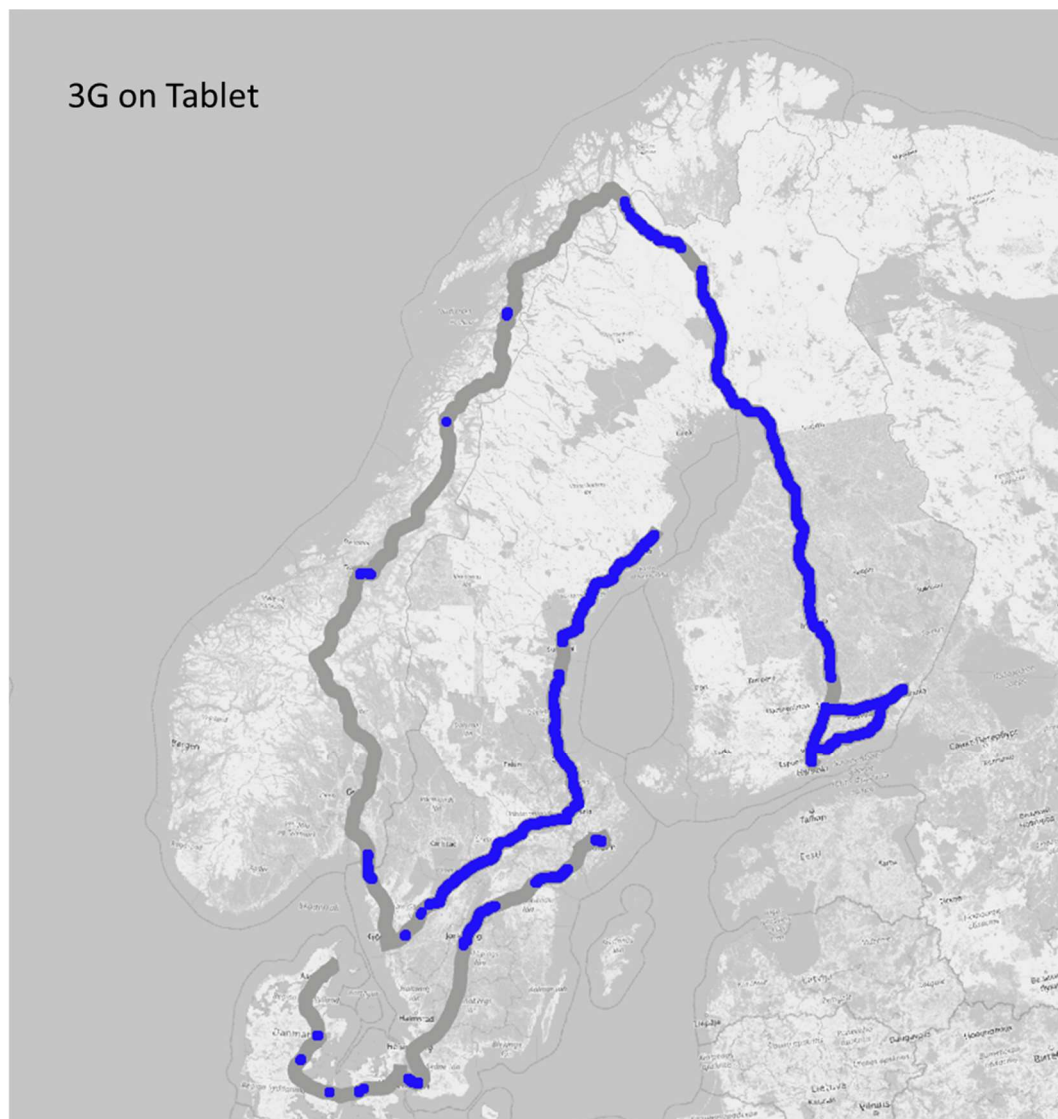
**Figure 15 3G Network connection to Tablet**

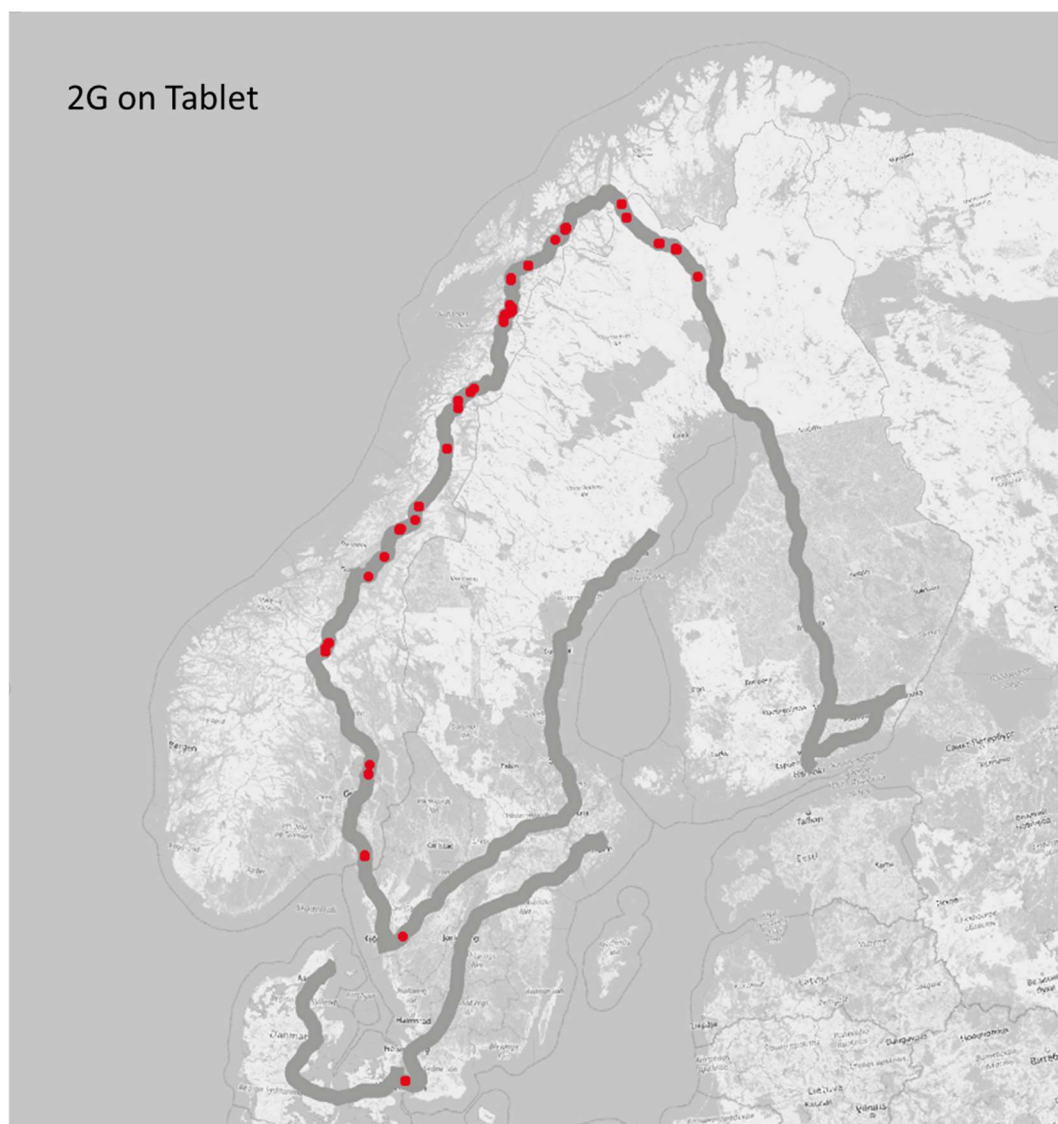
Figure 16 shows where the tablet used 2G communication. It is quite clear that 2G is only used when no other technology is available, even if there is coverage of 2G in the whole of Norway<sup>5</sup> as seen on the theoretical coverage maps produced by the telco operators.

**Figure 16 2G Network connection to Tablet**

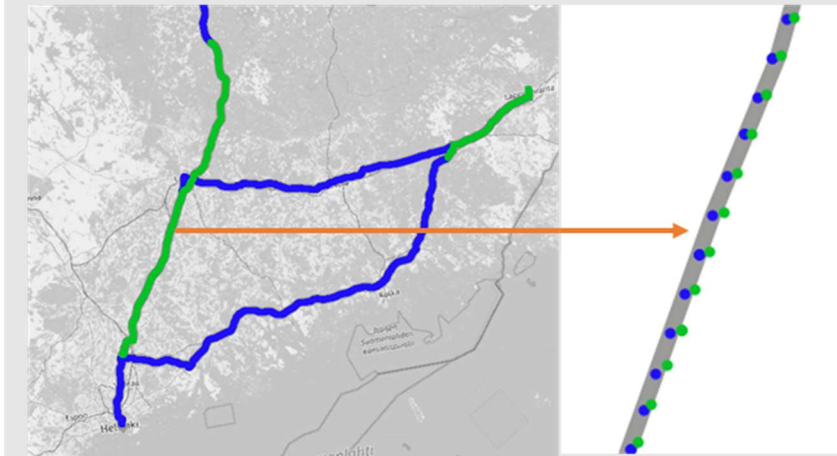
**Figure 17 Different technologies used on different days**

One interesting artefact was found north of Helsinki, a small road segment there was driven 2 times. On the first day the Tablet used 3G on the stretch. On the second day the vehicle used 4G on the stretch. Figure 17 shows this effect, the only difference between those days in the vehicle was that the NPRA crew were joined by a representative from the FTA, there was no difference in placement of the device. The reason for what was observed is hard to understand, every point on the stretch is connected to the same Finnish telco operator Elisa so it is not a difference due to different operators. To the extent 3G is inferior to 4G there could be issues if user devices can freely shift between available technologies. This is probably one reason for OEMs to choose specific radio technologies.

Blue: 3G, Green: 4G

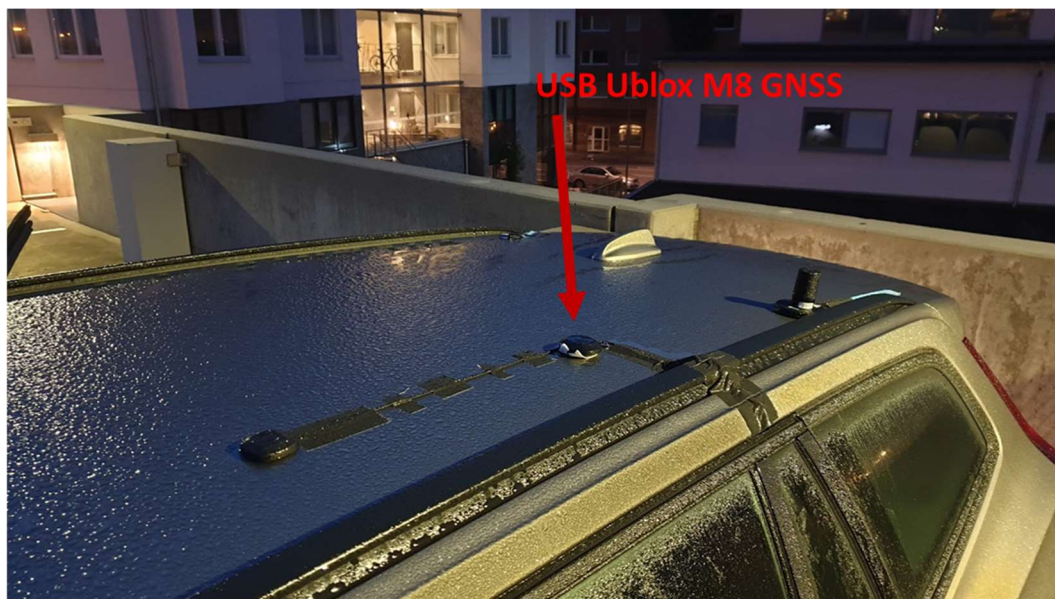
Figure 19 Location of Ublox M8 usb dongle with antenna

A Ublox M8 receiver was used to test consumer grade equipment. The low cost of the receiver, widespread usage and debugging capabilities made this GNSS equipment a good choice. The packaging of the unit was as a USB dongle, with a ceramic antenna on top of the GNSS unit. The unit was placed on the roof over the rear seat on the driver side.

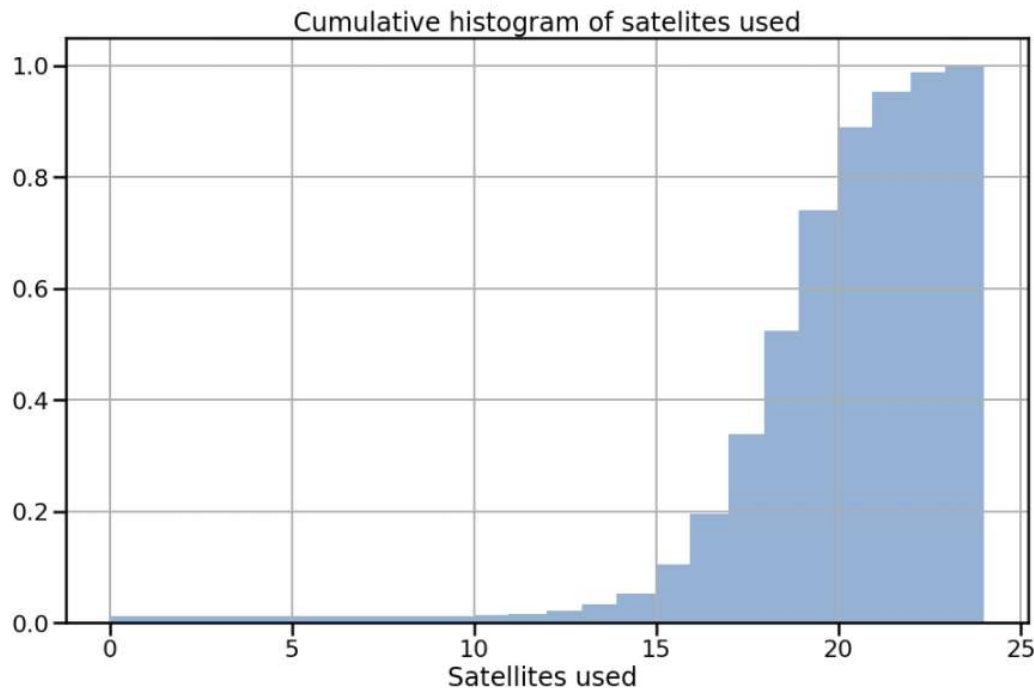
**Figure 20** Cumulative histogram over satellites used on the NordicTour

Figure 20 Shows a cumulative distribution of satellites used for calculation of position. 95% of the time the vehicle saw more than 14 satellites. It should be noted that the Ublox M8 is a concurrent GNSS receiver, concurrent GNSS receivers which can receive and track multiple GNSS systems: GPS, Galileo, GLONASS and BeiDou. For the NordicTour GPS + GLONAS was used, but with correctional data from both EGNOS and QZSS.

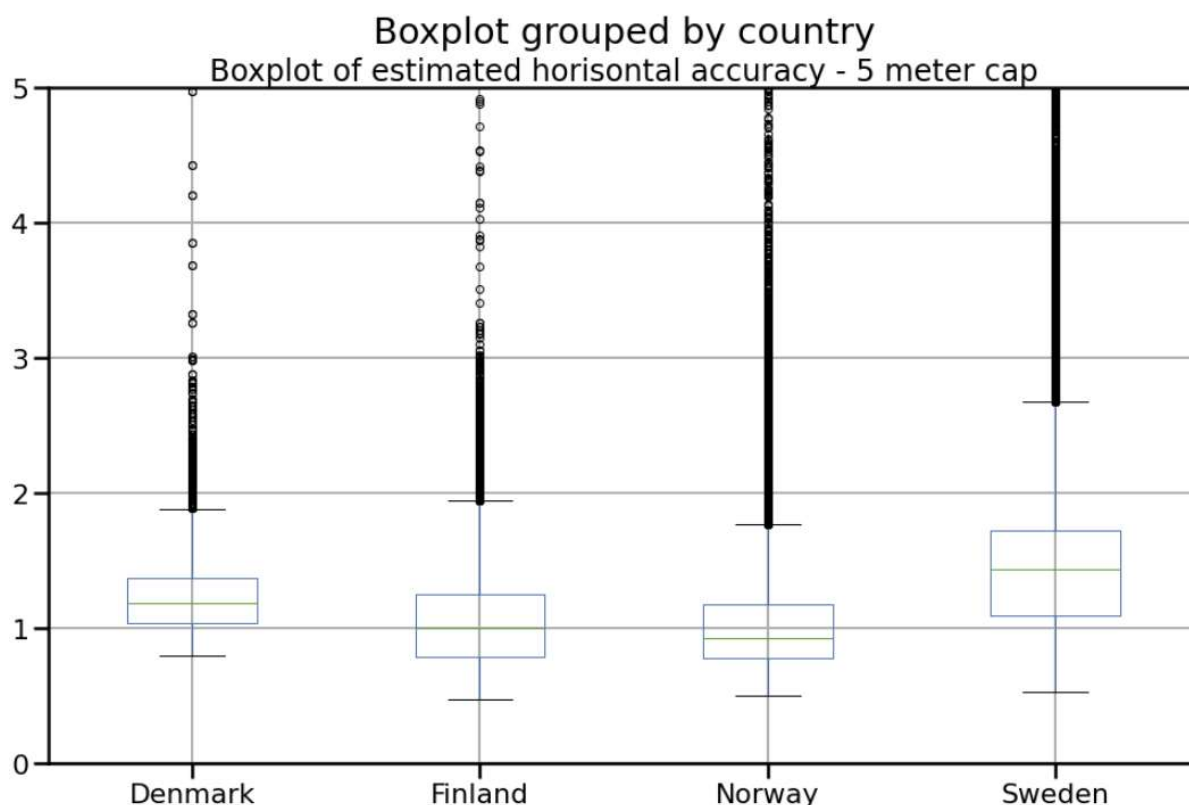
**Figure 22 GNSS self-reported accuracy**

Figure 22 shows a boxplot of the GNSS receivers self-reported accuracy. It is rather interesting to note that accuracy in Norway has a smaller spread than in Sweden. This is very interesting since the topography should be more challenging. It is also surprising to note that Denmark has a narrow spread of observations but a higher uncertainty. One plausible reason for this is the difference in speed observed on the main roads in the different countries.

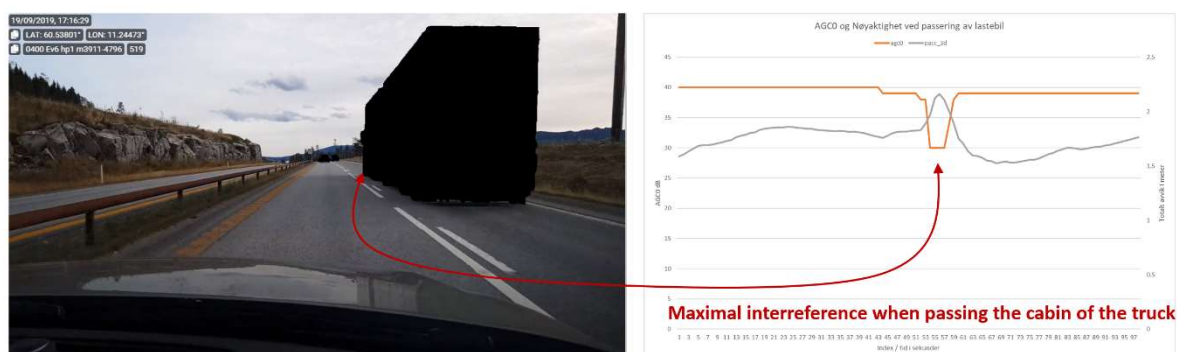
## GPS jamming fact or fiction ?

GPS jammers exist in the wild, in additions we have suspect data in Kilpisjärvi, Mo i Rana and Trondheim.

C-ITS services are susceptible to GNSS interference – need for cooperation with experts in the field.

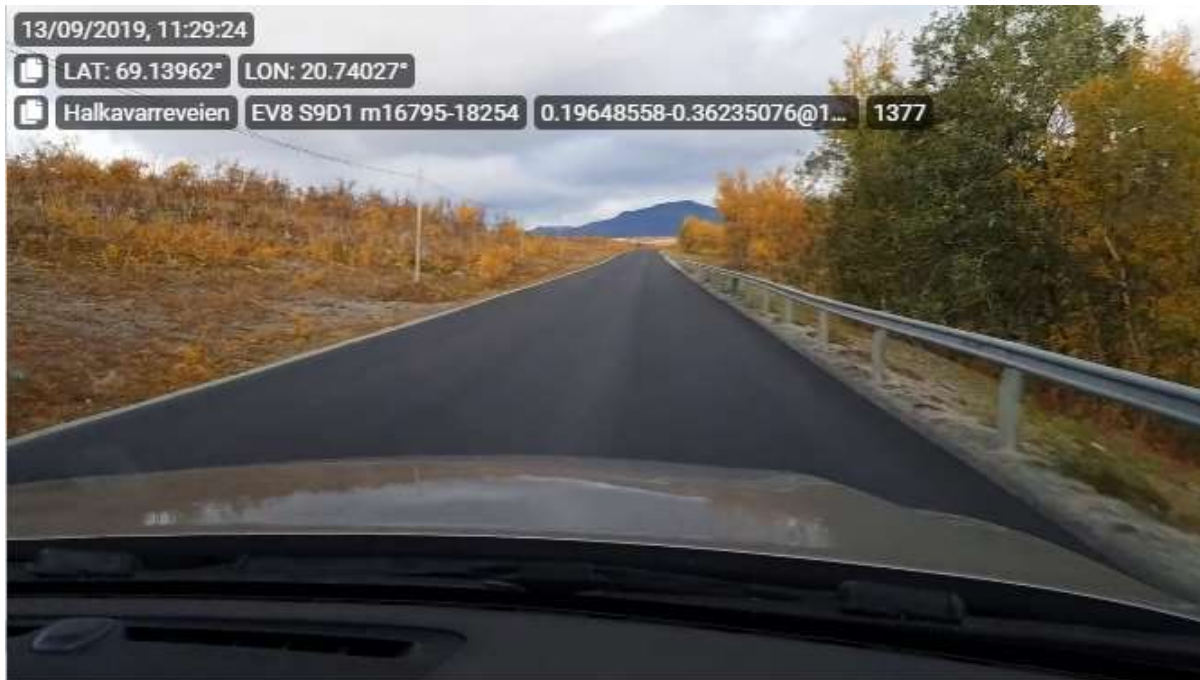
**Figure 29 Fresh asphalt and no road marking**

To understand these issues there is a need to go into the details and study specific areas where lane detection system does not understand the road infrastructure. Figure 29 shows a classic example with fresh paved road and no markings. It is quite normal that resurfacing takes place first and then the lane marking will get repainted later. Under real world scenario one has to take this into account, alternatively look into the standards and contracts to ensure the remarking is done immediately after repaving.

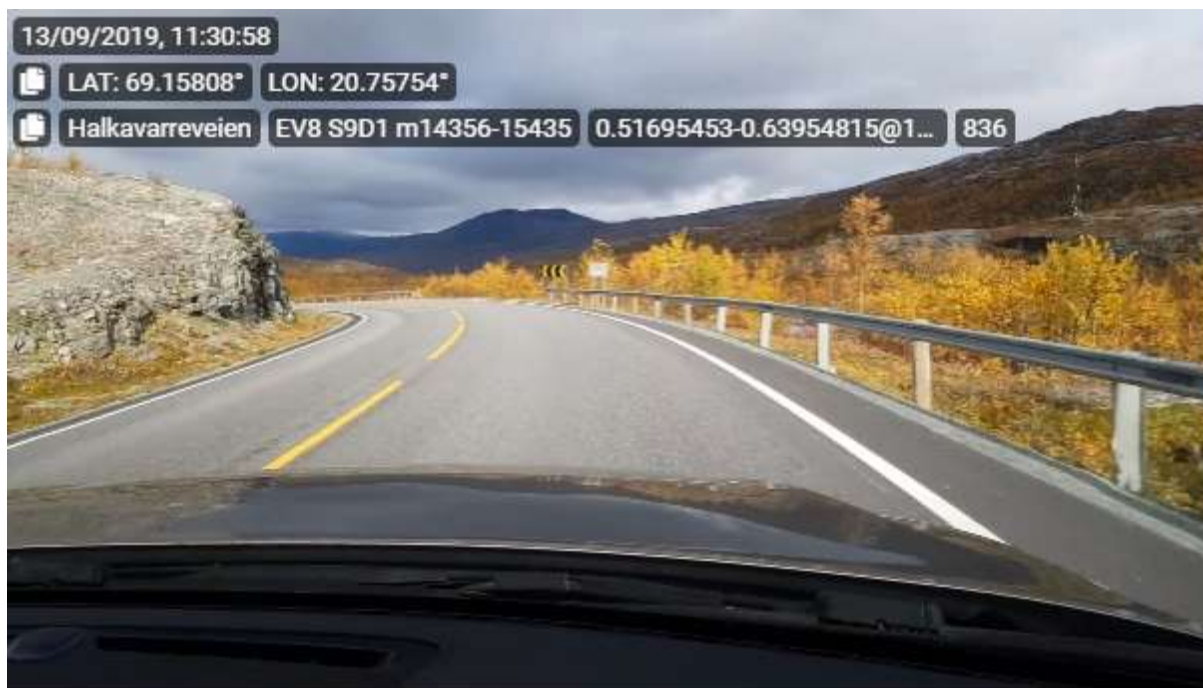
**Figure 30 Hard left turn**

Figure 30 shows another example where the vehicle no longer understands the markings. In the picture one can clearly see the markings, but the turn to the left is hard. This is also the reason for the chevron sign in the back. It will be very challenging or dangerous to try to take this turn with a speed close to the speed limit. These kinds of turns may not be within the operating limits of the system. There is a need for a dialogue between the OEMs and the NRAs to identify these issues. The issue of sharp turns also raises the question of whom is expected to set the safe speed in turns like the one above. The speed limits in Norway are not a recommended speed, but a maximum speed allowed. For summer conditions with ample friction, it is possible to calculate safe speed in advance, but how shall this be done in the future when algorithms take over the driving. Maintaining a specific friction level on the road network all the time will be very costly and hard to do.

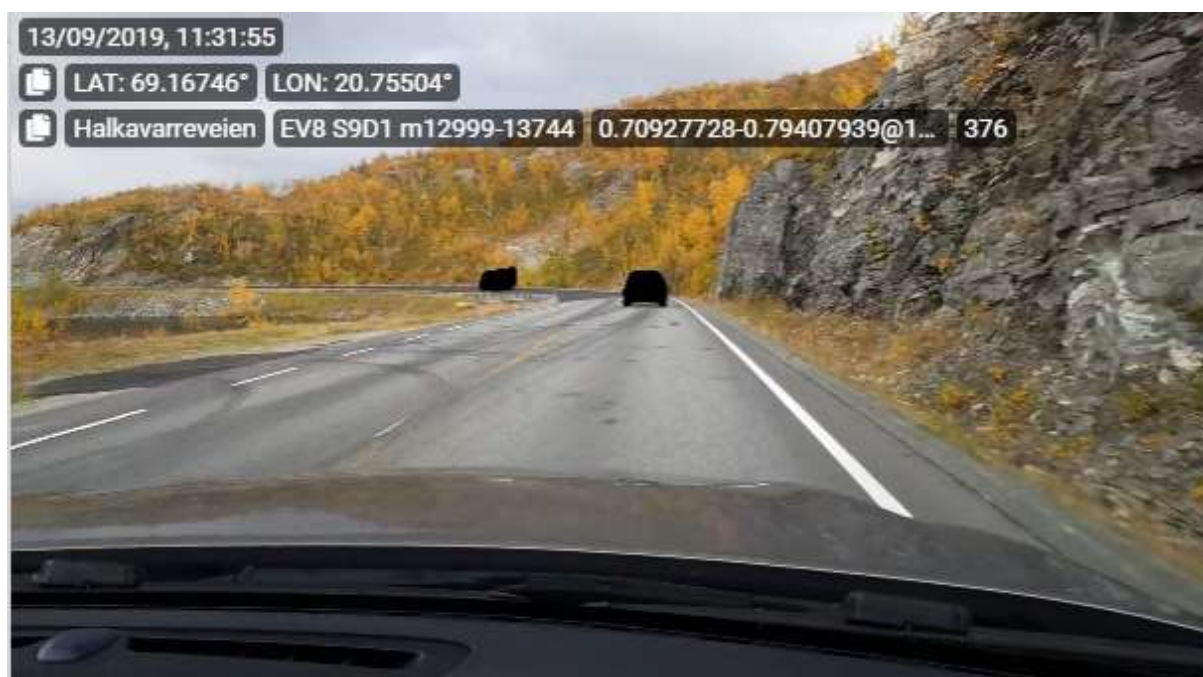
**Figure 31 Blurred area after asphalt works**

fresh asphalt over the old asphalt including the lane markings. This happened several places where there was a transition. It should also be noted that there are no lane markings on the fresh asphalt. This raises the questions about how road operators conduct maintenance work. There will always be a need for road works in a road network. The NRAs have standards for how this should be done, the standards are designed with the human driver in mind. There seems to be a need to rethink these standards in relation to automated vehicles. What kind of marking is needed for automated vehicles in roadwork zones?

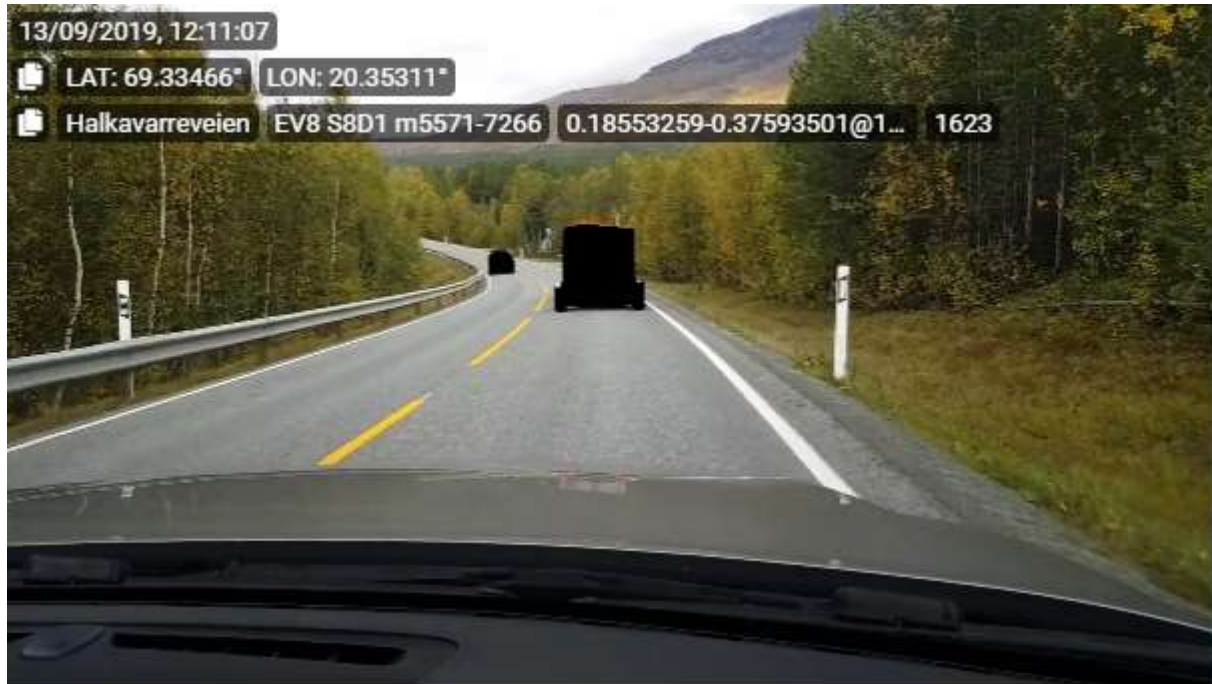
**Figure 32 NPRA measurement vehicle with flashing yellow blinker on top**

Figure 32 is rather interesting, the lane marking is quite visible, but the vehicle in front seems to confuse the system. The vehicle drives very close to the right edge marking. Another thing that is hard to see in the anonymized image is the yellow blinker of the vehicle. It is hard to say why the system does not detect the line marking, but it is probably linked to the vehicle in front. As soon as we pass the vehicle the system starts and finds the lane markings.

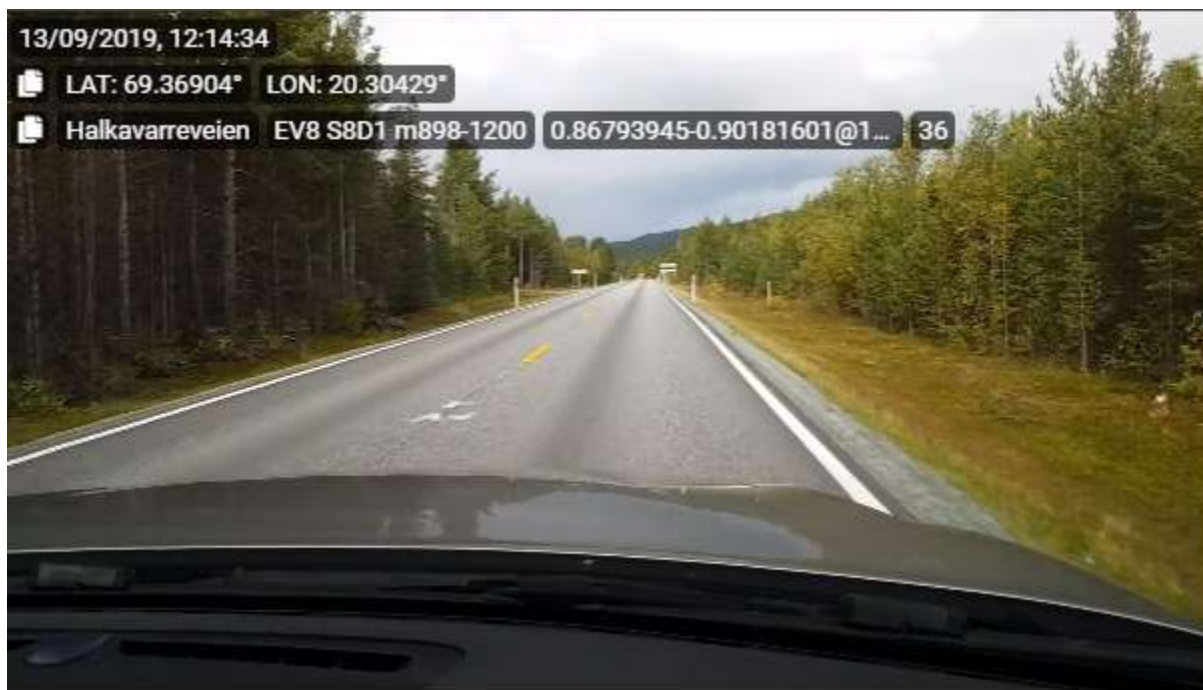
**Figure 33 Pre-marking for lane marking**

Figure 33 shows a stretch where the system is not able to detect the lane marking. The exact cause is hard to identify but compared to the stretch before and after, this stretch has pre-marking for lane marking. The pre-markings are the white spray-painted lines in the middle of the road in addition to yellow lines. Another cause could be the long vertical curve of the road that makes it hard to see the markings in the distance.

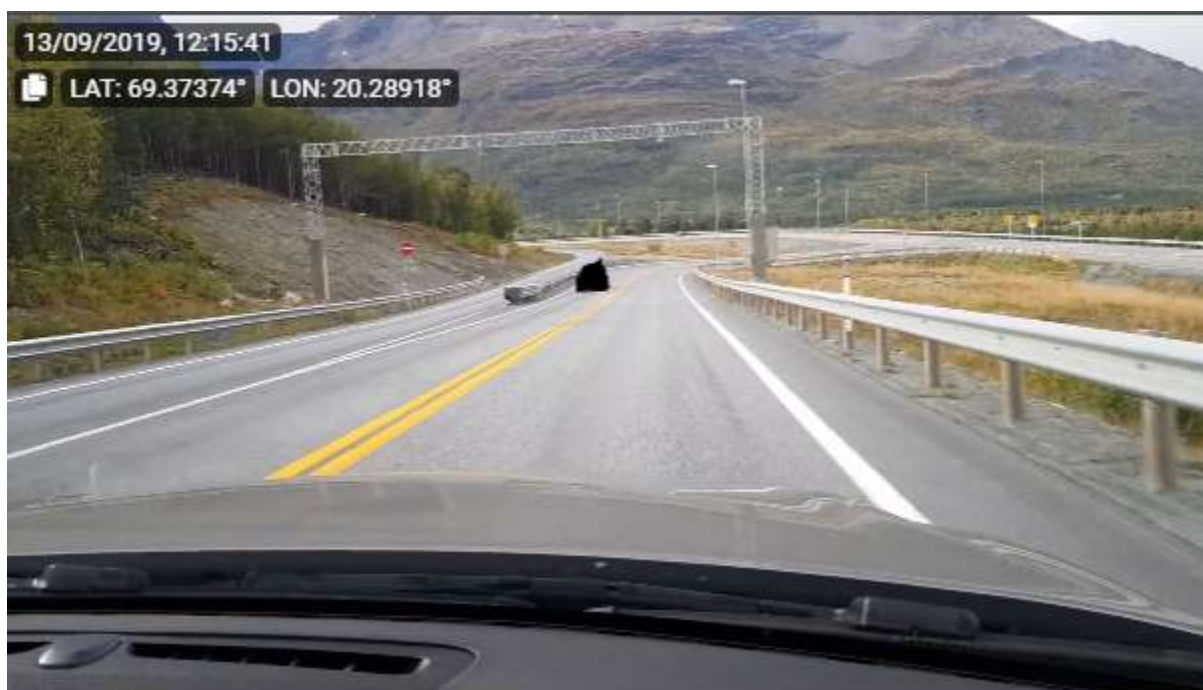
**Figure 34 Lane merger with barrier in the middle**

Figure 34 is rather confusing and shows the challenge of teaching these systems to understand the infrastructure. There is a single lane merging into the oncoming lane and due to the sharp curvature, there is a crash barrier in the middle separating lanes in the same direction.

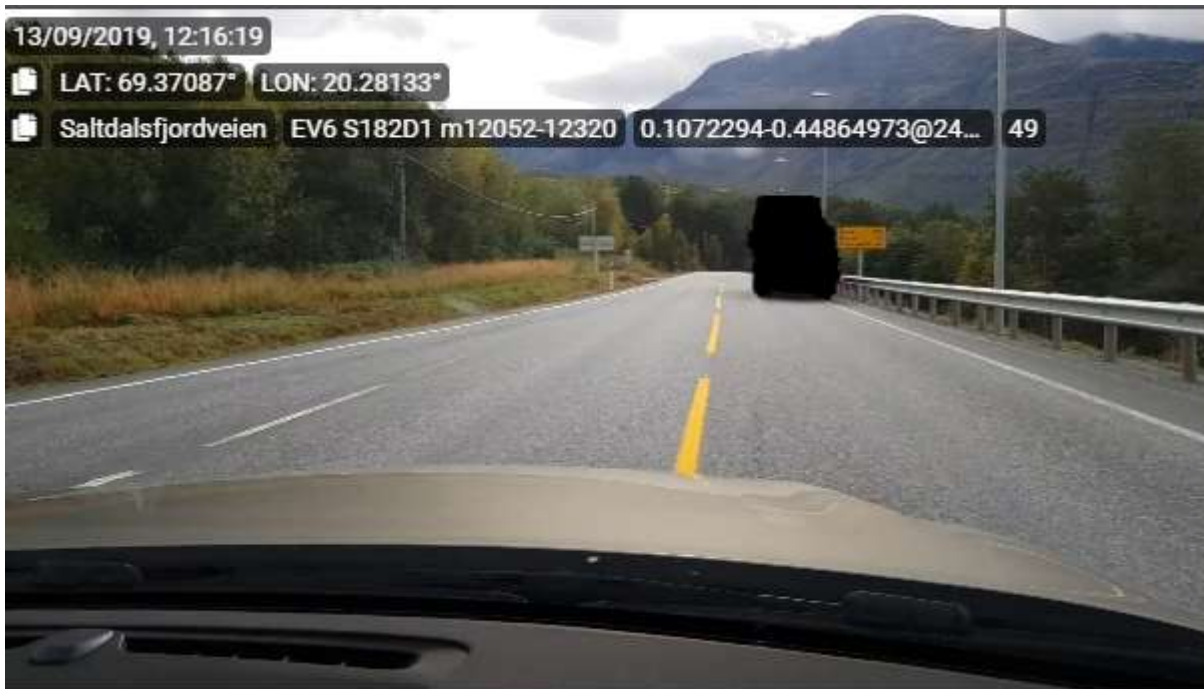
**Figure 35 Overtaking of maintenance vehicle and lane split in opposite direction**

Figure 35 shows a maintenance truck on the right shoulder that masks out the right lane, the centre line disappears under the horizon and there is a start of an extra lane in the oncoming direction. This is again a situation that occurs in real life which will make it hard for automated vehicles to interpret the surrounding. Norwegian road standards have sight and stopping distance requirements, but if these are obscured temporarily or the road is not built to standard then these issues will give problems.

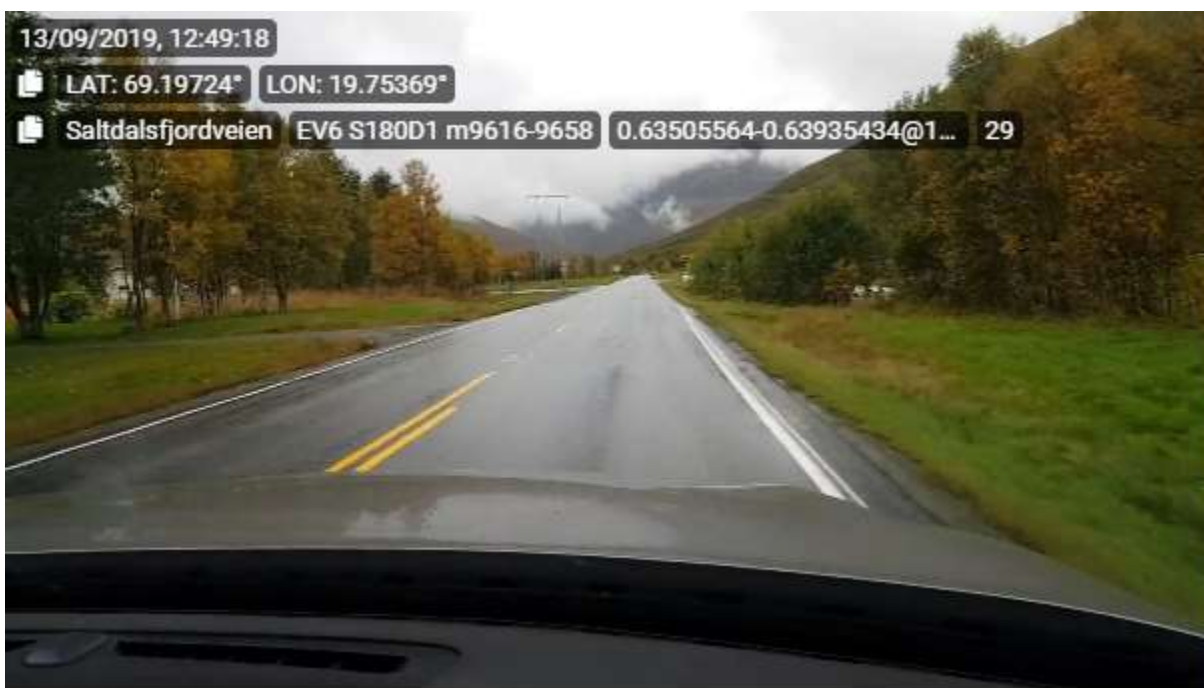
**Figure 36 Transition in centre marking, dual yellow to single yellow**

Figure 36 shows another edge case that we have seen a few of in the data set. Here the dual yellow lines change to single yellow lines in the centre, but in addition there is pre-marking, wet roads and flat light. A human driver will probably be able to filter out the pre-marking, but the wet and flat road makes it hard to know what the marking is. A human driver will probably assume a kind of lane marking.

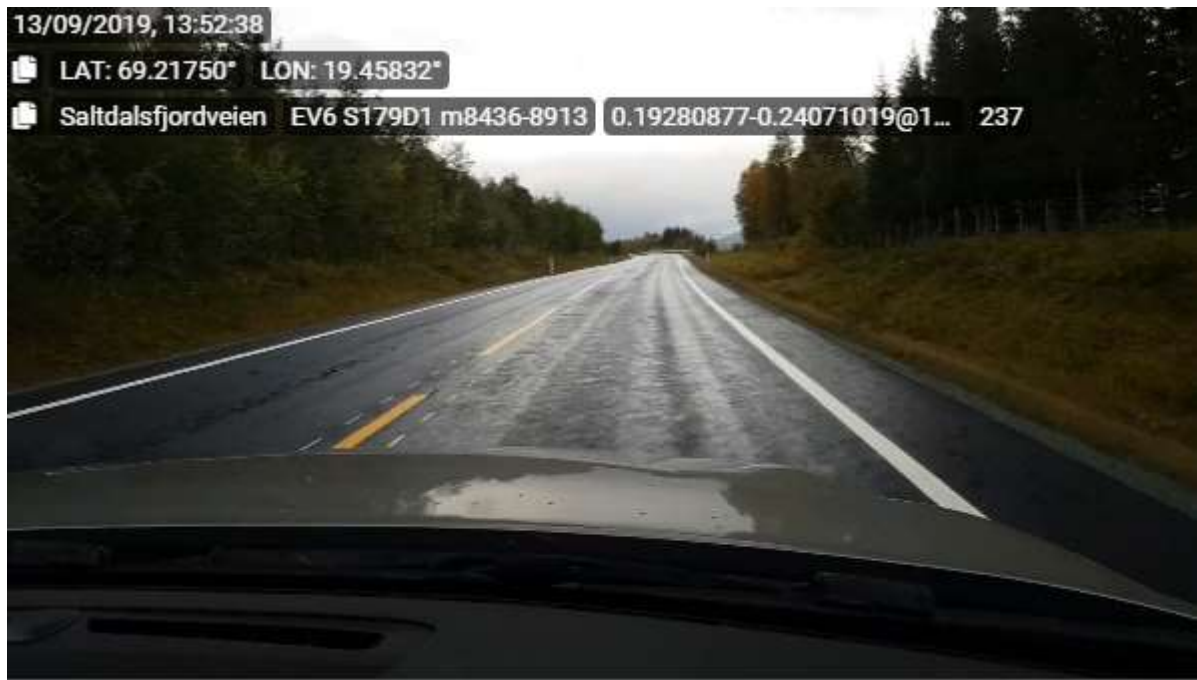
**Figure 37 Short period of outage, probably reflections from sun on wet asphalt about 2 seconds**

Figure 37 shows another type of pre-marking and freshly painted markings, fresh asphalt, wet conditions and plenty of lines in the picture. This is truly a hard scenario to identify lane markings. The period when the system does not detect the lane markings is short, about 2 seconds. Which is impressive when watching the video as it is hard to see the lane markings. The camera used for this video also has a polarizing filter to remove quite a lot of glare from the road surface.

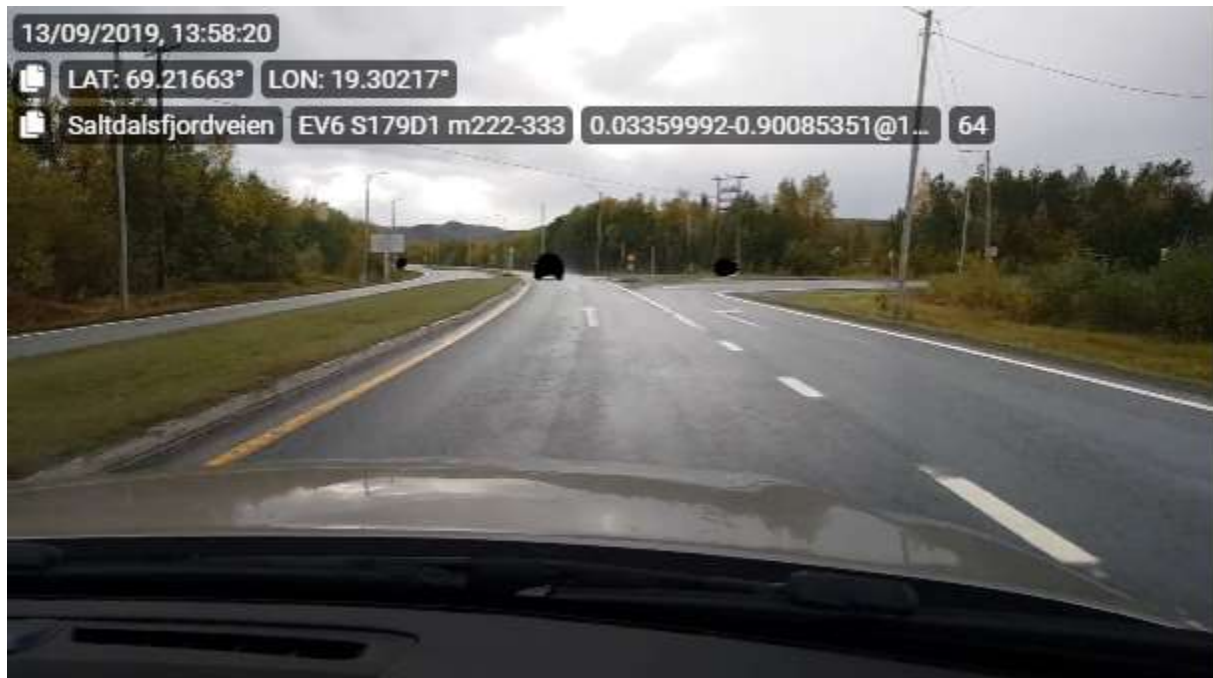
**Figure 38 Complex intersection with filter lane and separation between directions**

Figure 38 shows another interesting intersection, here the oncoming lane is separated by a small area with grass, on the right there is a filter lane. The system is confused coming into this intersection, but as soon as the vehicle passes the intersection lane marking is detected again. This example shows that intersections can be built in many ways and that this makes it hard for automated systems to understand the areas in and around the intersections.

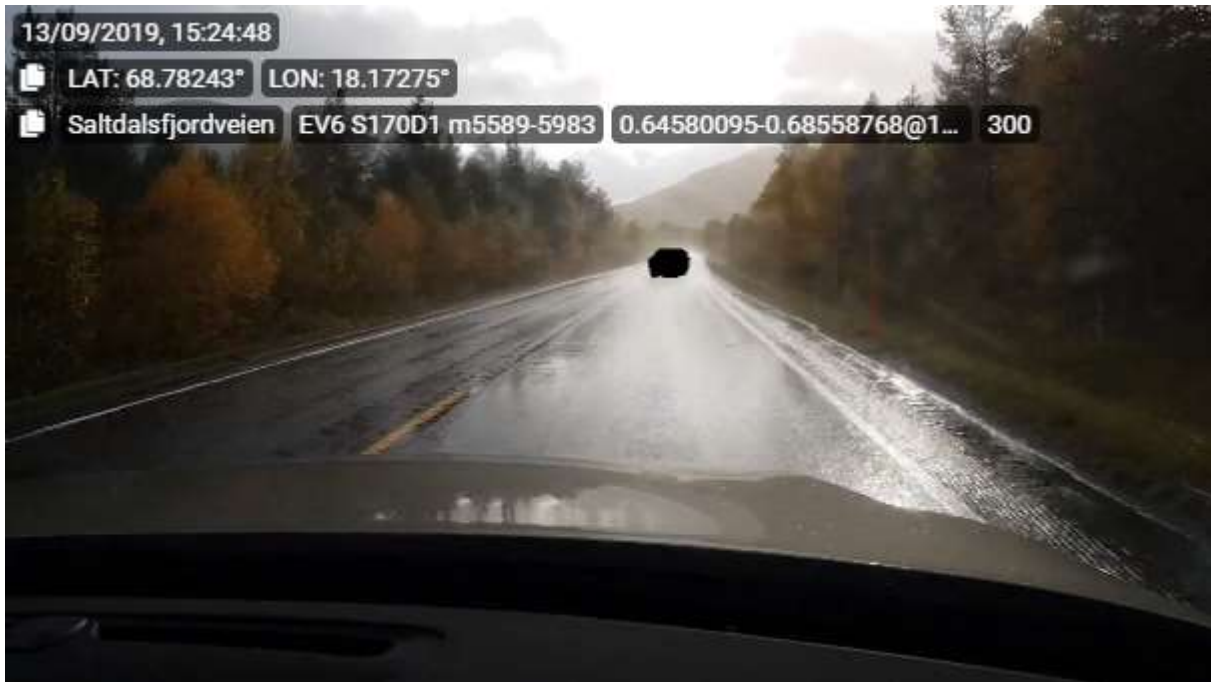
**Figure 39** Wet fresh asphalt and water vapor from vehicles in front

Figure 39 shows a stretch with extreme sun glare and spray from the vehicle in front. Again, the system is not able to detect the lane marking for a short period (2 seconds).

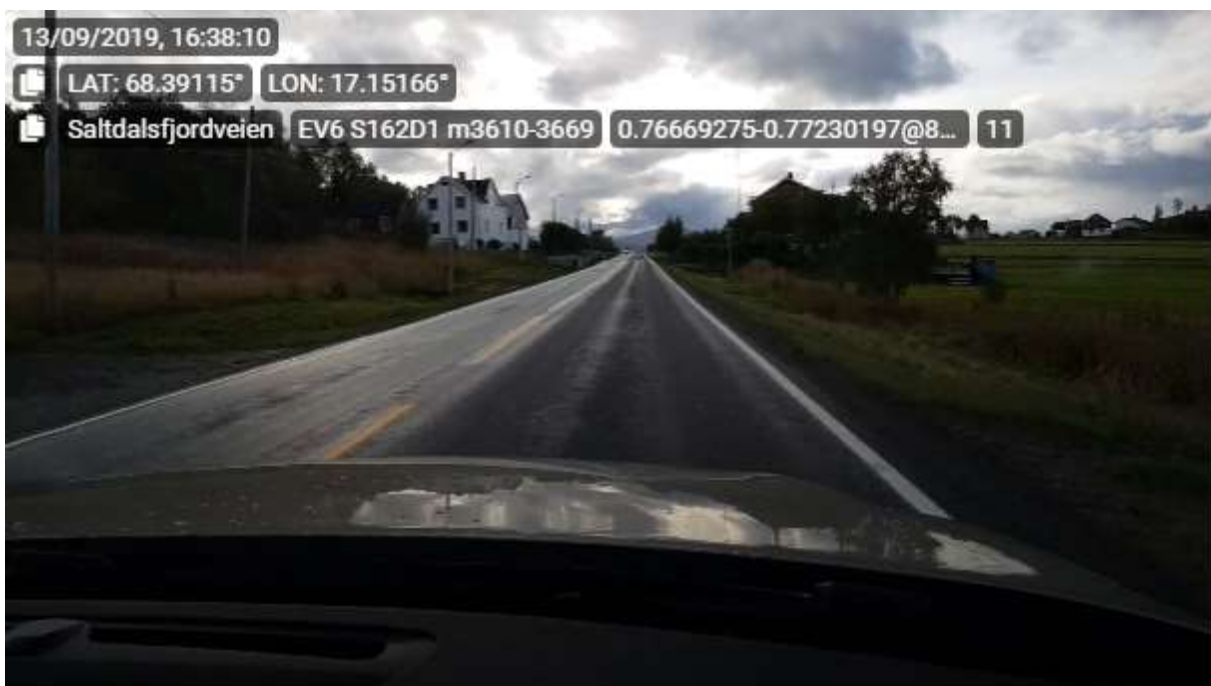
**Figure 40** Low light, wet asphalt and dry tracks (lines)

Figure 40 shows how the road dries, first the wheel track then the rest of the road. This causes plenty of lines in the picture, that can confuse the system. The duration of the system not being able to detect the lane markings was a few seconds.
