# **Norwegian Pilot 2**

## **A6 Evaluation and final report**

NordicWay 2

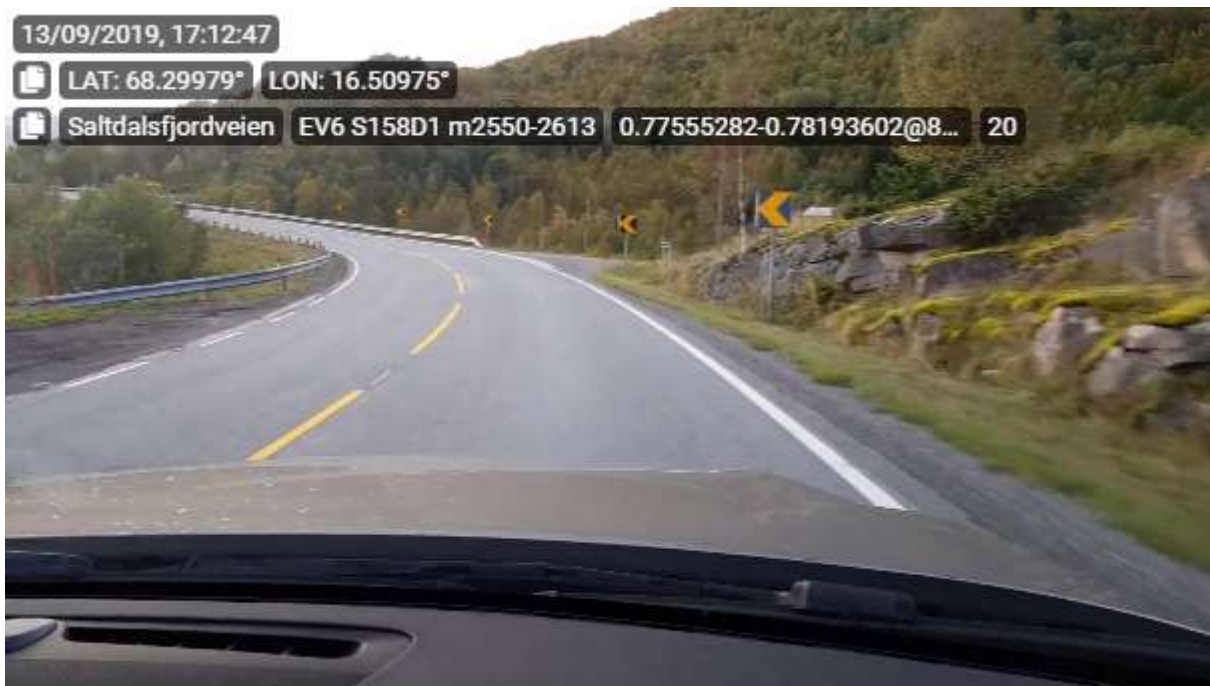
**Figure 41 Sharp left turn**

Figure 41 shows a sharp left turn where the system did not understand the markings. There is a road going off to the right also. The number of chevron signs are a clear indication that this turn is sharp. This was the longest outage seen due to the infrastructure, 23 seconds in total. A map of the curve can be seen in Figure 42. The three red dots just before the turn onto the bridge was due to a small stop on the right-hand side of the road with missing marking.

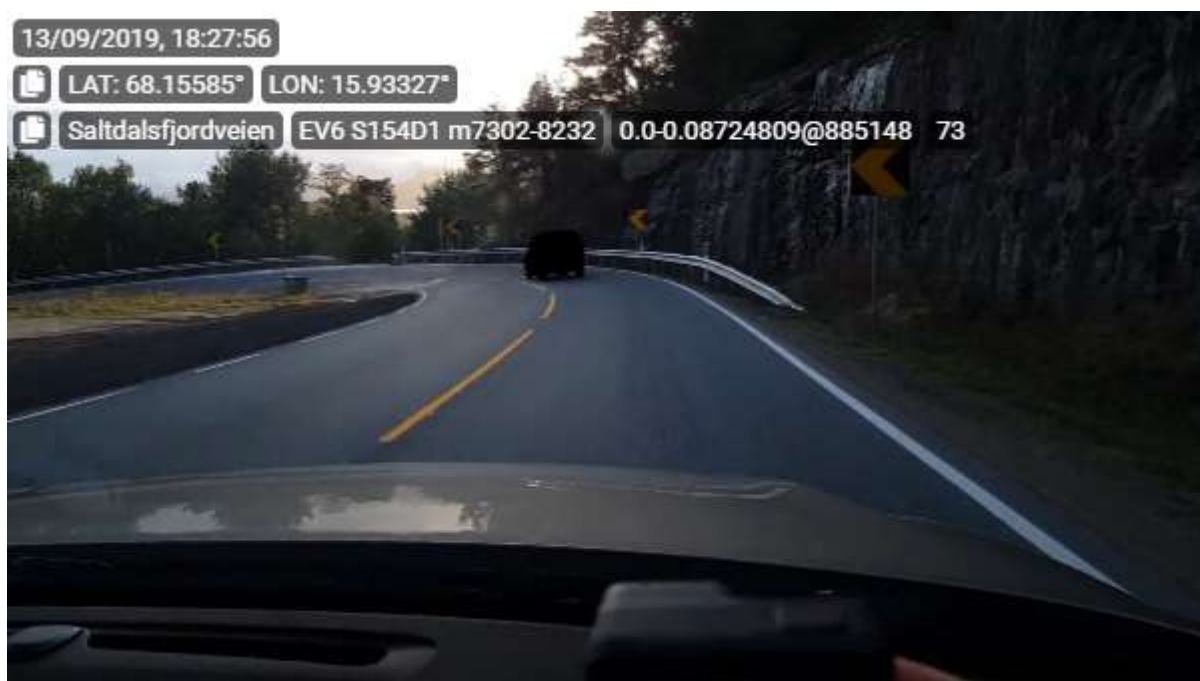
**Figure 43 Hairpin turn in 80km/h**

Figure 43 is a curiosity of the Norwegian road network. On the E6 (main freight route from North to South in Norway) there is a hairpin turn where the speed limit is 80 km/h. In addition to reducing the speed enough to complete the curve the driver needs to turn his/her head 90 degrees to see if there is oncoming traffic into the curve. This example shows that even though NRAs have standards for building roads there are parts of the road network that will be outside the standard.

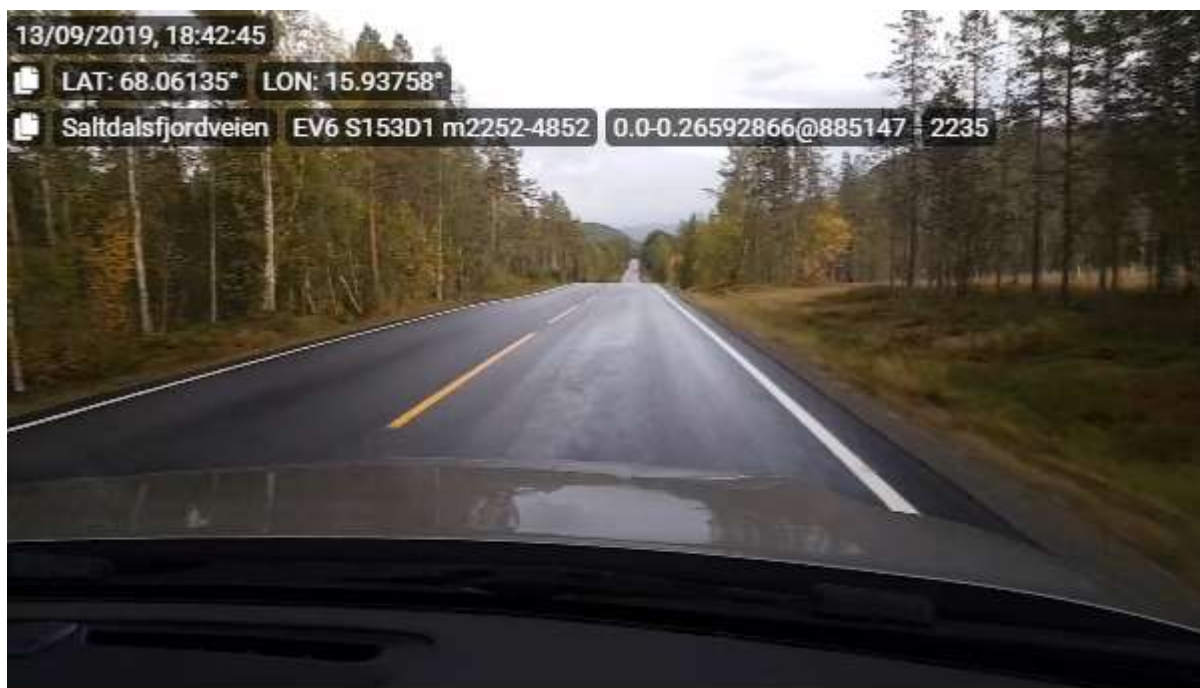
**Figure 44 Road disappears due to vertical topography**

Figure 44 shows a specific stretch of road with “rolling hills”, the vertical profile is such that the road disappears for a while. Whole vehicles will disappear from view as well as the road. Hence the traffic signs on this stretch says no overtaking. While the road marking says that one should take extra care when overtaking. Along this stretch of road there are 5 spots where the road disappears under the horizon so it's not possible to see the road markings.

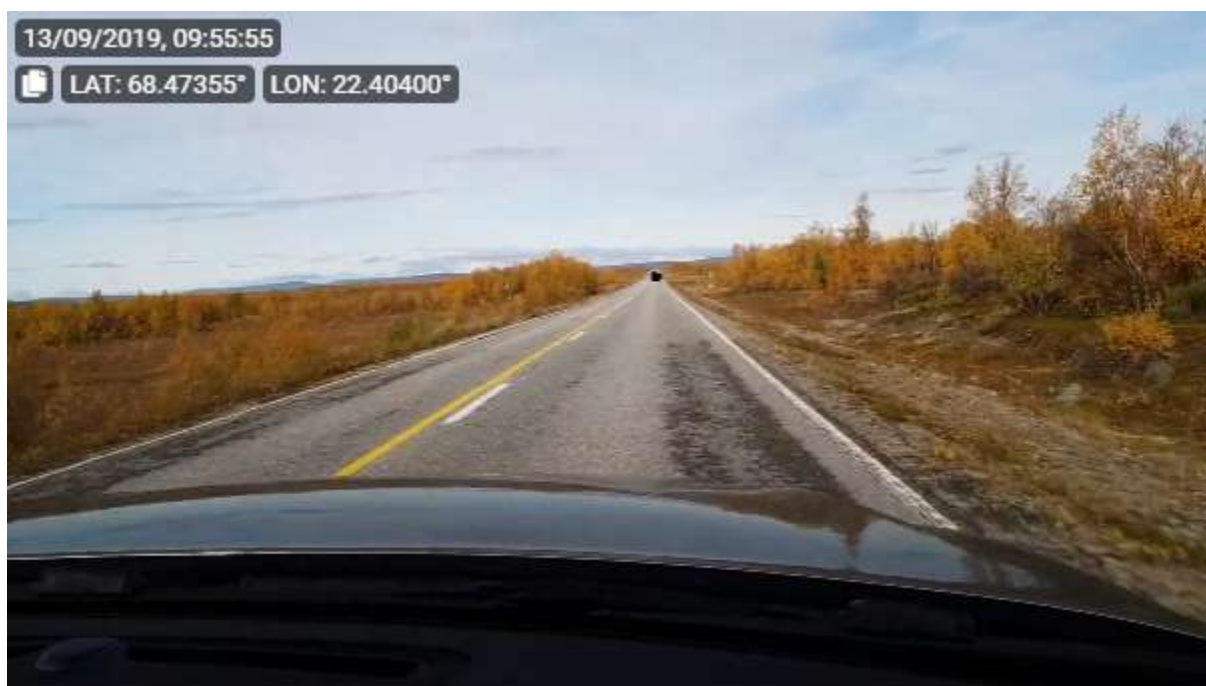
**Figure 46 Strange markings in Finland**

Figure 46 shows an interesting view from Finland. There is a mix of yellow and white markings in centre. This is unusual for Norwegian human drivers. It is unclear if this is normal or not in Finland. In other parts of Finland, on comparable roads, the middle marking was white. This picture shows that NRAs have quite different lane markings and that this could potentially be challenging for automated systems. This again raises questions about standardization and the cost benefit of such standardization from NRAs.

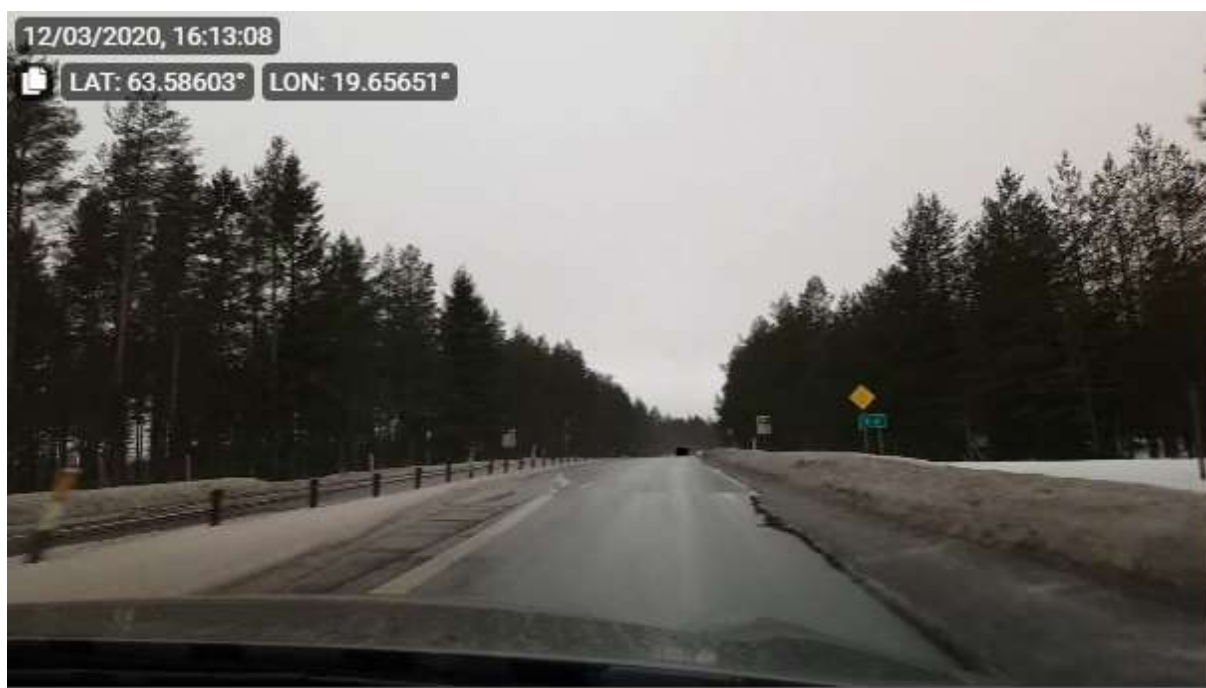
**Figure 47 Slush coverings up the right line and expansion to 2 lanes in same direction**

Figure 47 is taken from the second part of the NordicTour. This is North of Umeå where there still was snow. Here the combination of going from one lane to two lanes in the same direction and snow makes it quite hard for the system to understand. Contrast under such weather conditions is also challenging and one can see that the snow on the right-hand side covers the right lane marking. There are quite a

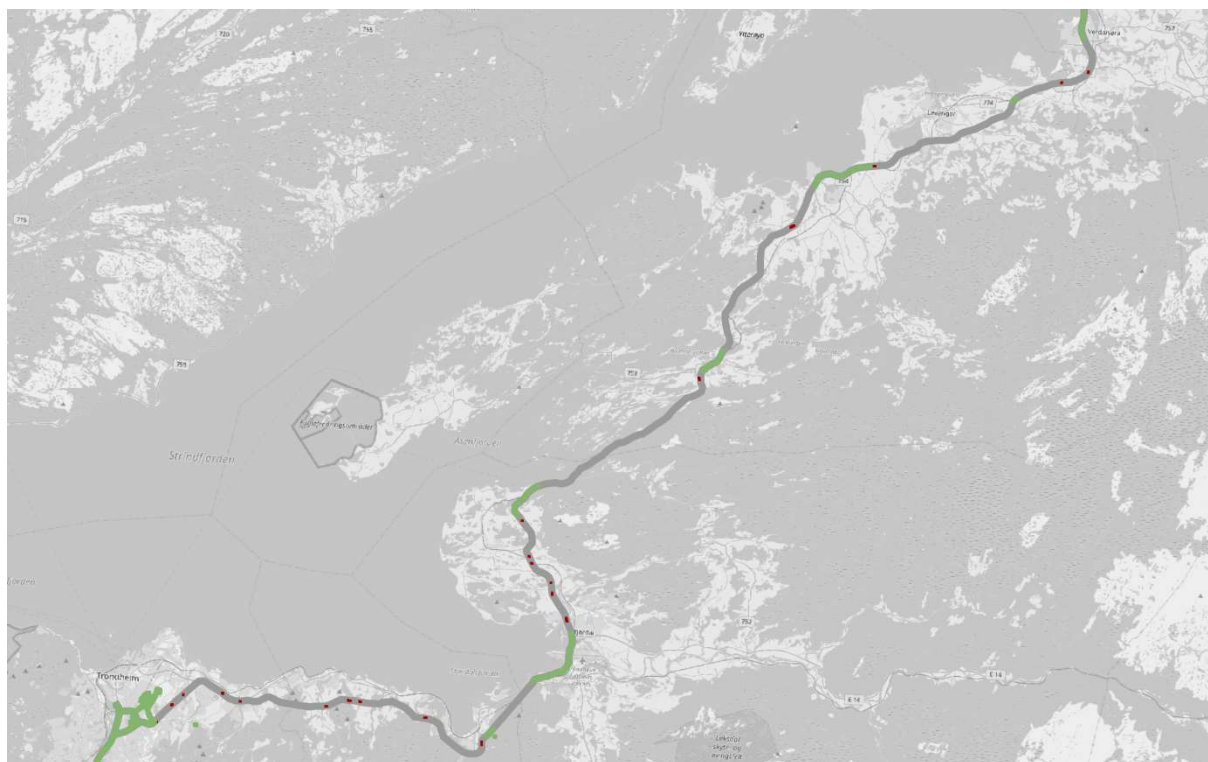
**Figure 48 Spots with one hour of driving**

Figure 48 shows one hour of driving from Levanger to Trondheim. The green areas are areas with speed limit 60 km/h or less. The data collected shows that lane markings are not detected when the speed limit is 60 km/h, or lower. While the red spots show where the system does not understand the lane markings. Here it is possible to see that the parts with red dots are small and of limited duration. In this picture there are 21 segments where the system is not able to understand the lane marking. On this map the typical incidents of where the system does not understand the lane marking is where there is no lane marking (the longest stretch is on a bridge with no marking, 8 seconds).

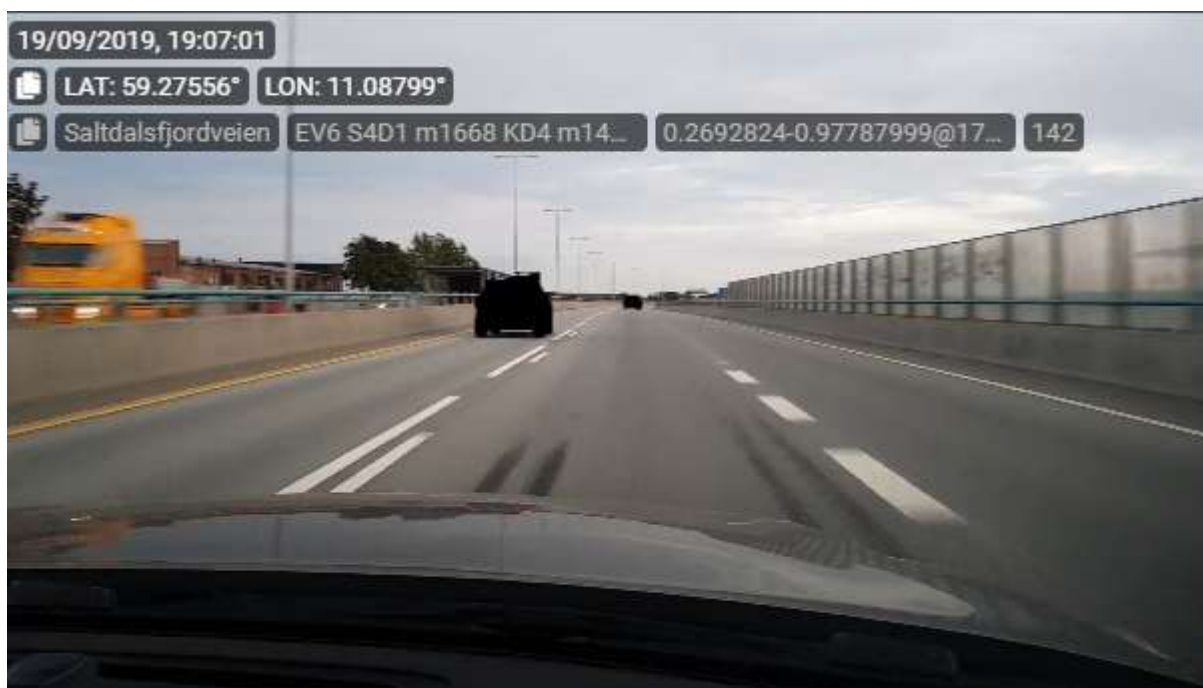
Figure 49 Norwegian end of merger lane

Another very specific issues in relation to lane markings is national differences. A specific case that we saw in the dataset was show merging lanes on motorways end. Form the video one can see that Finland and Sweden have the same system, where the white stapled line continues all the way across the merging lane at the end. While in Norway and Denmark, the stapled line stops when there is not enough room for a vehicle. In addition, Norwegian marking has double lines to the right, to tell driver do not change lane into the right lane when there is an entering merging lane on the right lane. These differences make it hard for the system to understand. Figure 49 Shows the end of a Norwegian merging lane south of Oslo while Figure 50 shows the end of merging lane in Sweden, just south of the border.

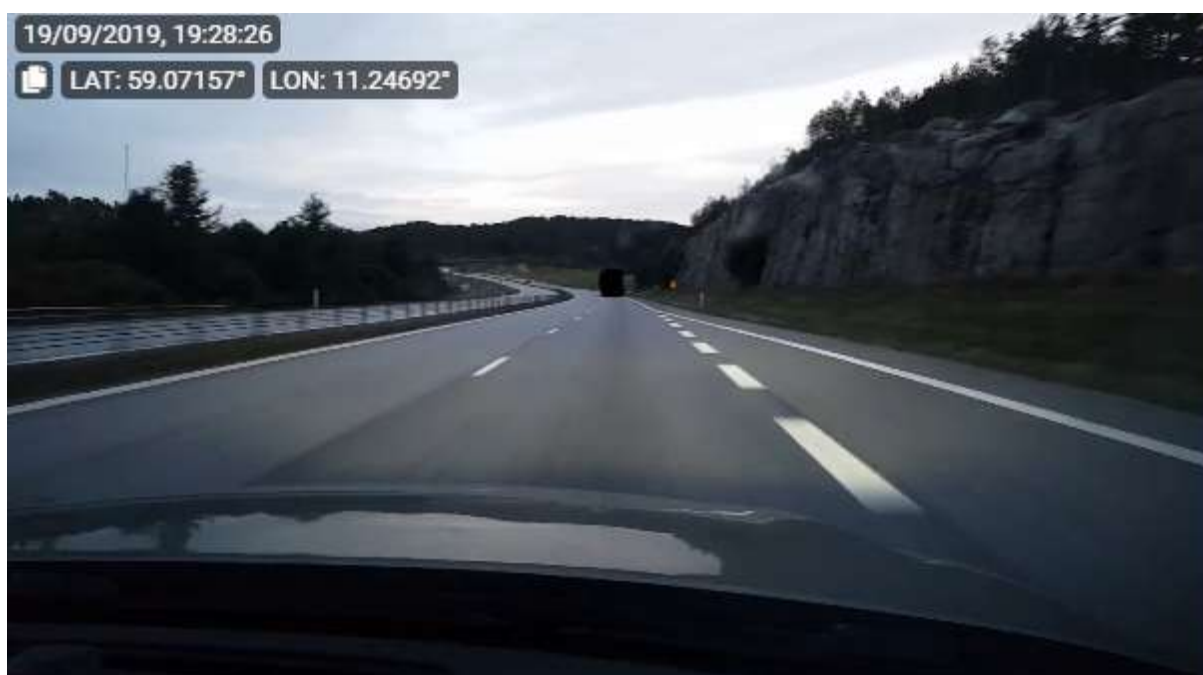
Figure 50 End of Swedish merger lane

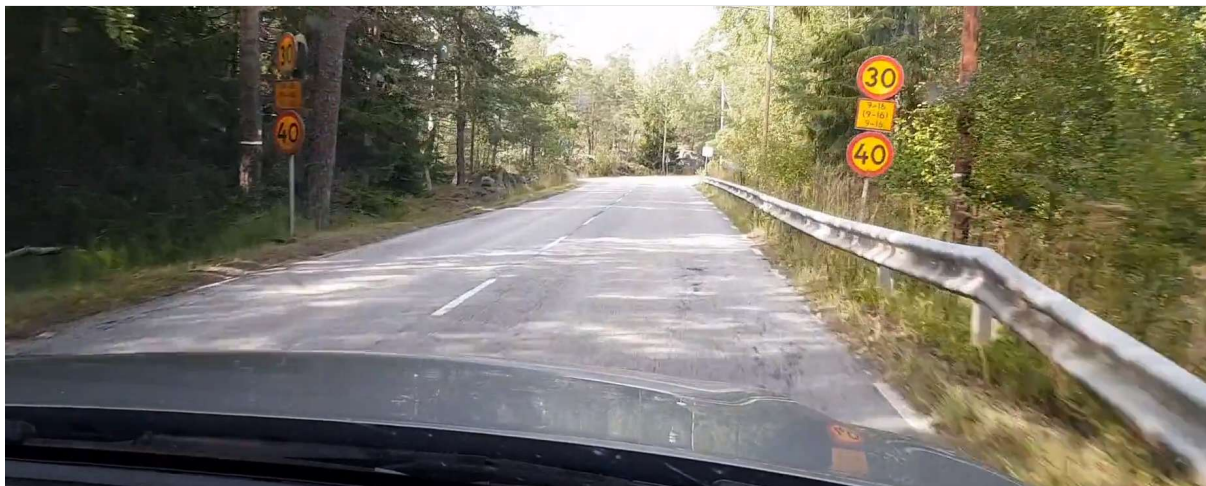
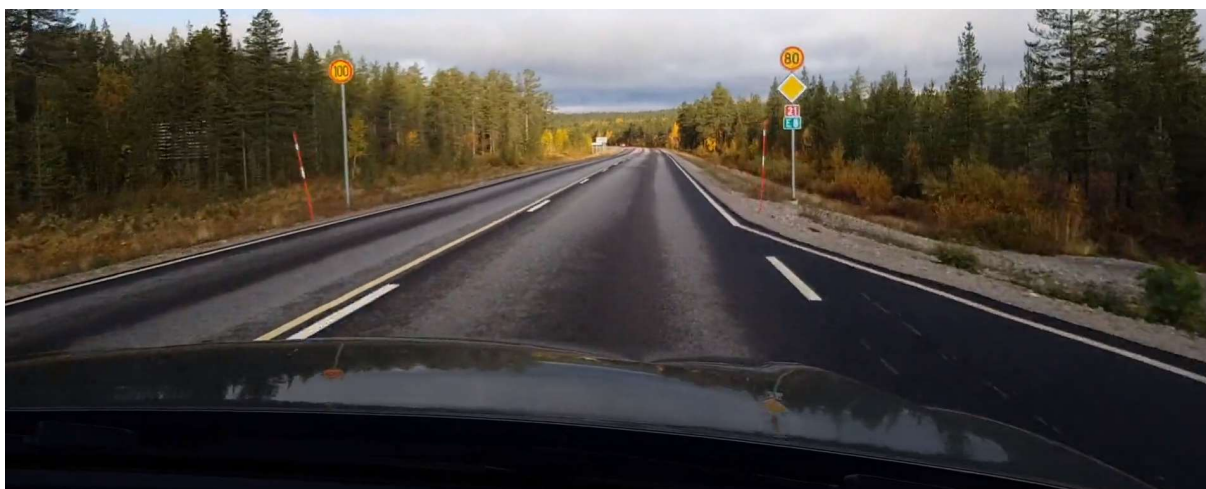
On the NordicTour, other issues were also identified. One of them was signs that do not make sense or are complicated to understand. Figure 50 and Figure 51 show signs observed that make little sense. The first one tries to explain that there are different speed limits depending on time of day and the day of week. The second picture is a probably an issue with maintenance where two different signs are used.

Figure 51 Speed signs with time limitation

Figure 52 Different speed signs on either side of the road

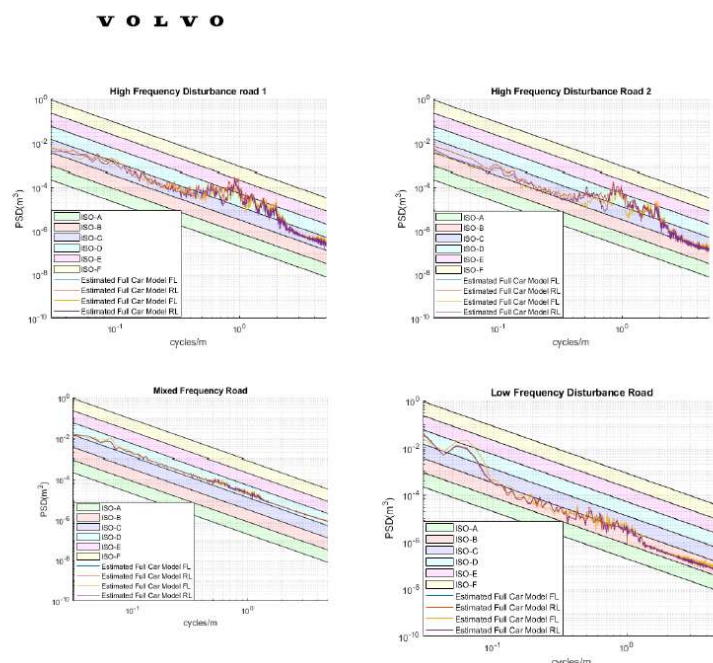
Clear differences between the different types of roads.

The results are promising and showing that the vehicle can produce a continuous profile that can be classified into the ISO 8608. The ISO 8608 specifies a uniform method of reporting measured vertical road profile data for either one-track or multiple-track measurements. A full car model will provide for multi tracks.
