## Heritage-listed Albert Bridge, Adelaide

In early 2015, the City of Adelaide Council sought to restore the Albert Bridge to its former glory. The bridge, located over the River Torrens on Frome Road was opened in 1879 and is the oldest, large road bridge in the Adelaide city area.

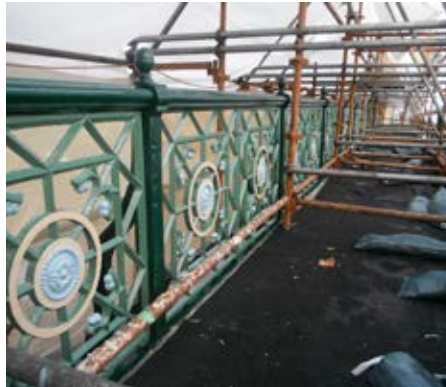
**Work in progress inside the containment; cleaning and surface preparation to prepare metalwork for application of new coatings**

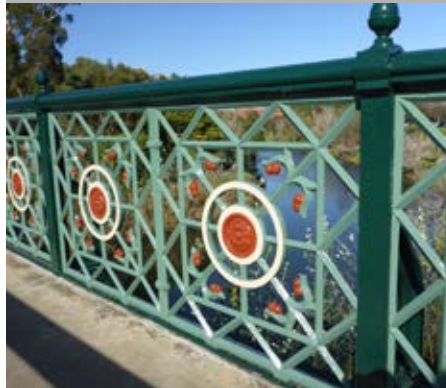
**Bridge metalwork hand-painted in heritage colours as detailed in the painting specification**

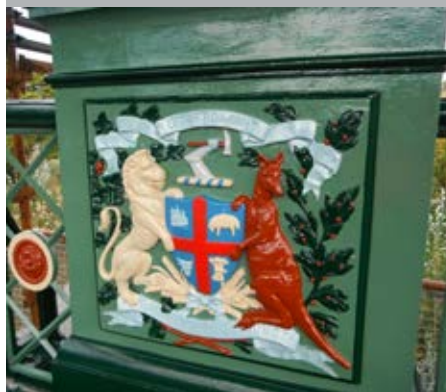
**Restoration of the City of Adelaide Council's coat of arms on the southern side of the bridge**
