# Gippsland Lakes Shore Erosion & Revegetation Strategy

Final Report; June 2002

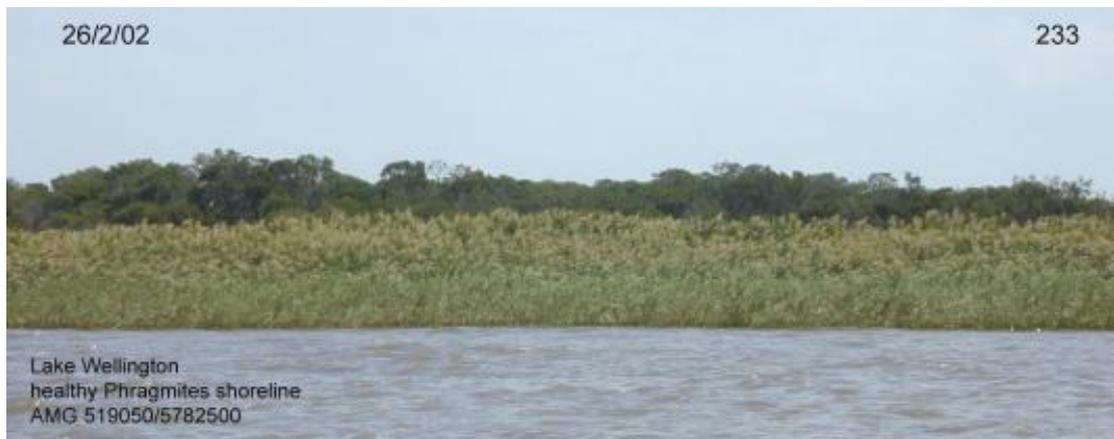
**Figure 1:** Healthy *Phragmites australis* reedbed prograding into water

The ongoing wide-spread reduction in extent of fringing *Phragmites australis* reedbeds can clearly be attributed to the Gippsland Lakes now being far more of an estuarine ecosystem compared with the predominantly freshwater regime that prevailed 110 years ago. Figures 1 and 2 illustrate healthy and retreating *Phragmites australis* reedbed stands respectively.

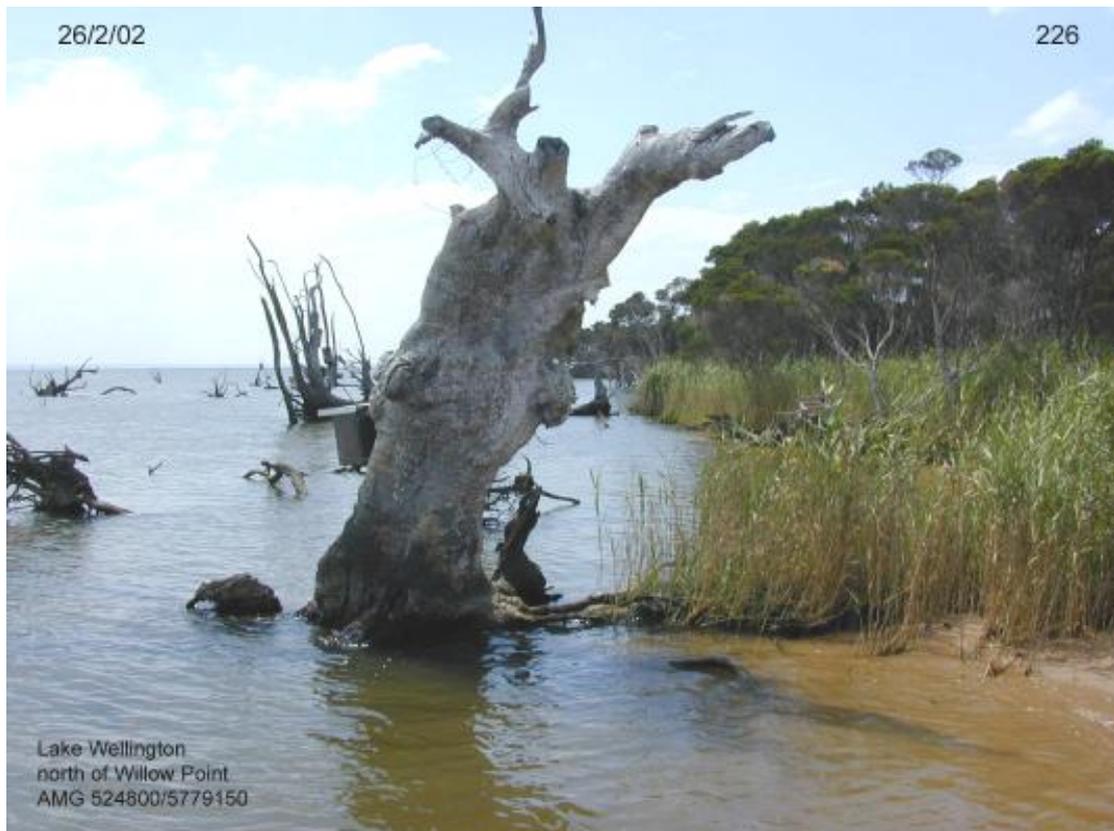
**Figure 2:** Retreating *Phragmites australis* reedbed

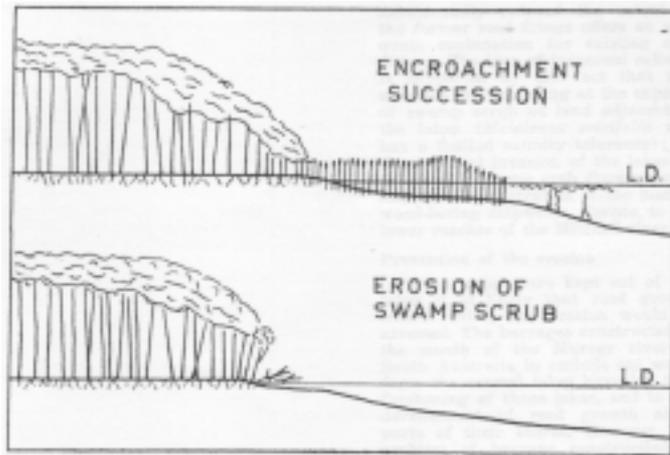
**Figure 3:** Schematic representation of healthy fringing *Phragmites australis* reedbeds encroaching into lake waters (top) and erosion caused by loss of reedbeds (bottom) (From: Bird, 1961).

The loss of energy-absorbing fringing *Phragmites australis* reedbeds exposes adjacent shoreline vegetation (primarily *Melaleuca ericifolia* dominated Swamp Scrub thickets, but also *Leptospermum laevigatum* and *Banksia integrifolia* Coastal Dune Scrub) to greater wave energy, causing undermining of the sandy and peaty substrate, collapse of standing vegetation and ultimately resulting in shoreline erosion. Figure 3 illustrates this schematically.

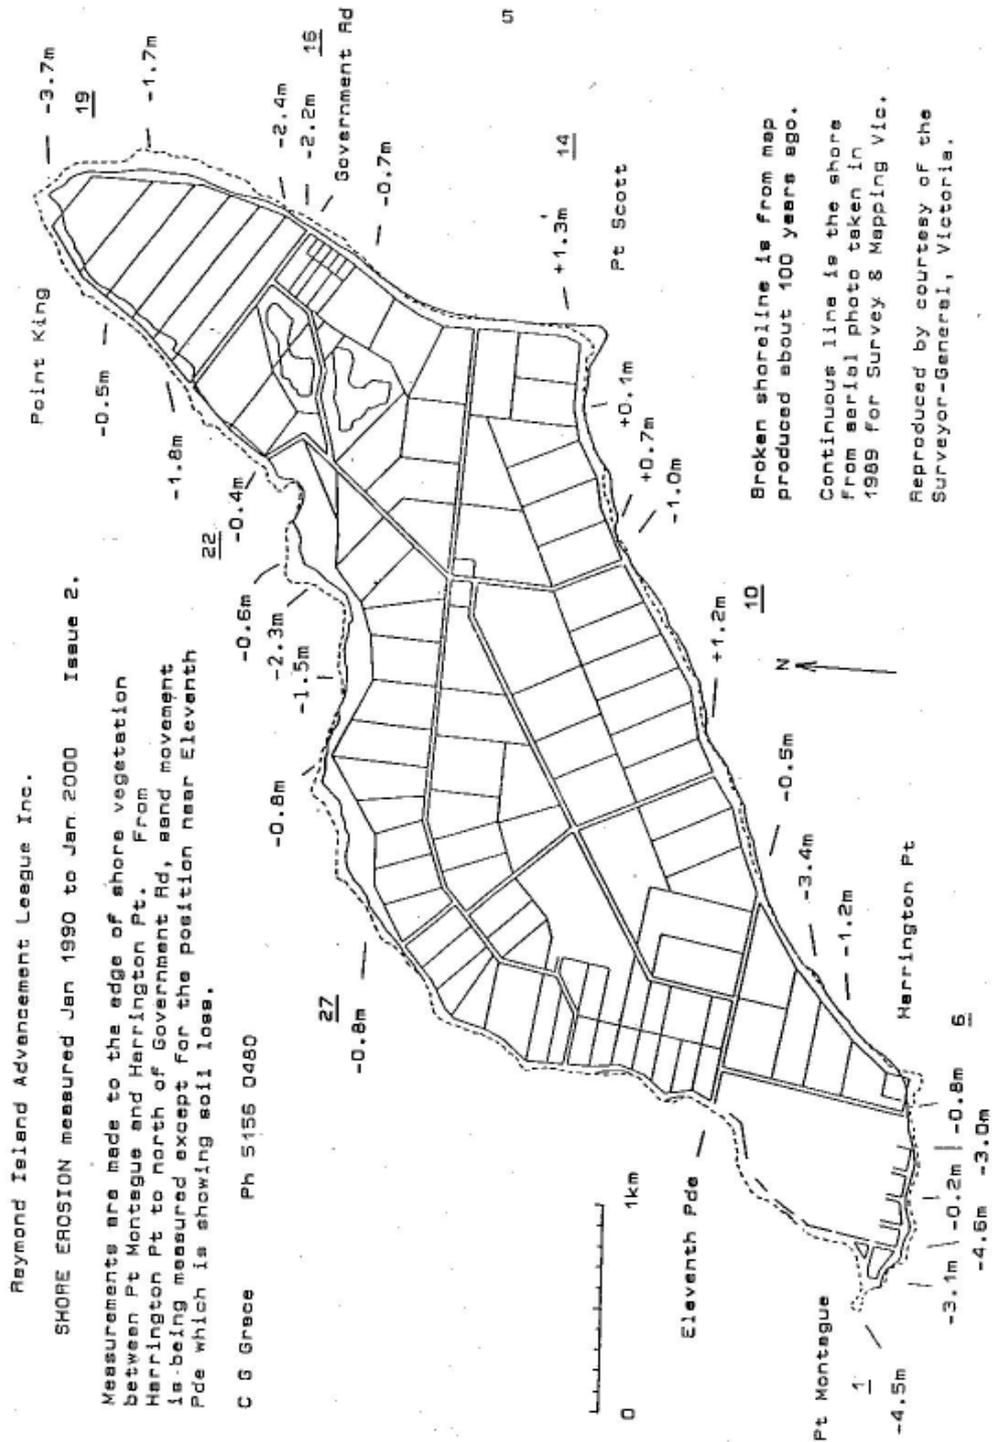
**Appendix 2: Raymond Island Shore Erosion Measurement Project.**

Shore Erosion Changes in Metres.
