Crookneck Lake Management Plan

Crookneck Lake Improvement District
And
Lake Crookneck Improvement Association
2023

Executive Summary

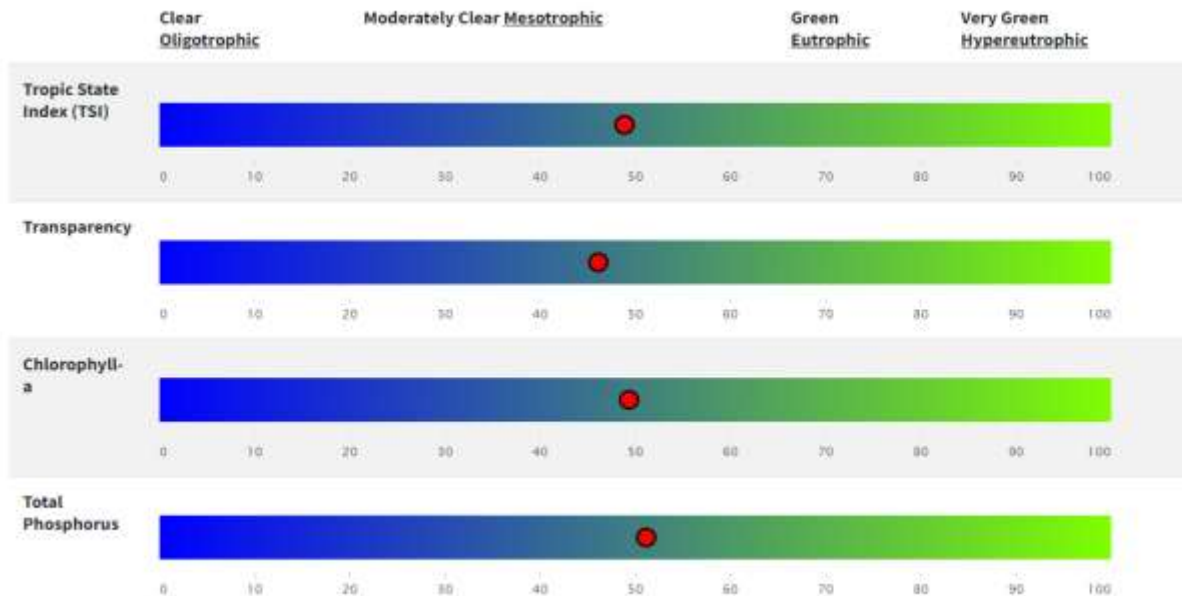
The **TSI** is a number that summarizes a lake's overall nutrient richness. Nutrient richness ranges from clear lakes, low in nutrients (oligotrophic), to green lakes, with very high nutrient levels (hypereutrophic). The chart below shows the overall TSI rating for Crookneck Lake (top bar), followed by TSI ratings for the individual parameters that contribute to nutrient richness. The TSI calculations are based on data collected between June and September 2008 to 2017. Overall Trophic State Index for this lake: **49**.

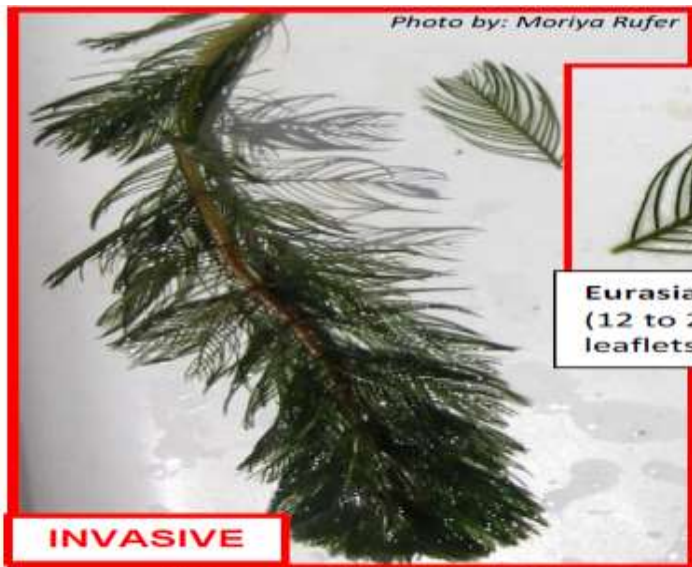
Eurasian Watermilfoil
(12 to 21 pairs of
leaflets)

Eurasian Watermilfoil
(*Myriophyllum spicatum*)

Aquatic Invasive Species of Interest: Below is a pictorial of the common aquatic invasive species found in Minnesota waterways within the Crookneck Lake region. The photos were extracted from RMB Vegetation Surveys of Crookneck Lake.

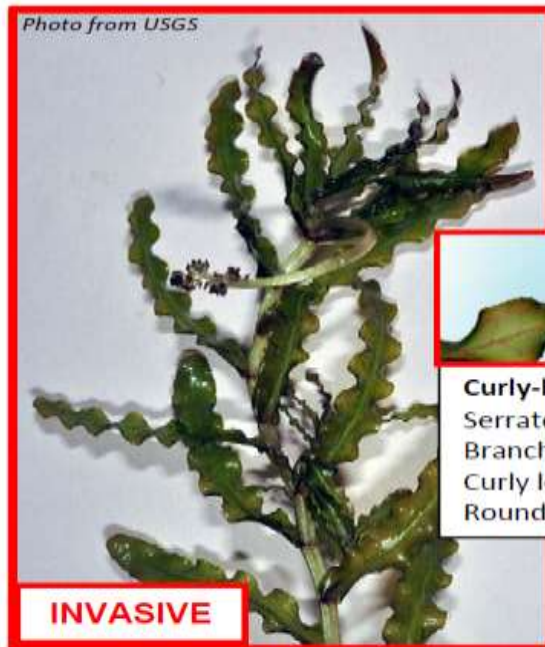
Curly-leaf Pondweed
Serrated edges,
Branched veins
Curly leaves
Round leaf tip

Management of the Curly-leaf pondweed Population: Prior to 2007, Curly-leaf pondweed dominated Crookneck Lake submersed invasive plant community and caused most of the aquatic plant related problems across the lake. Curly-leaf pondweed grows throughout the winter months and is only a nuisance prior to the Fourth of July, at which time it completes its life cycle and drops out of the water column until the following year. The western end of the lake was covered by a solid mass of pondweed plants in 2005, with dense patches present in many other locations around the lake.

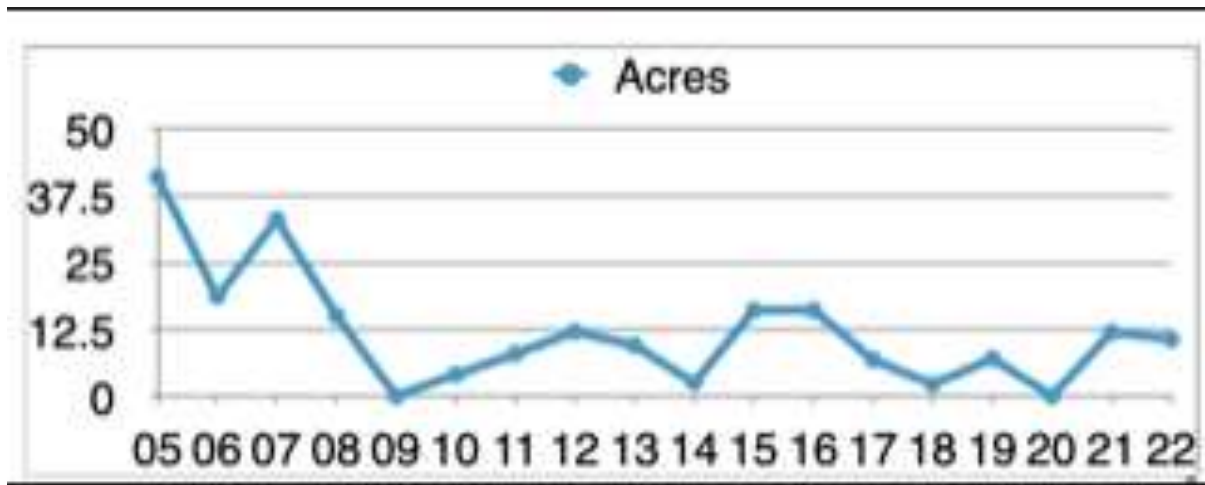
The table below illustrates the number of acres treated annually for Curly-leaf pondweed. No treatment was done during 2009 and 2020 due to a low zonal density of Curly-leaf pondweed identified for treatment.

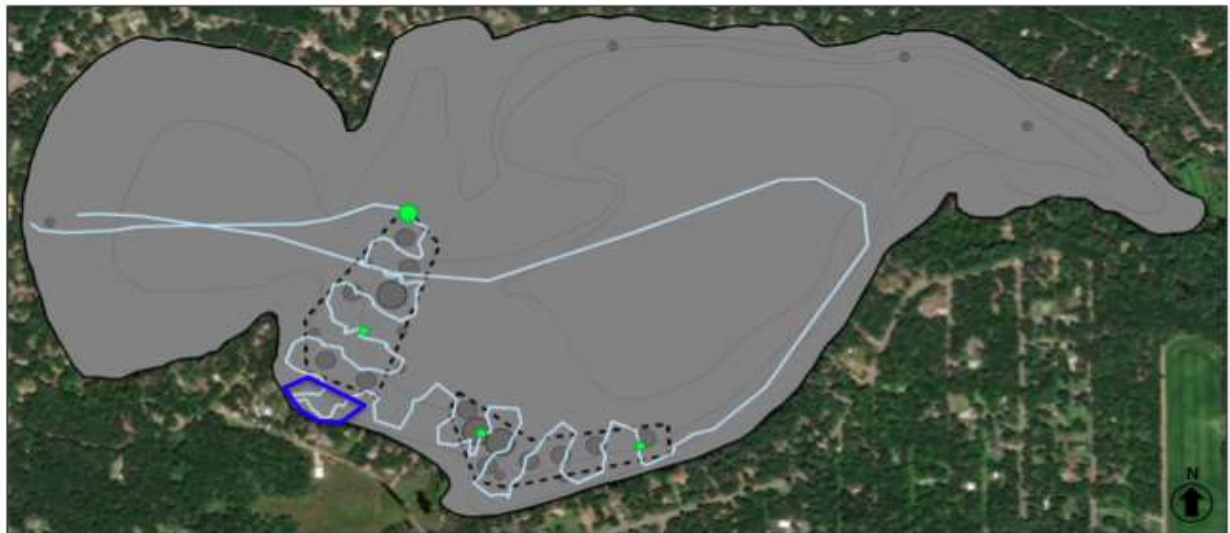
Management of the Eurasian watermilfoil (EWM) Population: During 2018, Eurasian watermilfoil (EWM) was identified in an isolated location and subsequently treated by herbicide during 2019 and 2020. One plant was located along the east shoreline and physically removed during 2019. No additional EWM has been located during 2021 or 2022.

Location of 2018-2020 Eurasian watermilfoil delineated by the blue zone.

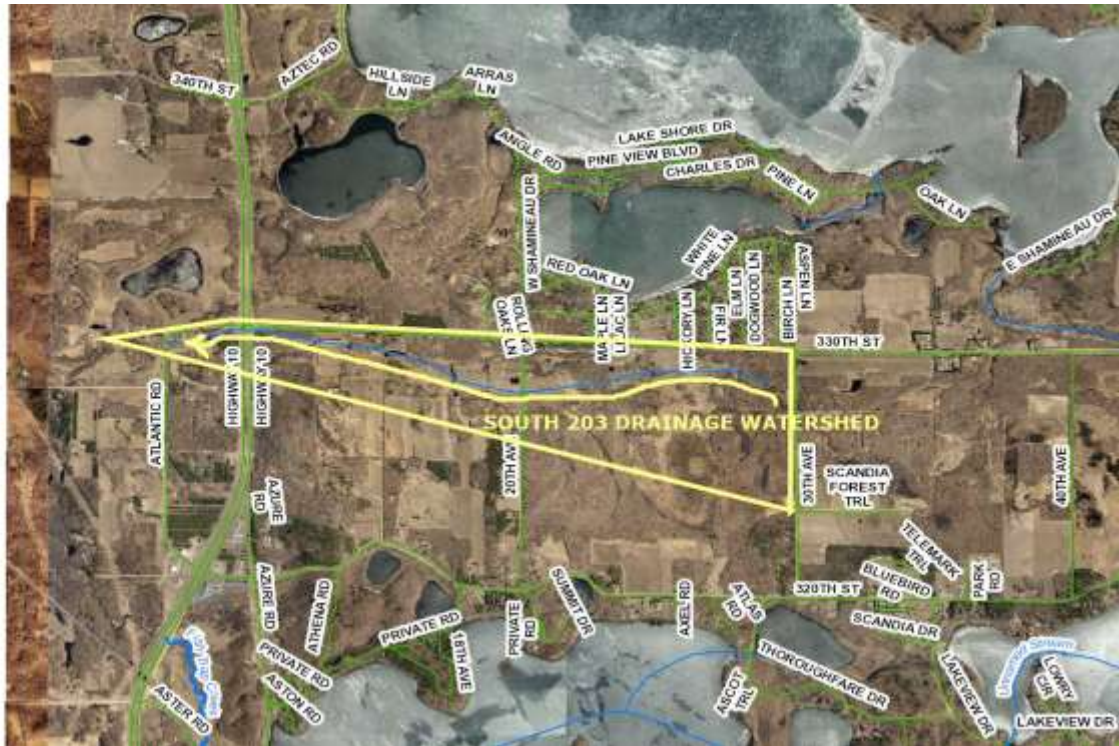
South 203 Watershed Project: This watershed is located to the south of CR 203 (330) and north CR 3 (320) and beginning approximately at 30th Ave on the east extending to HWY 10 on the west with an outlet leading to the Fish Trap Creek via the “Blue Line Trench” which was developed during 1932 by the CPA (see map below). A lateral ditch from the Blue Line Trench just west of the Friendly Inn flows north to Crookneck Lake. Dating back to 1962, following the spring thaw, water has flowed from this watershed to Crookneck Lake into June providing a source of what is considered quality water. During the winter of 2020, a project was undertaken by Shamineau Lake to clear out the Blue Line Trench to promote the flow to the west and lower the watershed. Since 2020, no water has flowed into Crookneck Lake via the lateral ditch, a first dating back to 1962. During 2022, the South 203 Watershed reached the lowest level in modern history.

South 203 “Blue Line Trench” Project (February 2020)

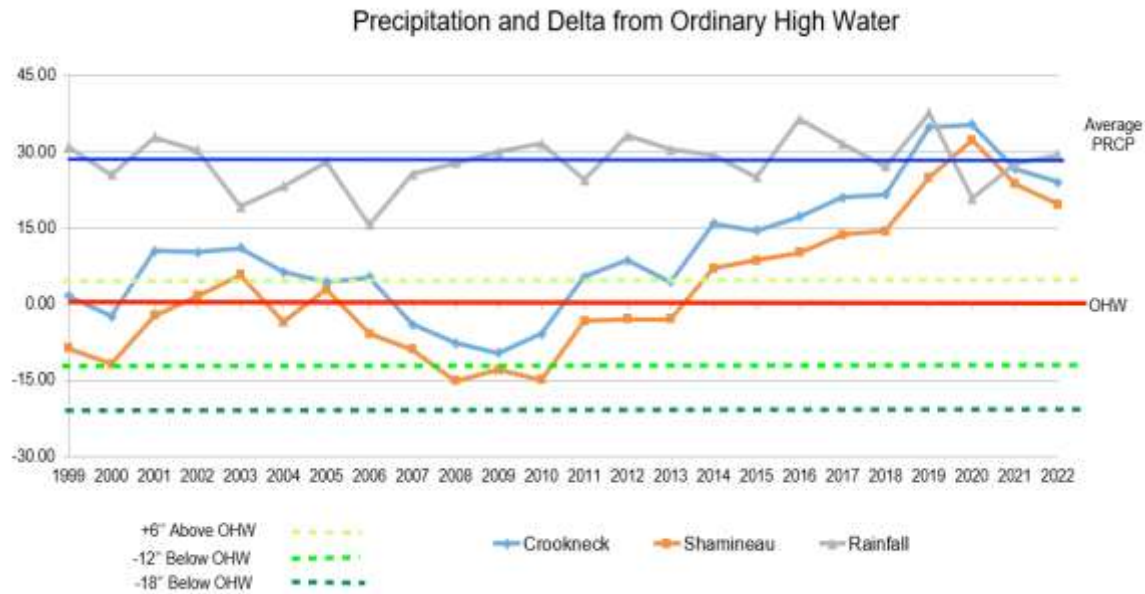
Figure 1: Precipitation and Delta from Ordinary High Water Level

Year	Crookneck	Shamineau	Rainfall
1999	1.62	-8.75	31.01
2000	-2.46	-11.87	25.54
2001	10.44	-2.28	32.91
2002	10.26	1.56	30.37
2003	10.98	5.76	19.23
2004	6.36	-3.54	23.19
2005	4.38	2.87	28
2006	5.28	-5.82	15.62
2007	-4.07	-8.94	25.6
2008	-7.68	-15.18	27.86
2009	-9.6	-12.96	29.98
2010	-5.82	-14.88	31.6
2011	5.4	-3.36	24.43
2012	8.64	-3	33.19
2013	4.32	-2.94	30.4
2014	15.84	6.96	29.3
2015	14.52	8.64	24.99
2016	17.22	10.14	36.44
2017	21	13.62	31.6
2018	21.6	14.4	27.08
2019	34.8	24.96	37.7
2020	35.4	32.3	20.79
2021	26.6	23.7	27.7
2022	24	19.68	29.45
