Near real-time building impact tool

Earthquake Losses

Indicator building concept

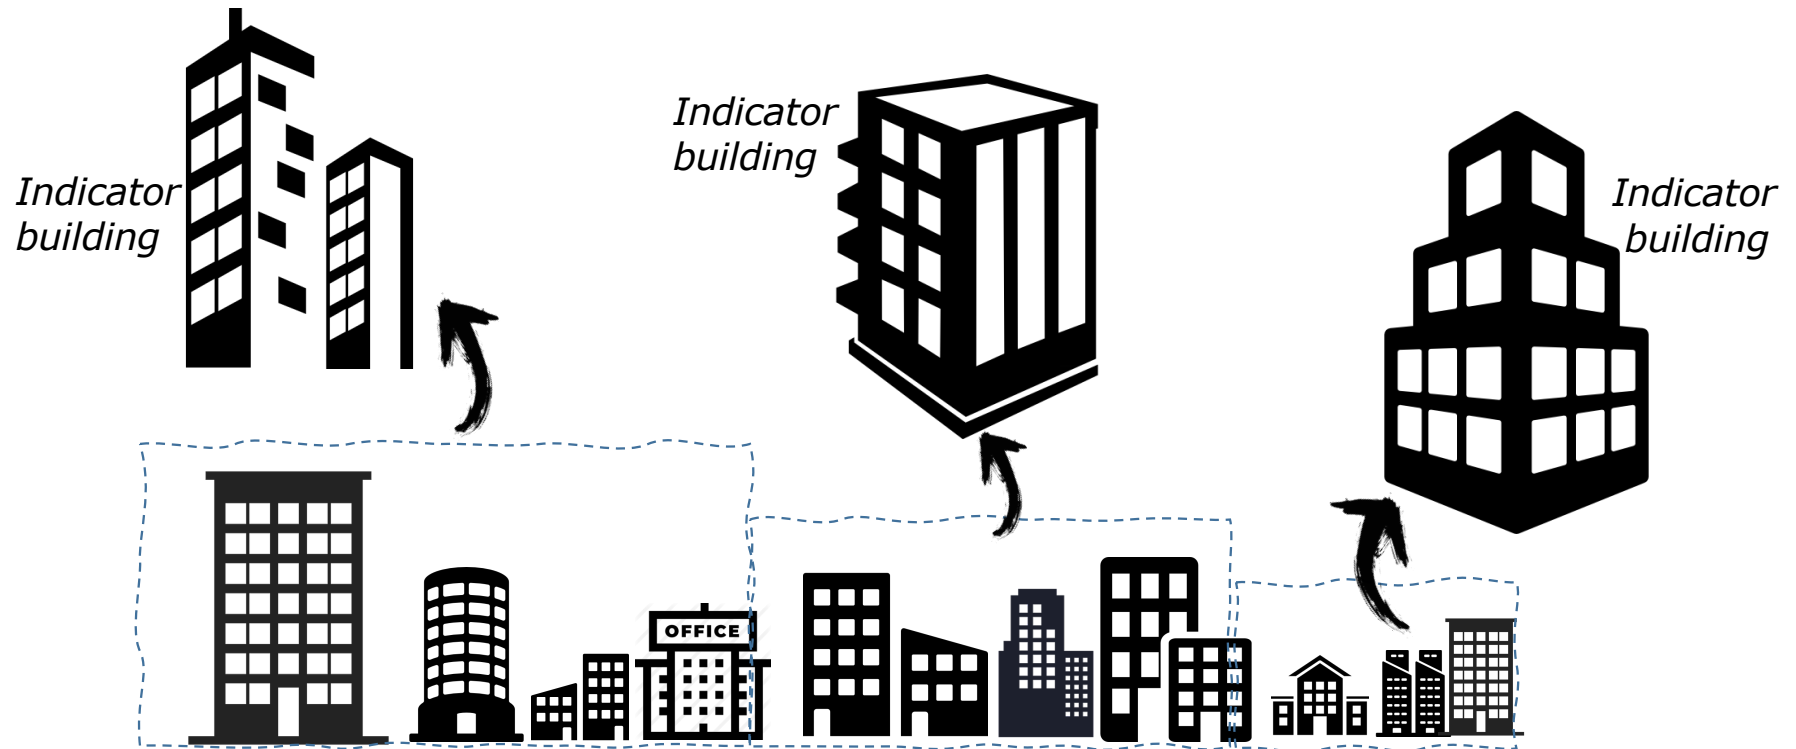
Typologically representative buildings that can be used to evaluate the response at a community scale

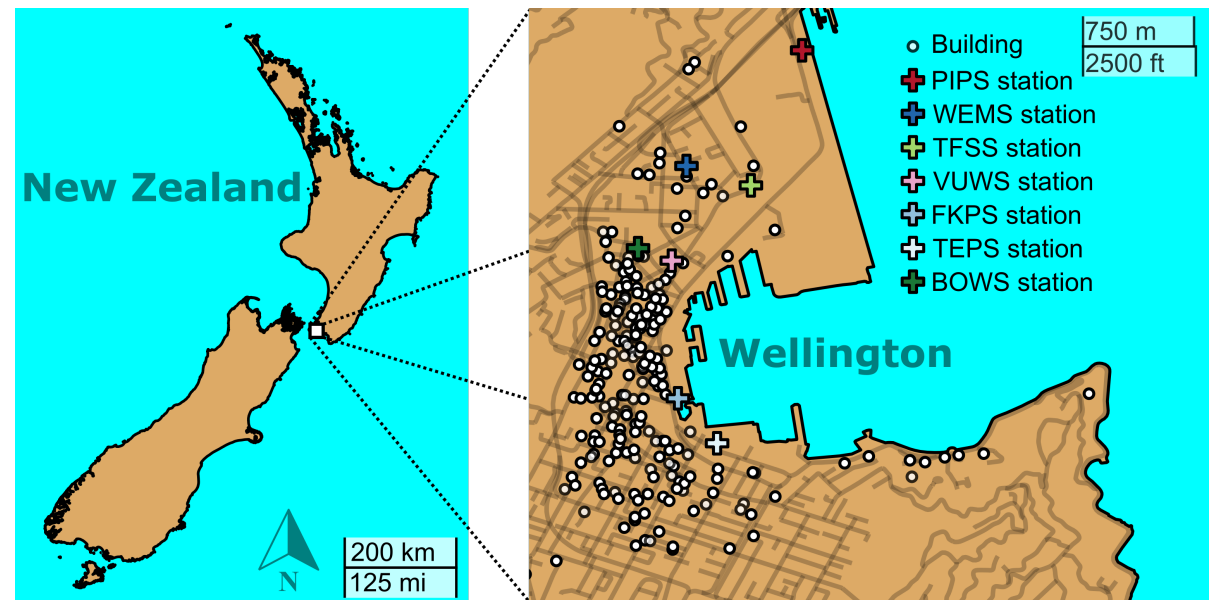
Wellington Building Inventory

- ~800 five+ storey buildings in CBD
- Building information:
 - Structural parameters
 - Site characteristics (soil type, strong motion station)
 - Code of seismic design

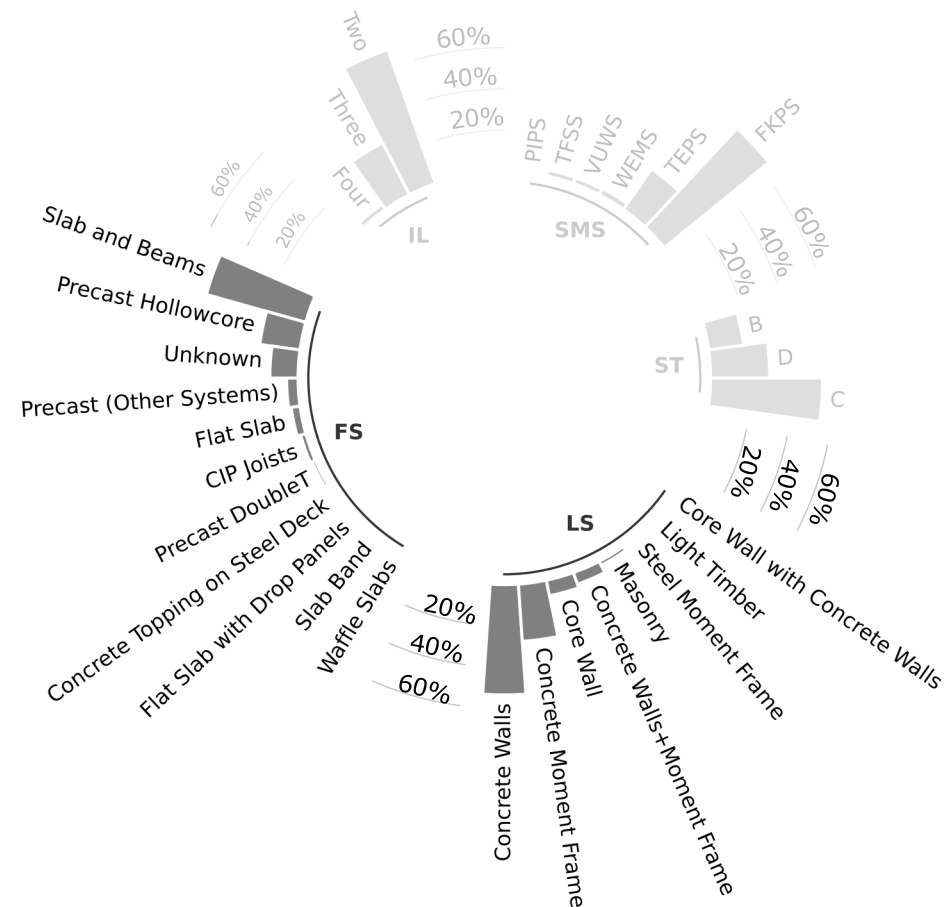
Categorical Data

- Importance level (IL)
 - Strong motion station (SMS)
 - Soil type (ST)
 - Lateral system (LS)
 - Floor system (FS)
- **Note:** low proportion for some variables

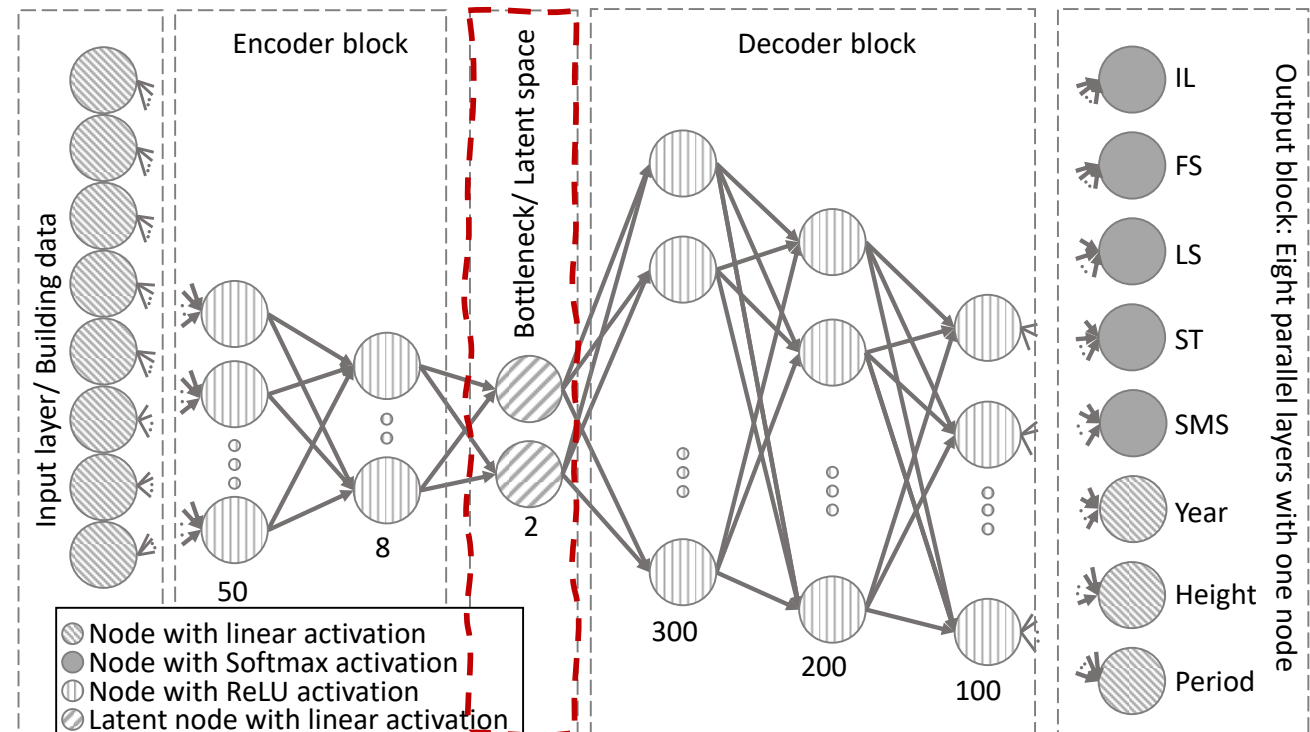
Autoencoder Neural Network

Extracts 2D numerical subspace from original database

- Preserves information in compressed numerical form in latent space

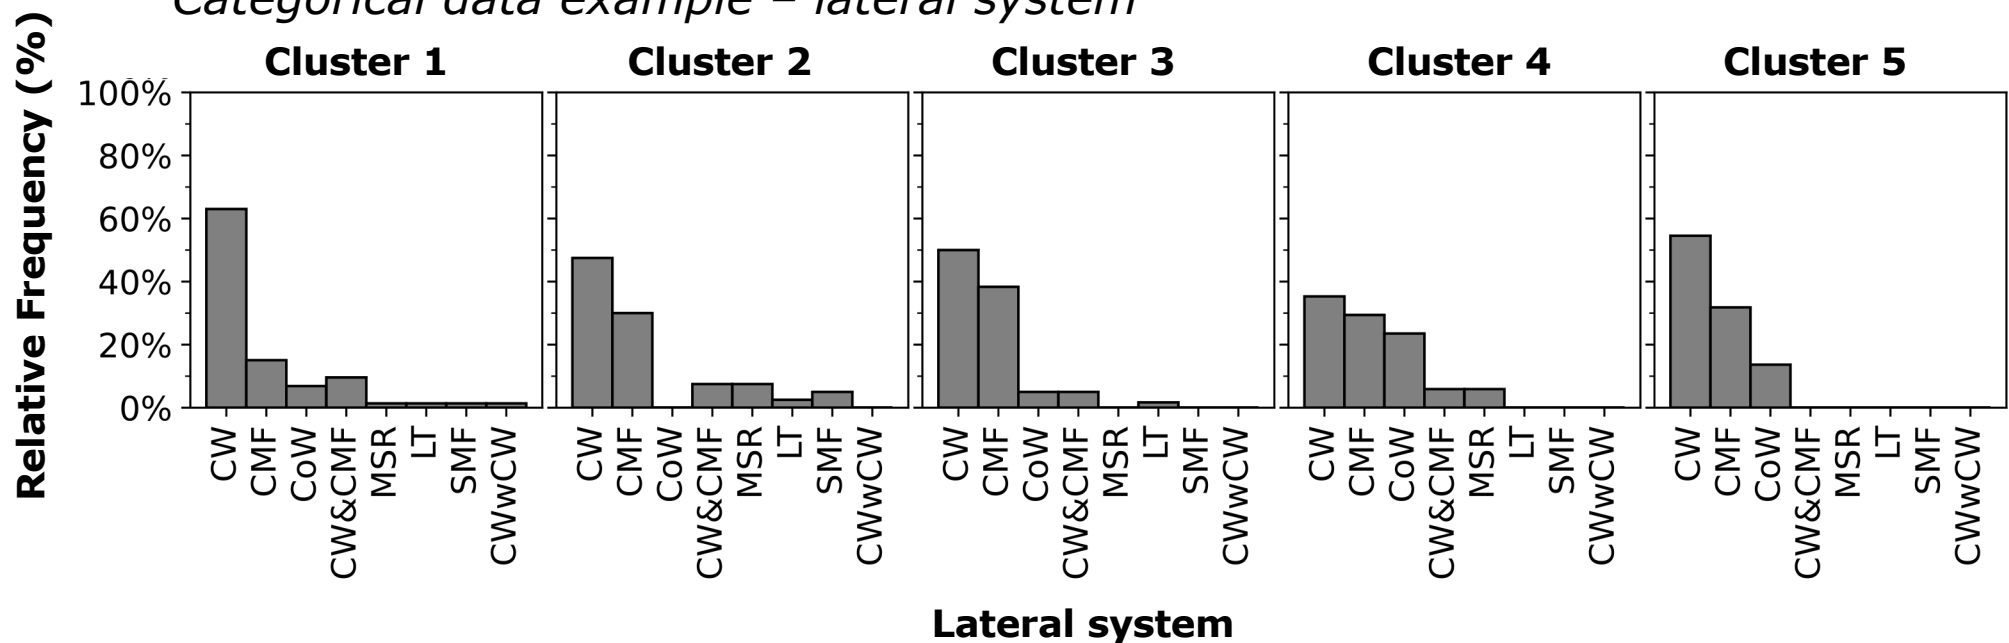
K-means on latent space most effective for both numerical and categorical data

Categorical data example – lateral system

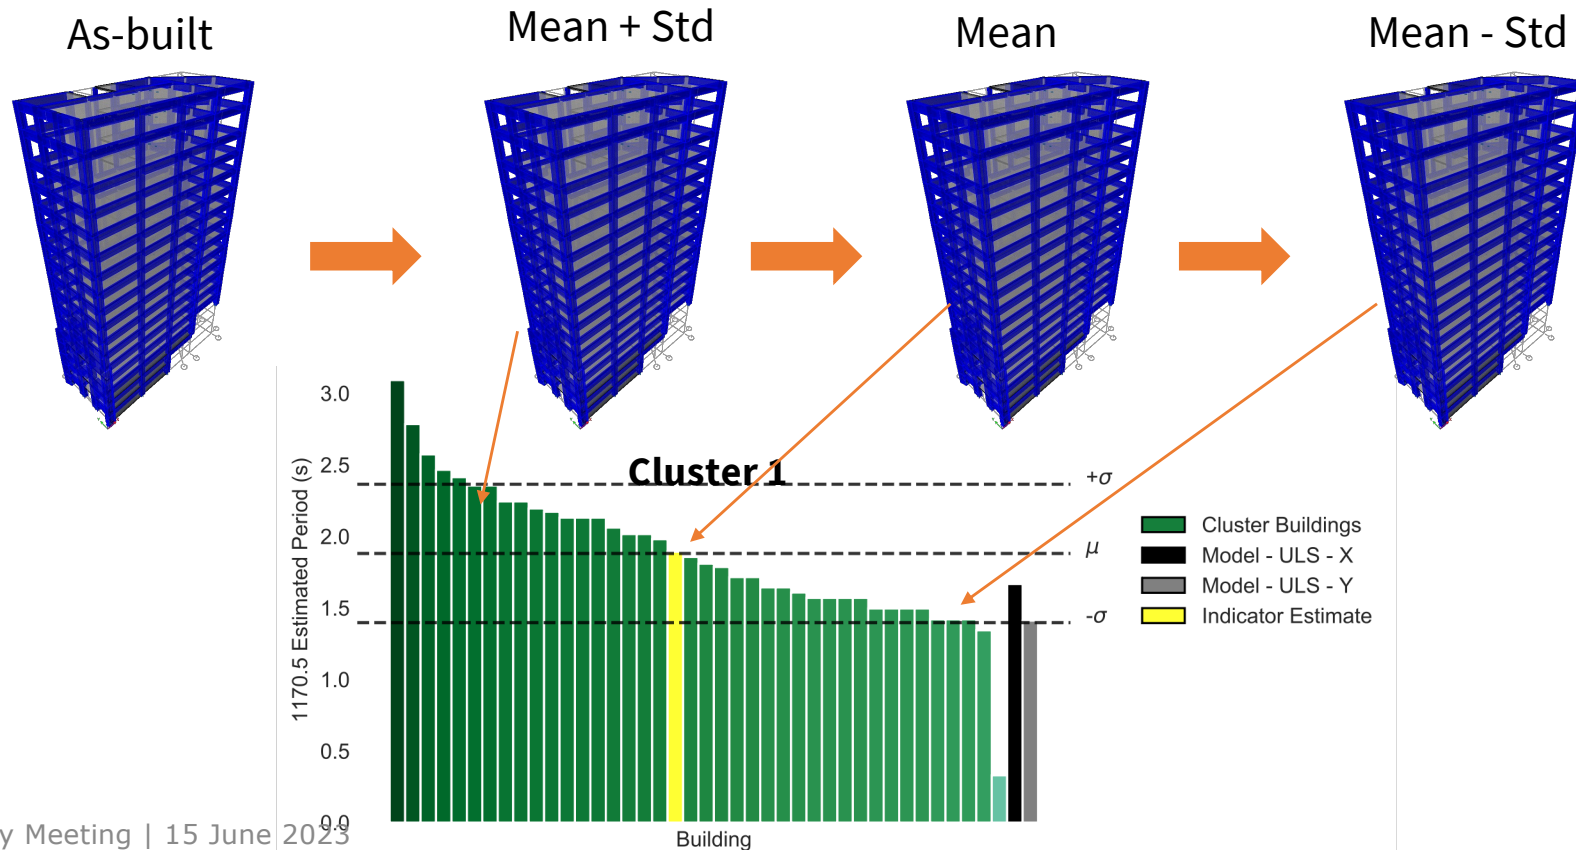
Supplementary models

Four elastic models developed for each cluster

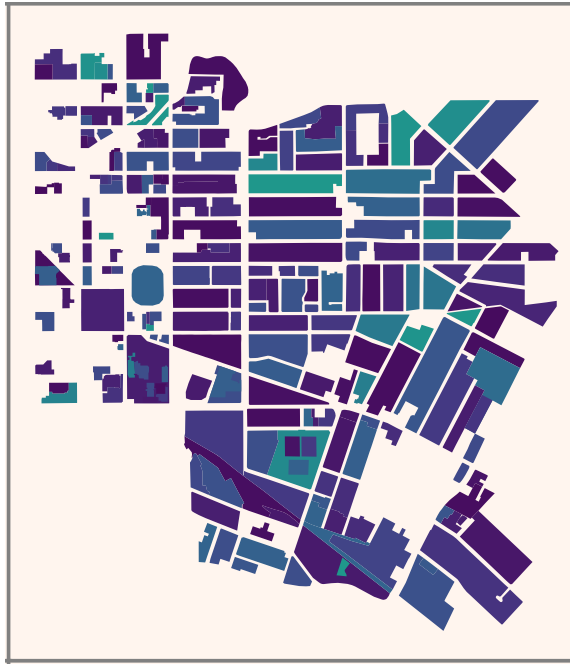
Kaikōura EQ

Drift estimation – shake city

- Building level 'shake maps' can be developed
- Can be used for scenario planning or NRIT following event
- **Note:** Shake city is Wellington buildings assigned to footprints in fictional city
