Implementation and Effectiveness Monitoring for the Washington
Conservation Reserve Enhancement Program (CREP) for Federal Fiscal
Year 2022

December 2022

Washington State Conservation Commission

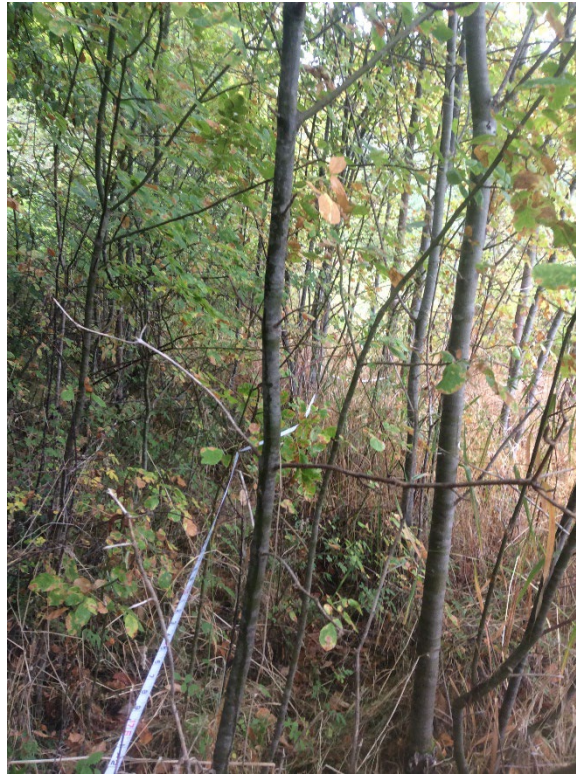
Figure 3. A Lewis County site showing dominance by deciduous trees. Site was one that conifers and shrubs were not sufficient to determine growth rates compared to other sites previously monitored west of the Cascades.

Consistent with previous monitoring reports, the sites with plant type results classed as “n too small” doesn’t necessarily mean the sites are unsuccessful. Typically it means that one class or another was shaded out as the stand matured. Figure 3 shows an example of a transect showing dominance by deciduous, lacking shrubs and conifers, yet still providing riparian buffer functions.

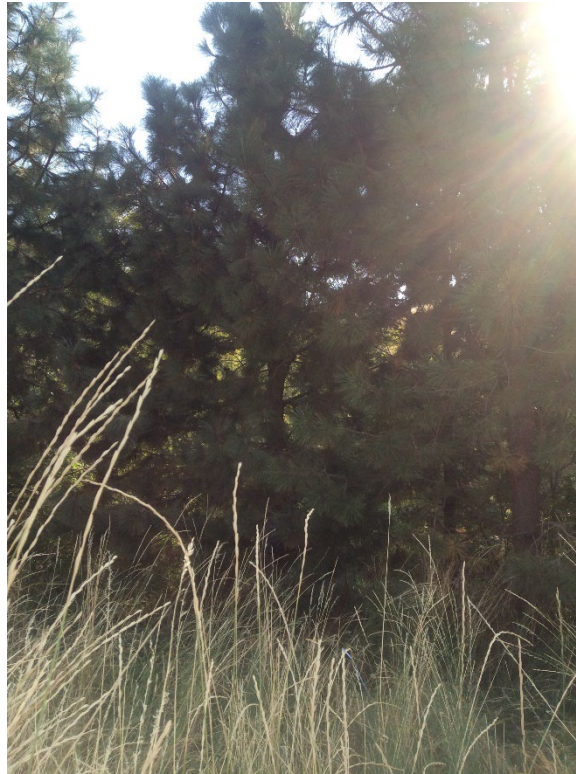
Figure 4. Site in Walla Walla County showing conifers growing at 4.17 feet/year compared to 1 foot/year typical of conifers on other CREP sites east of the Cascades.

In six (6) cases, growth rates were not the same (“no” in Table 3) as the population of equivalent plant types for each side of the Cascade mountains. Of these, one occurrence was for a site in eastern Washington that showed conifer growth at more than 4 times faster than other conifers for the same side of the Cascade mountains (Figure 4). Three (3) sites showed deciduous growth different from equivalent sites. All of these sites had some degree of existing alder present on site initially, providing shade that slowed the deciduous growth. The remaining two (2) occurrences for shrubs that grew faster than the comparison group.

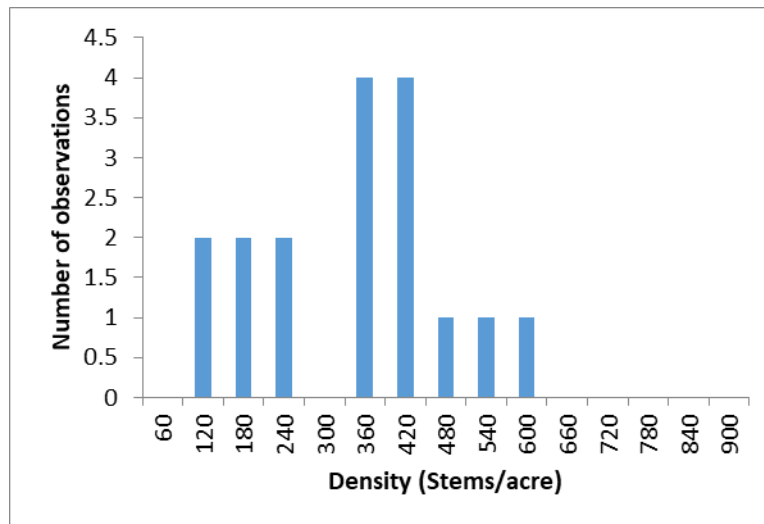
Density was calculated for all transects measured in 2022. As noted in 2020, considerable difficulty detecting dead plants in mature stands skews data as projects age, thus the value of percent survival is less meaningful than plant density. Density at all sites monitored for this report ranged from 89 plants per acre to 561 plants per acre, with a mean of 310 plants per acre. This compares to a range of 60 -678 stems/acre reported for FFY 2020 and 2021. Distribution of site density for all sites monitored in 2022 is shown in Figure 7, below. Plant density measured for this report are consistent with previous CREP report densities of less than 100 plants per acre to greater than 600 stems per acre with a mean near 250 plants per acre.

Figure 7. Histogram of site overall (conifer, deciduous, shrub combined) plant density at monitoring sites sampled in 2022.
