PROJECT PROFILE: Historic Carriage Barn

Project:
Historic 1850 Carriage Barn

Location:
Waynesville, Ohio

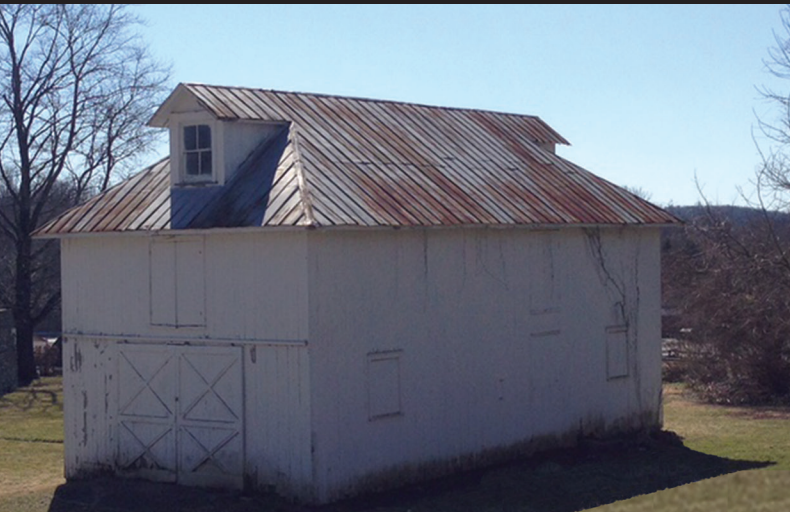
BEFORE

Problem:
5V crimp metal roof
experiencing
corrosion and leaks

Today, the carriage barn is being restored and will eventually become living quarters, but before work could begin on the remodel, the roof issues needed to be addressed first. While not the original roof, the 5V metal crimp roof was very old and in disrepair.

Sams said that his crew pressure washed the existing metal roof and used Karna-Flex to seal the seams and repair areas that were curling. The KARNAK 298 Alumin-R was applied to the metal using a roller. The roof pitch was steep enough that access was a bit challenging so the crew worked using chicken ladders for a safer working environment.

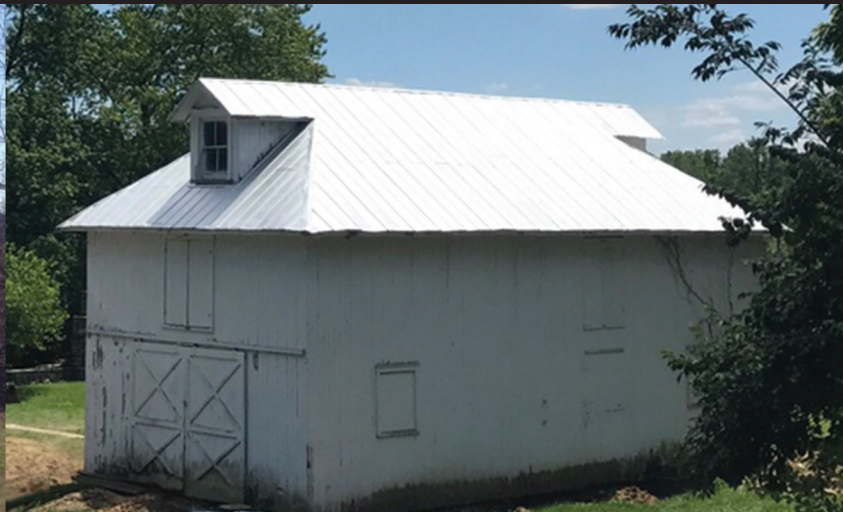
AFTER

Solution:
KARNAK 298 Alumin-R
