**SUBSURFACE
SCANNING
SOLUTIONS**

Subsurface Investigation for Storage Tanks/Anomalies

9/18/2019

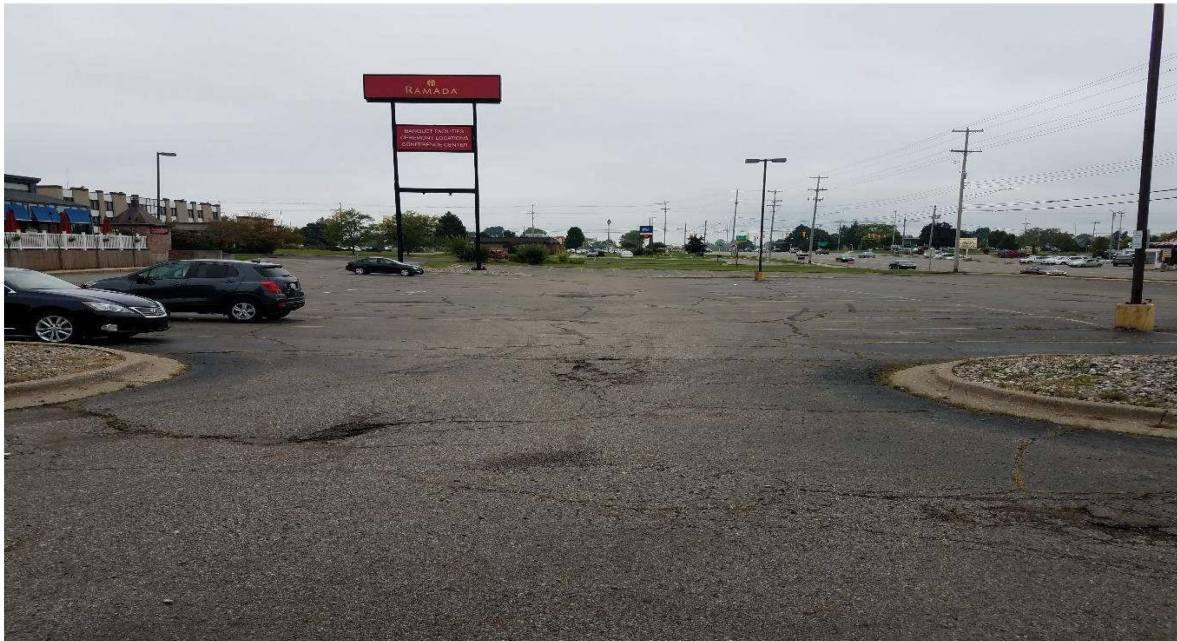
View of the GPR scan area facing west.

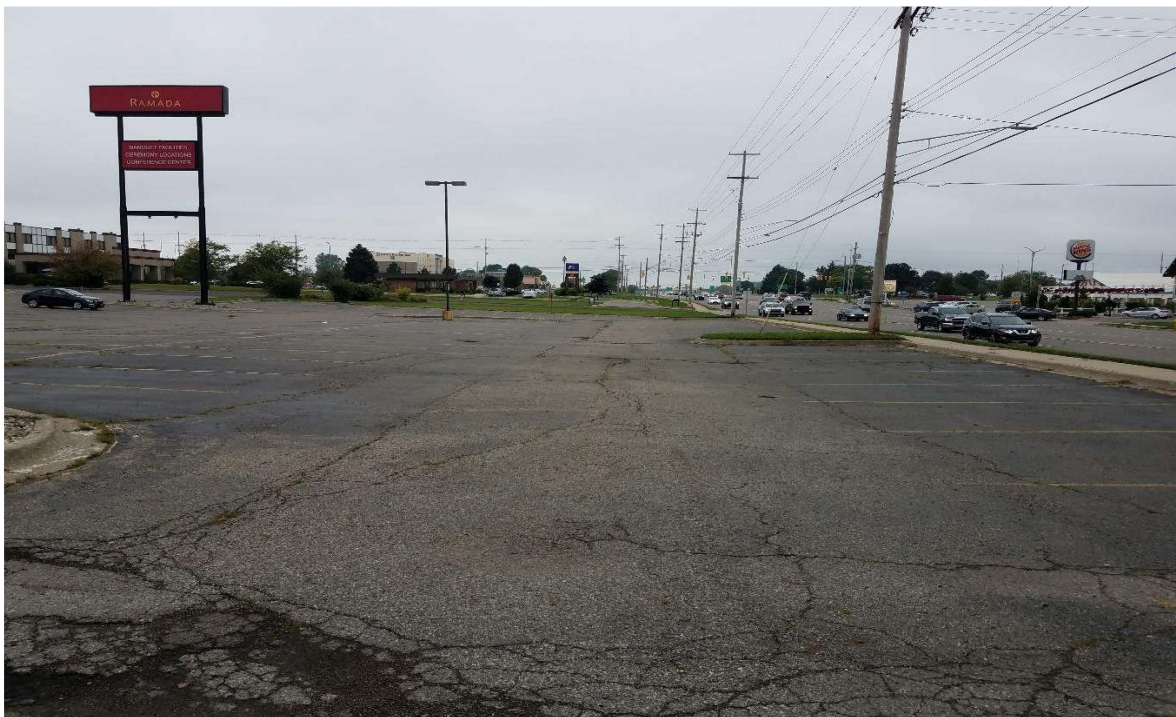
Additional view of the GPR scan area facing south.

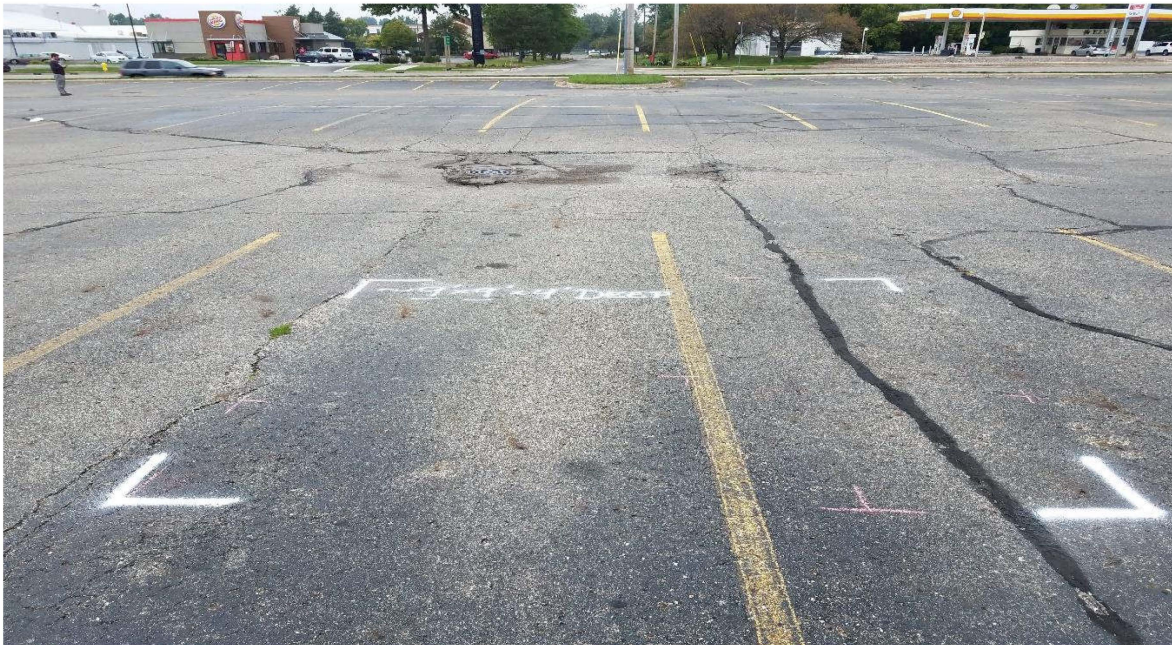
One large isolated anomaly (9 feet in length and width) was identified in the southern-central portion of the scan area at approximately 4 feet below ground surface (bgs). GPRS recommends additional investigation of this area to determine the nature of the anomaly (i.e. test pitting and/or hand augering).

View of the identified anomaly, facing north.

One large isolated anomaly was identified in the southern-central portion of the scan area at approximately 4 feet bgs. GPRS recommends additional investigation of this area to determine the nature of the anomaly (i.e. test pitting and/or hand augering).
