Locality: ROSEDALE
Place address: 1-3 CANSICK STREET
Citation date 2016
Place type (when built): Shire Office, Trees
Recommended heritage protection: Local government level
Local Planning Scheme: Yes
Vic Heritage Register: No
Heritage Inventory (Archaeological): No

Place name: Rosedale Shire Offices (former) & English Elms

Locality: ROSEDALE
Place address: 10 LYONS STREET
Citation date 2016
Place type (when built): Residence
Recommended heritage protection: Local government level
Local Planning Scheme: Yes
Vic Heritage Register: No
Heritage Inventory (Archaeological): No

Place name: McCarthy House

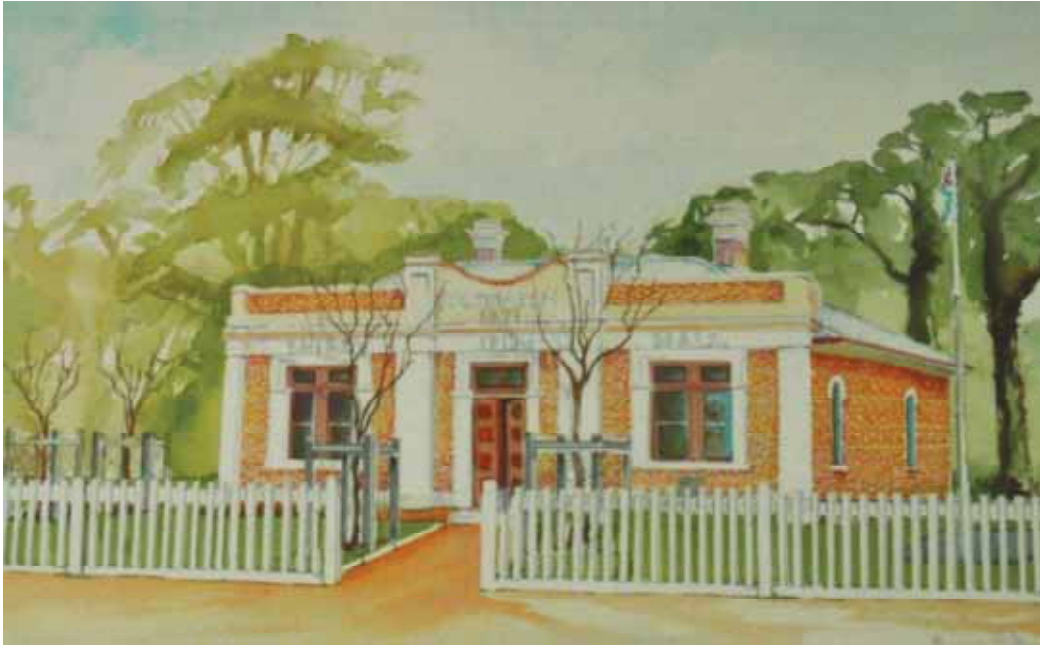
Figure H1. View showing the original design, finishes and colour scheme. Note the decorative chimneys, parapet, red brick walls with round arched windows on the north side, and picket fence, with deciduous trees protected with tree guards.

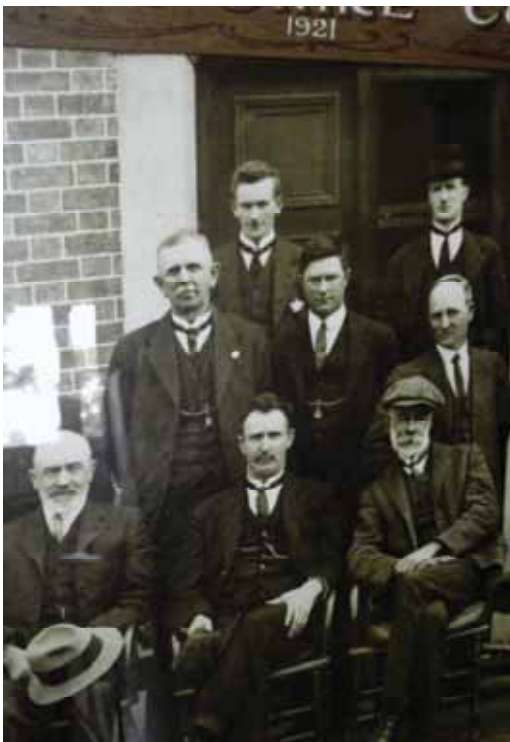
Figure H2. View showing the original finish of tuck pointed red brick walls, unpainted rendered architraves and timber doors, with Councillors in 1921 (RDHS).

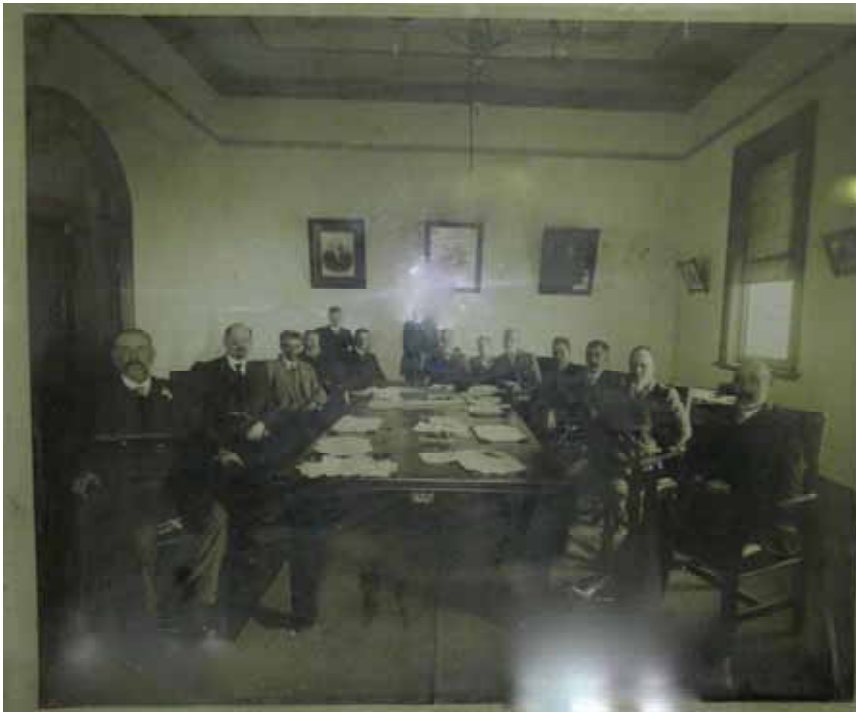
H3. The interior of the building in 1914 (RDHS).

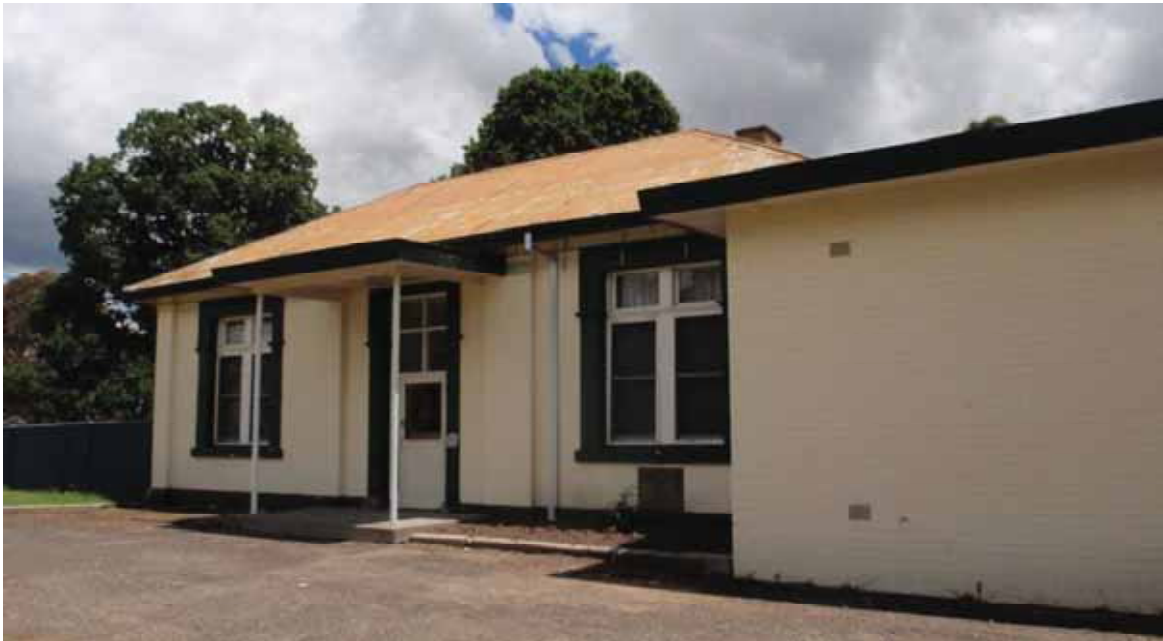
Figure D1. The original 1913 building is red brick with tuck pointing (overpainted), and rendered details, with an M-hip roof clad in corrugated iron and a symmetrical facade. Alterations include the removal of the parapet, eaves, replacement of the entrance door and highlights, addition of an unsympathetic entrance porch and a 1961 addition to the north elevation.

Figure D1. The original part of the 1913 building is brick with tuck pointing (overpainted), with an M-hip roof clad in galvanised corrugated iron. The two original brick chimneys have been reduced in height and the decorative original cornices removed (HV). The 1913 building has a rendered plinth (overpainted). The 1913 façade is symmetrical, with engaged pilasters at the corners and either side of the entrance door, and double windows with prominent rendered architraves either side of the door. The foundation stone remains to the right of the façade, beneath the window (Figure D4). It reads 'Rosedale Shire, 1913, J. Widdis President' and names the Councillors, Secretary and Engineer at that date, and the builder of the offices 'W. Allen'. The 1913 building is in fair condition but retains a low level of integrity due to alterations and unsympathetic additions in the 1960s.

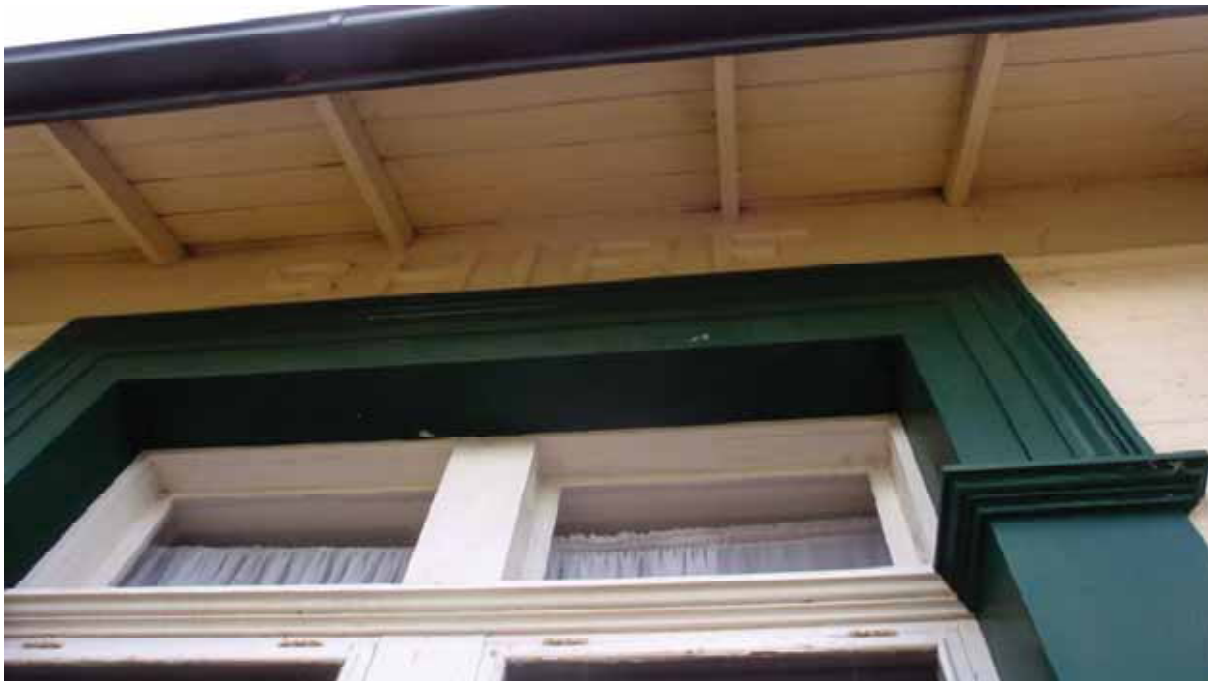
Figure D2. The words 'Shire Hall' and the date '1913' remain in raised letters beneath the 1961 eaves. The entrance and flanking windows are framed with original wide pilasters and sills (all overpainted in a heavy green colour). The eaves are from the 1961 changes, but the windows are original.

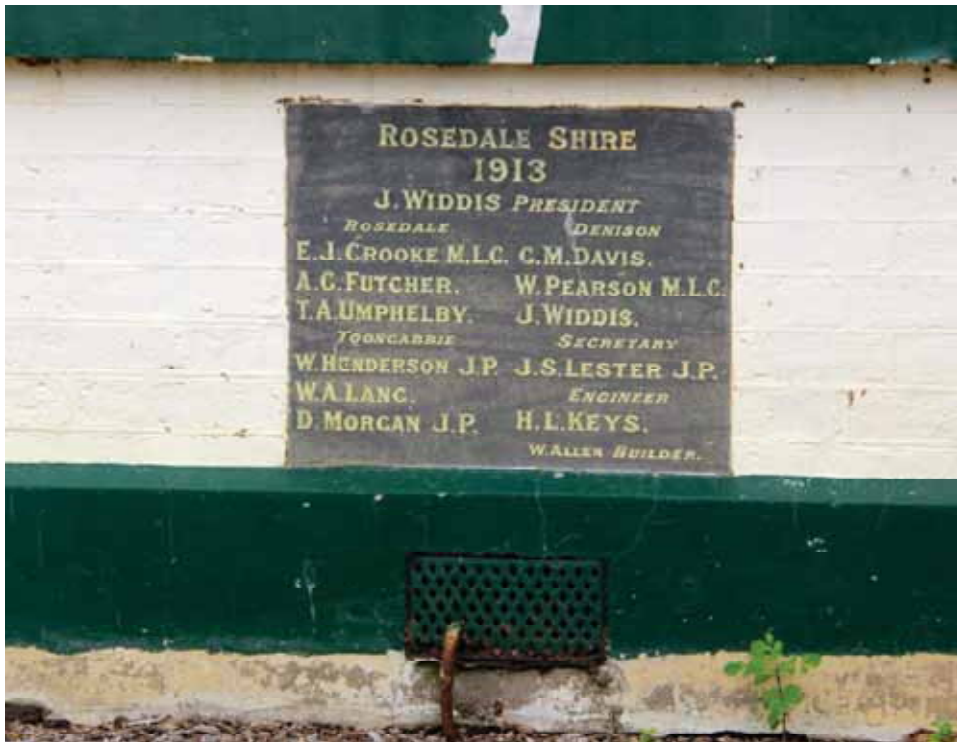
Figure D3. The 1913 Foundation Stone with hand cut incised and gilded lettering has remained intact. The raised lines of the tuck pointed can be seen under the white paint. The dark green coloured render was originally unpainted.

Figure D3. The 1913 basalt Foundation Stone with hand cut incised and gilded lettering has remained intact. The raised lines of the tuck pointing can be seen under the white paint. The dark green coloured render was originally unpainted.

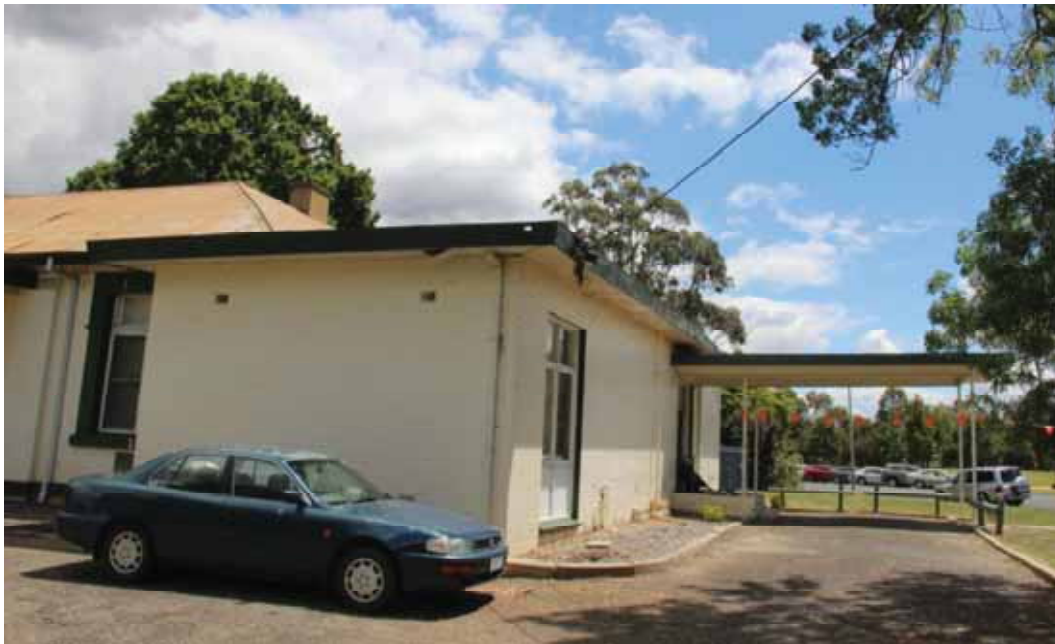
Figure D4. The large unsympathetic addition and carport was added to the north elevation in 1961, this is a cement-brick construction with a flat roof.

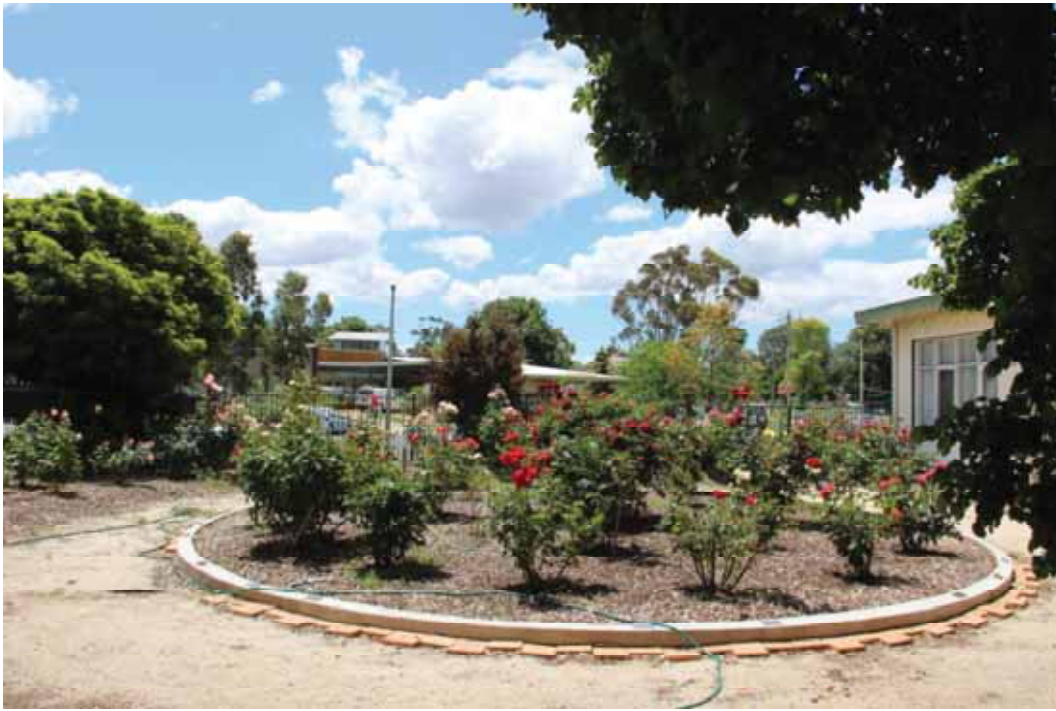
Figure D5. To the rear of the building is the Memorial Rose Garden, which contains roses, pavers and plaques bearing the names of descendents of early settlers and pioneers of Rosedale.

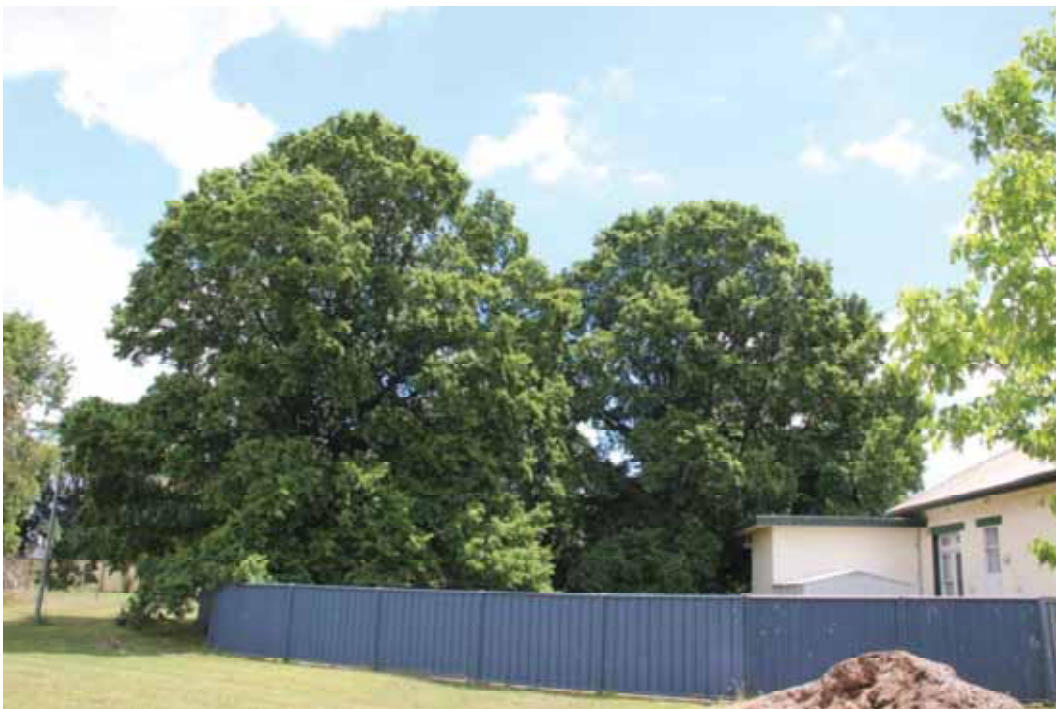
Figure D6. The mature English Elms (*Ulmus procera*) to the south-west of the building and unsympathetic Colorbond deck fencing.

Figure D6. To the south-west of the building are several mature English Elms (*Ulmus procera*), which probably date to the late 1930s or early 1940s. They are in good condition and good examples of the variety.

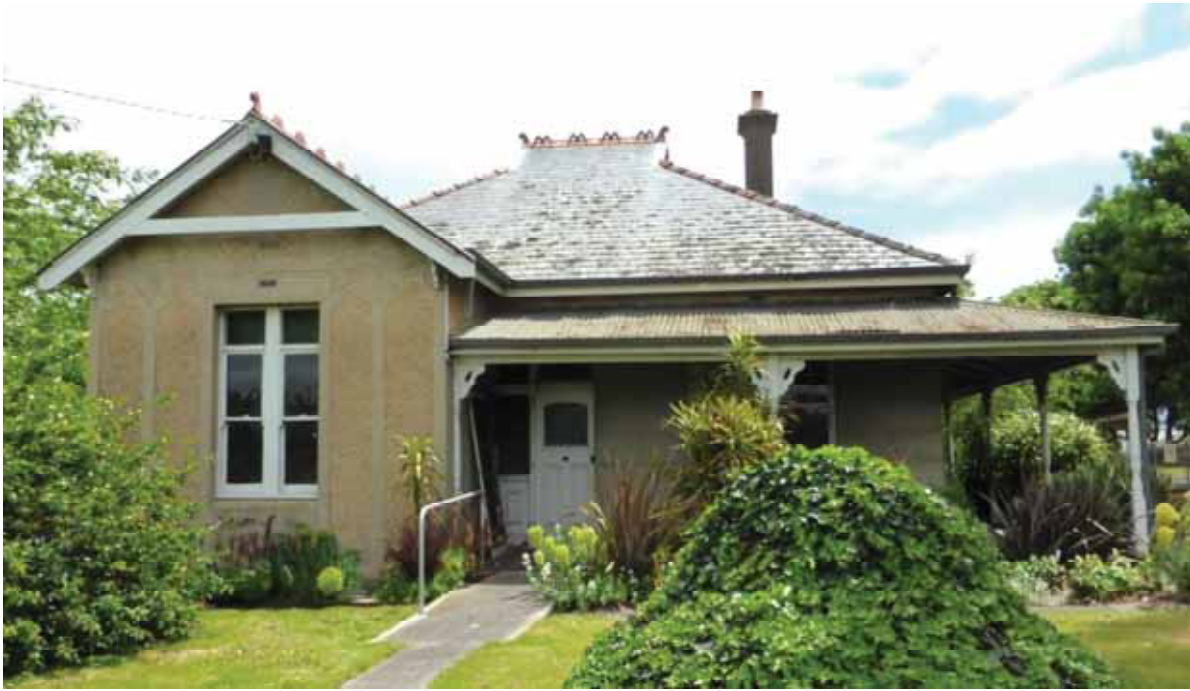
Figure D1. The 1914 concrete house fronts Lyons Street and has a hip-and-gabled roof, with gablettes to the peak (facing the sides), clad in slate with terracotta ridge cresting and gridding. The asymmetrical facade has a projecting gabled-bay to the left side that is finished with a coarse aggregate of smooth river pebbles and, in contrast, has elaborate Art Nouveau and linear details defined in a smooth render. A verandah covers the right of the facade and returns on the north and west elevations.

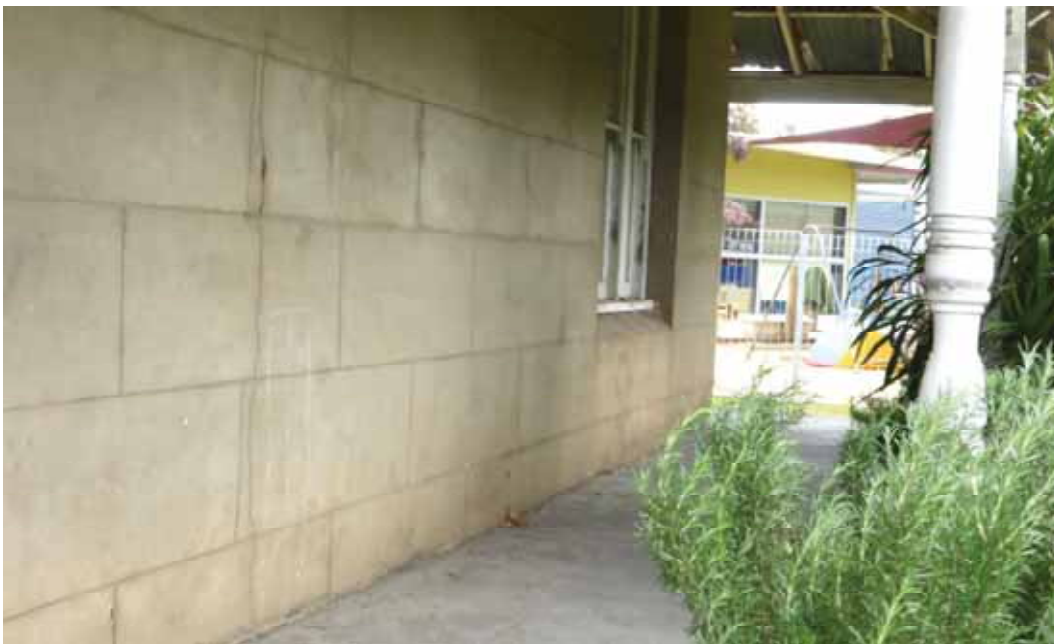
Figure D2. The walls are a concrete construction, finished with a smooth cement render that has ruled incised lines to create a large ashlar effect.

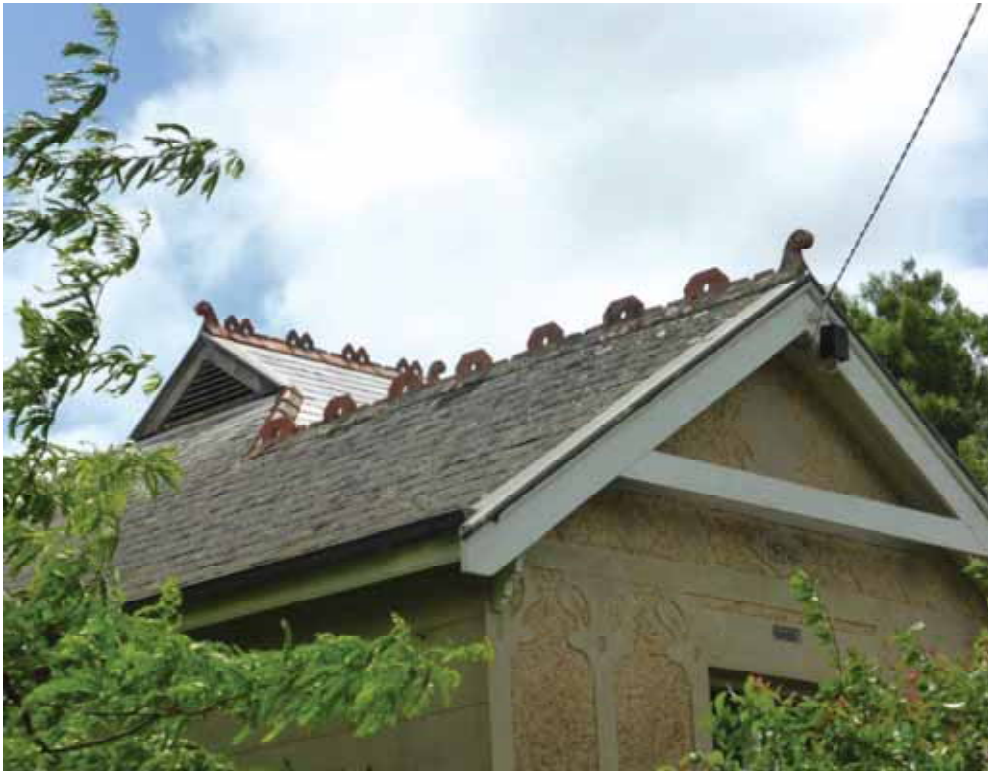
Figure D3. The elaborate hipped and gable roof is clad in slates, with terracotta ridge cresting and finials. The decorative wall pattern can be seen in the gable end.

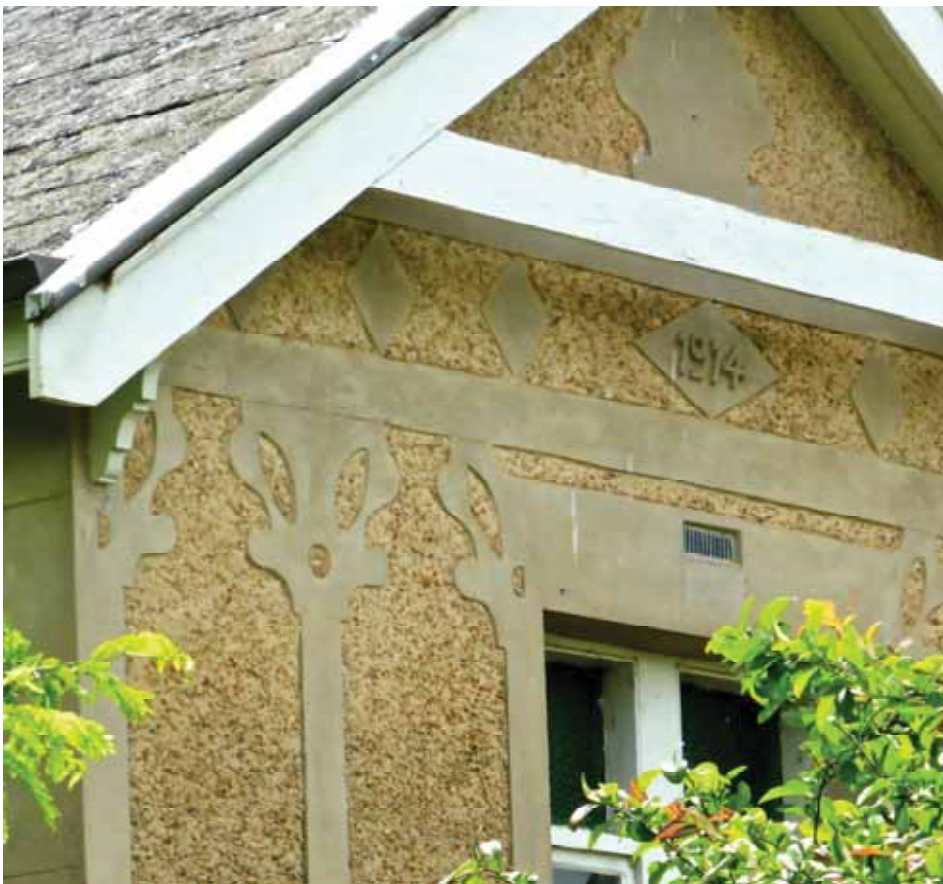
Figure D4. Detail of the elaborate unpainted Art Nouveau roughcast stucco and smooth render pattern and date of construction 1914.

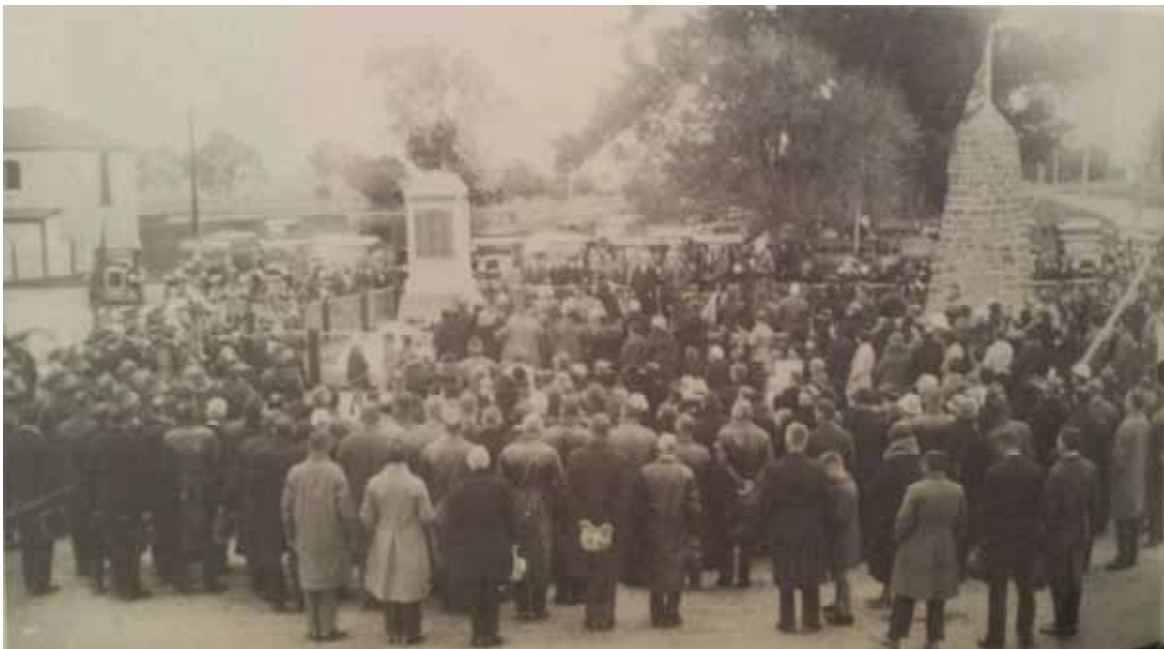
Figure H3. A detailed photo dating to 1935, of the unveiling of the soldiers' memorial, with a surrounding fence, and Elm to the rear (Hardy 1989:142).

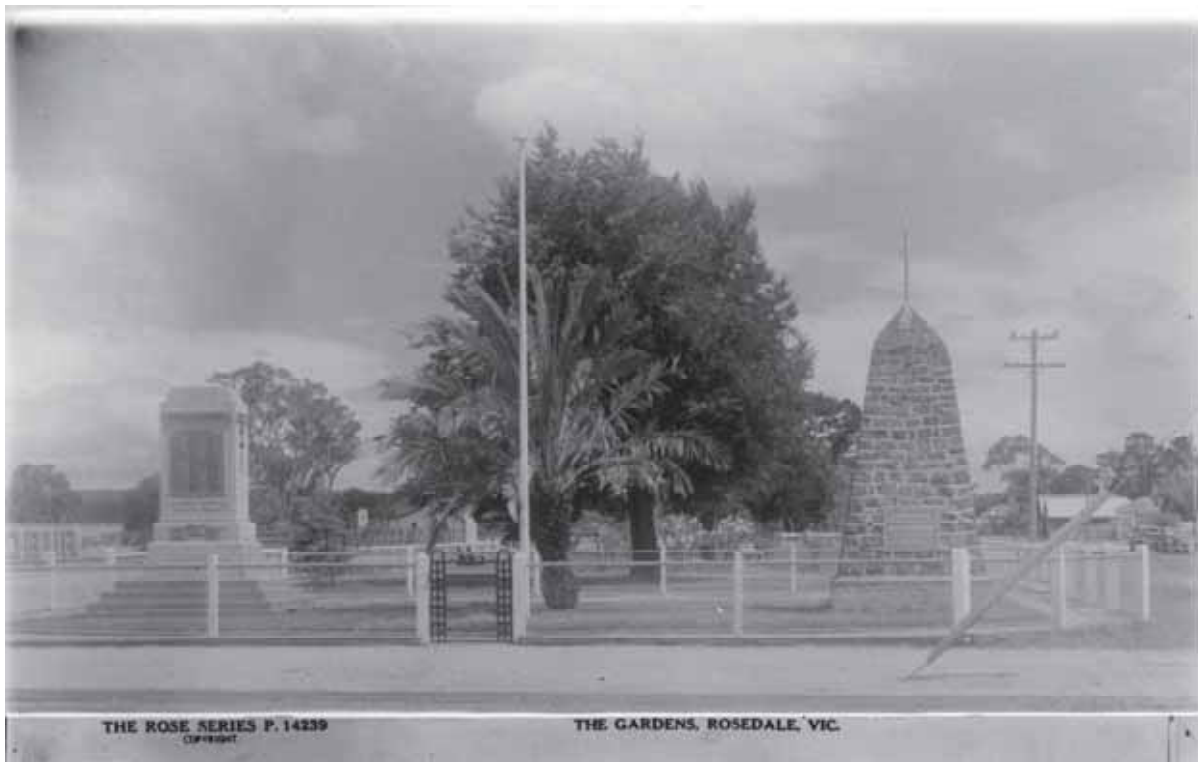
Figure H4. A c1955 photo showing the memorials and memorial gardens to the rearm including the young Himalayan Cedar to the left of the gates and an Elm in the centre behind the palm (SLV).

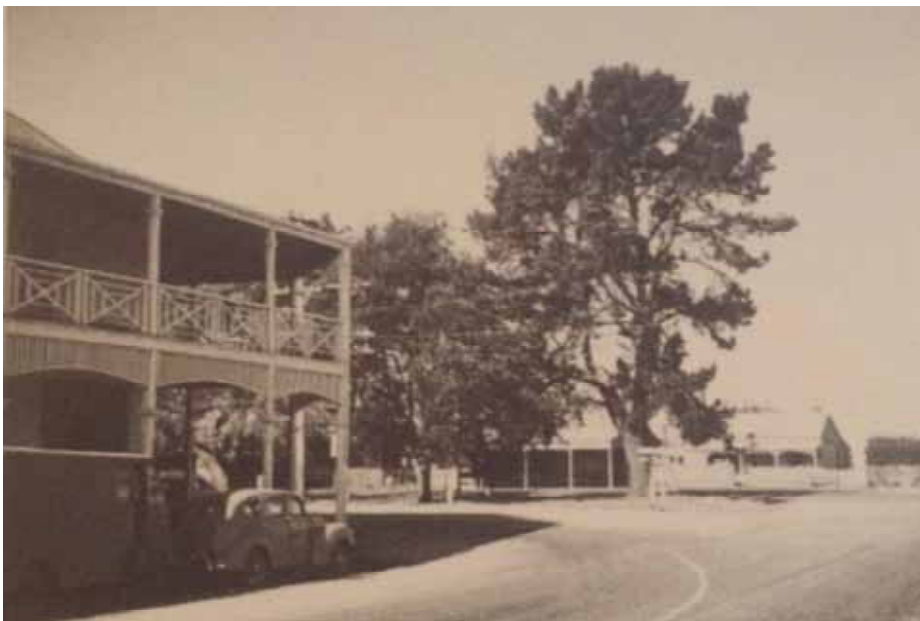
Figure H5. A c1950 photo showing a mature tall pine and elm on the northern road reserve of Lyons Street (since removed). The Exchange Hotel is in the foreground (Hardy 1989:590)

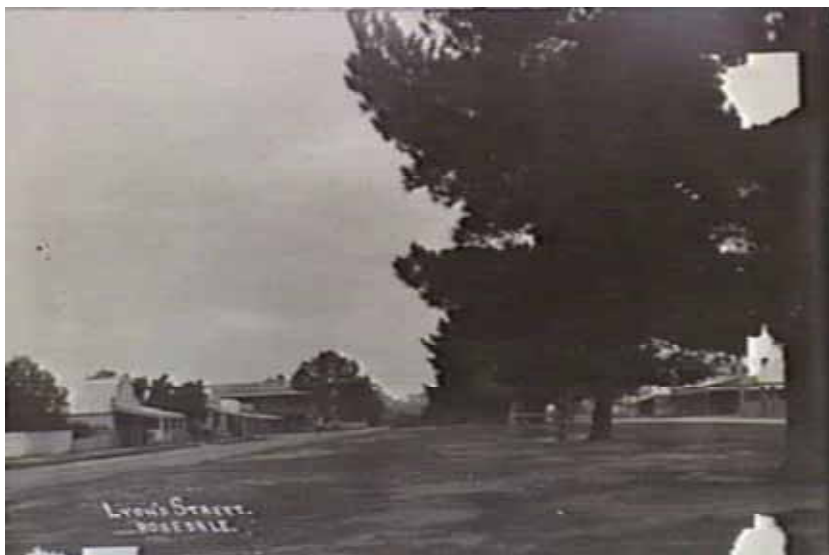
Figure H7. View illustrating the line of mature trees (pines and elms) which appear to continue past the Exchange Hotel, looking north along Lyons Street (SLV).

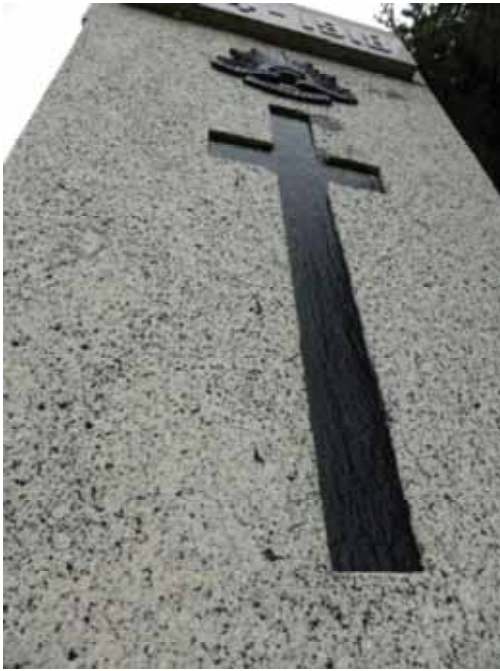
Figure D1. Detail of the polished granite of the Soldiers' Memorial, with the incised cross painted black, and metal ornament on the WW1 memorial.

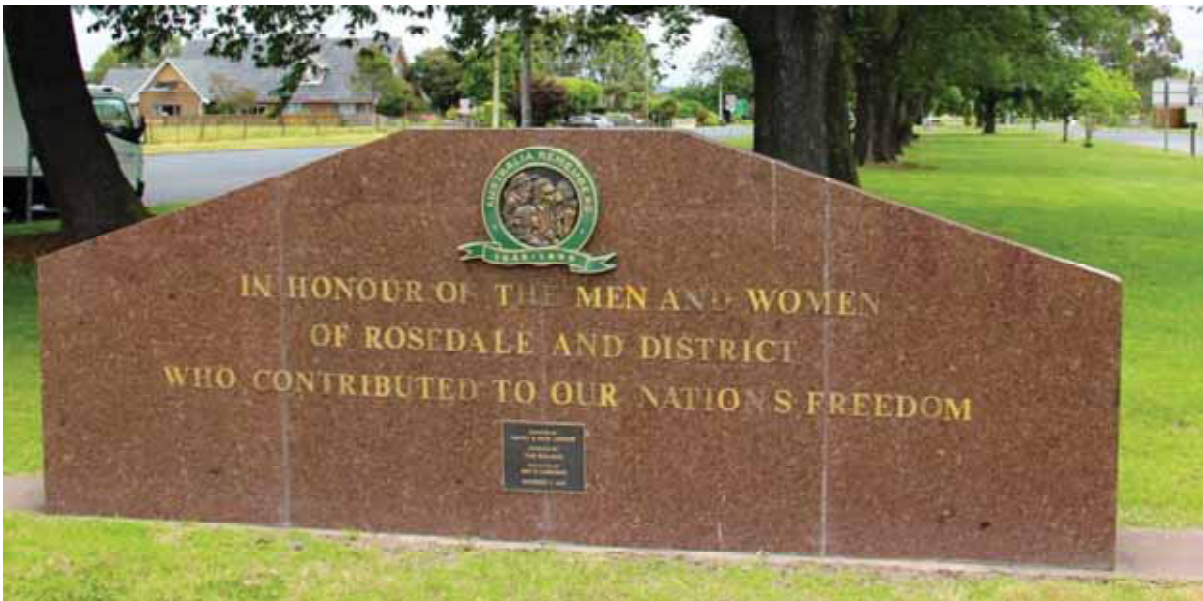
Figure D2. The 1996 polished red granite memorial showing tarnished lettering and staining along the joints.

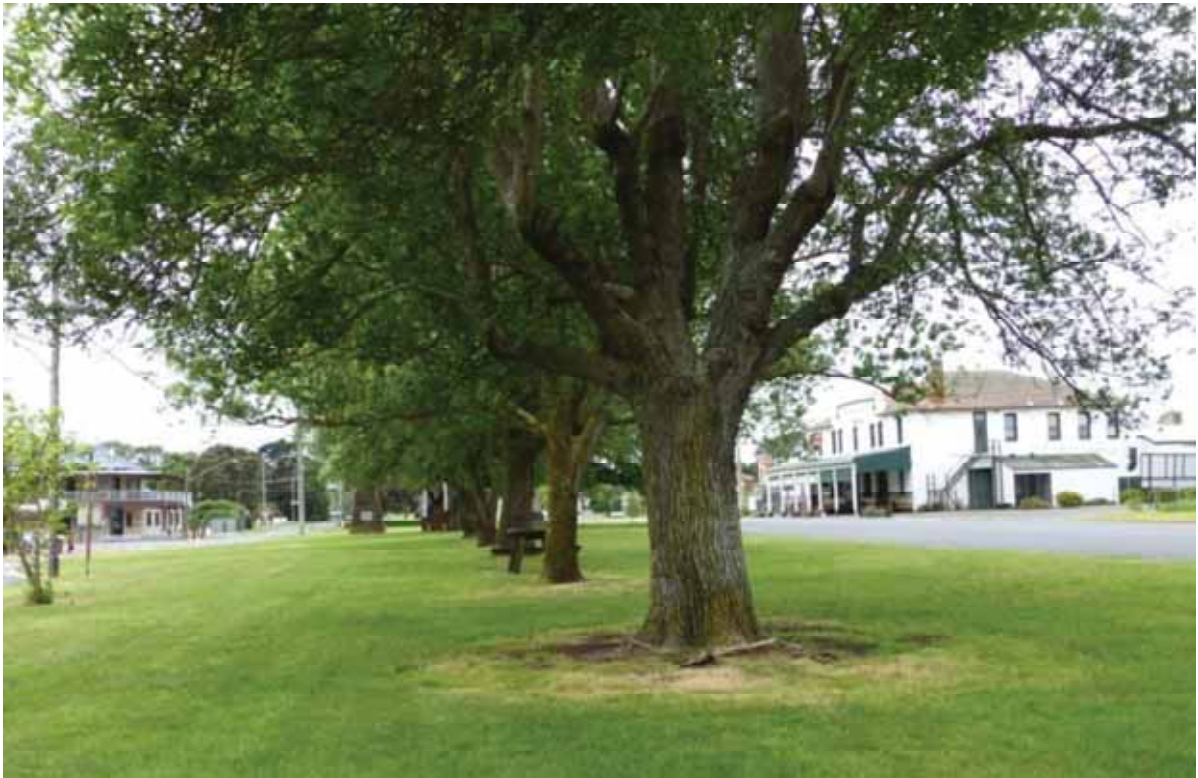
Figure D3. South end of Elm trees interspersed with 1950s trees planted as part of the Memorial Gardens. This photo is looking north along the straight line of mature trees, towards the Exchange Hotel, memorials, and Rosedale Hotel.

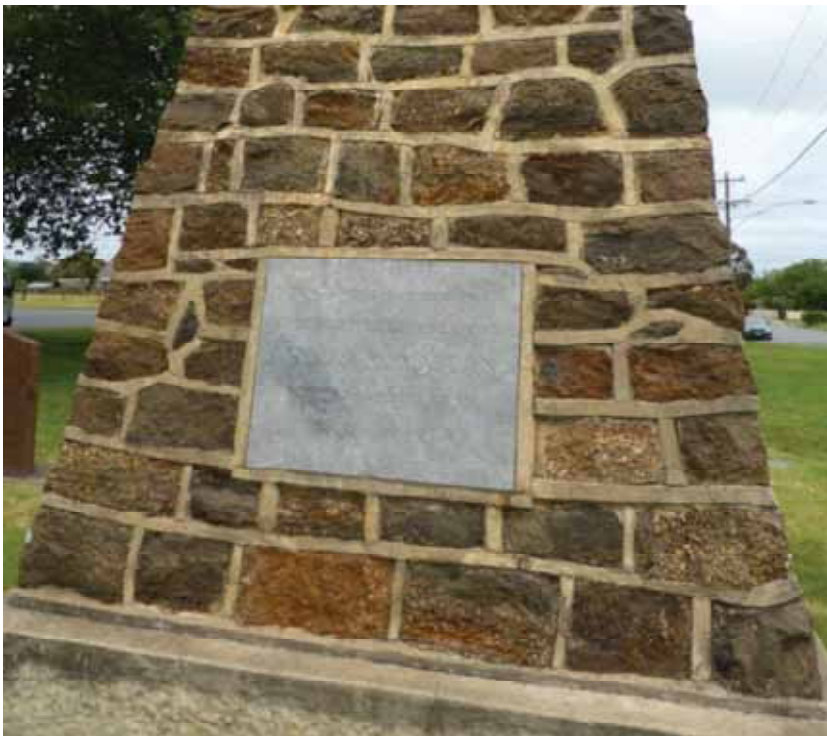
Figure D4. Detail of the 1927 Angus McMillan cairn, showing the local stone blocks, heavy protruding lime- mortar joints, 'concrete' plinth and marble plaque with hand cut incised lettering.

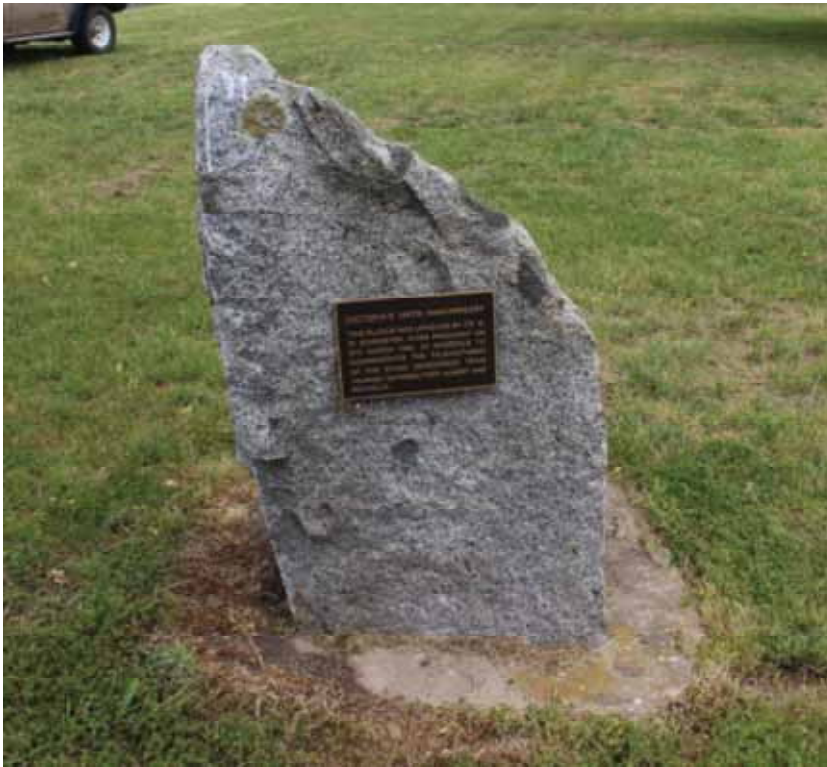
Figure D5. The plaque commemorating Victoria's 150th anniversary in 1985, mounted on the granite rock.

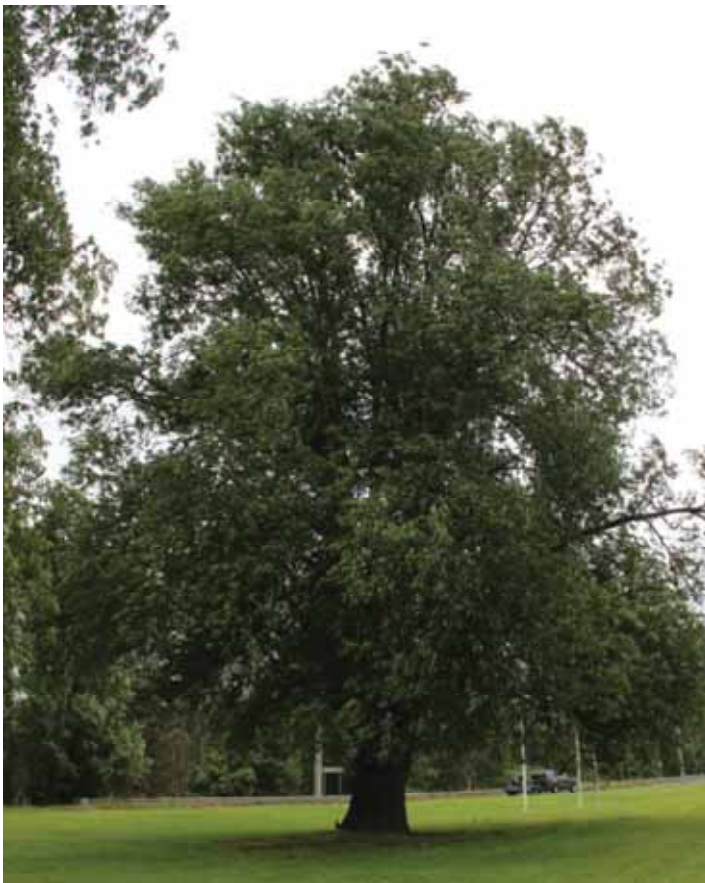
Figure D6. The largest Elm tree at the north end of the row (closest to Latrobe Bridge).

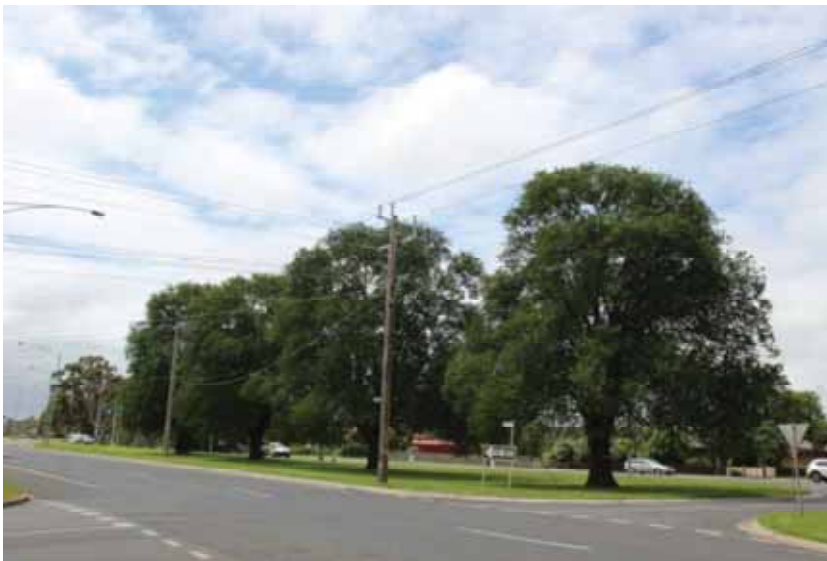
Figure D8. The northern end of the row of Elms in Lyons Street.

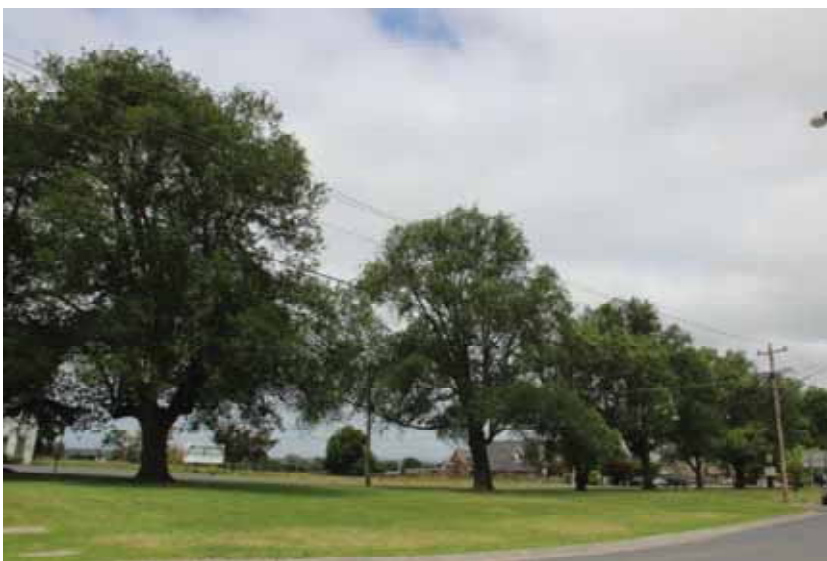
Figure D9. The southern end of the row of Elms, behind the Rosedale memorials (interplanted with other species).

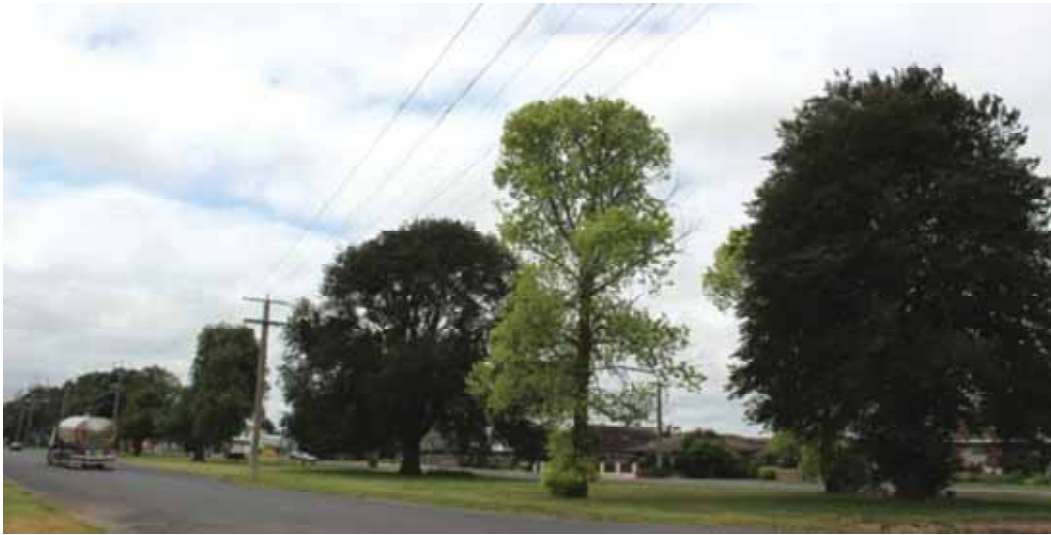
Figure D10. Looking north, the southern end of the row of Elms, interplanted with other species.

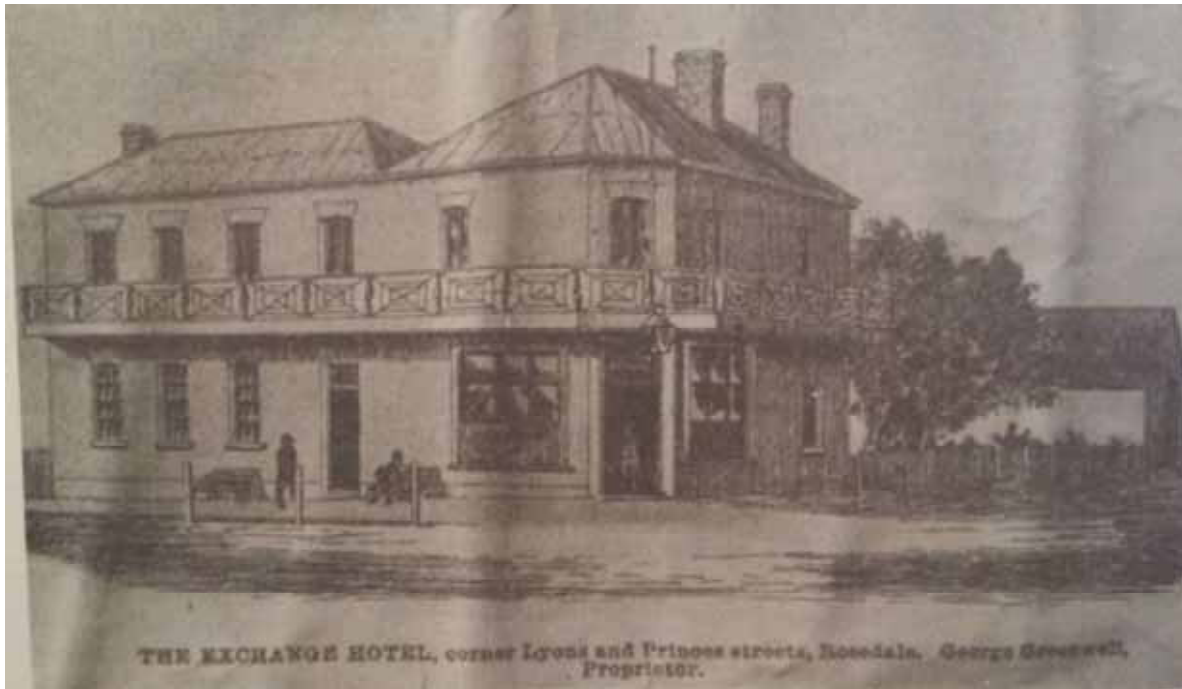
Figure H1. Drawing dating between 1881 and 1890 when George Greenwell was the proprietor. The cantilevered balcony with its cross-pattern is shown. The building looked like two separate buildings at this date (Macreadie 1989:143) and the very steeply pitched roof at the corner is intact in 2016, and may be clad in 'Morewood and Rogers' flat metal tiles in this drawing.

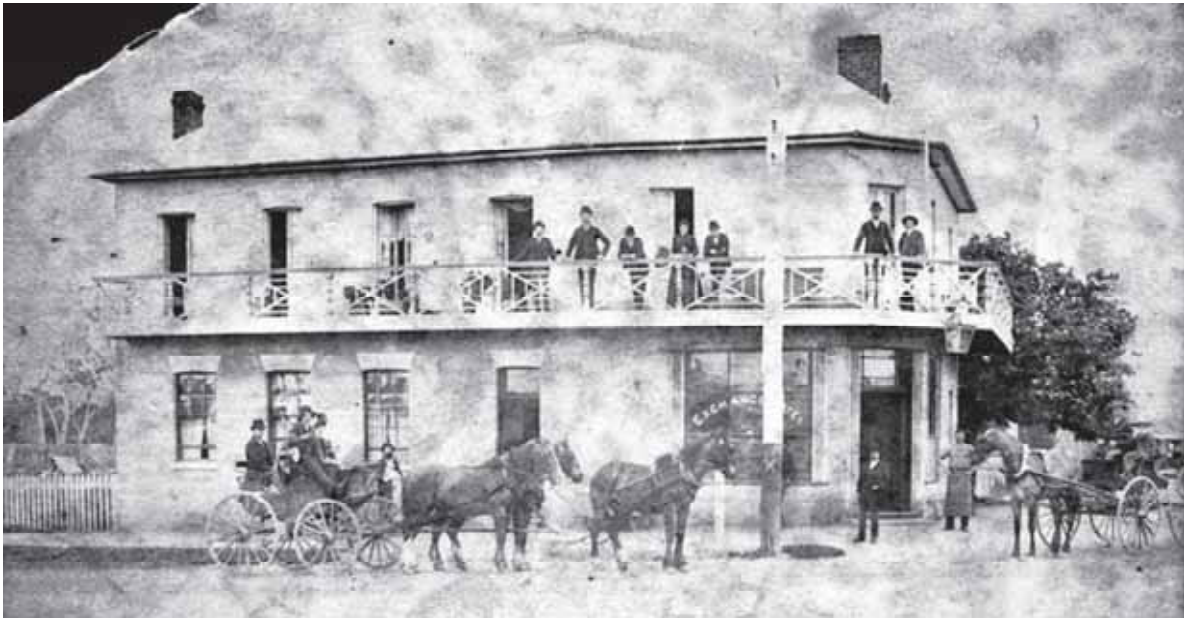
Figure H2. Photo of the hotel in 1890 showing the cantilevered balcony with its cross-pattern balustrade with turned timber posts, rendered walls, and layout of the openings of each level (Museum Victoria).

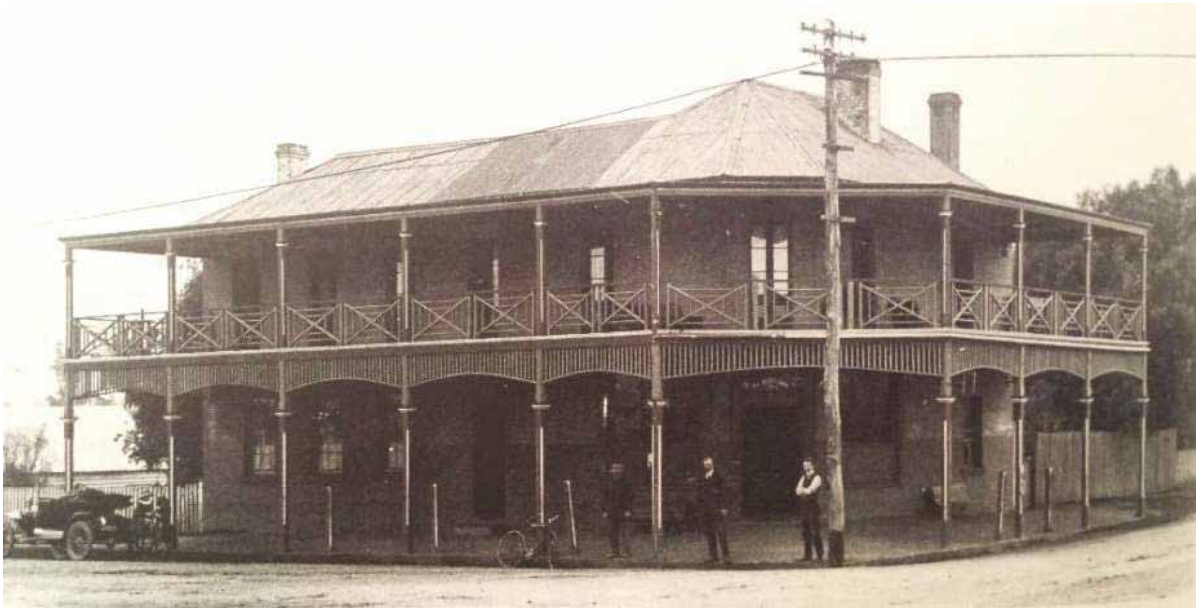
Figure H4. This photo dating to 1920 confirms that either a new balcony was constructed or that the balcony was now supported by timber posts and had a roof to the first floor. The verandah had chamfered timber post supporting both levels, with capitals and an arched timber frieze to the ground level. The cross-patterned balustrade to the first floor appears to have been retained from the earlier balcony (Hardy 1989:182). The French doors are still intact on the first floor and the walls are rendered.

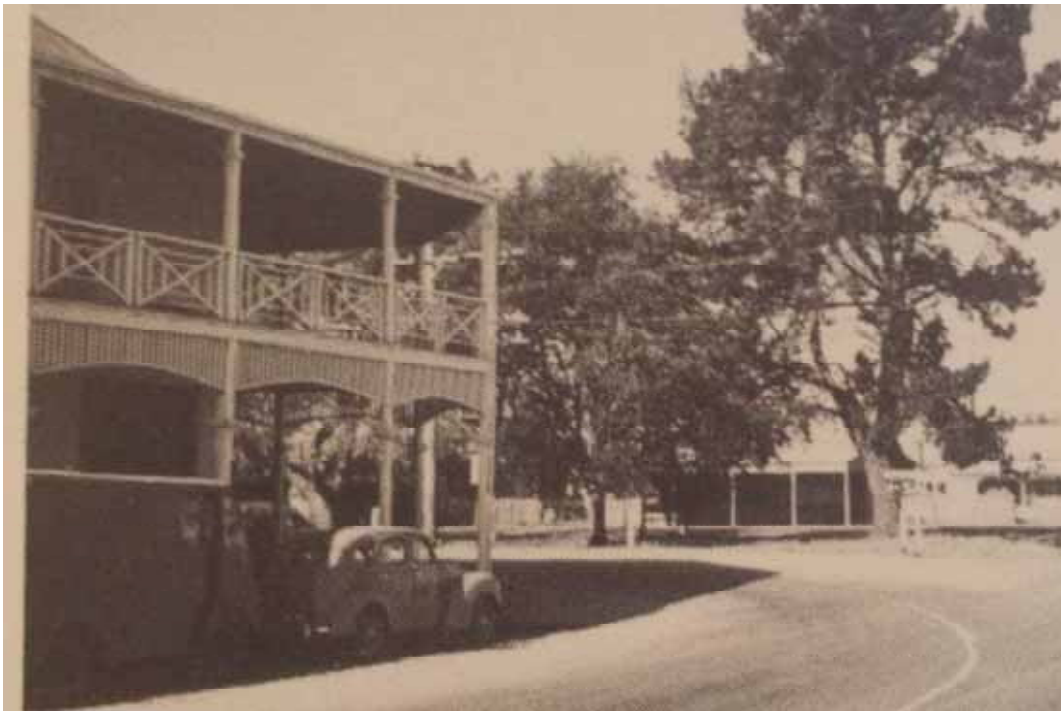
Figure H5. Photo dating to c1950 showing the corner of the hotel, looking east. At this date, the hotel retained the 1911 verandah, comprising the cross-patterned balustrade, capitals to the columns and arched timber frieze to the ground floor (Hardy 1989:590).
