Locality: ROSEDALE
Place address: 1-3 CANSICK STREET
Citation date 2016
Place type (when built): Shire Office, Trees
Recommended heritage protection: Local government level
Local Planning Scheme: Yes
Vic Heritage Register: No
Heritage Inventory (Archaeological): No

Place name: Rosedale Shire Offices (former) & English Elms

Locality: ROSEDALE
Place address: 10 LYONS STREET
Citation date 2016
Place type (when built): Residence
Recommended heritage protection: Local government level
Local Planning Scheme: Yes
Vic Heritage Register: No
Heritage Inventory (Archaeological): No

Place name: McCarthy House

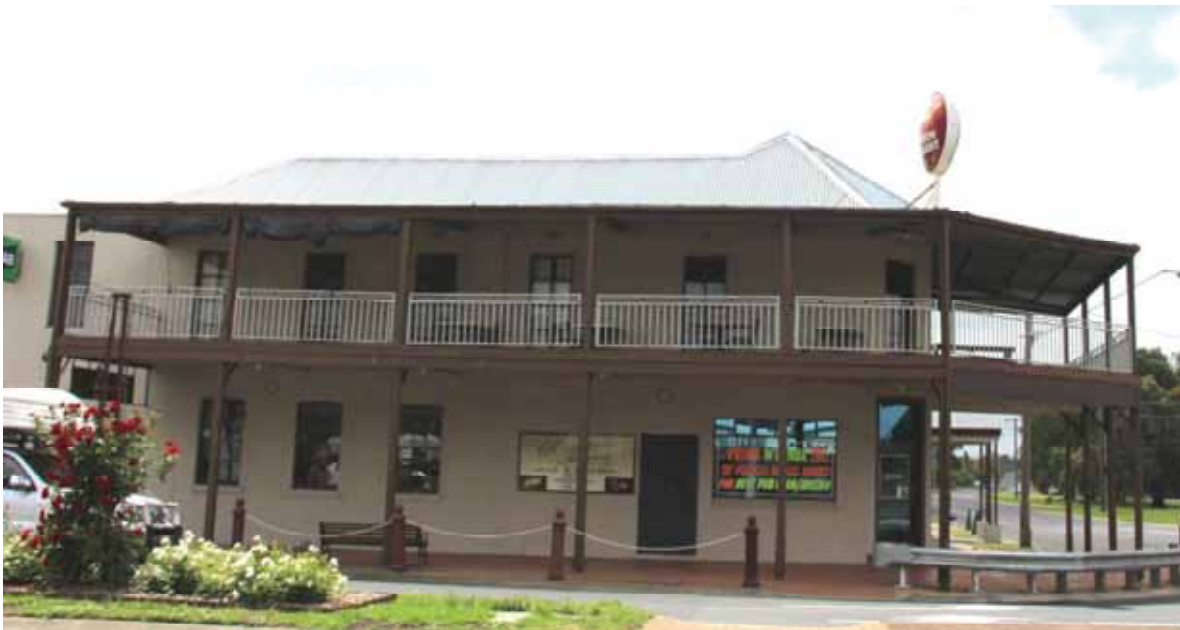
Figure D1. The 1863 two-storey building has an M-hipped roof clad with (recent) corrugated iron and one brick chimney at the west end. The rendered brick building has a two-storey verandah to both the south and east elevations. A cantilevered balcony was originally built in 1863 and this may have been retained in 1911, when timber supports to both levels and a wide hipped roof clad in corrugated iron were added (or the entire verandah may have been constructed in 1911).

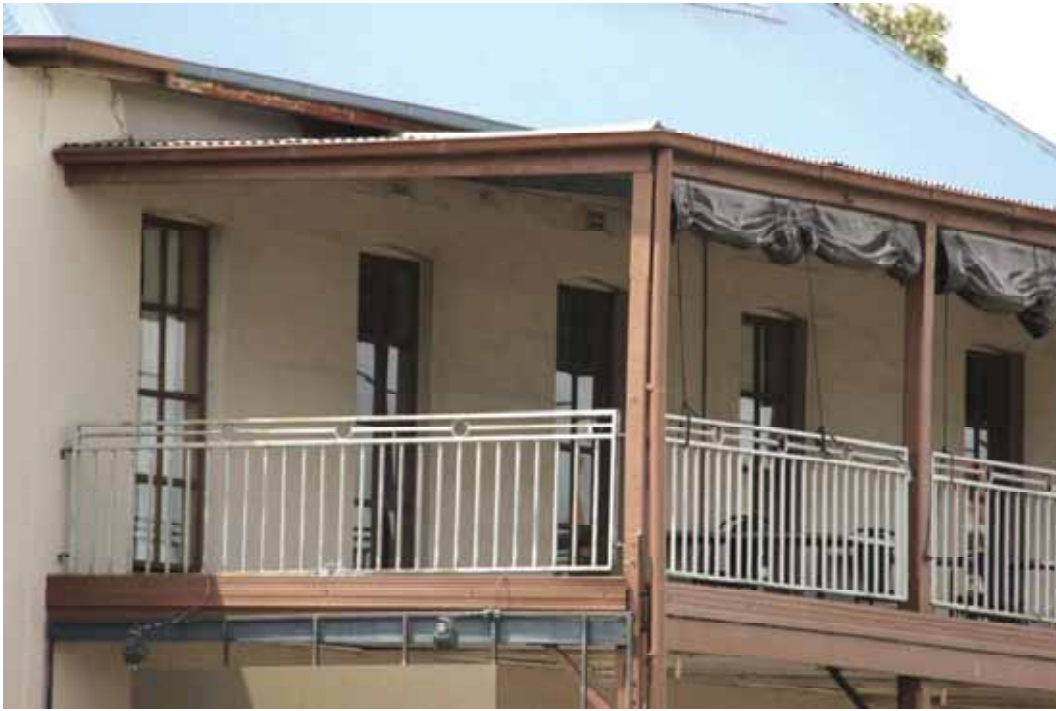
Figure D2. The tall openings to the first floor of the south elevation are all original (with modern multi-paned windows that replaced the original French doors).

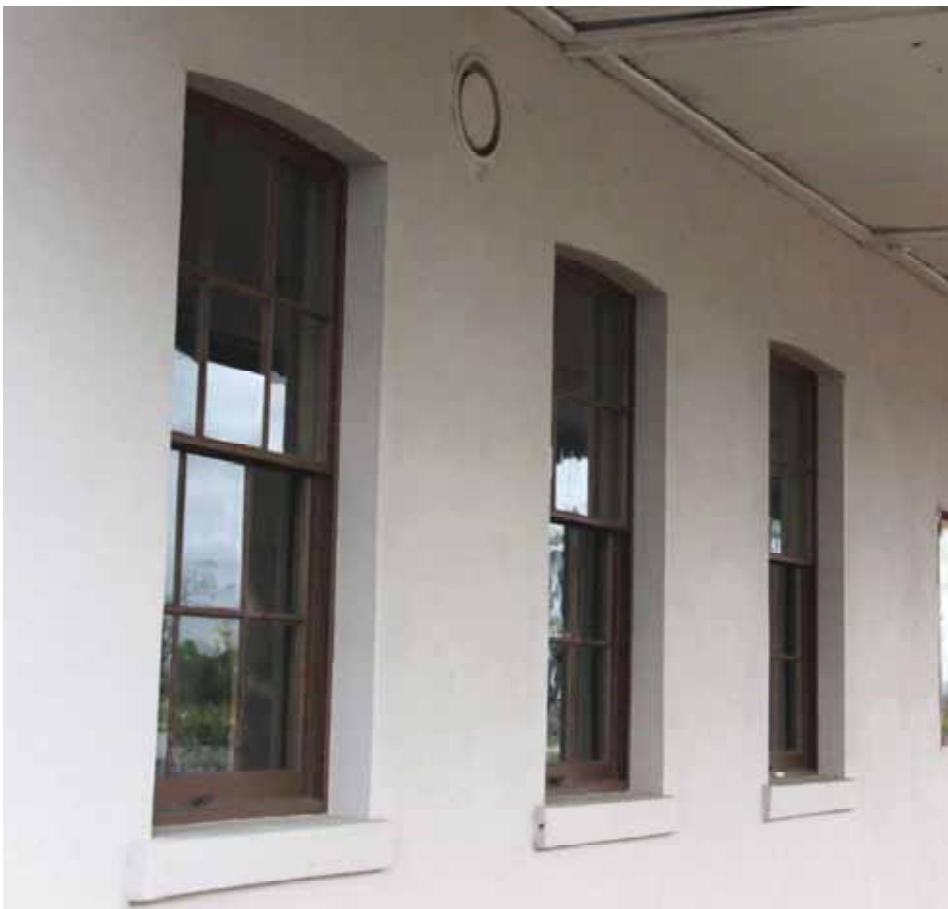
Figure D3. The ground level retains three original six-over-six sash windows on the southern elevation. All openings to the south elevation have radiating voussoirs above, and the windows have projecting sills (all rendered and overpainted).

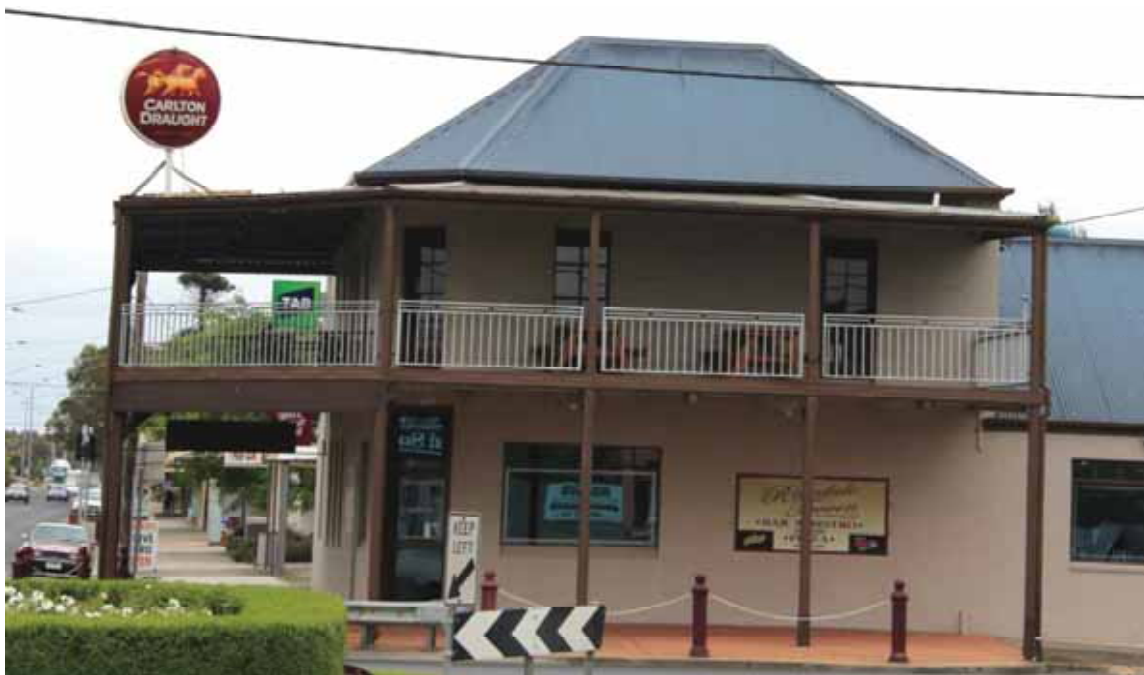
Figure D4. The east elevation is the shorter side, with two tall openings (with modern windows replacing the original French doors) to the first floor and a large opening to the ground floor (with a modern window), next to the entrance.

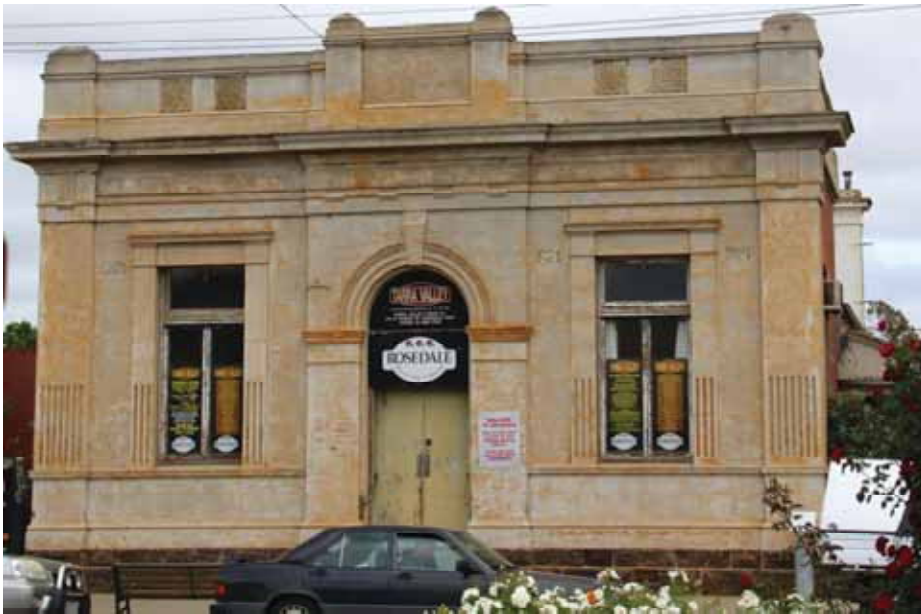
Figure D1. The rendered façade, prominent parapet and central projecting bay with the entrance.

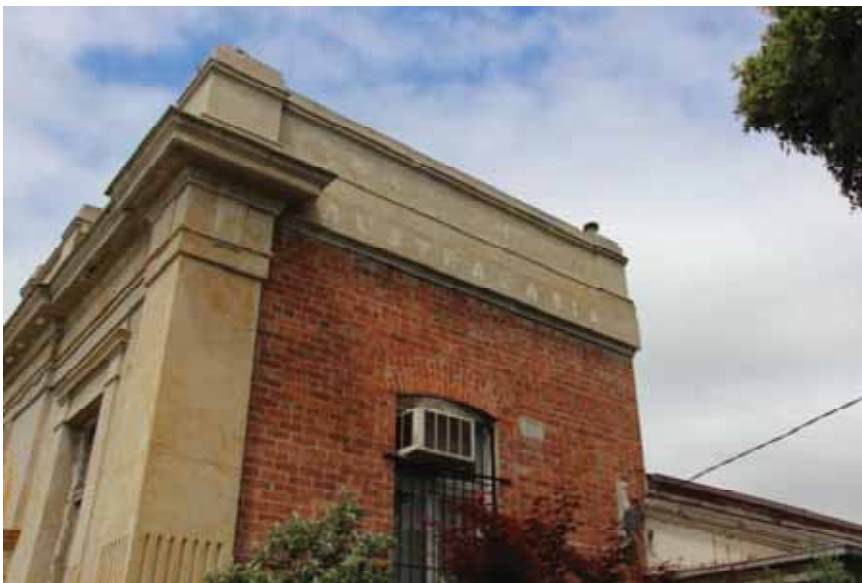
Figure D2. The west elevation of the bank, partially showing 'Bank of Australasia' and the original face red-brick wall (exposed after the chemical removal of the paint in 2010).

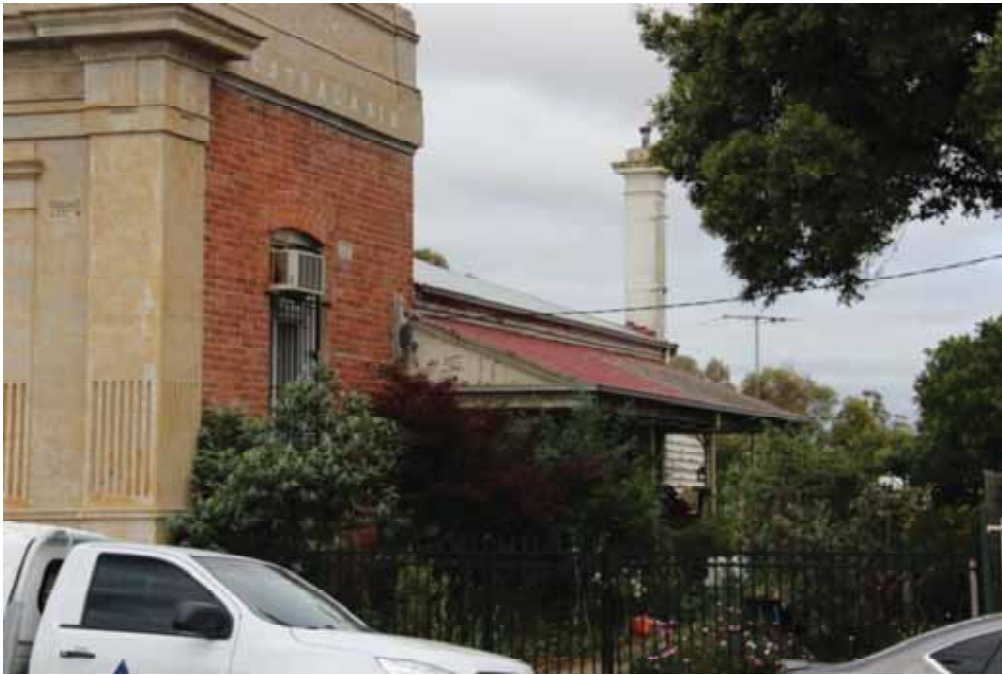
Figure D3. The west elevation showing the rendered pilaster and parapet wrapping around from the front elevation to the face red-brick wall of the bank, and the residence to the rear. The early/original skillion-roof verandah attached to the residence has been altered (cast iron brackets removed and columns replaced with simple metal pole supports).

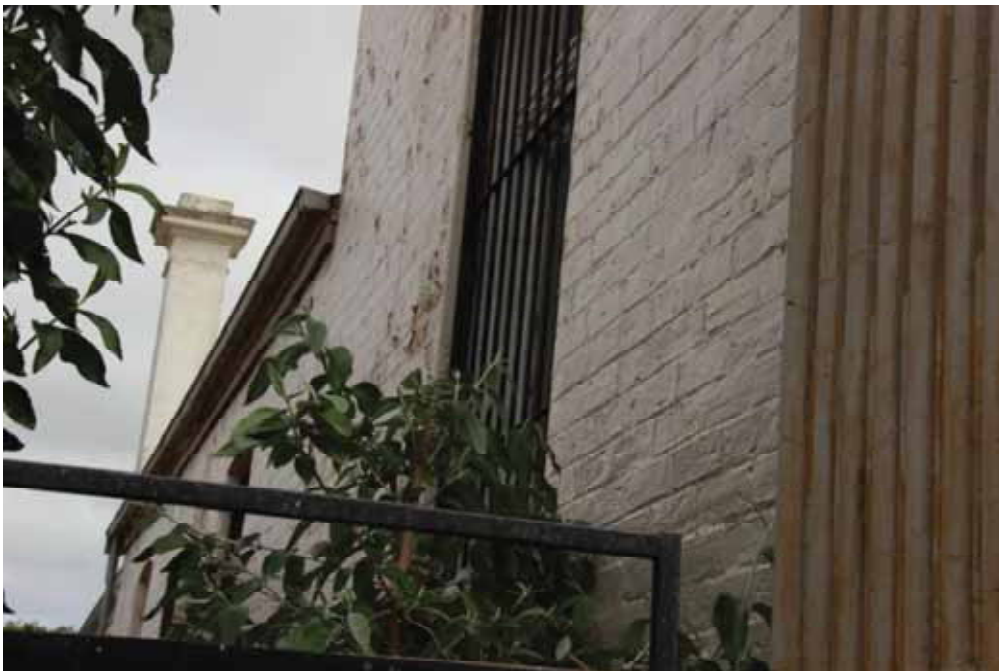
Figure D4. The east elevation, showing the overpainted brick walls and chimney of the bank and residence.

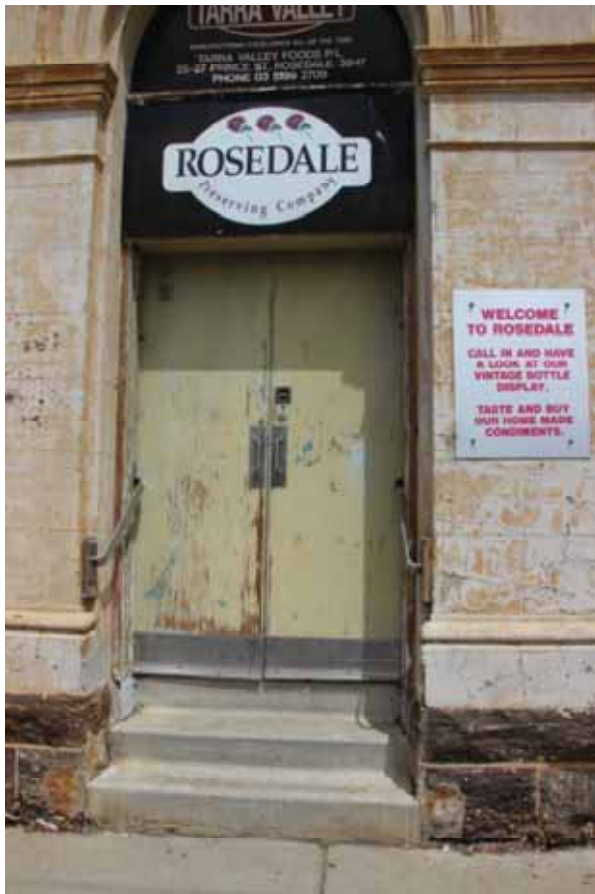
Figure D5. A detail of the facade and entrance showing the unpainted original local stone plinth ruled lines to the unpainted rendered wall planes, and the later doors, metal balustrades and concrete steps.

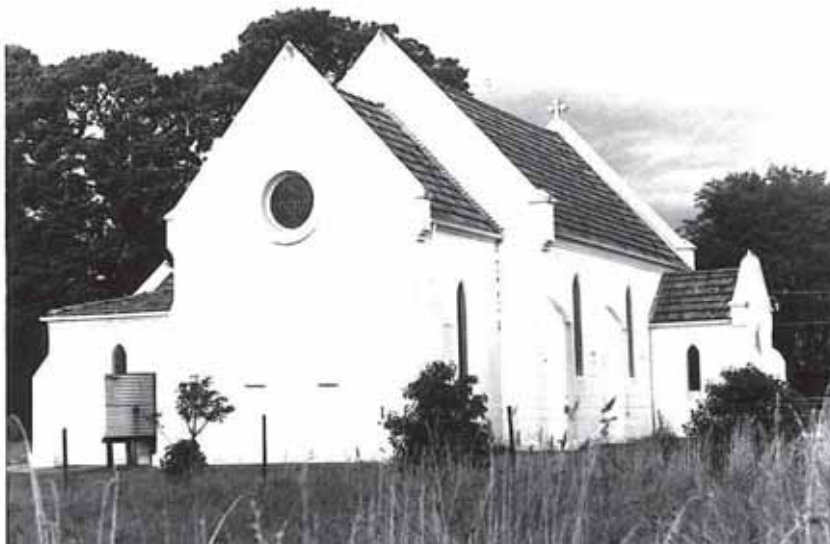
Figure H2. Photo dating to 1984, showing the (later) terracotta tiles on the roof, rear (west) end of the church. Off the chancel was the vestry and a second smaller room, all of which remain in 2015 (SLV).

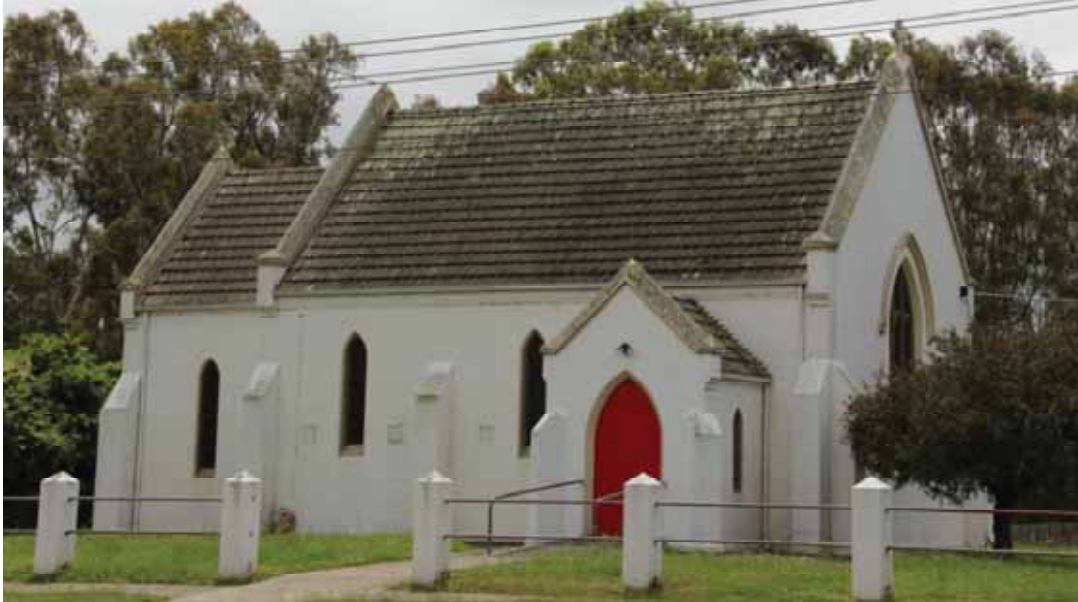
Figure D1. The church is a brick construction, with rendered walls and buttresses, with incised ruled lines to create an ashlar effect. The gabled roof is clad with (later) tiles (replacing the original slate). The entrance porch off the south elevation imitates the details of the nave, with small pointed-arch windows to the sides and a large pointed-arch opening facing south, with timber ledged and framed doors.

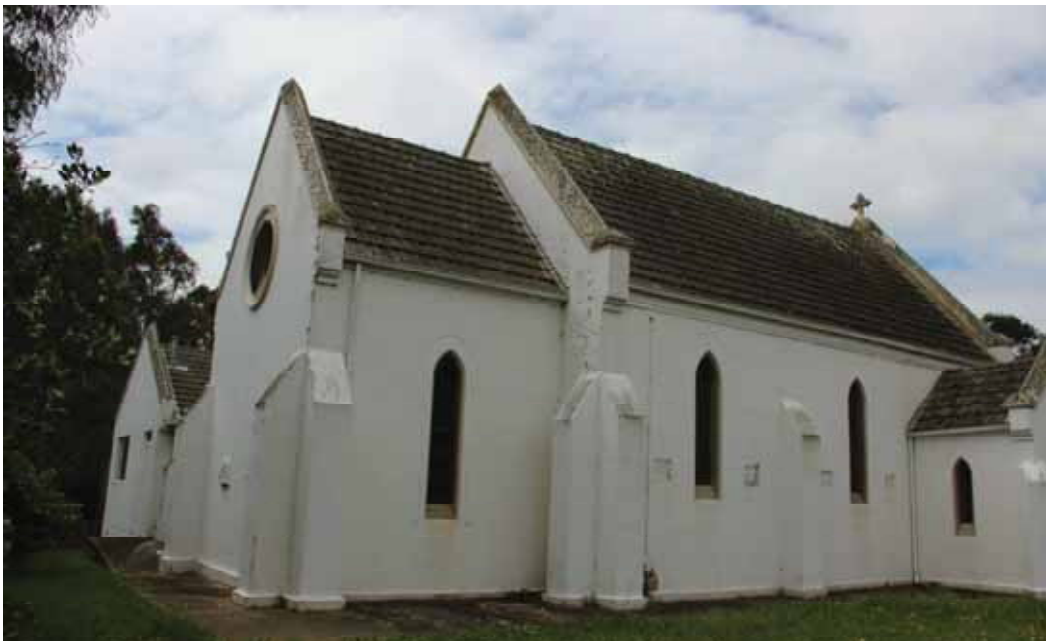
Figure D2. At the west end (rear) of the church is a chancel (constructed 1906) with a gabled roof clad with tiles and the same architectural details as the nave. The west elevation of the chancel has a large round window with leadlight to the gabled end. In the background is the sympathetic modern addition.

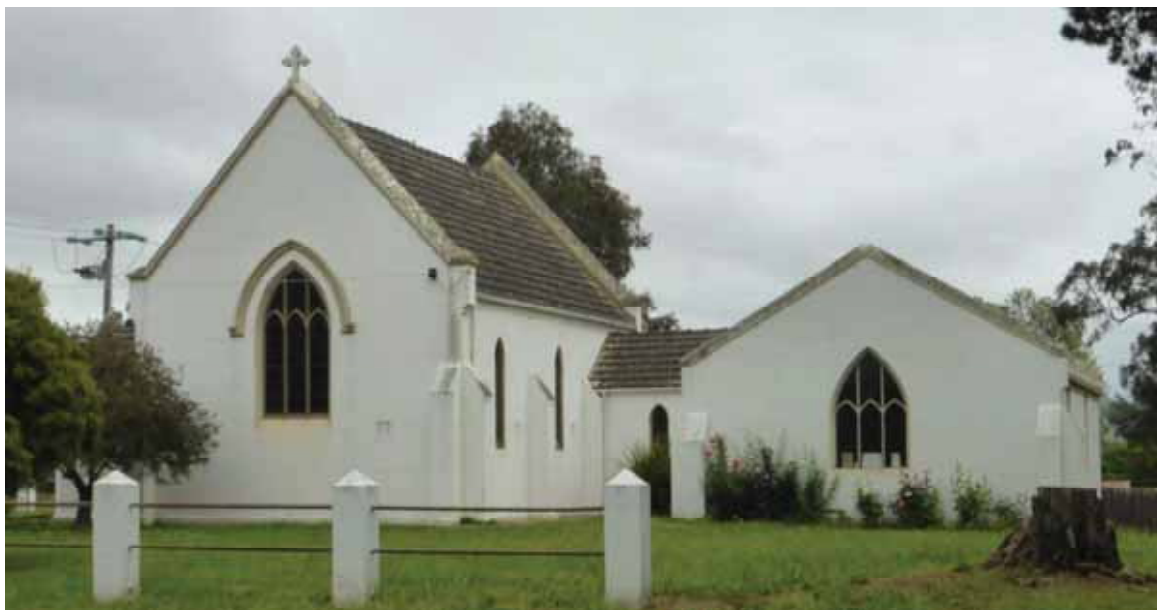
Figure D3. The east elevation of the church and its gabled-end fronts Lyons Street and is the main elevation viewed from this main street. The elevation comprises a large pointed-arch window with a label moulding. To the north of the church is a large hall constructed in a sympathetic style but is clearly a modern addition, with aluminium windows. A cement pier and metal pole fence runs along the south and east boundaries, with an interwar pedestrian gate at the south-east corner

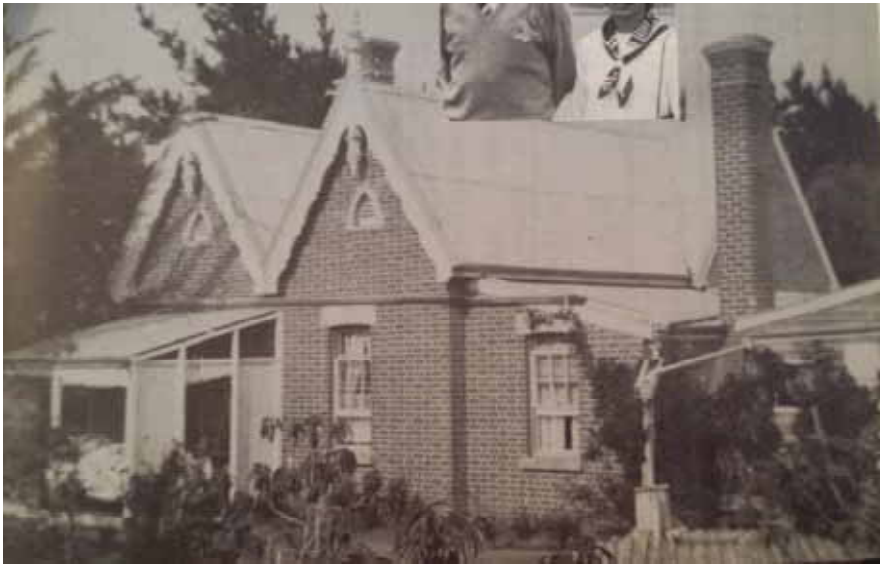
Figure H1. Pre-1988 photo of the east elevation with a car port (left) and skillion roof of the rear (right) of the manse. The roof of the brick house was clad with corrugated iron and had decorative bargeboards and finials to each gable peak (with a pendant below; the finial and pendants since removed). (Hardy 1989:94).

A photo dating to pre-1988 (Figure H1) showed the rear (north) and east elevation (Hardy 1989:94). The roof of the brick house was clad with corrugated iron and had decorative bargeboards and finials to each gable peak (with a pendant below; the finial and pendants since removed). The two windows visible on the east elevation were six-over-six double hung sash windows, with a rendered segmental arch above. A skillion-roofed timber addition was located on the southern end of the east elevation (remains in 2015). The one gabled-end of the rear (north) elevation was evident, with the skillion-roofed section below, which was constructed of the same brick as the main portion of the house and had a very tall chimney (since removed or incorporated into a later addition as the chimney appears to remain; see aerial). One other brick chimneys were visible on the manse (all remain in 2015). There was a weatherboard outbuilding to the rear of the manse. A photo dating to 1988 (Figure H2) showed the facade of the brick manse, as it appears in 2015 (Macreadie 1989:190). The finial to the facade's gable appears to have been removed or lost by this date. The timber skillion-roof additions were evident on the side elevations (remain in 2015).

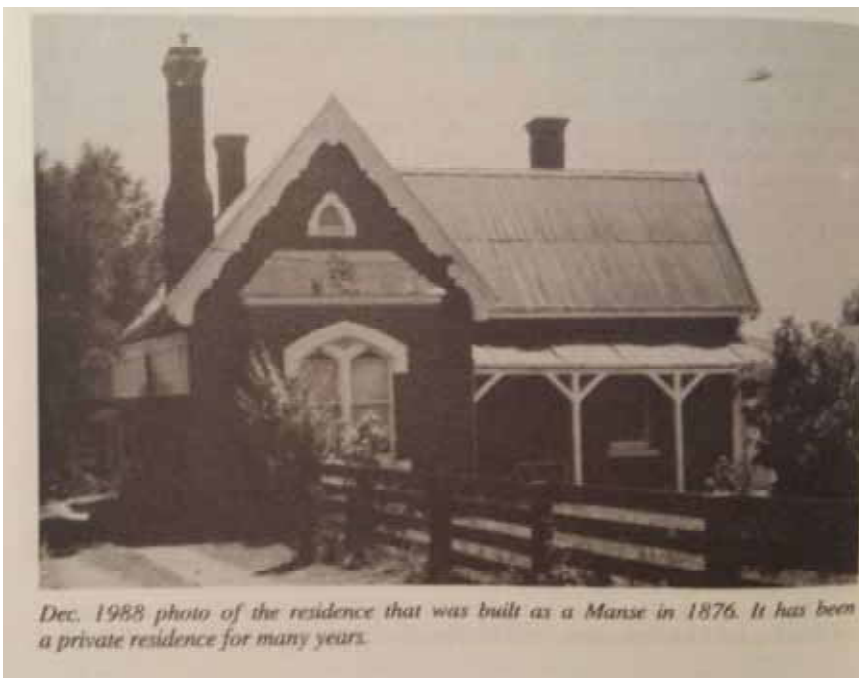
Figure H2. A photo dating to 1988 showing the south-facing facade of the manse. The finial to the facade's gable appears to have been removed or lost by this date. The timber skillion-roof additions were evident on the side elevations (remain in 2015) (Macreadie 1989:190).

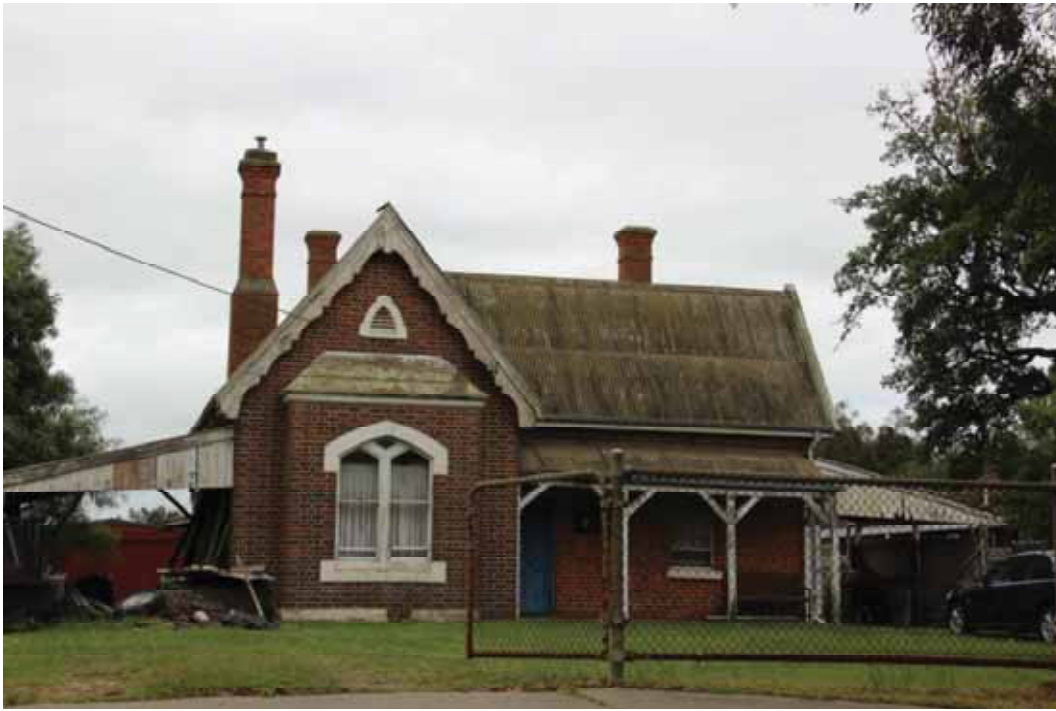
Figure D1. The brick manse has steeply-pitched gabled roofs, clad with lapped corrugated iron. From the street view, it is evident that the recessed portion of the house is constructed of red brick, while the projecting gabled-bay to the left of the facade is constructed of brown brick (this bay probably built in 1891).

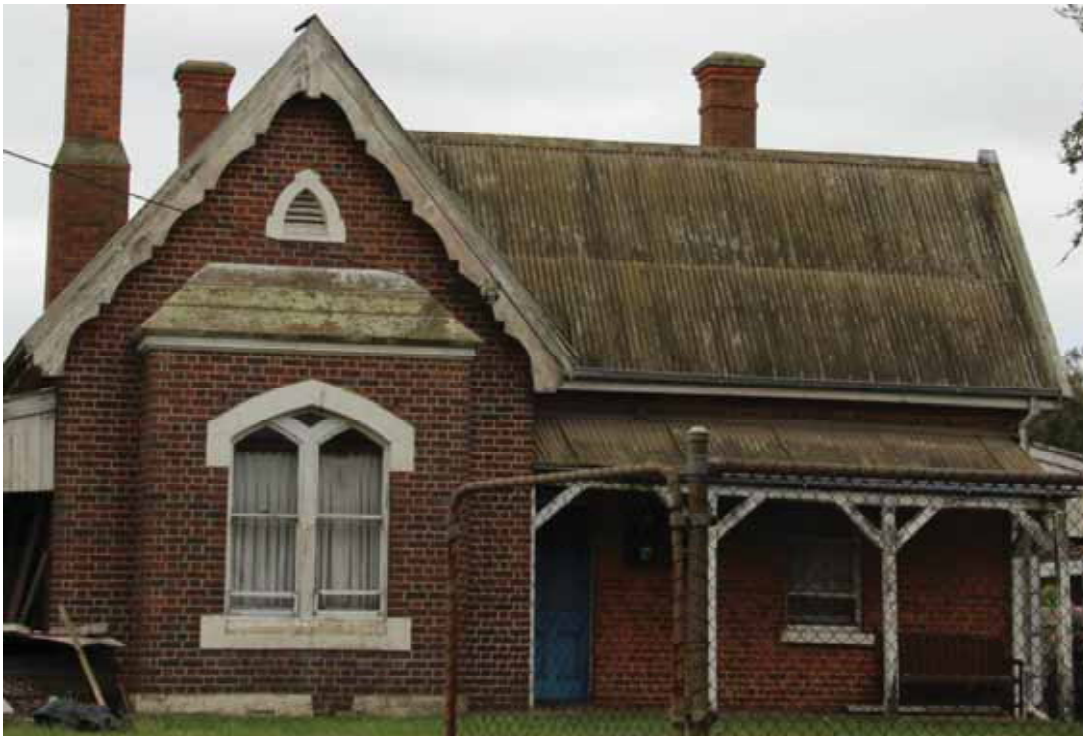
Figure D2. To the left of the facade is the brown-brick projecting gabled bay and to the right of the facade is a skillion-profile verandah clad with lapped corrugated iron, supported by timber posts with simple timber brackets.

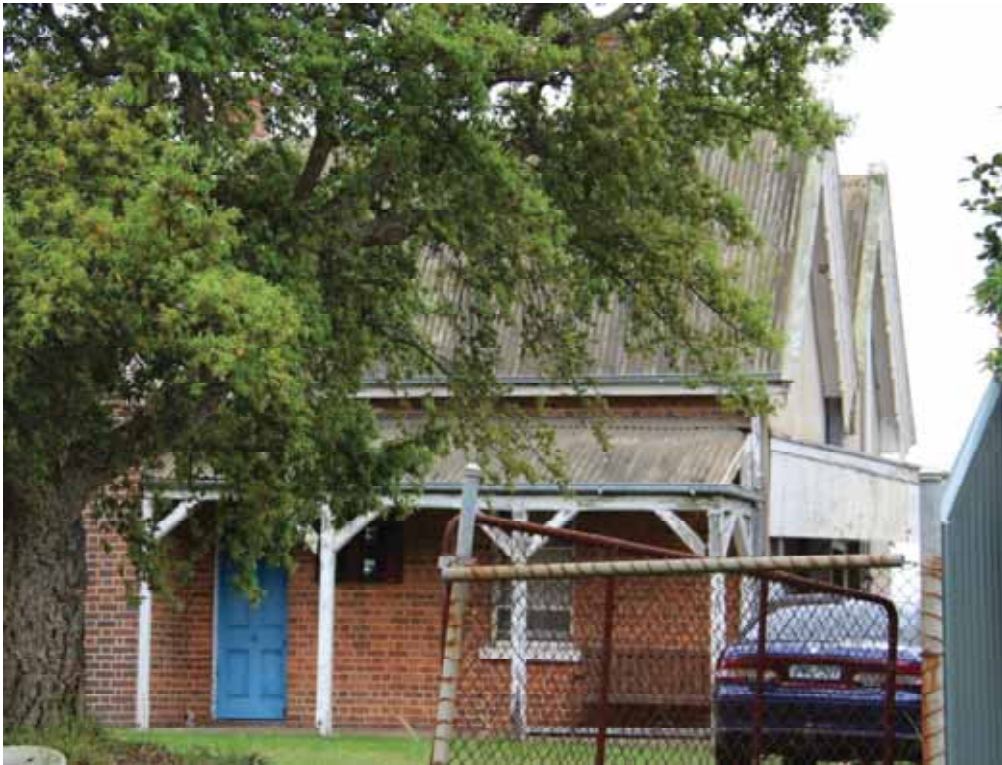
Figure D3. The two transverse gabled-ends of the east elevation have decorative bargeboards and what appears to be a render or plain cladding to the gabled-ends (previously face brickwork see Fig H1).

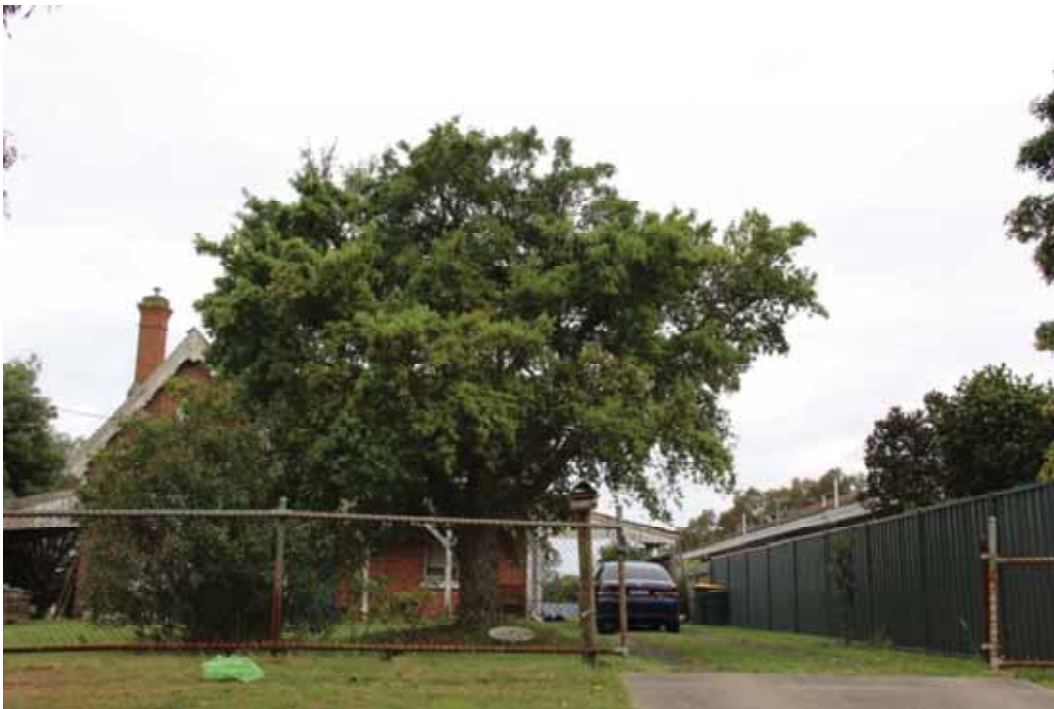
Figure D4. In the front yard is a mature Cork Oak (*Quercus suber*) that dates to c1900. It is an impressive example of the variety.

In 2015, the front (south) boundary is lined with a metal pole and chain-wire fence with vehicular gates. A mature Cork Oak (*Quercus suber*) remains in the front yard, and dates to c1900. It is an impressive example of the variety (Hawker 2016).

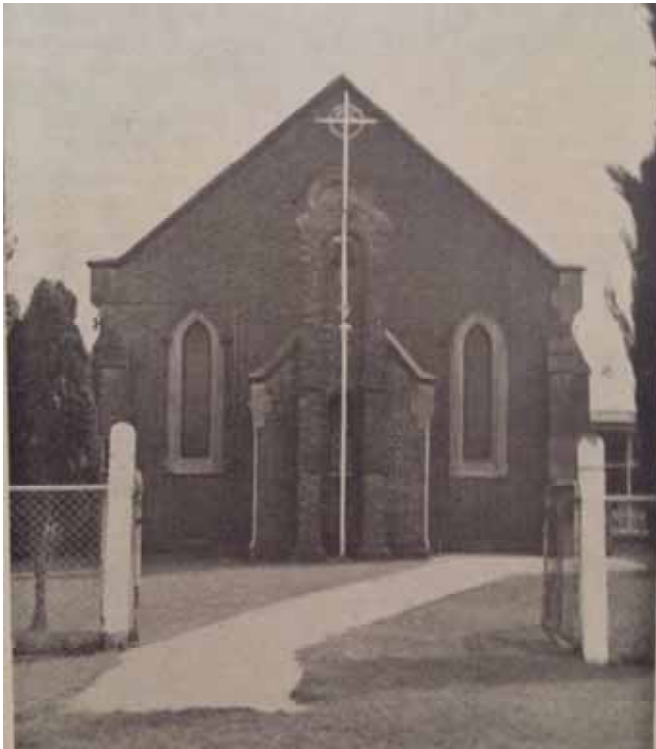
Figure H1. Photo dating to pre-1971 photo that showed the facade. The decorative render remained unpainted at this date. An immature cypress was evident inside the left (west) of the gate, while a mature one was growing inside the fence to the right (east) of the gate (remain in 2015) (Maddern 1971:82).

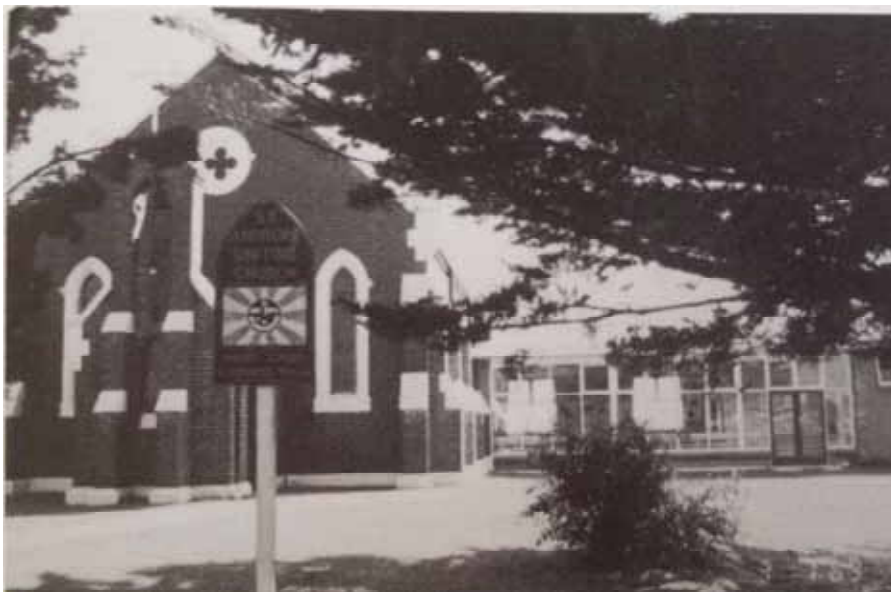
Figure H2. A photo dating to 1987 that showed the facade, with the decorative render painted bright white. The 1960s addition was evident to the east of the church and in the foreground a mature pine is partly visible (since removed; probably the large stump which remains in 2015) (Hardy 1989:96).

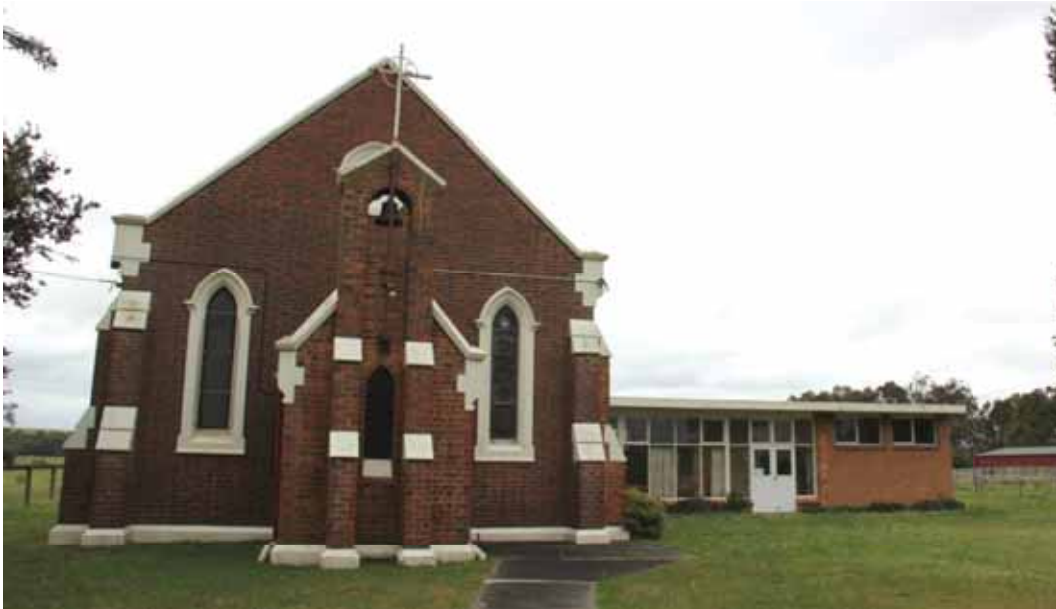
Figure D1. The church is constructed of handmade brown-bricks with a rendered plinth and rendered dressings and coping to the parapeted gables, buttresses and window surrounds. The façade has a central entrance porch which also serves as a bellcote. Attached to the rear of the east elevation is a c1960s cream brick hall.

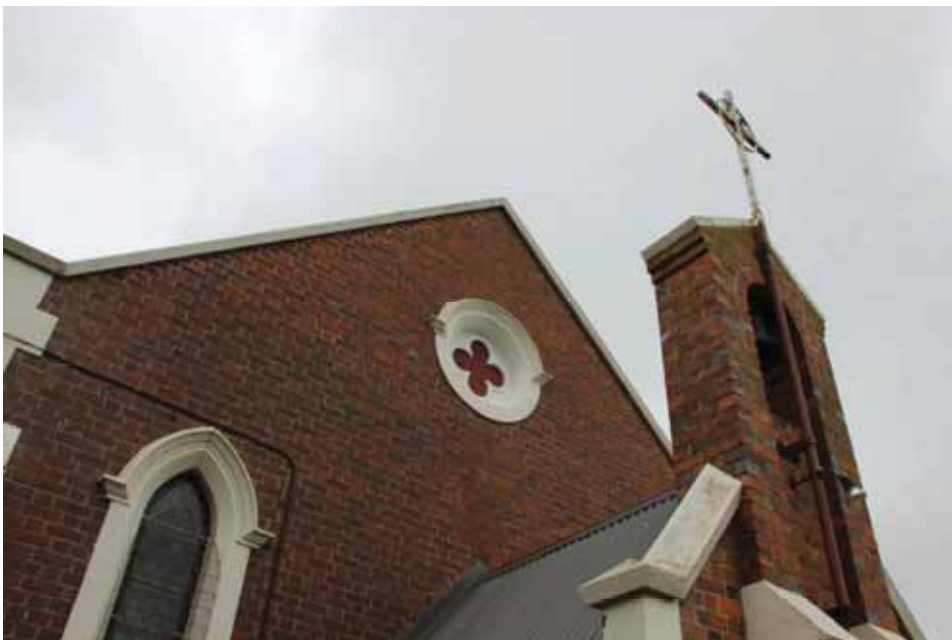
Figure D2. The façade has a round niche with a quatrefoil motif to the gabled-end. Flanking the entrance are two pointed-arch windows with rendered, moulded frames, with labeling moulds above. All the windows have either pictorial or diaper-patterned leadlight.

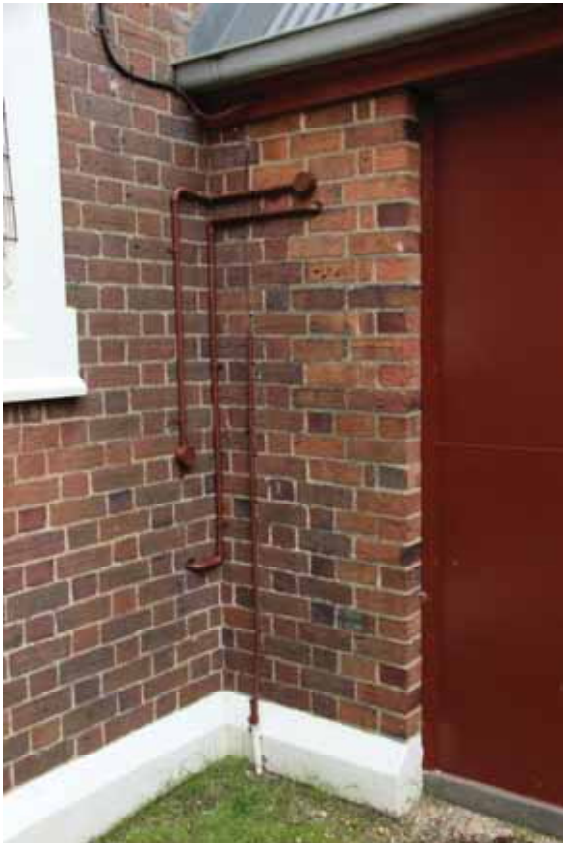
Figure D3. The entrance porch is constructed of a different coloured (lighter) handmade brick, which is keyed in to the brown brick of the nave.

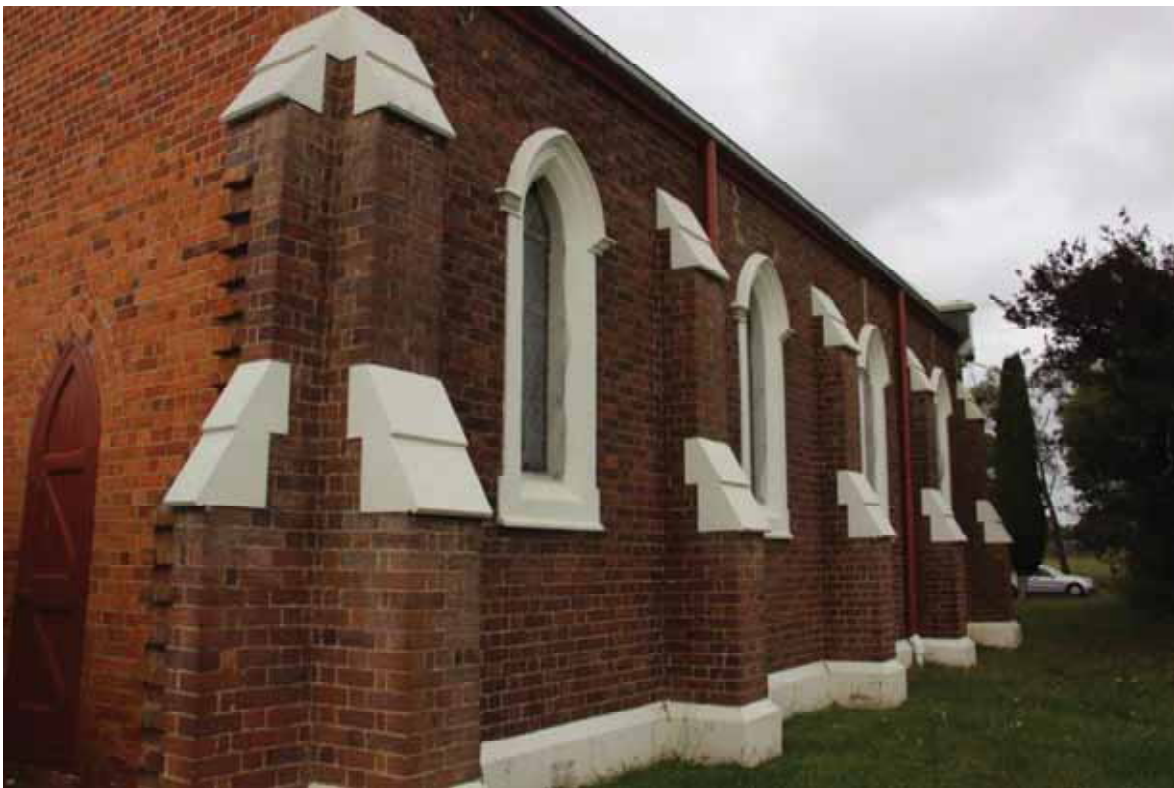
Figure D4. The west elevation. The side elevations are broken into four bays but buttresses, each bay with a single window like those of the façade.

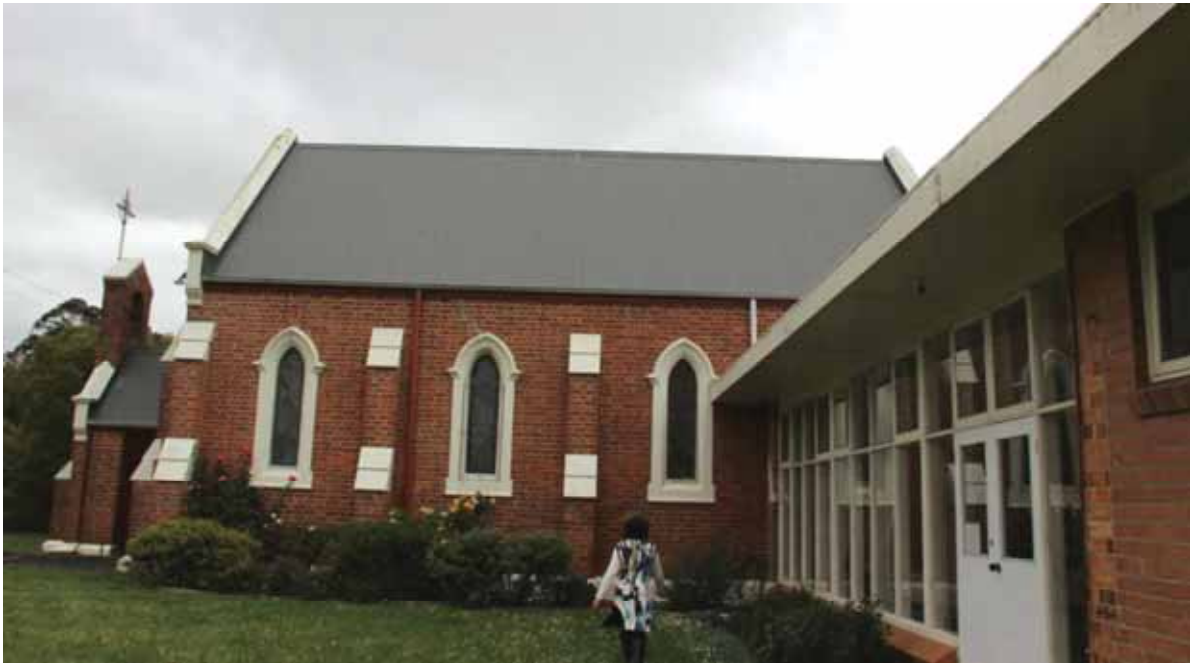
Figure D5. The east elevation. Three bays of the east elevation are visible. The c1960s cream brick addition adjoins the church in the fourth bay, at the rear of the church.

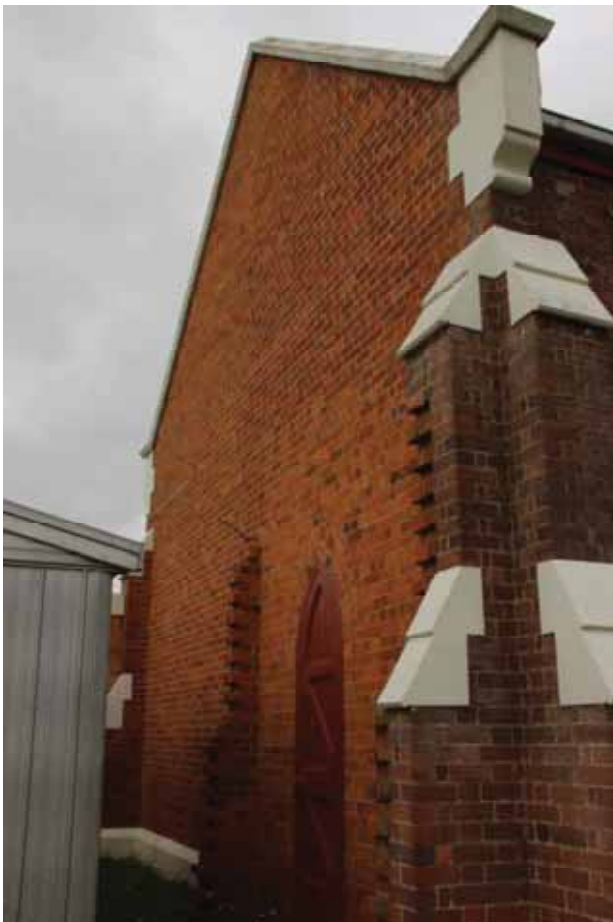
Figure D6. The rear (north) elevation is of red brick. Keyed bricks remain on the right side, that were ready for an extensions that never eventuated. The space in between the keyed bricks has a pointed-arch opening with a timber ledged and framed door.

In 2015, the church serves as St Andrews Uniting Church. The rear (north) elevation of the church retains brickwork keys anticipating an addition that wasn't constructed.
