Locality:	YARRAM
Place address:	5 BUCKLEY STREET
Citation date	2016
Place type (when built):	Church, Presbytery
Recommended heritage protection:	Local government level
	Local Planning Scheme: Yes
	Vic Heritage Register: No
	Heritage Inventory (Archaeological): No
Place name:	St Mary's Catholic Church and Presbytery

Architectural Style:	Federation Romanesque and Post War Romanesque Revival (church); Postwar Moderne (presbytery)
Designer / Architect:	A. A. Fritsch (church)
Construction Date:	1915, 1960s (church); 1954 (presbytery)

Locality: YARRAM
Place address: 2-4 CHURCH ROAD
Citation date 2016
Place type (when built): Mechanics Institute
Recommended heritage protection: Local government level
Local Planning Scheme: Yes
Vic Heritage Register: No
Heritage Inventory (Archaeological): No

Place name: Yarram Soldiers' Memorials

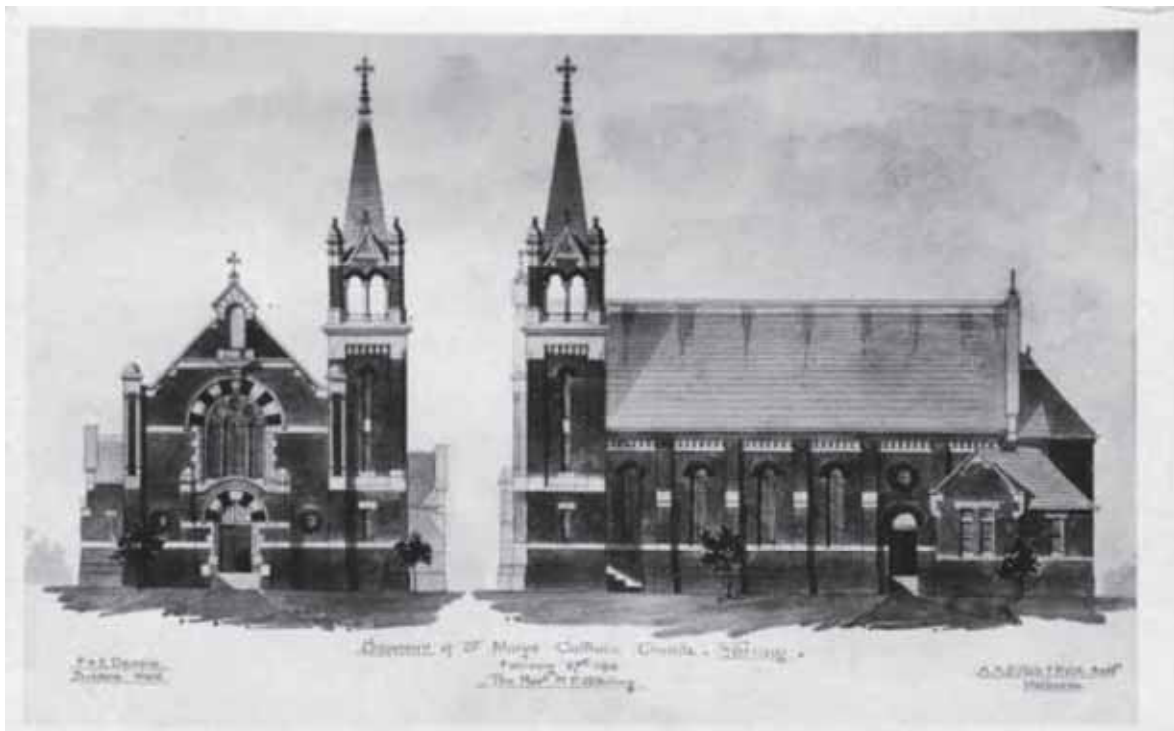
Figure H1. A souvenir postcard dating to the opening of the church on 27 February 1916, showed Fritsch's architectural drawings of the church at its intended full extent. The sketch showed the facade of the church and entrance (as built) with the tower (the base of which was initially built) with a different spire as to what was later constructed (SLV, Image No: pc000175).

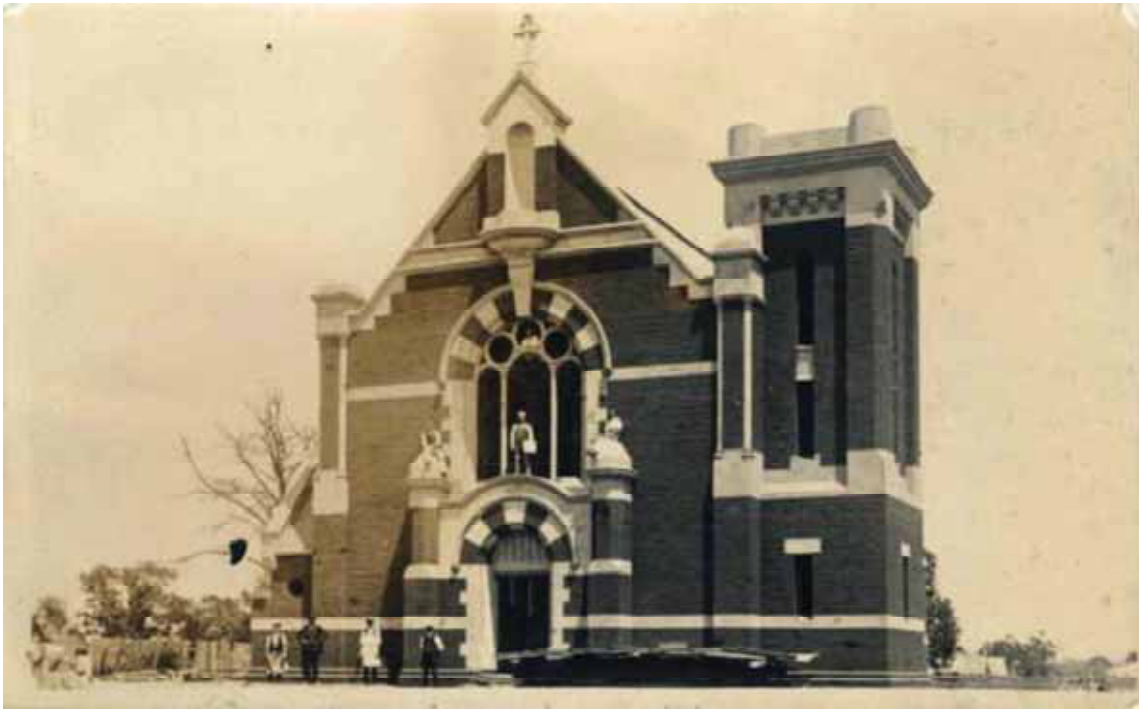
Figure H2. An early photo (c1915) showed people posing in front of the church, and on top of the entrance porch, even looking out of the window where the glass had apparently not yet been installed. The statue of the Virgin Mary has not been placed in the niche. The spire of the tower had not yet been constructed (SLV, Image No: pc000176).

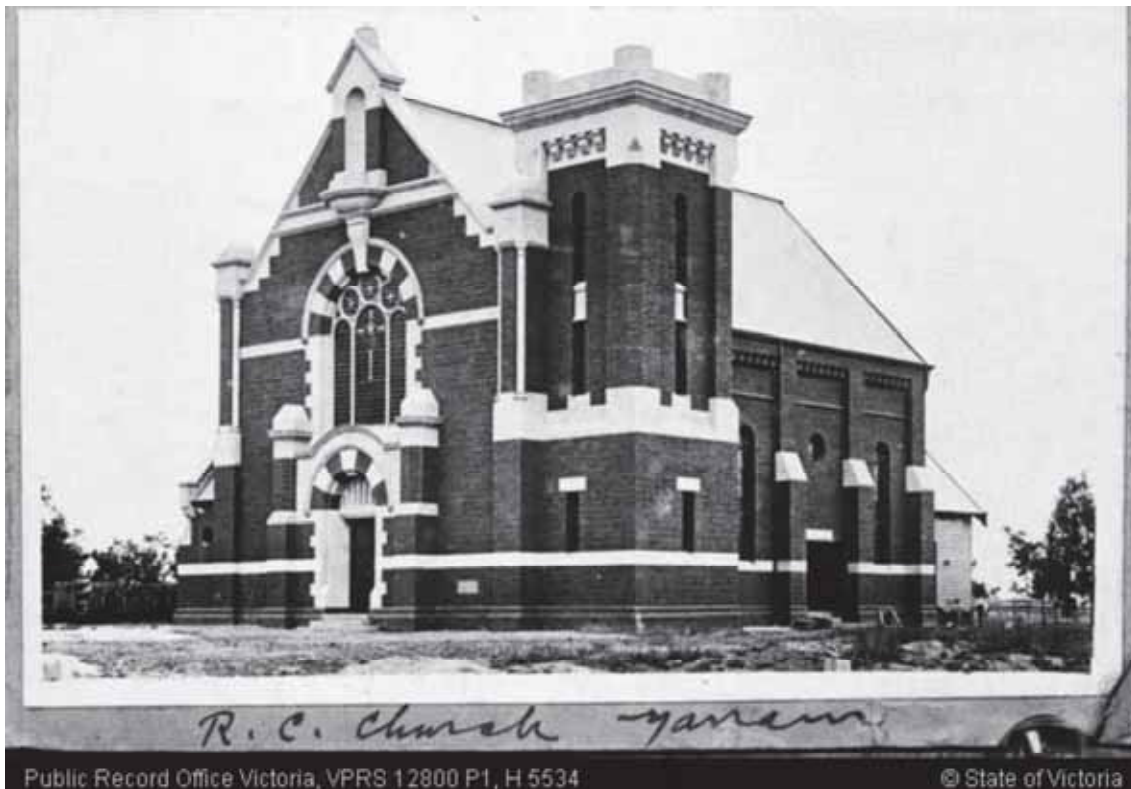
Figure H3. A second early photo (c1916). The original stained glass arrangement in the large window was evident (since replaced). The statue of the Virgin Mary has not been placed in the niche. The nave consisted of five bays, with a timber addition constructed at the apse end (PROV VPRS 12800 P1 H 5534).

A second early photo (c1916; Figure H3) showed the original extent of the church (PROV). The facade and north elevations were evident in the photo. The original lead light arrangement in the large window was evident (since replaced). The nave consisted of five bays, with a timber addition constructed at the apse end. The fourth bay on the north elevation comprised a small round window above an entrance door (a small room was later constructed off this bay).

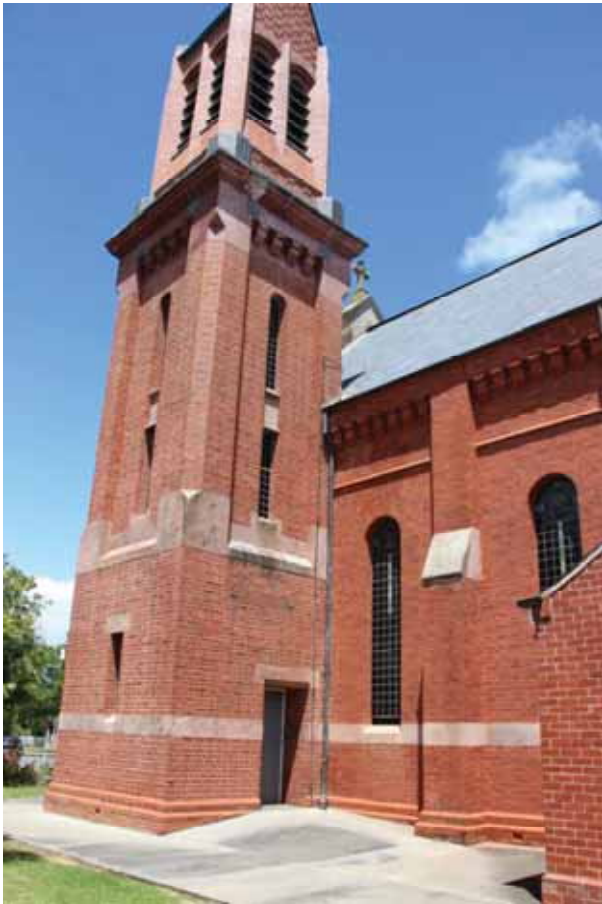
Figure D2. The gabled-roof is clad with slate, with a row of bold brackets at the eaves on the side elevations. The extent of the 1915 building comprises the five bays to the side elevations.

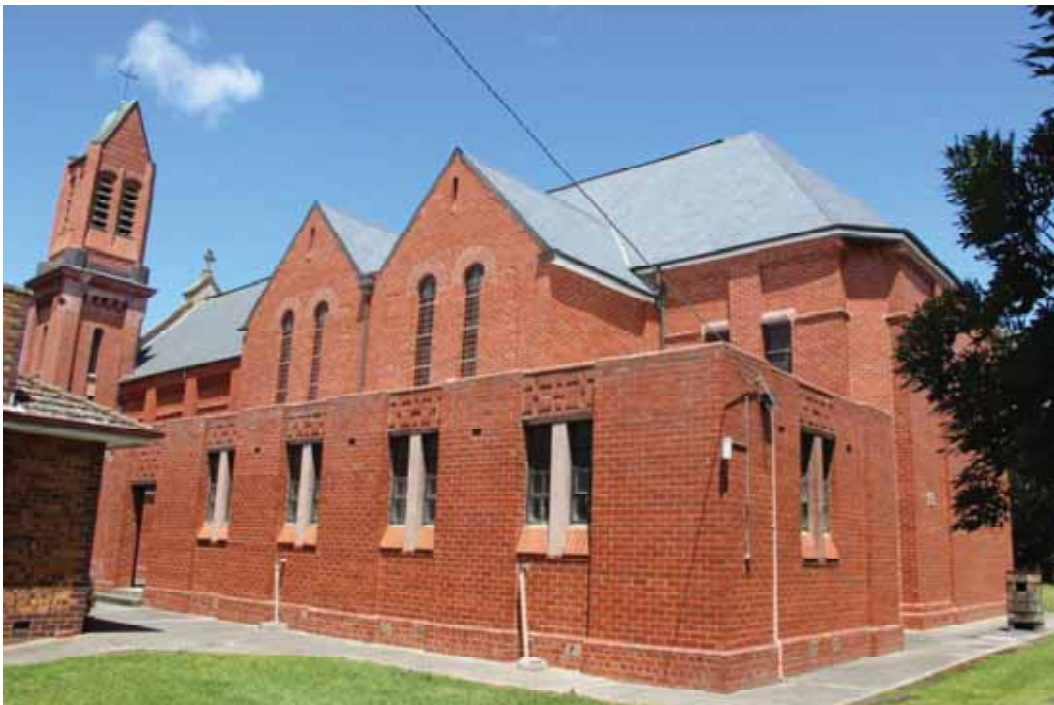
Figure D3. The north elevation. To the rear of the 1915 church, at the west end, is very large brick addition constructed in the 1960s. This later addition is identifiable by the later brickwork and single-tiered brick plinth. The 1960s addition comprises the tall double-gabled transepts, the chancel end, and the flat-roofed addition off the north elevation.

The 1915 church is in very good condition and retains a high level of integrity, and the 1963 additions are in excellent condition and have a very high level of integrity.

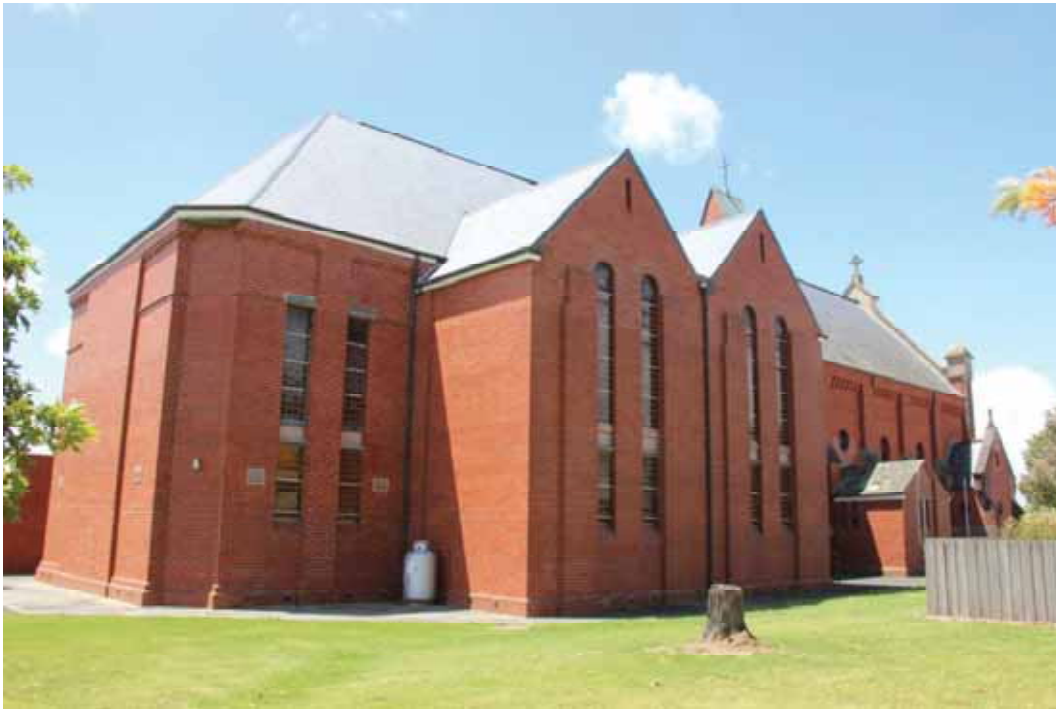
Figure D4. The two smaller gabled-roof rooms projecting off the centre of the side elevations were also constructed in the early 1960s.

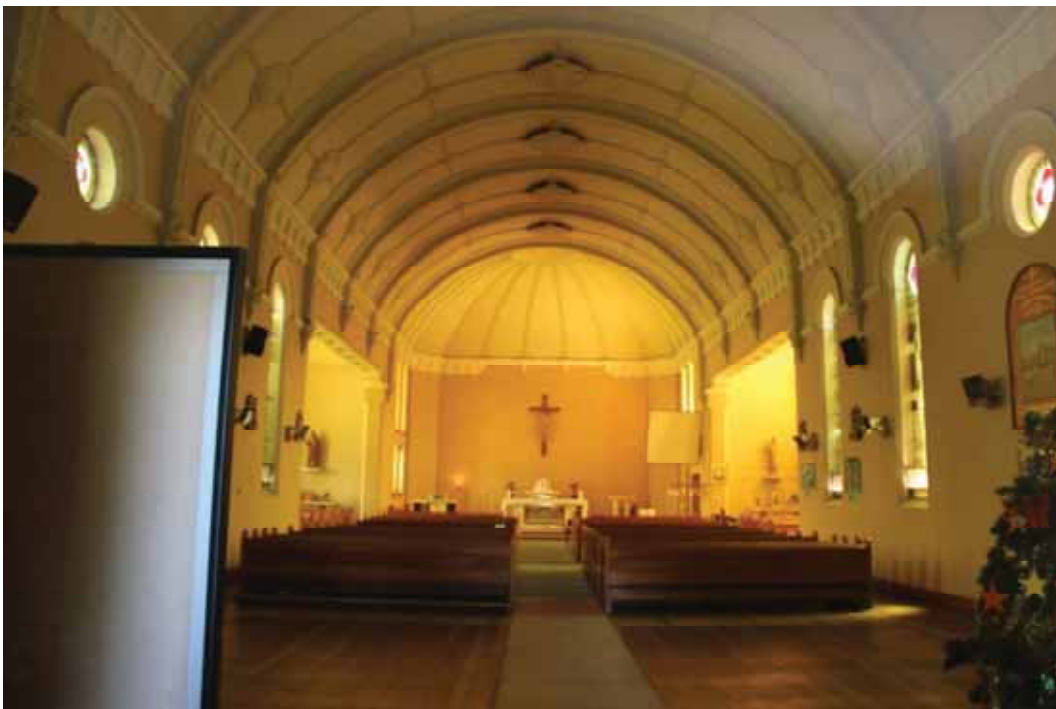
Figure D5. The interior of the church has a large barrel-vaulted ceiling lined in plaster. The 1915 extent of the church extends to the round-arched windows. The interior space and historic finishes of the interior are imbued with the rituals and aesthetics associated with worship, marriages, christenings, confirmation, and funerals.

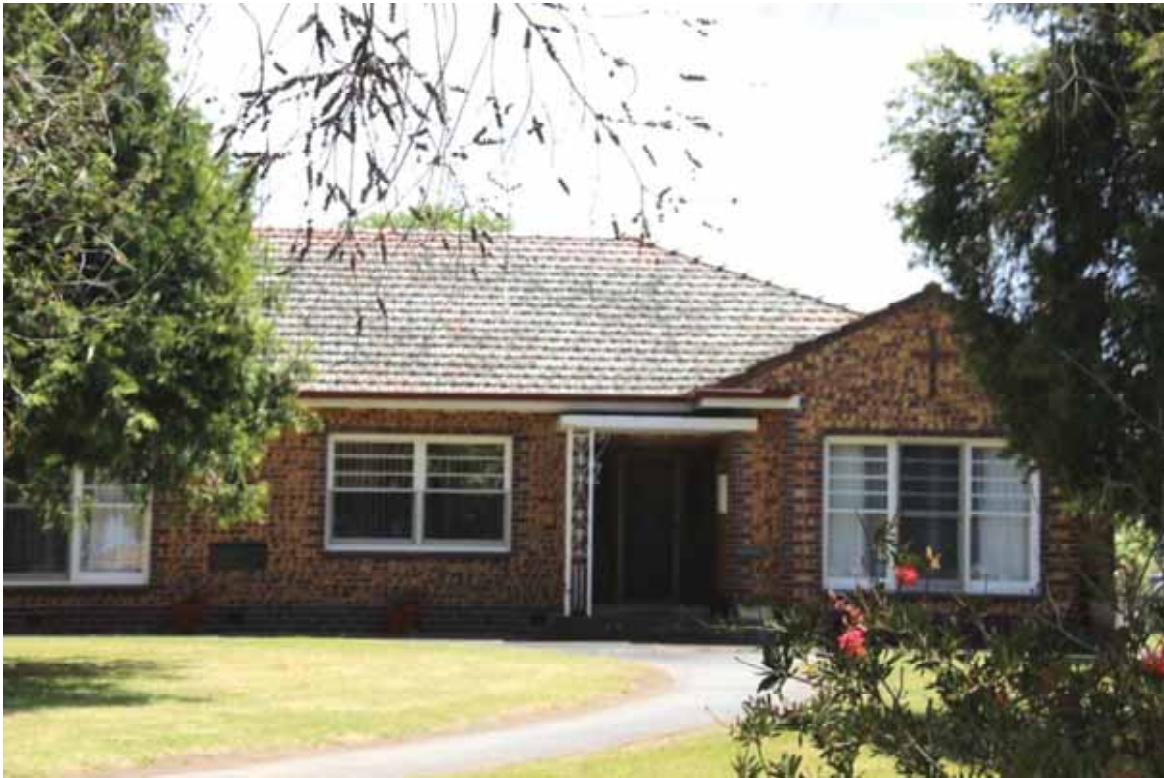
Figure D6. The large presbytery is constructed of tapestry bricks with dark brick quoining to the corners and openings, and a dark brick plinth. The shallow-pitched hip-and-gabled roof is clad with terracotta tiles. The house has groups of windows with a horizontal emphasis, each with horizontal glazing bars to the top sashes.

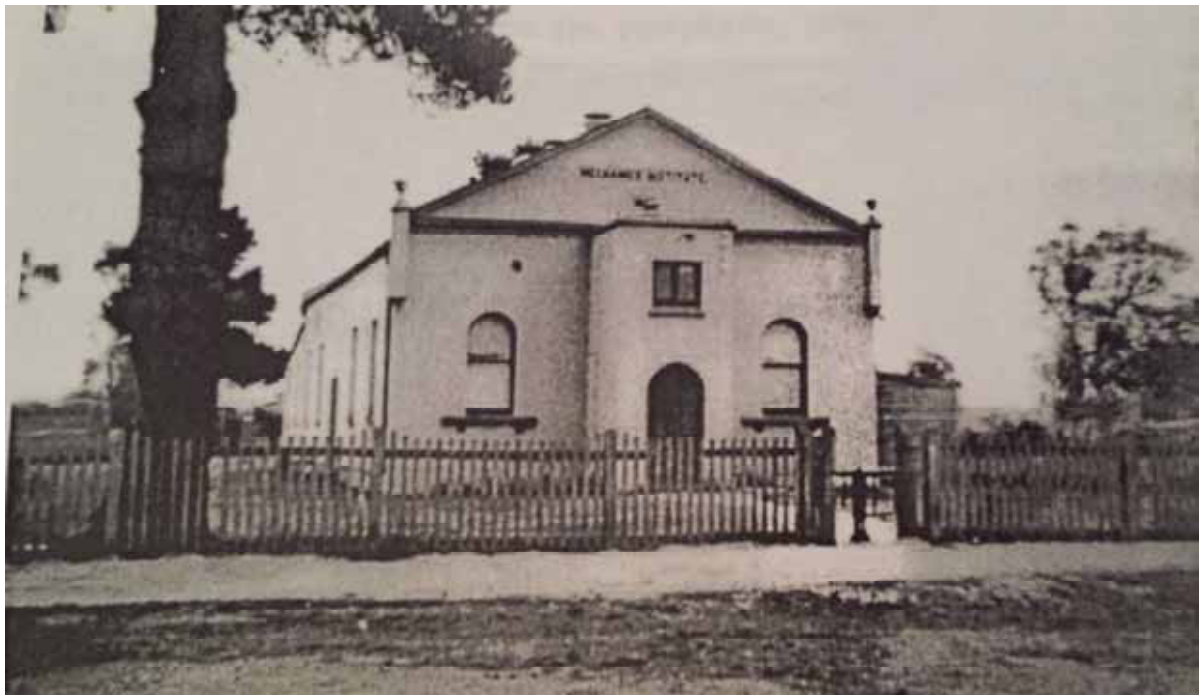
Figure H1. An early photo (exact date not known) of the hall with its entrance porch on the facade, (Note the porch appears to have been altered at the top, to accommodate a biobox for movies, but the whole structure was removed, filled in, and a new entry placed on the south-east elevation in 1973) (YDHS heritage trail).

As can be seen in a plan of the original building (Figure H2), the front entrance was through a narrow porch, but additional entrances with double doors were also located on the side elevations. The hall was renovated and the main entrance moved to the south-east elevation in 1972 (with the original entrance porch removed) (YDHS; Baragwanath & James 2015).

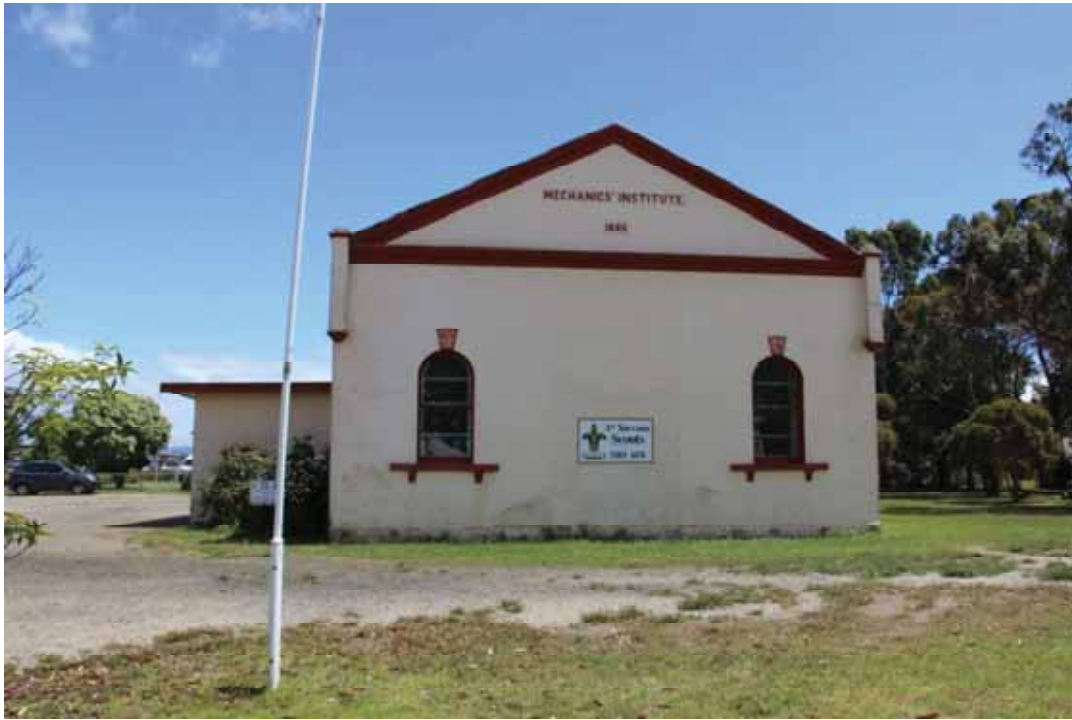
Figure D1. The facade of the hall which faces the South Gippsland Highway. The bold parapeted gabled-end is framed by a bold moulding, creating a pediment effect. The original front door and porch have been removed.

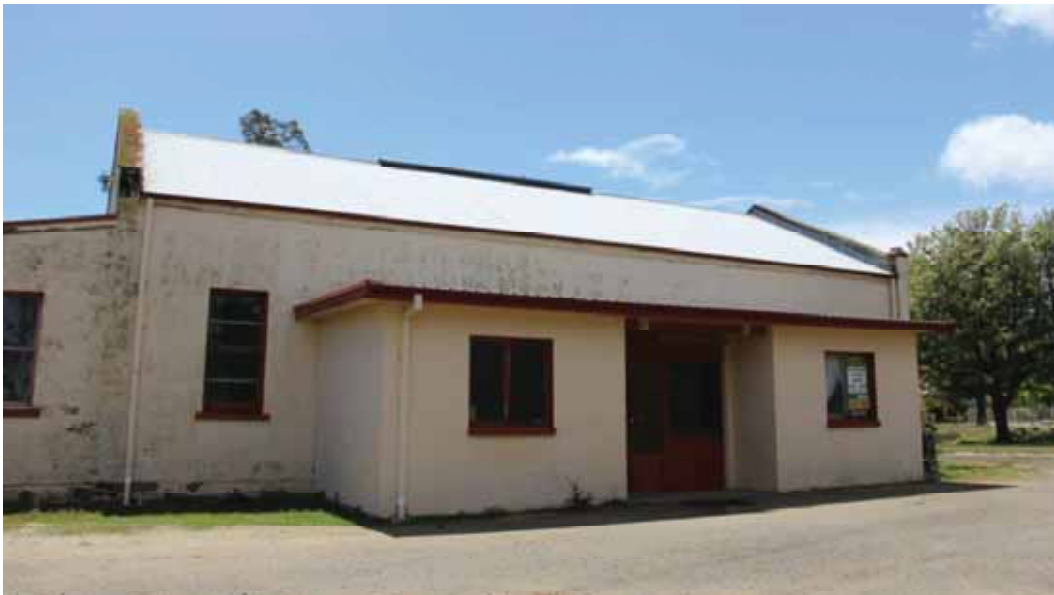
Figure D2. The south-west elevation with the 1973 entrance porch (not significant).

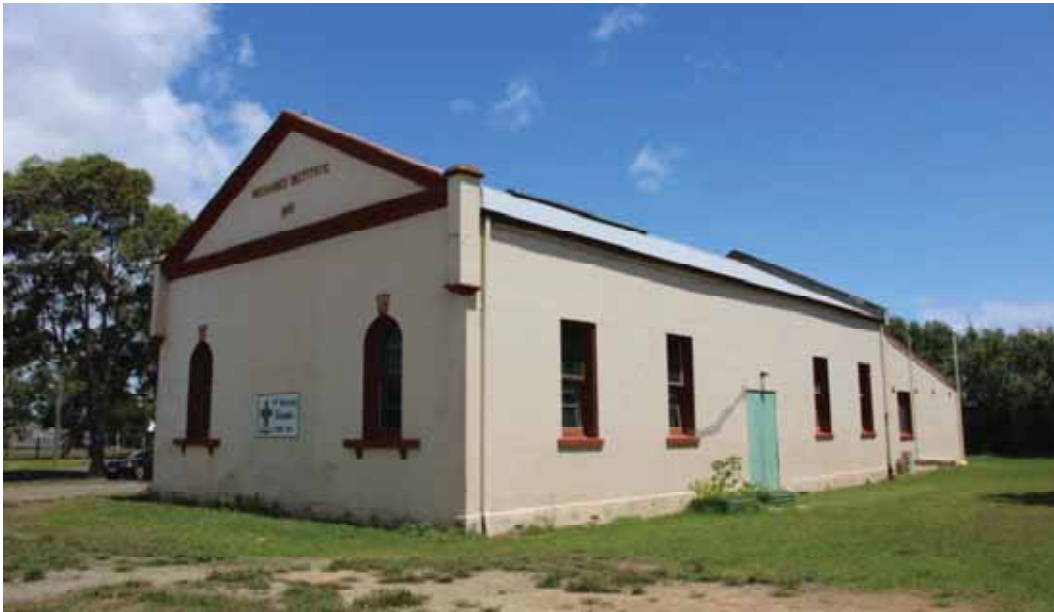
Figure D3. The north-east elevation has four timber windows and a central entrance.

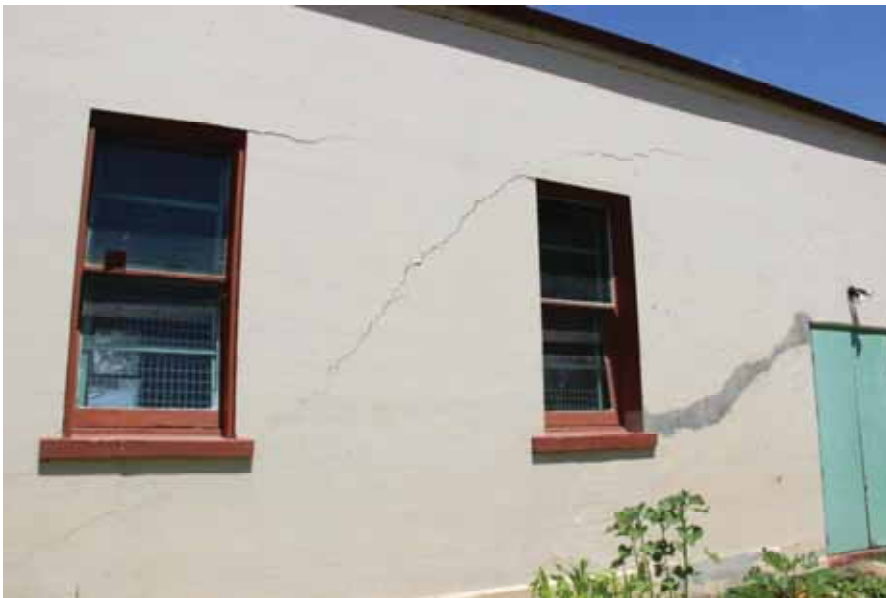
Figure D4. A detail of the windows on the north-east elevation, which are (later) timber windows. Note the cement repairs of a large crack.

- 5.1. Mortar. Remove the cement patch repairs in the mortar and render, and repair with lime mortar in the brickwork. Traditional mortar mixes were commonly 1:3 lime:sand.

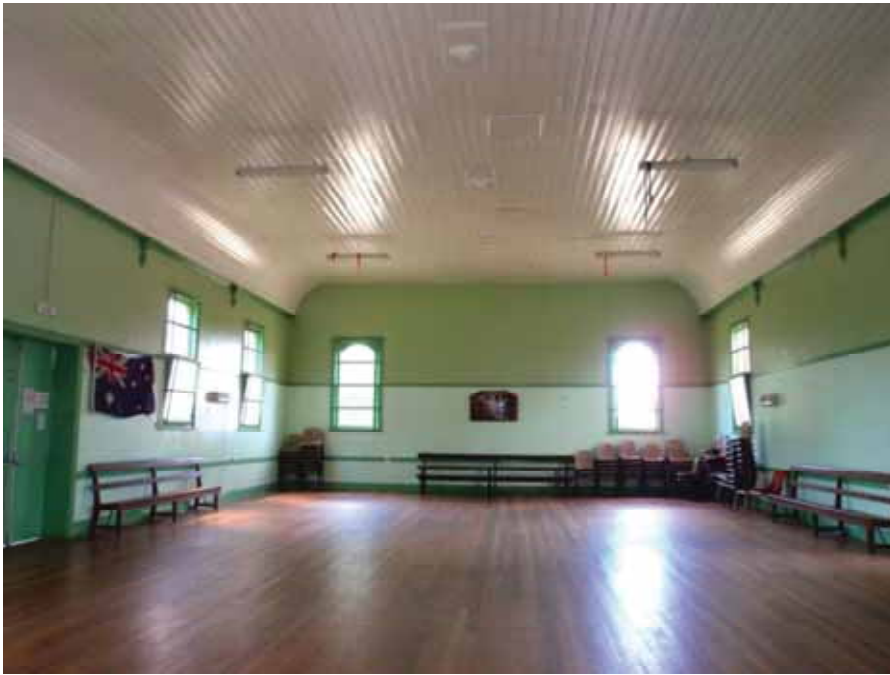
Figure D5. View of the interior looking towards Church Street (where the front entry door has been blocked up). Note the timber panelled coved ceiling, picture rail moulding and classical consoles.

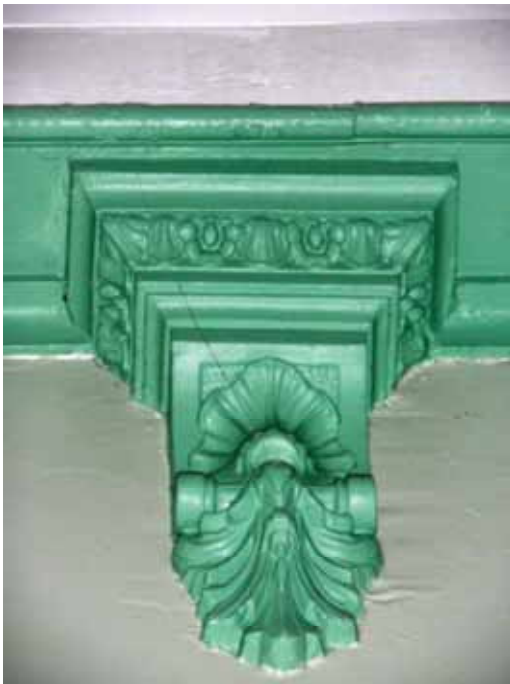
Figure D6. Detail of console decoration inside.

Figures D5 & D6. View of the interior looking towards Church Street (where the front entry door has been blocked up). Note the timber panelled coved ceiling and classical consoles.

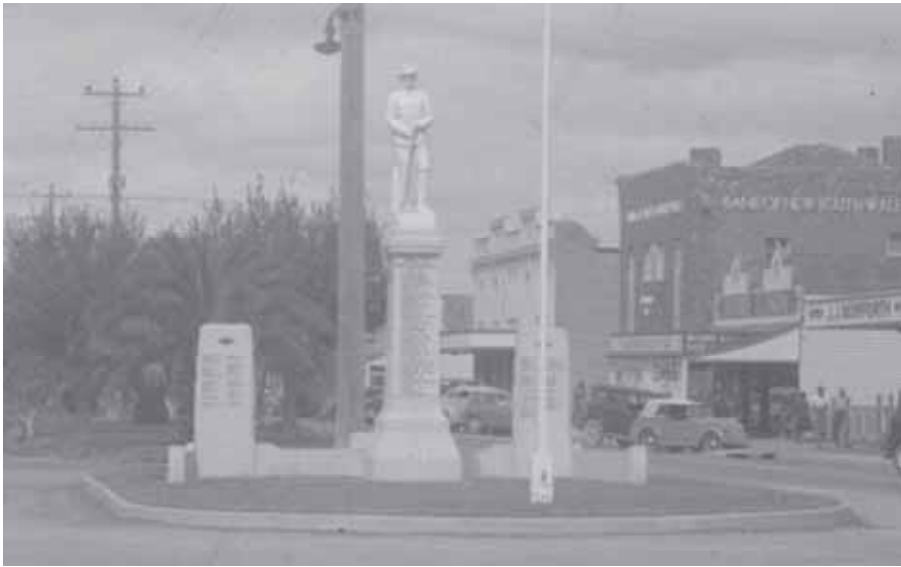
Figure H4. Photo dating between 1947 and 1954, after the erection of the World War II Soldiers' monuments (SLV).

A photo dating between 1947 and 1954 (Figure H4) showed that the World War II memorial (two pillars connected by the low wall) had been erected by this date. At this time the monument was sitting in a grassed area of concrete kerbed reserve with no other landscaping and no fence. A photo dating to c1969 (Figure H5) showed that the memorial and road reserve remained unchanged since the 1947-1954 photo (SLV).

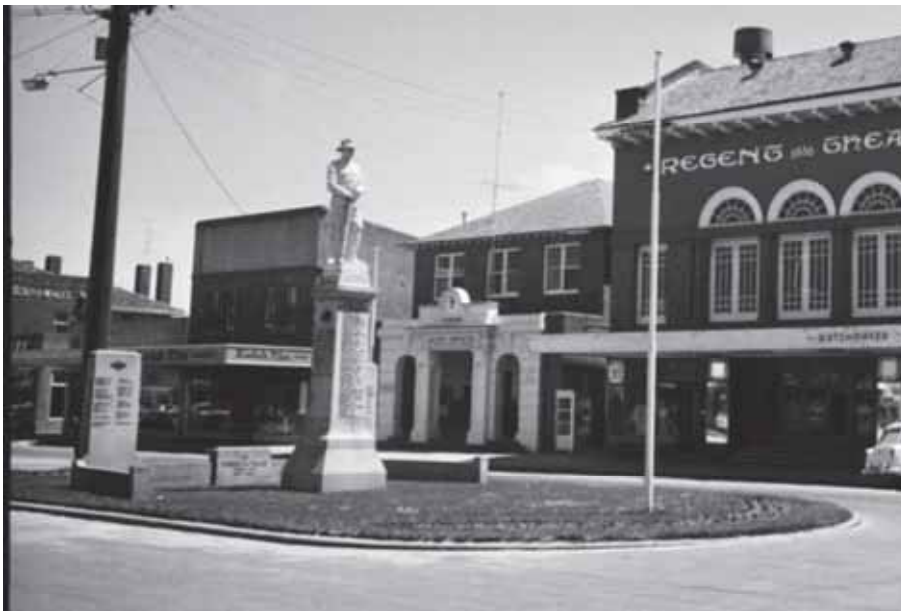
Figure H5. The memorial c1969 (SLV).

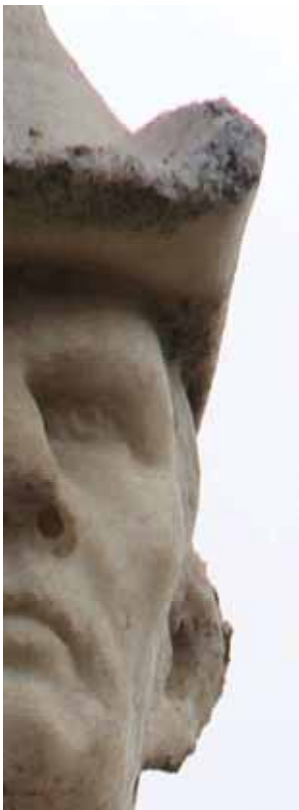
Figure D1. Detail of the damaged 'sugary' surface of the digger, particularly visible in this photos, on the edges of the hat and ears.

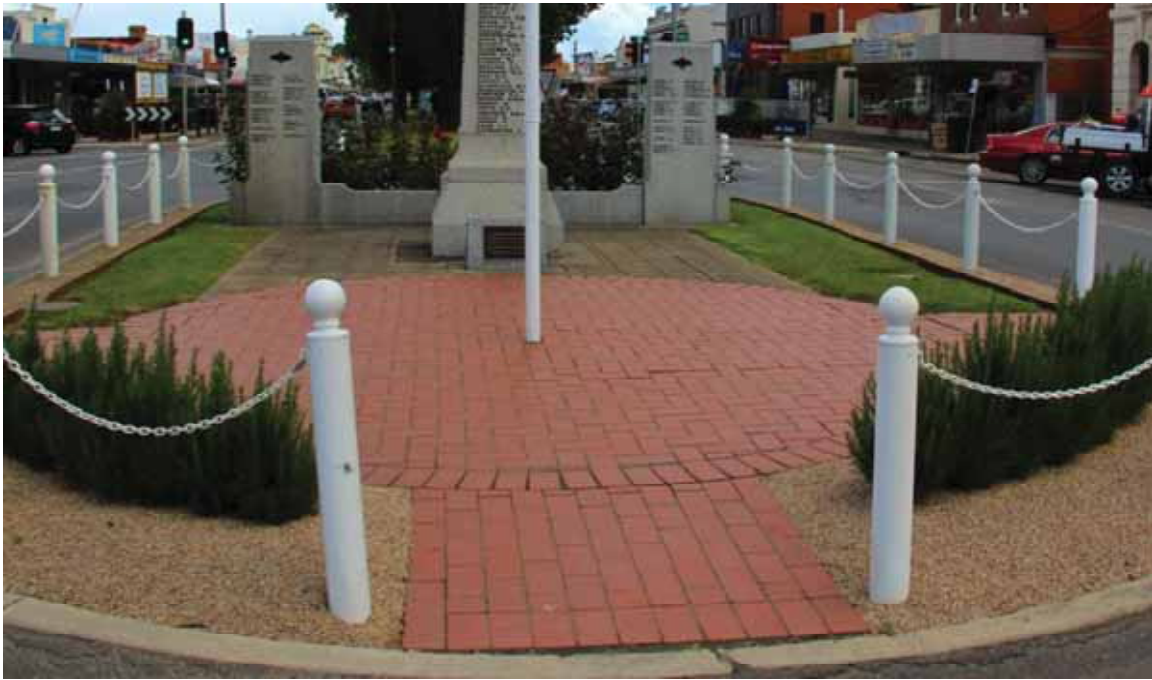
Figure D2. Detail illustrating the inappropriate dominance of the large area of 'recent' red brick.

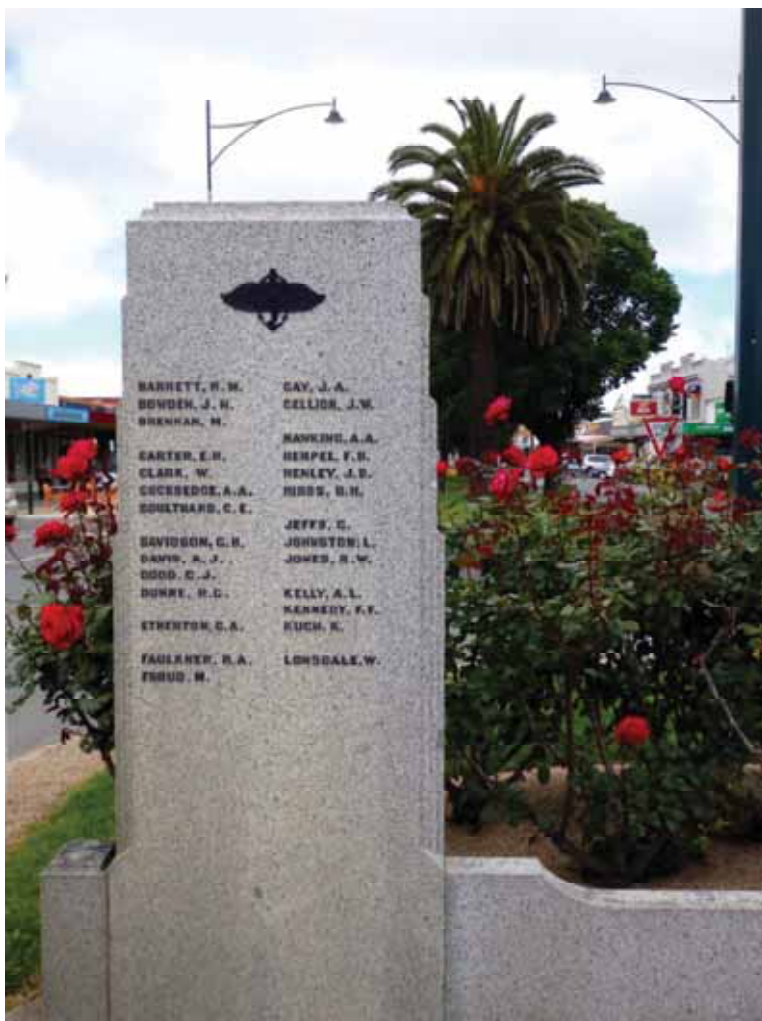
Figure D3. Illustrates the design of the WW2 monument, good condition of the polished granite, and black painted hand cut, lead lettering.

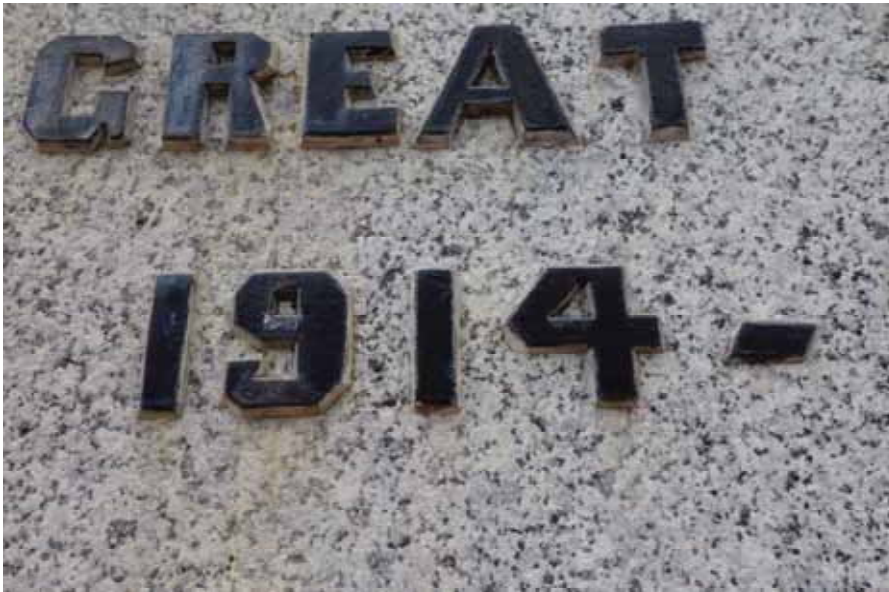
Figure D4. Detail of the polished granite surface, and hand cut black painted lead lettering, all in excellent condition.

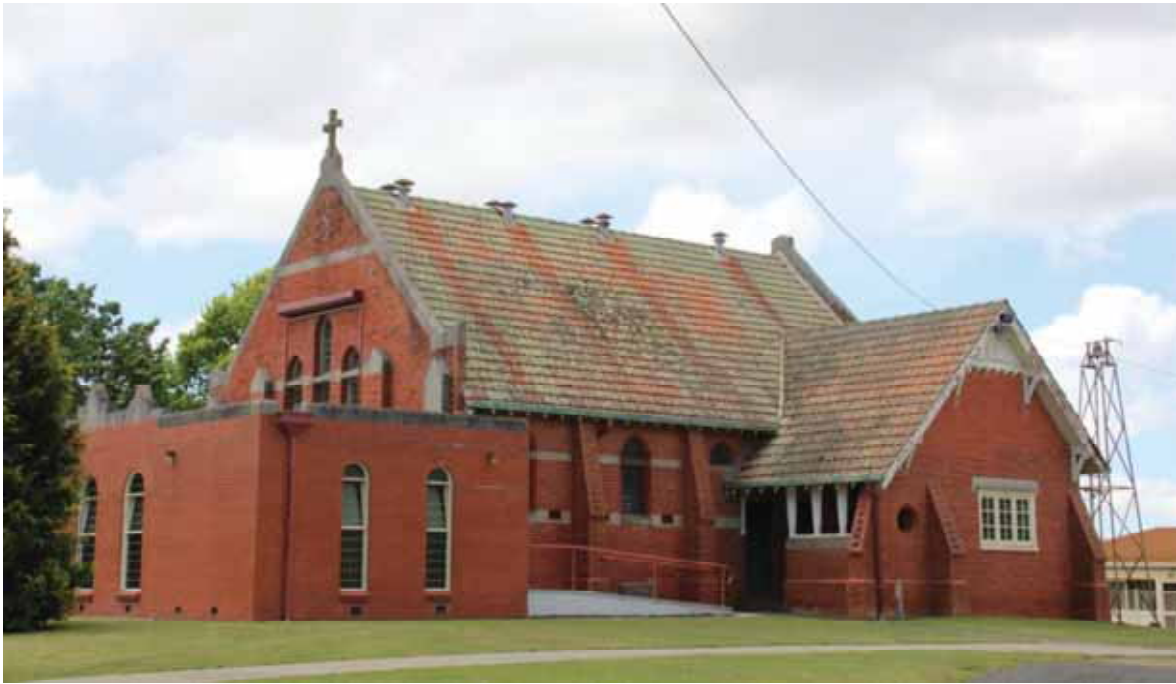
Figure D1. The church is constructed of tuck pointed red brick, with a tall brick plinth, a steeply-pitched roof clad in terracotta tiles (with lichen) and rendered parapeted gables. Round metal vents are located along the ridge of the roof. At the rear of the southern elevation is a large gabled-roof porch, built in 1918. A modern single-storey flat-roofed narthex has been added to the facade of the building.

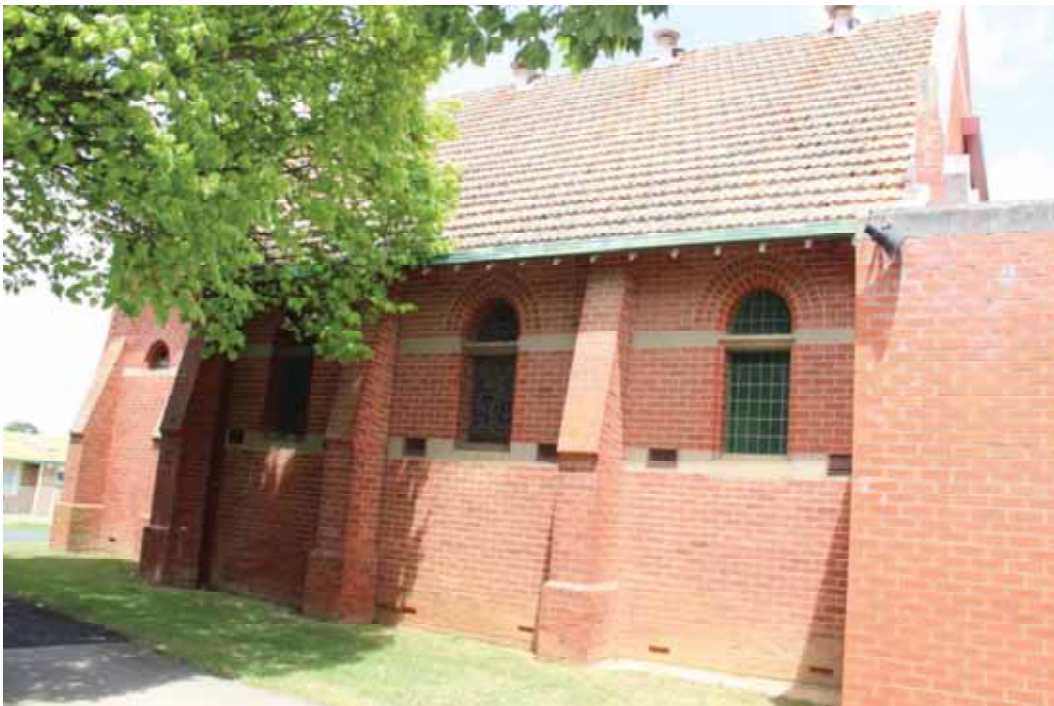
Figure D2. The north elevation. The side elevations are broken into bays by wide brick buttresses. The bays have a single (slightly pointed) arched window with three rows of bricks voussoirs radiating above. Two bands of decorative render run across the wall planes of the side elevations at sill level and the spring point below the arch.

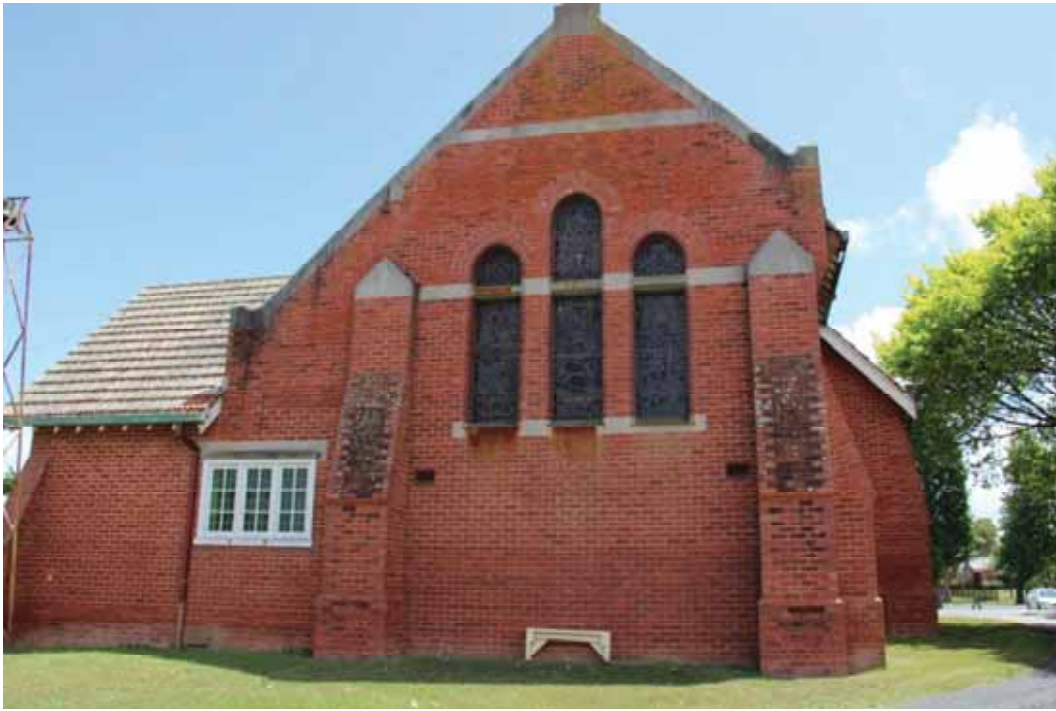
Figure D3. The rear (east) elevation has the same detail as the facade and three large (slightly pointed) arch windows with stained glass. To the left of the rear elevation is the wall of the south porch and a grouping of three square-headed windows.

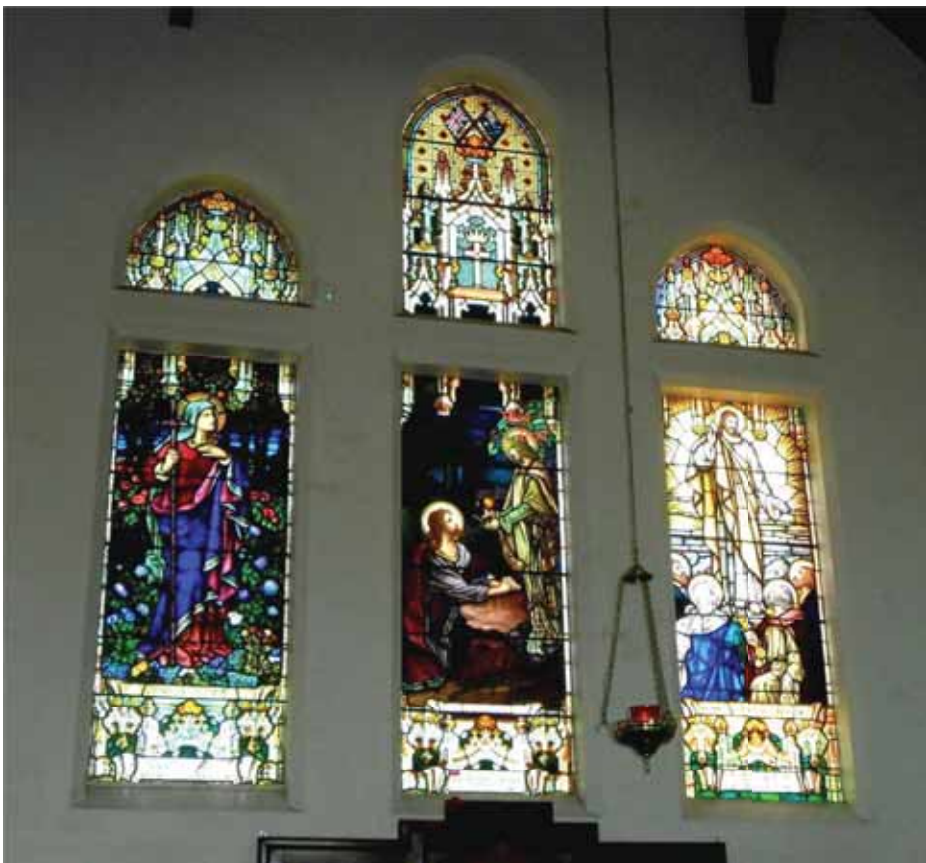
Figure D4. The stained glass leadlight windows to the chancel end were installed in 1919 in memory of Cyril Ben Hamlyn Johnson (Barraclough).

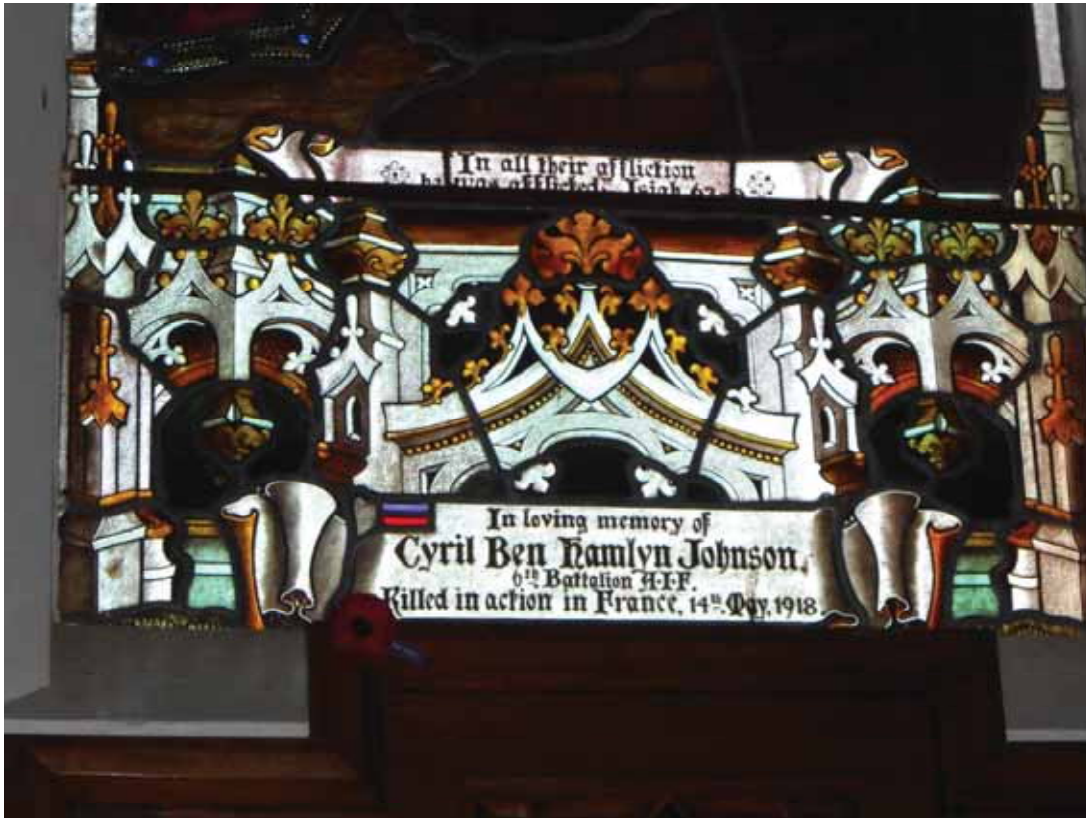
Figure D5. A detail of the central panel of the 1919 stained glass leadlight windows, in honour of Johnson (Barraclough).

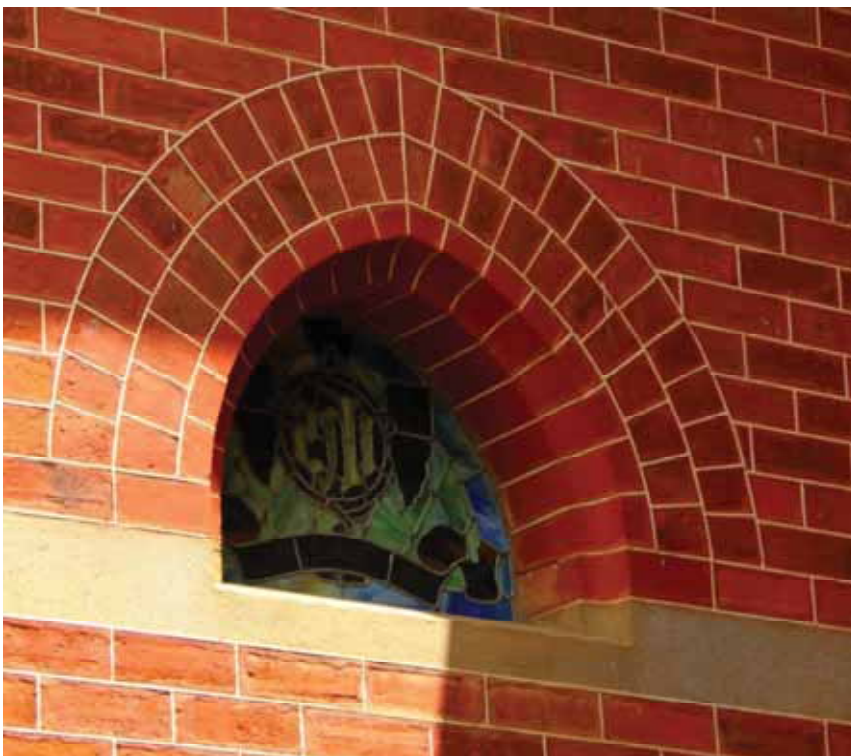
Figure D6. Detail of the exquisite 98 year old brickwork and tuck pointing of the lime mortar, unpainted render and lead lighting, which is all in excellent condition. It should never be painted or treated with any modern sealants. This is testimony to the excellent design, quality of the materials, the builder's skills, and the skills of the craftsmen who created the tuck pointing and lead light by hand.

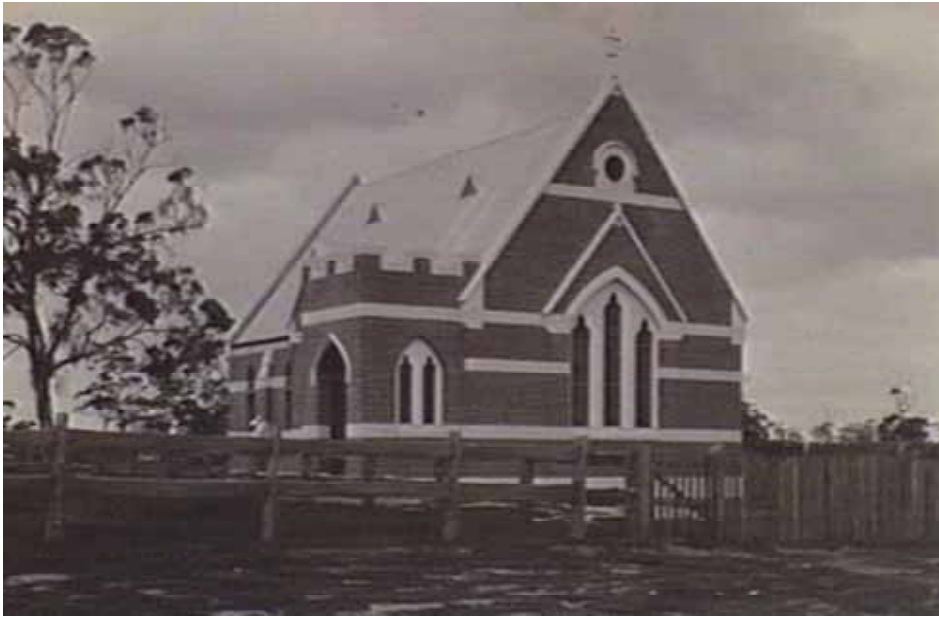
Figure H1. An early photo dating between 1895 and c1909 showed the facade and north elevation of the church. The nave of the church appeared as it does in 2015, however, the spire had not yet been constructed on the tower base. The new render is still a light grey colour (SLV, image no. b23150).

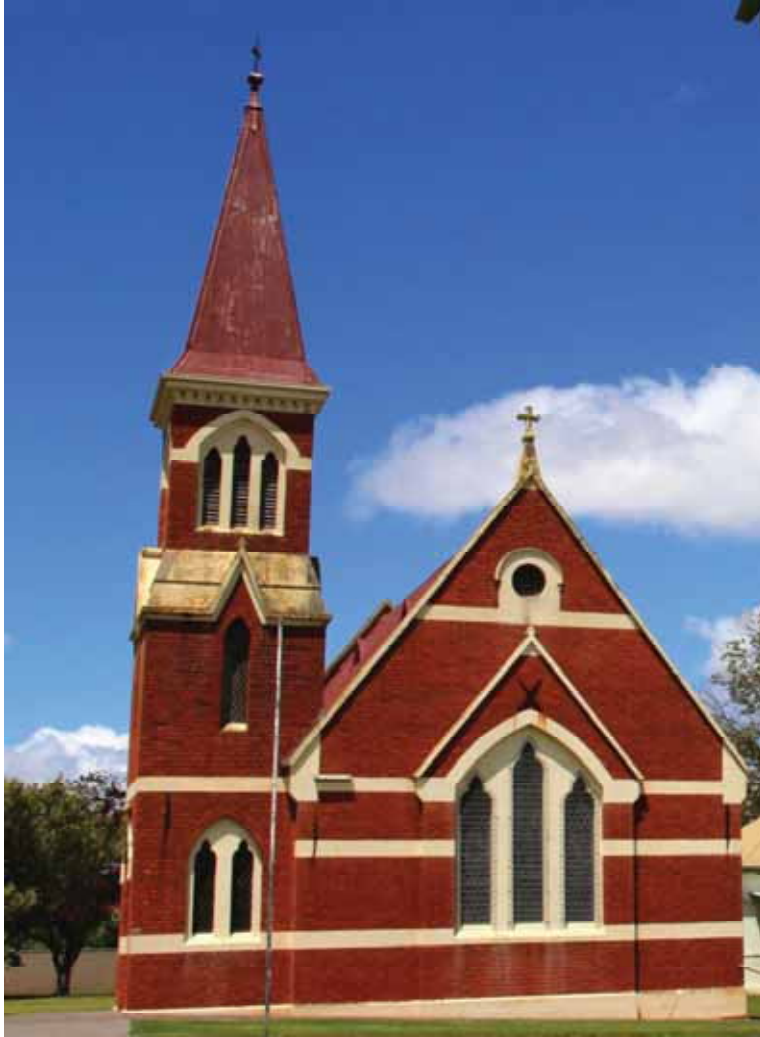
Figure D1. The church is constructed of handmade, tuck pointed red bricks, with a rendered plinth and gabled roof clad with corrugated iron. Four horizontal bands of decorative render (overpainted), run across the facade, creating dominant lines across the face-brick.
