Locality:	YARRAM
Place address:	5 BUCKLEY STREET
Citation date	2016
Place type (when built):	Church, Presbytery
Recommended heritage protection:	Local government level
	Local Planning Scheme: Yes
	Vic Heritage Register: No
	Heritage Inventory (Archaeological): No
Place name:	St Mary's Catholic Church and Presbytery

Architectural Style:	Federation Romanesque and Post War Romanesque Revival (church); Postwar Moderne (presbytery)
Designer / Architect:	A. A. Fritsch (church)
Construction Date:	1915, 1960s (church); 1954 (presbytery)

Locality: YARRAM
Place address: 2-4 CHURCH ROAD
Citation date 2016
Place type (when built): Mechanics Institute
Recommended heritage protection: Local government level
Local Planning Scheme: Yes
Vic Heritage Register: No
Heritage Inventory (Archaeological): No

Place name: Yarram Soldiers' Memorials

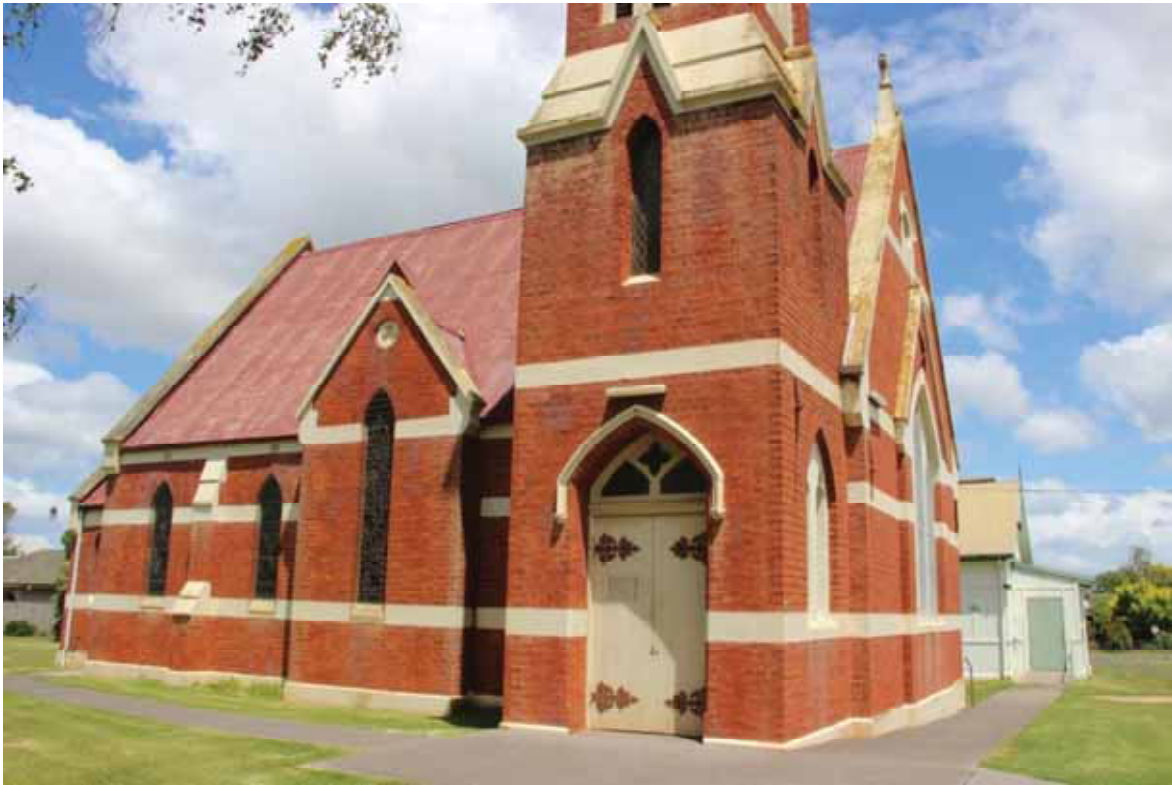
Figure D2. The north elevation contains the entrance on the north side of the tower. The pointed-arch opening has a label moulding stopped by rosettes, and recessed entrance with double timber ledged and framed doors (with ornate metal hinges) and a highlight with a quatrefoil motif.

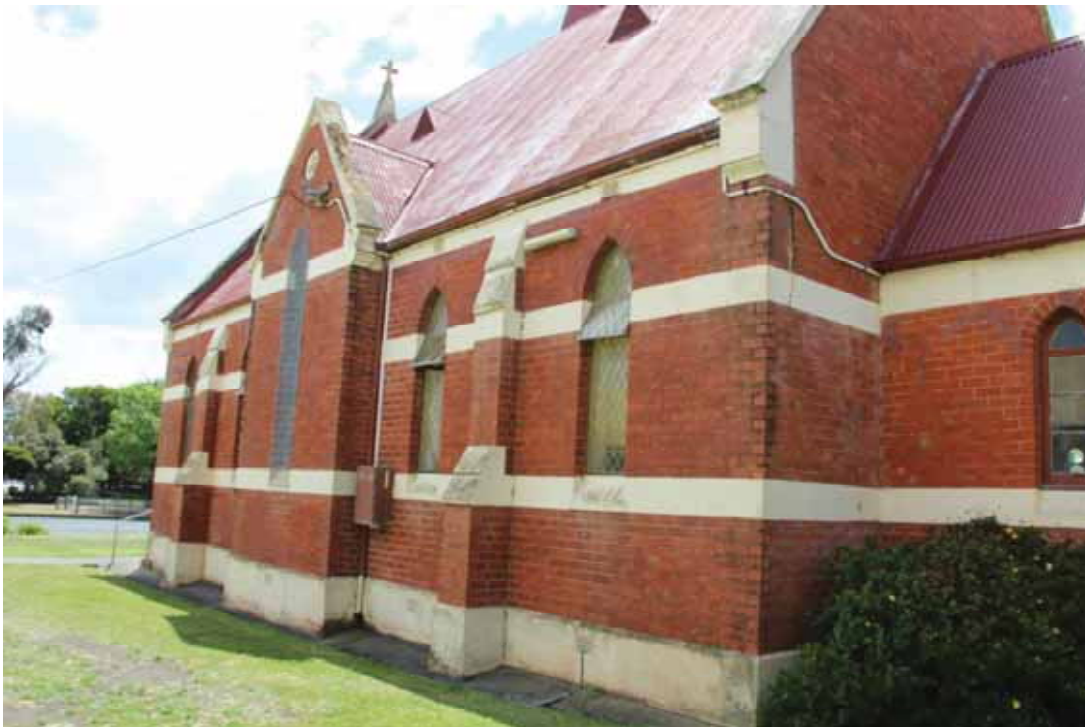
Figure D3. The south elevation. The side elevations of the nave are divided into five bays by buttresses with rendered coping. The central bay of each elevation has a (slightly projecting) gabled bay with a very tall pointed-arch window with leadlight. On both elevations, bands of decorative render (overpainted) run across the walls at sill level and impost level, (near the tops of the windows).

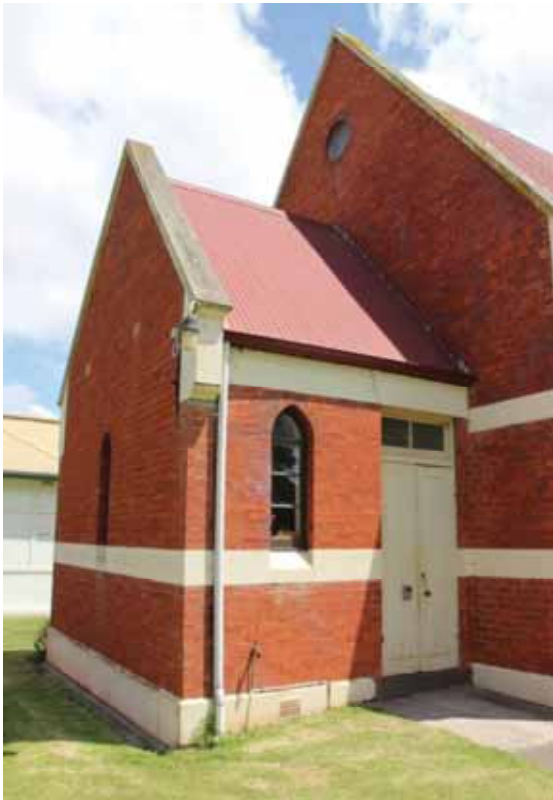
Figure D4. The gabled-end of the rear (east) elevation of the church has a round opening, above a chancel with a rendered parapeted gable. Timber doors with a highlight provide access off the north elevation. Small pointed-arch windows with three-paned casement windows (with clear glass) appear on each side.

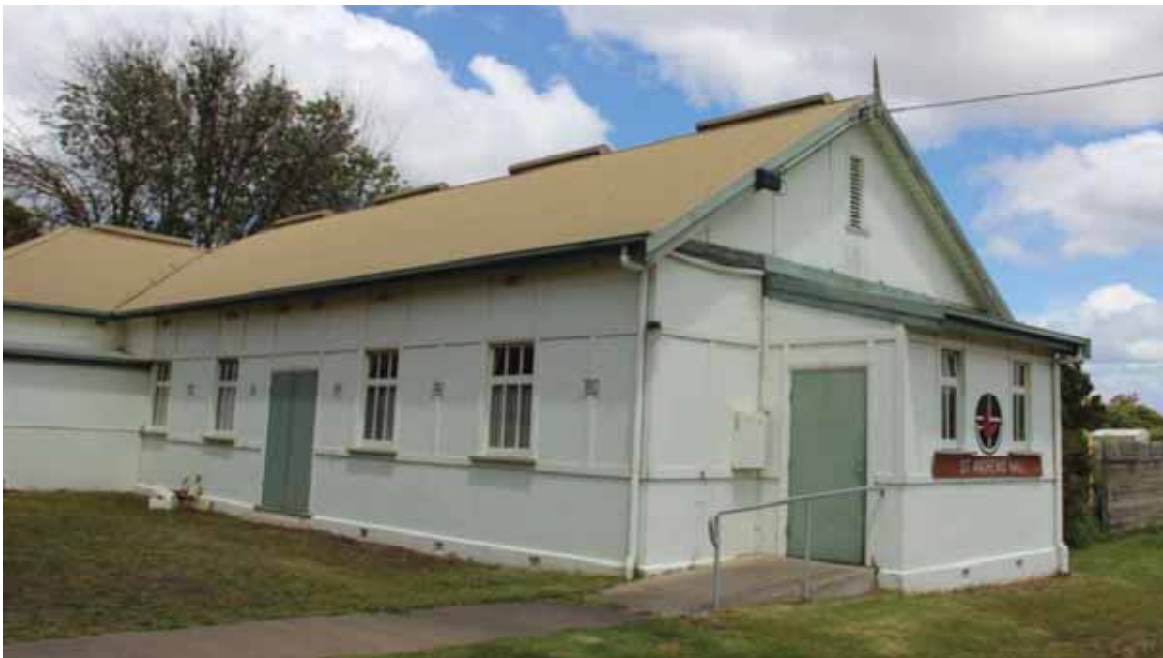
Figure D5. To the south of the church is the 1929 hall which underwent extensions in 1955, which comprised the hipped section to the rear with one-over-one sash windows. Both sections of the hall have a rendered plinth and are constructed of rendered brick to the bottom third of the wall, which is incised with ruled lines to create an ashlar effect. The top 2/3 of the wall and gabled-ends are clad with fibro-cement sheets and strapping (all overpainted).

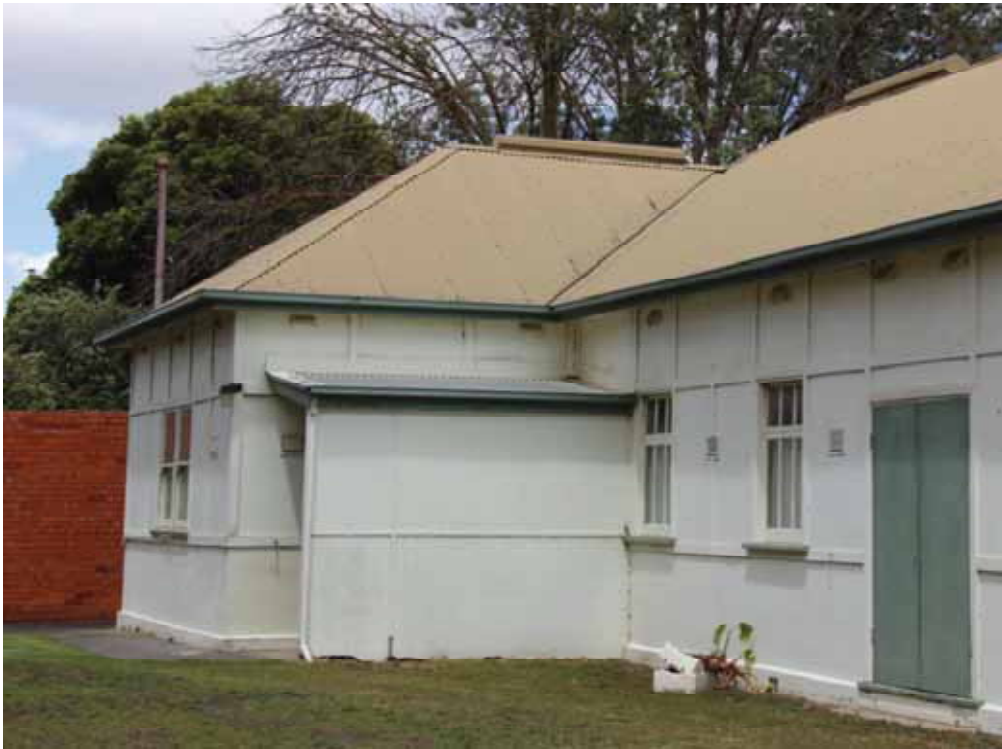
Figure D6. The 1955 hipped-roof addition to the rear imitates the architectural details of the 1929 section, but has one-over-one sash windows. A small skillion-roof section is enclosed with one wall, located on the west side of the 1955 section.

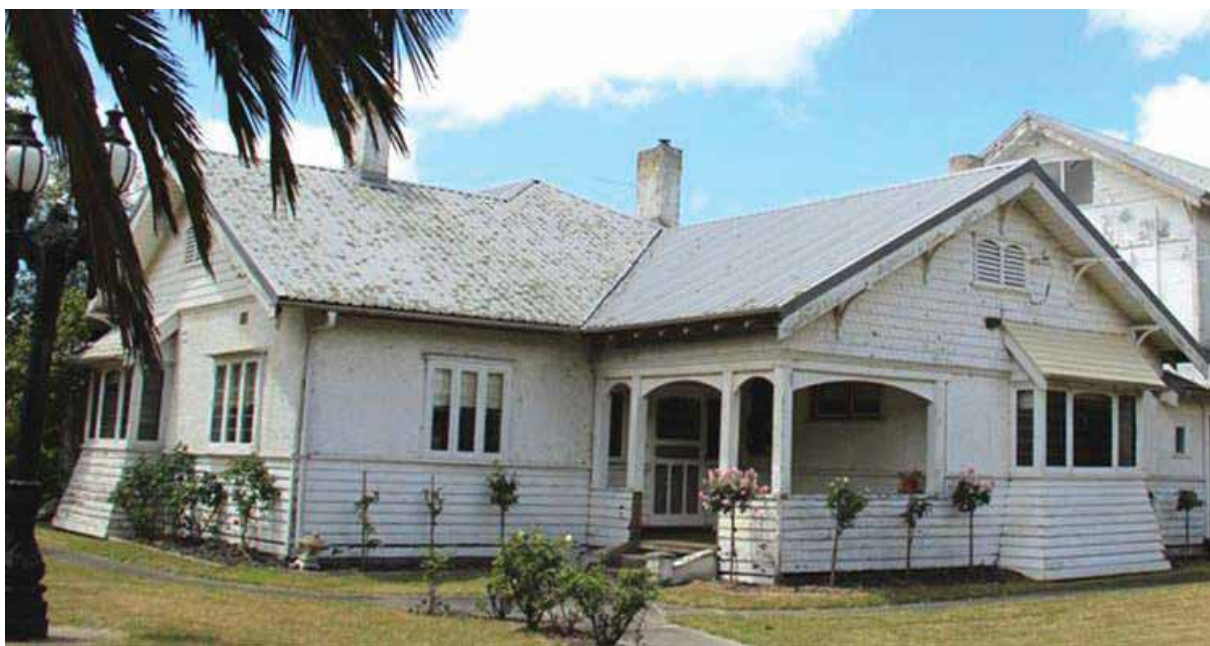
Figure D1. The single-storey is the original section of the house that dates to 1912. The entrance porch is on the right. The original galvanised corrugated iron has been replaced with Colorbond decking (which is growing lichen).

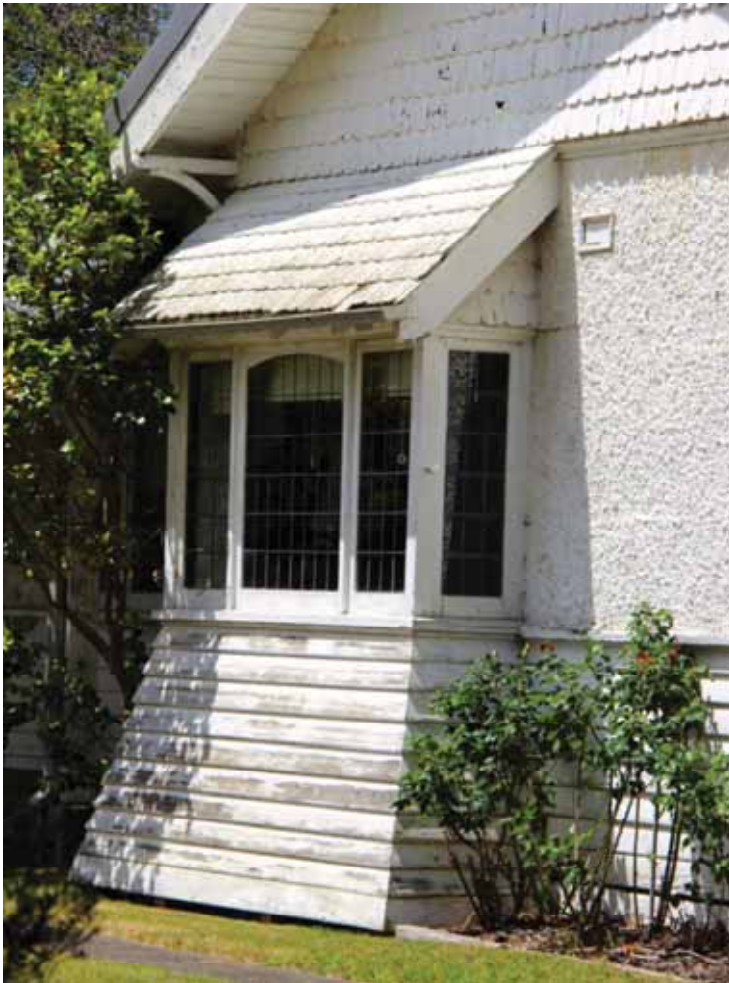
Figure D2. The projecting box window on the west elevation with a detail of the splayed base clad with mitred weatherboards, geometric leadlight timber windows and shingled roof. Half of the base of the exterior walls is timber, with roughcast render to the top half of the wall.

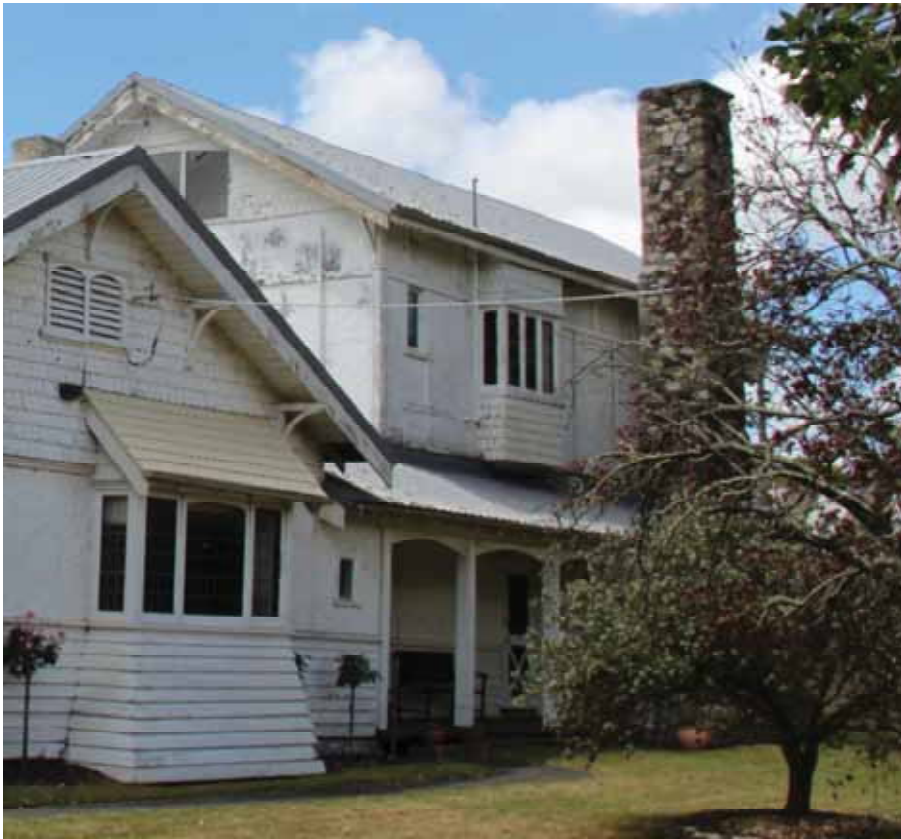
Figure D3. The 1920 section of the house is two-storey and similar in design to the original 1912 section. It is notable for its large two-storey external stone chimney.

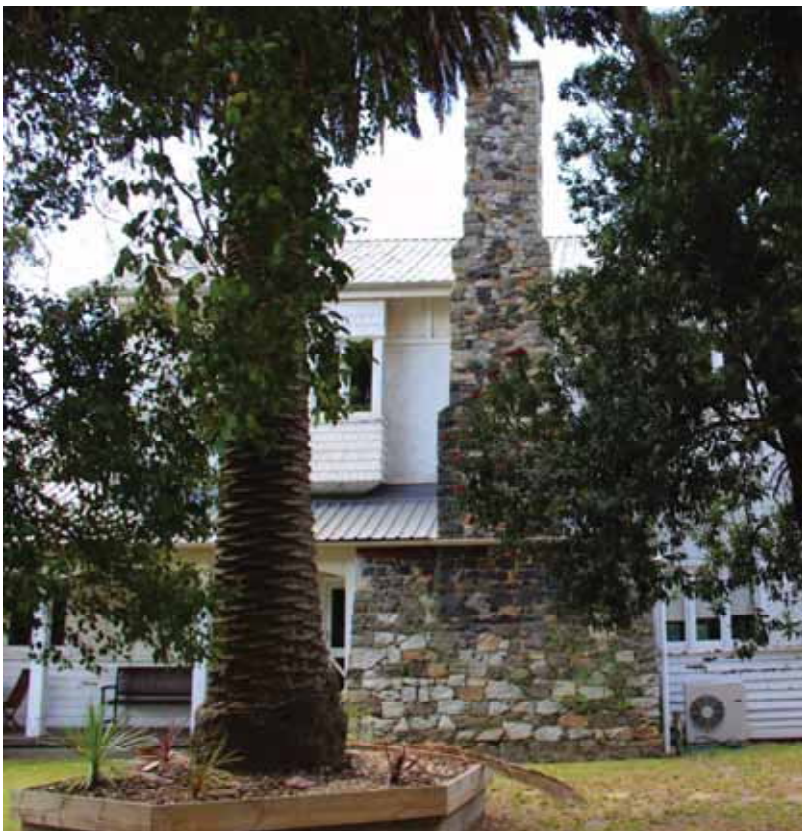
Figure D4. The palm trunk, and Arts and Crafts unpainted chimney seen from King Street, on the southern boundary of the property.

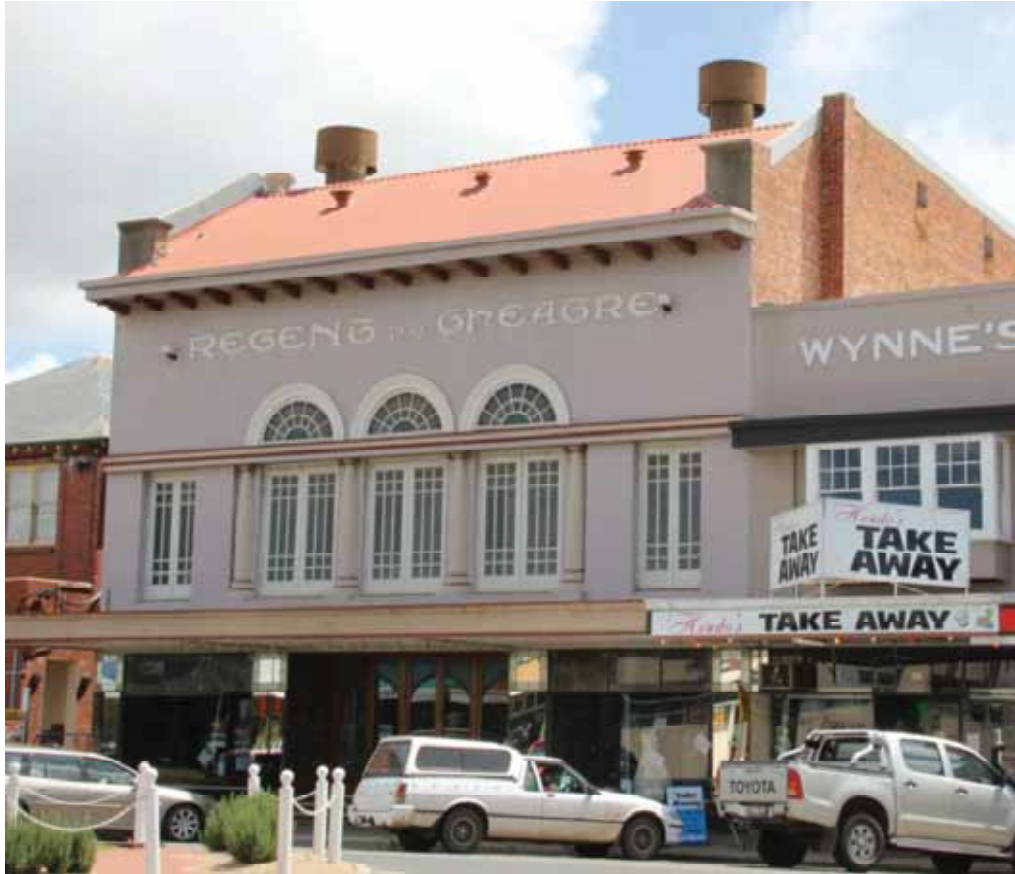
Figure D1. The theatre is a red-brick construction, visible on the side elevations where it extends into the gable ends, but concealed by decorative painted render on the front façade. The gable roof is clad in Colorbond deck, which replaced a former tile roof.

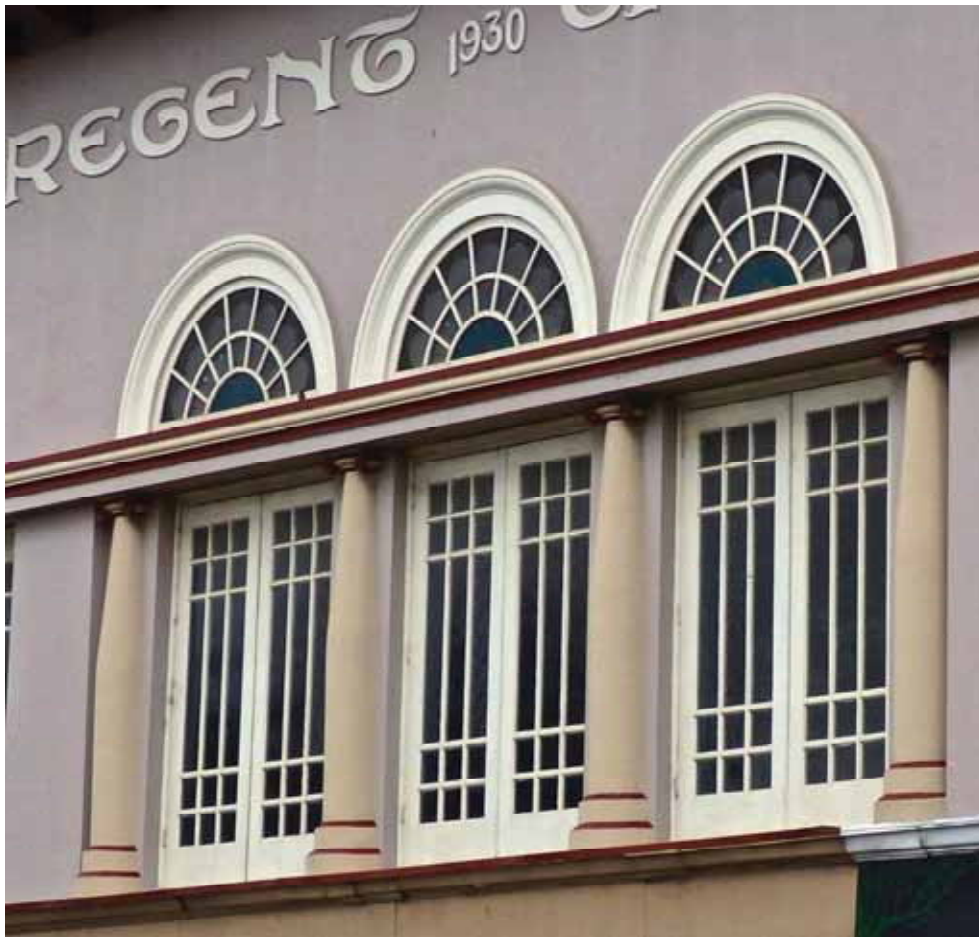
Figure D2. Detail showing the four Ionic columns with exaggerated entasis, separating the three pairs of French windows and supporting a moulded entablature with elaborate fanlights above.

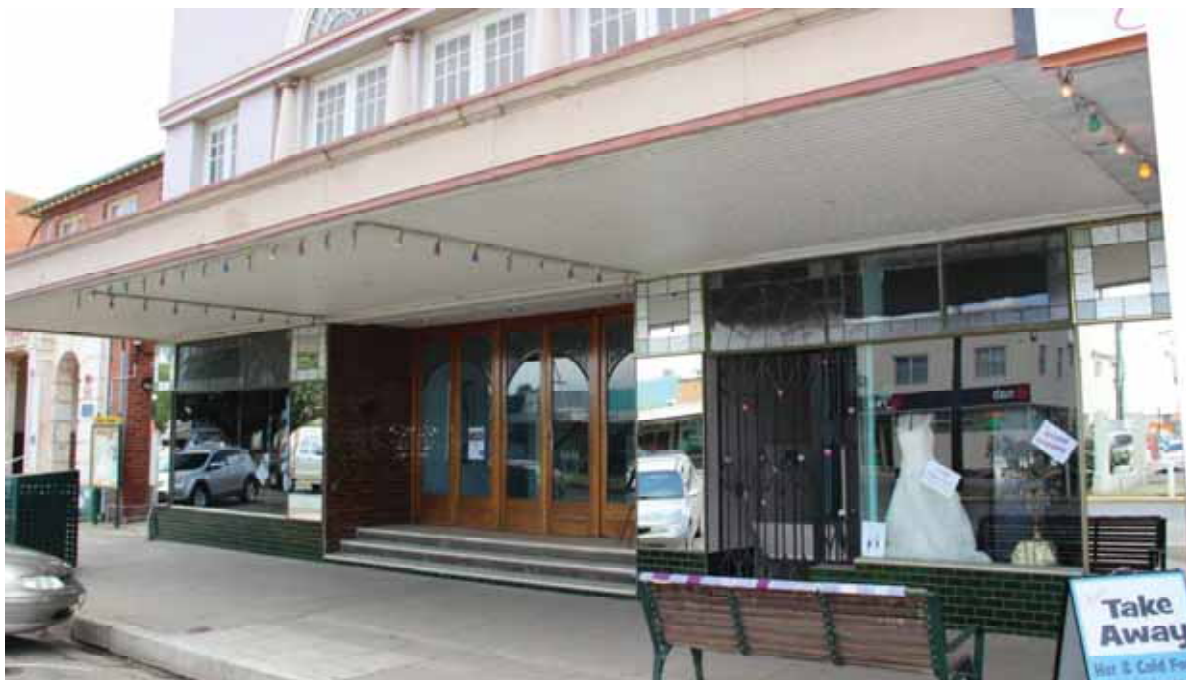
Figure D3. The cantilevered verandah covers the two elaborate shopfronts either side of the recessed entrance, reached by three marble steps.

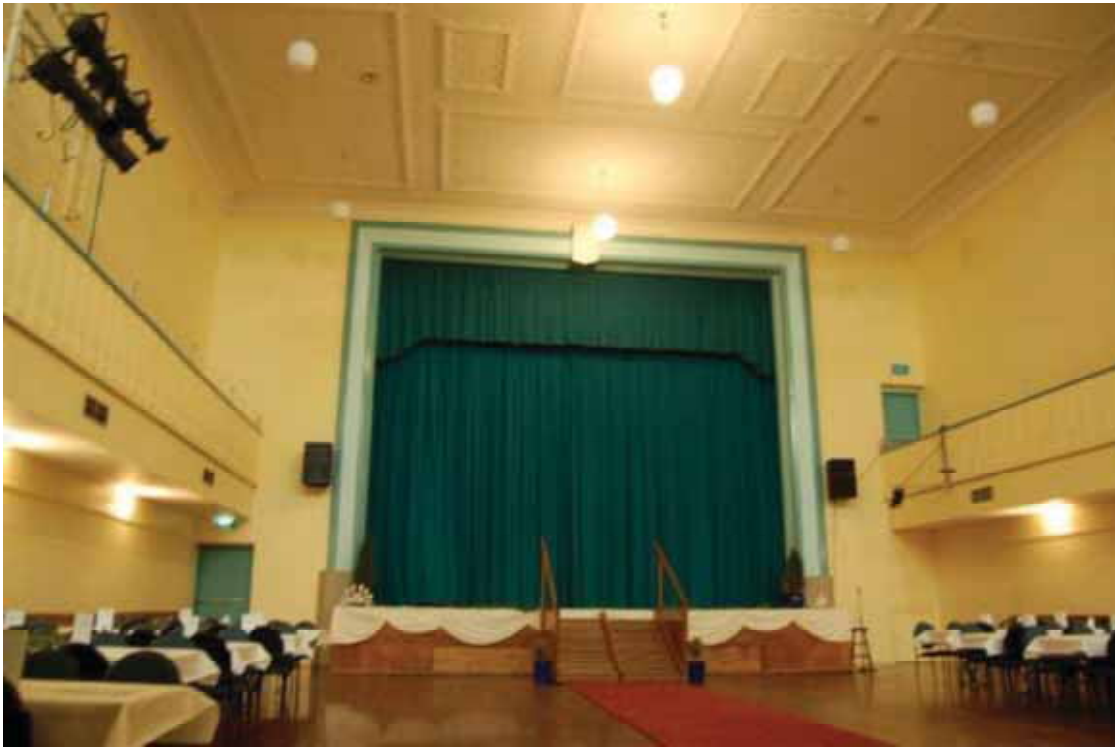
Figure D4. The auditorium with the stage, proscenium and catwalks to the sides (Source: HV).

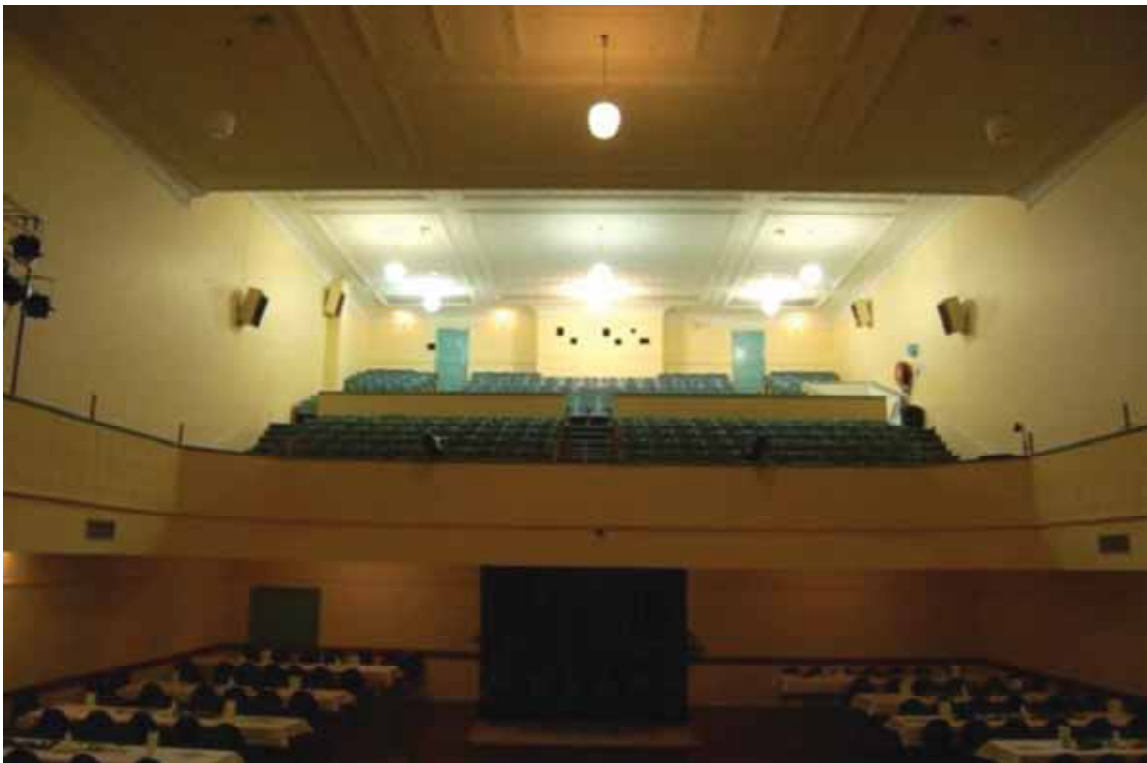
Figure D5. The auditorium also contains dress circle seating. Pressed metal clads the ceiling and the front of the circle and catwalks (Source: HV).

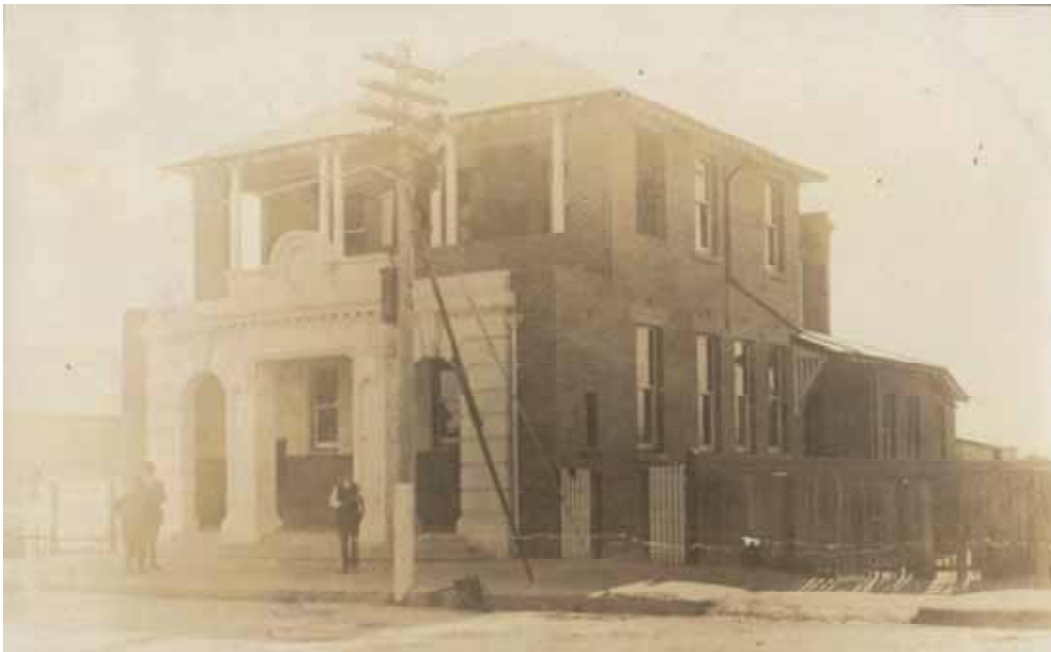
Figure H1. Photo of the post office dating between 1917-1930. The clock had not been installed and the first floor retained its recessed balcony supported on elegant classical columns. The single storey residential residence is visible on the side elevation (SLV).

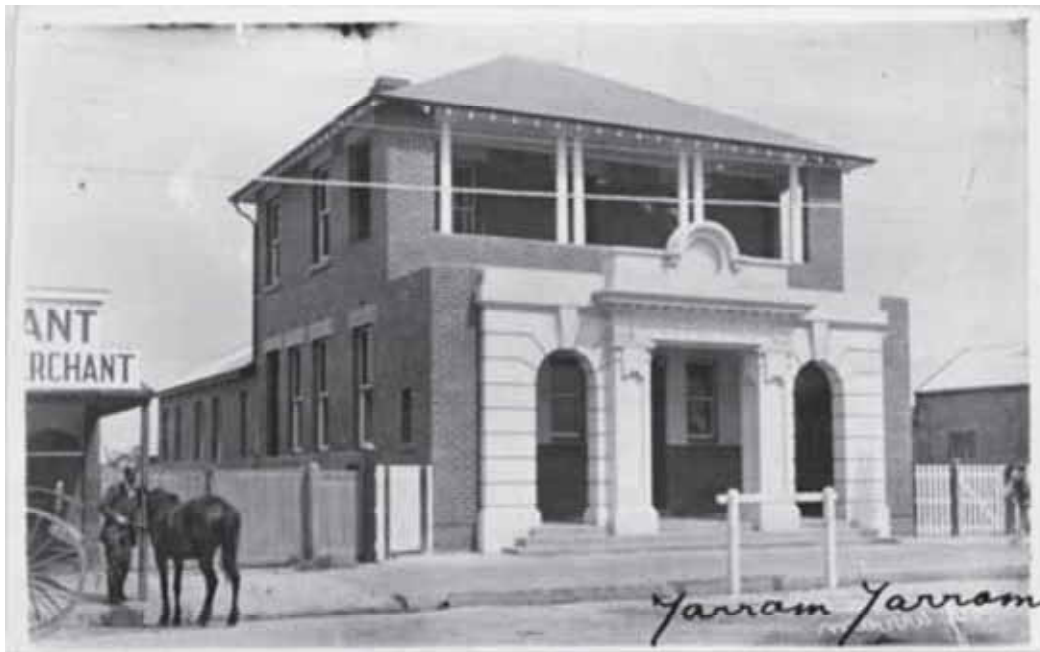
Figure H2. The post office between 1917-1930 in its original unpainted state. The first floor was only three rooms deep (later extended) (NAA).

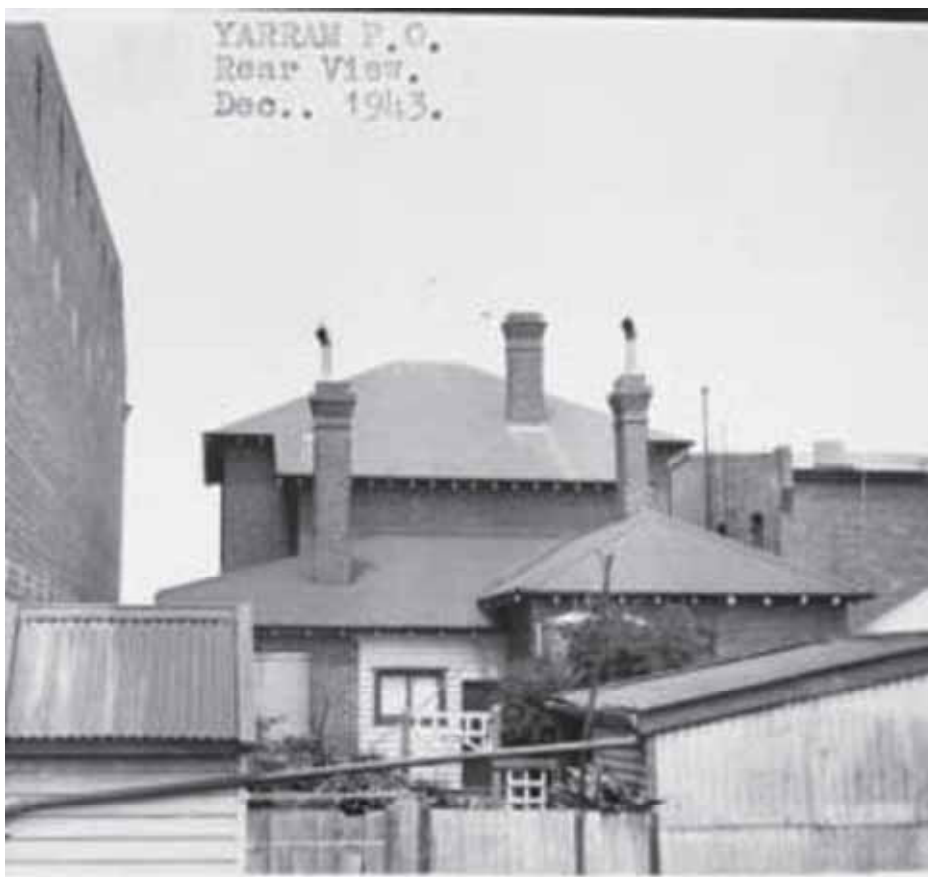
Figure H3. The original rear elevation of the post office in 1943, prior to the extension of the first-floor in the 1950s (NAA).

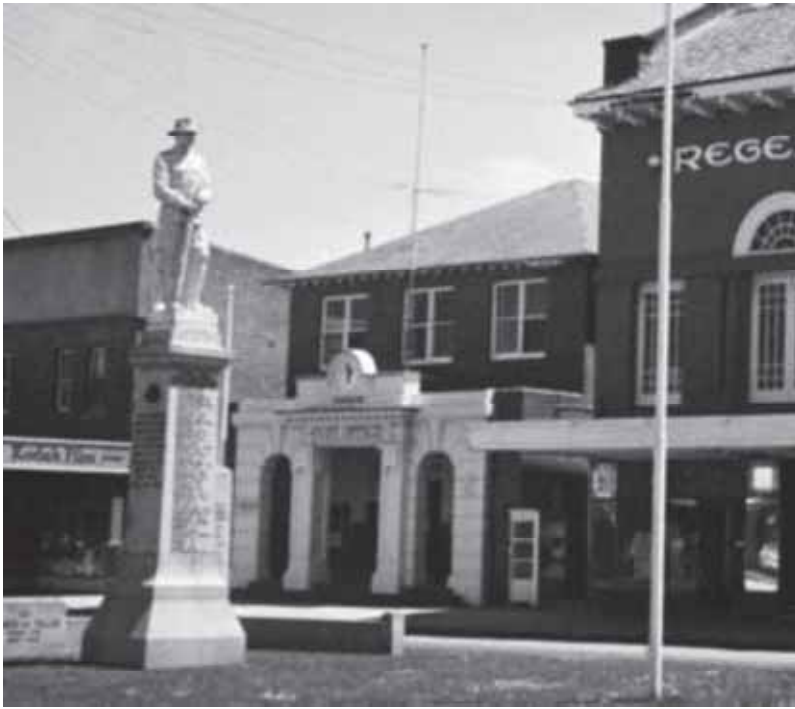
Figure H4. The post office in c1969. The first floor balcony had been in-filled by this date. The clock and name had been installed on the entrance porch (SLV).

A photo dating to c1969 (SLV) showed that the clock and post office name had been installed on the entrance porch (Figure H4). The recessed balcony to the first floor was also in-filled with three windows by this date.

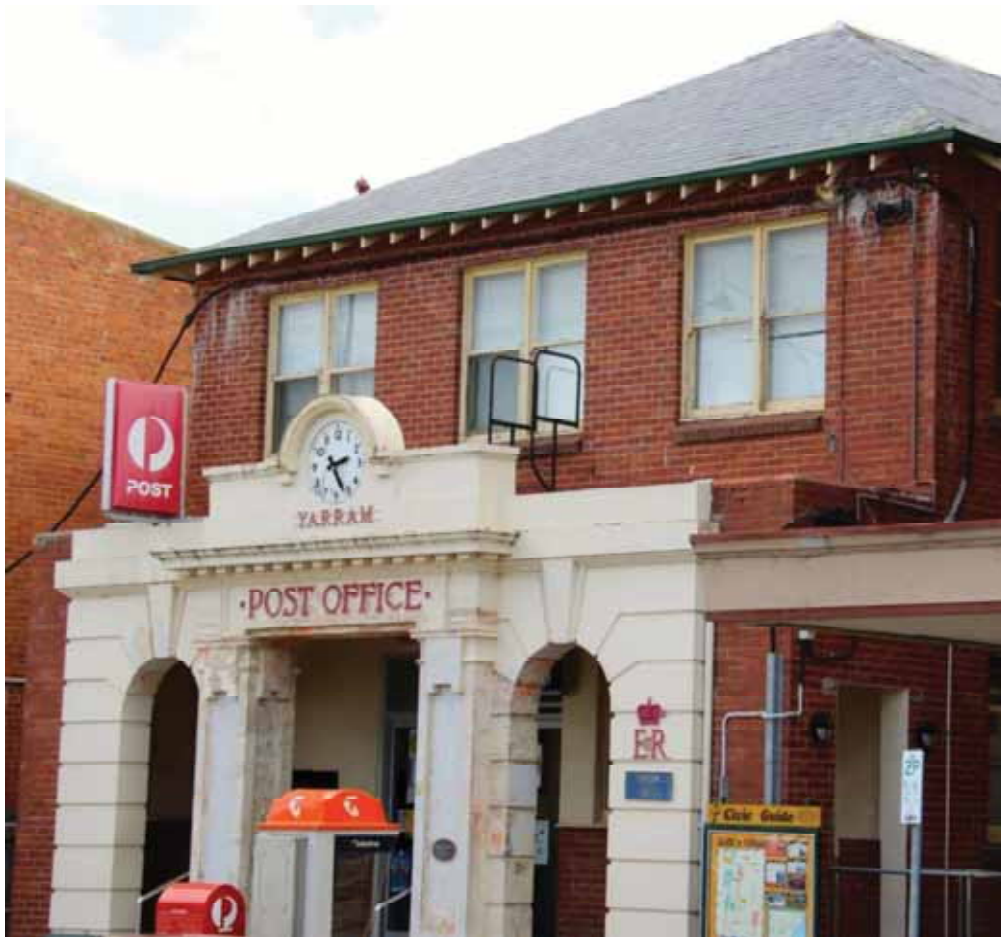
Figure D1. The post office with its hipped roof clad with slate and wide eaves with exposed rafter ends, and the rendered Palladian-inspired Classical portico dominating the facade. The first floor balcony was in-filled with windows by c1969.

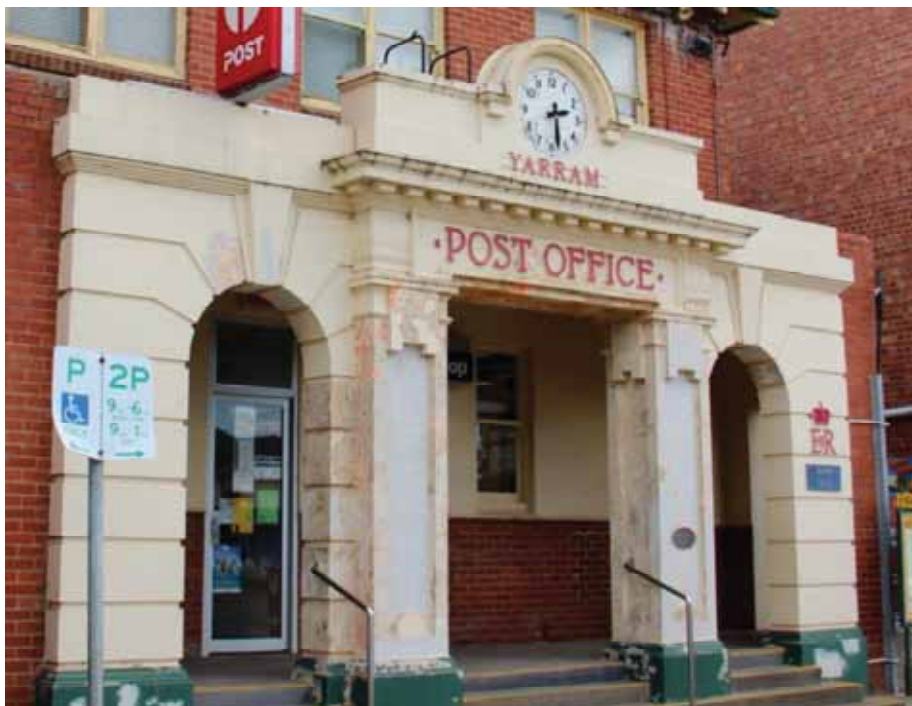
Figure D2. A detail of the rendered Palladian-inspired Classical portico with the clock and name.

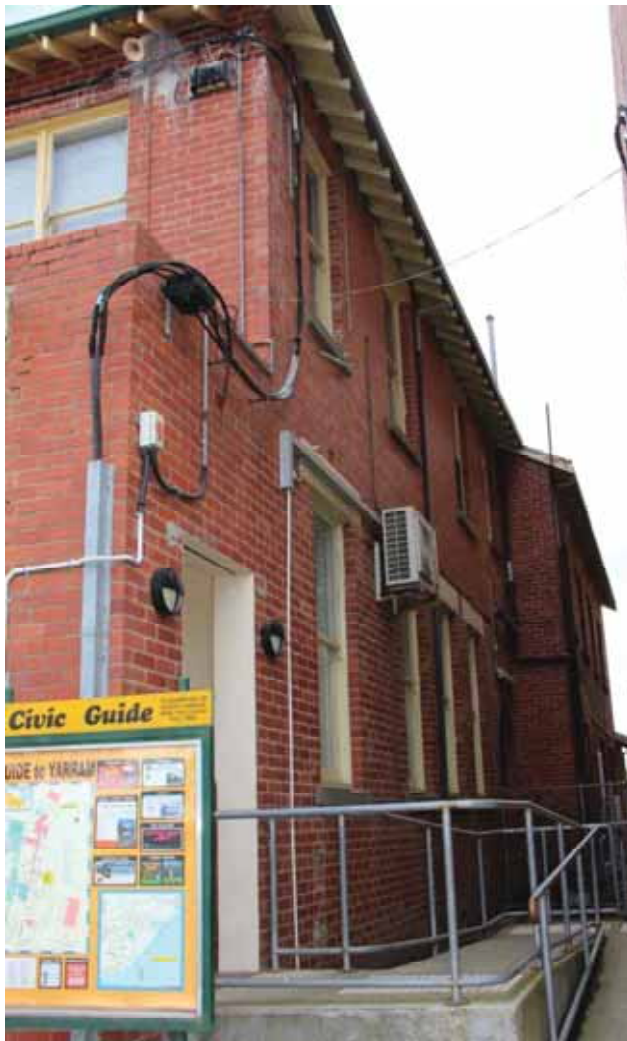
Figure D3. The north elevation. The 1913 section of the first-floor has the wide eaves and exposed rafter ends. To the rear of this is the 1950s first-floor addition, built on top of the 1913 single-storey residence.

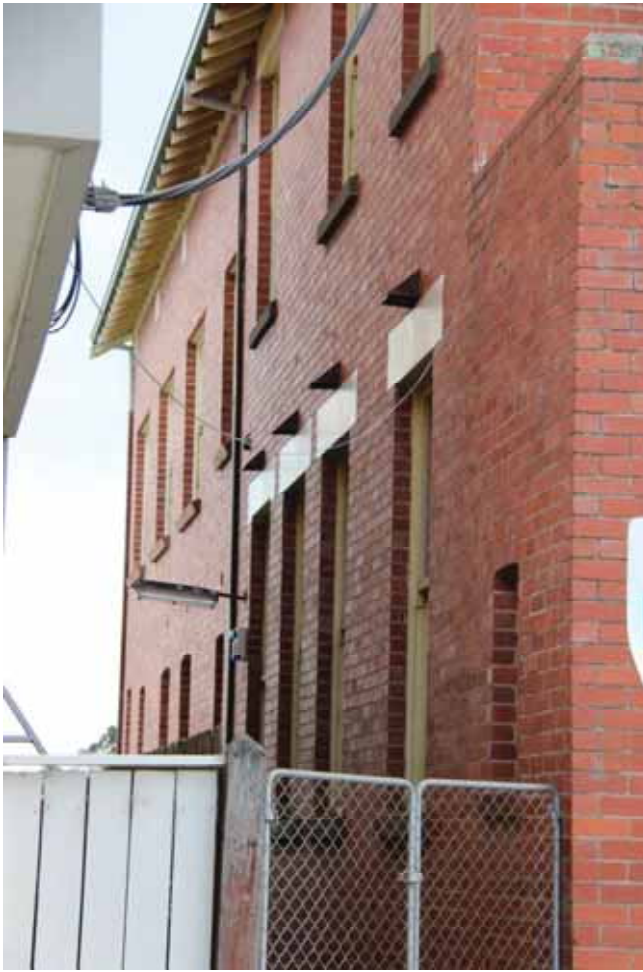
Figure D4. The south elevation. The 1950s addition to the first floor was built with wide eaves with exposed rafter ends, like the original 1913 section.

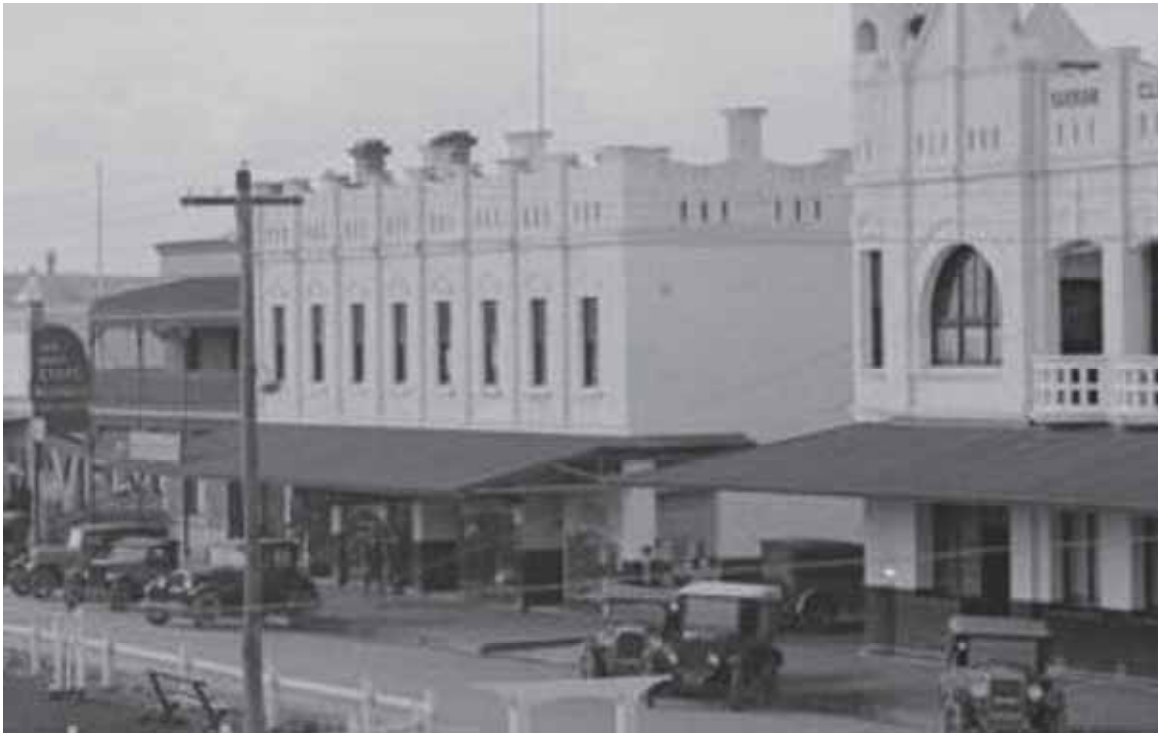
Figure H3. A photo dating to c1930 (by the date of the cars), shows the Coffee Palace was predominantly a single light colour like the Yarram Club (which may have been the original colour of the render without paint) except for the smooth render dado along the ground floor level and side wall (SLV: H32492/5527).

Figure D3. The parapet continues on the side elevations, reducing to single-storey height at the rear of the building. At ground level is a dado of smooth render, which was originally a darker colour on the side and front elevations. A small shopfront window is located on the south elevation, as appears in the historic photos (Figures H3 & H4).

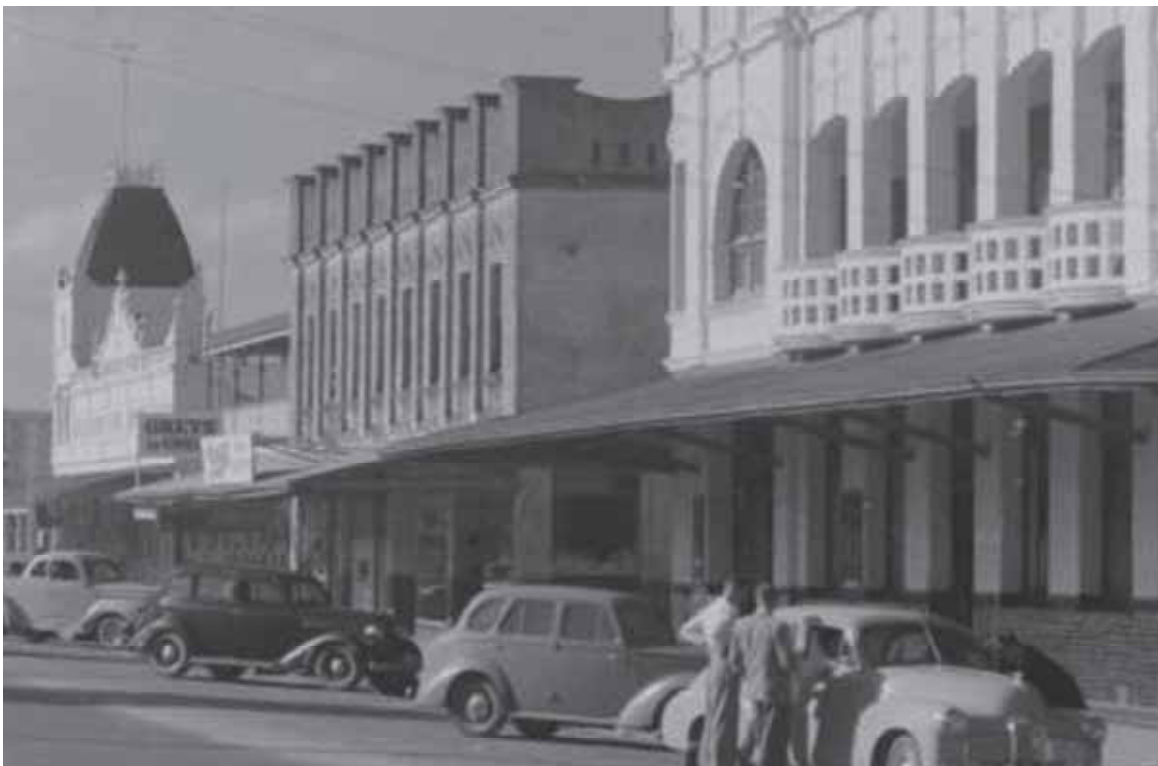
Figure H4. A photo dating between c1945 and 1954 also showed the Stockwell Building from the south, now painted, and in darker tones, with the parapet in a contrasting tone. The photo (as does Figure H3) showed that the original shop fronts had large panels of glazing between large piers, and the piers had a dark coloured dado, the same height as the one on the Yarram Club Hotel. (SLV H91.50/526).

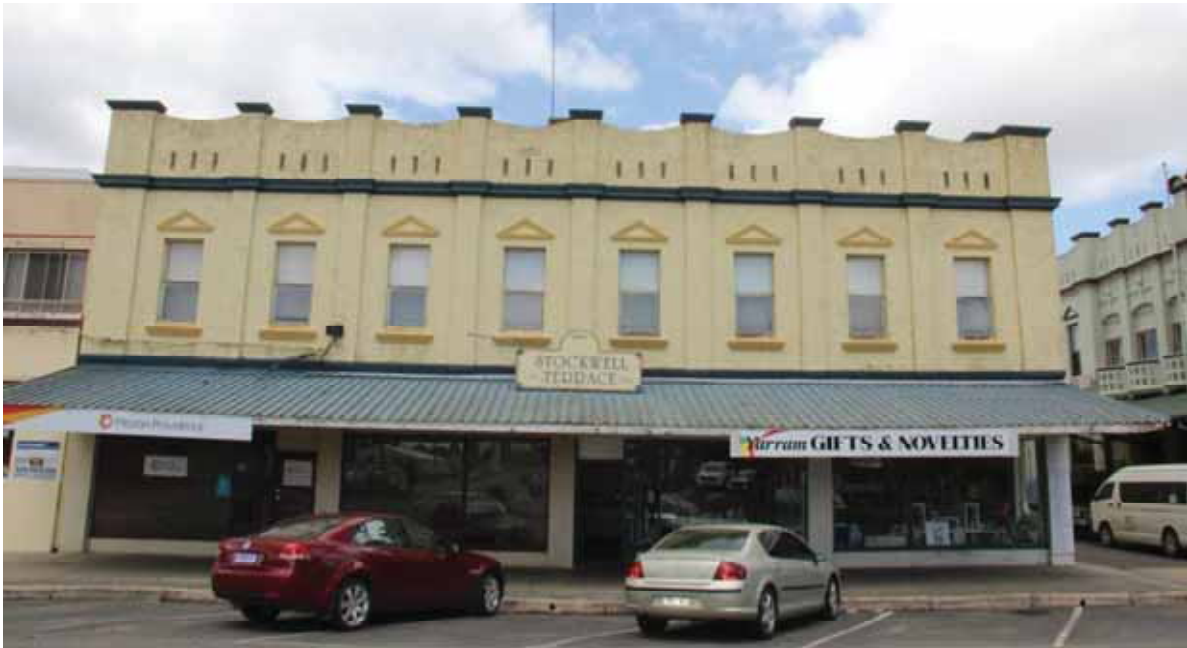
Figure D1. The symmetrical facade is dominated by the tall parapet, Classical details and very wide verandah to the ground floor. The first floor and parapet are divided into eight bays, created by engaged pilasters, which gives the building a strong vertical emphasis.

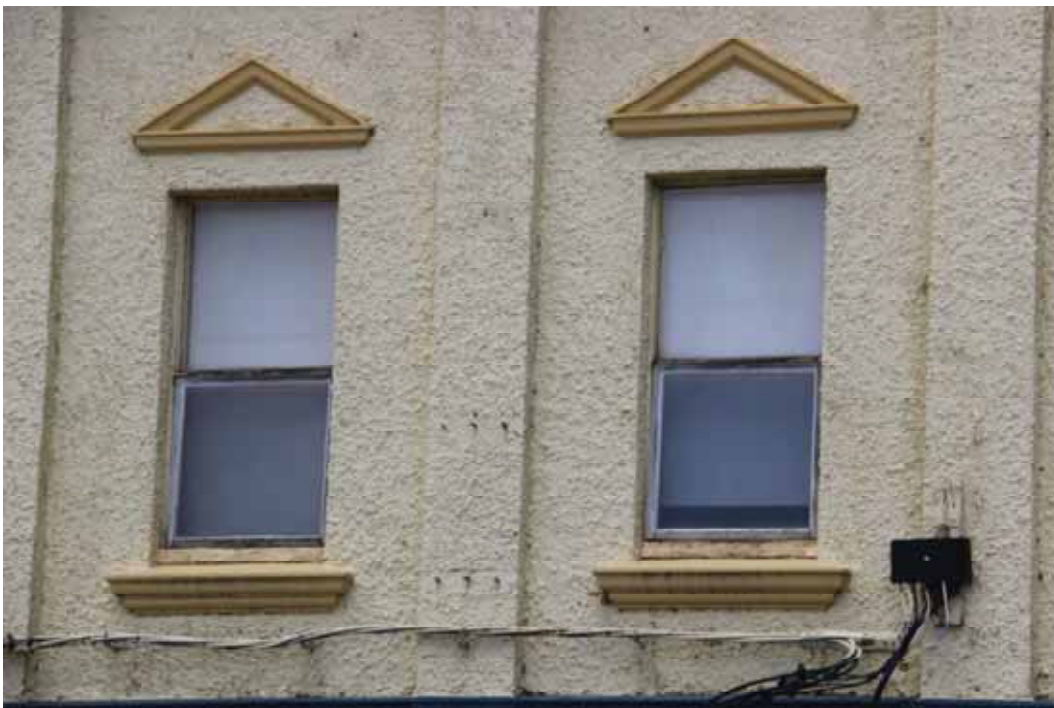
Figure D2. A single window appears in each bay (formed by the pilasters) to the first floor. The windows are one-over-one timber sashes with a moulded sill and moulding above that forms an abstracted Classical pediment.

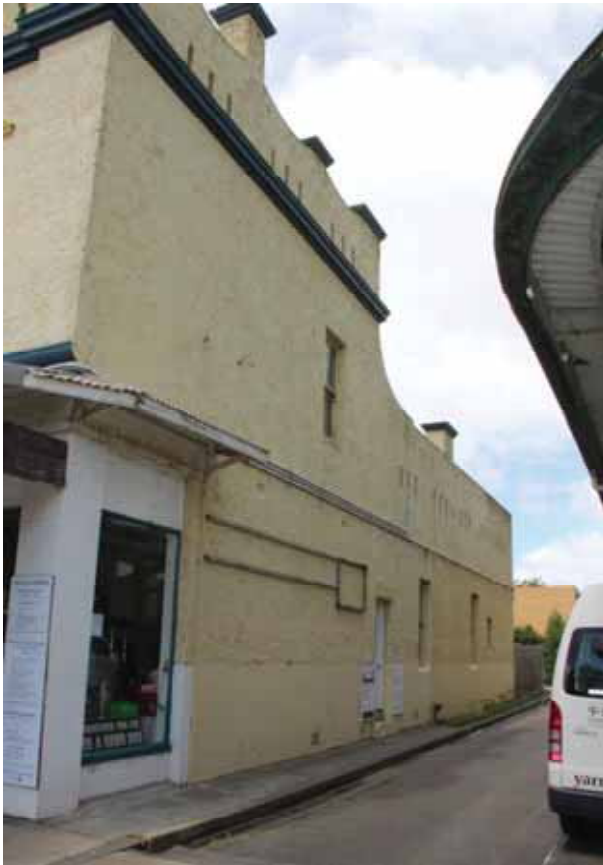
Figure D3. The south elevation. The parapet continues on the side elevations, reducing to single-storey height at the rear of the building. At ground level is a dado of smooth render which was originally a darker colour than the rest of the building. A small shopfront window is located on the south elevation, as appears in the historic photos

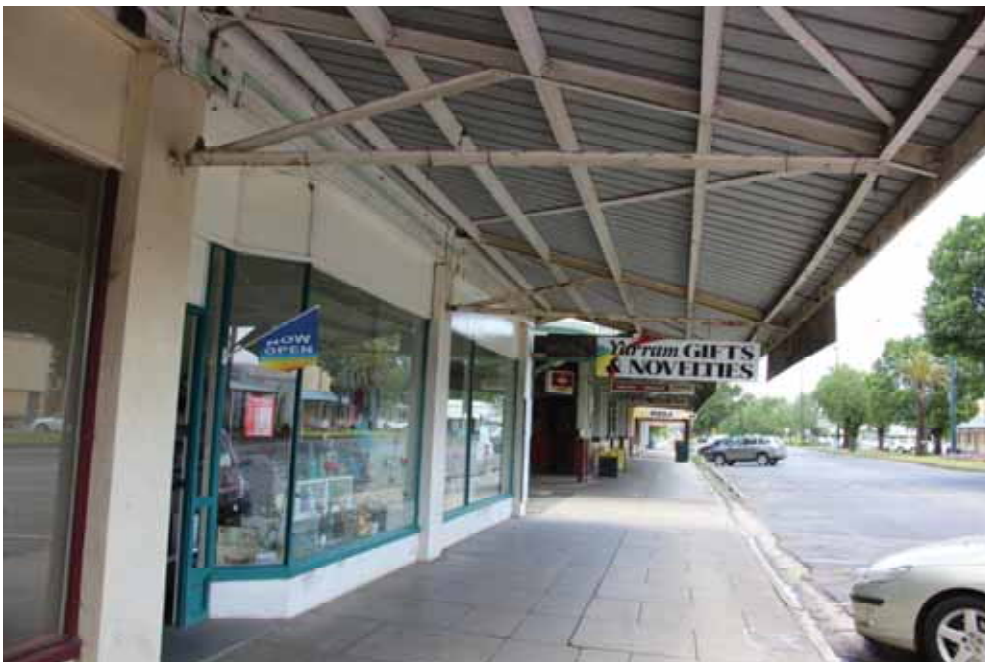
Figure D4. The shopfronts are covered by a wide cantilevered verandah with a skillion-roof (with modern cladding), which retains the original metal structure underneath. The shopfronts at ground level are early timber-framed windows with recessed entrances.

4.3.1. The original verandah is an example of a very early use of cantilever supports and this structure must be retained. Replace the steel cladding and install galvanised corrugated iron (not Zinalume or Colorbond).
