Locality:	YARRAM
Place address:	5 BUCKLEY STREET
Citation date	2016
Place type (when built):	Church, Presbytery
Recommended heritage protection:	Local government level
	Local Planning Scheme: Yes
	Vic Heritage Register: No
	Heritage Inventory (Archaeological): No
Place name:	St Mary's Catholic Church and Presbytery

Architectural Style:	Federation Romanesque and Post War Romanesque Revival (church); Postwar Moderne (presbytery)
Designer / Architect:	A. A. Fritsch (church)
Construction Date:	1915, 1960s (church); 1954 (presbytery)

Locality: YARRAM
Place address: 2-4 CHURCH ROAD
Citation date 2016
Place type (when built): Mechanics Institute
Recommended heritage protection: Local government level
Local Planning Scheme: Yes
Vic Heritage Register: No
Heritage Inventory (Archaeological): No

Place name: Yarram Soldiers' Memorials

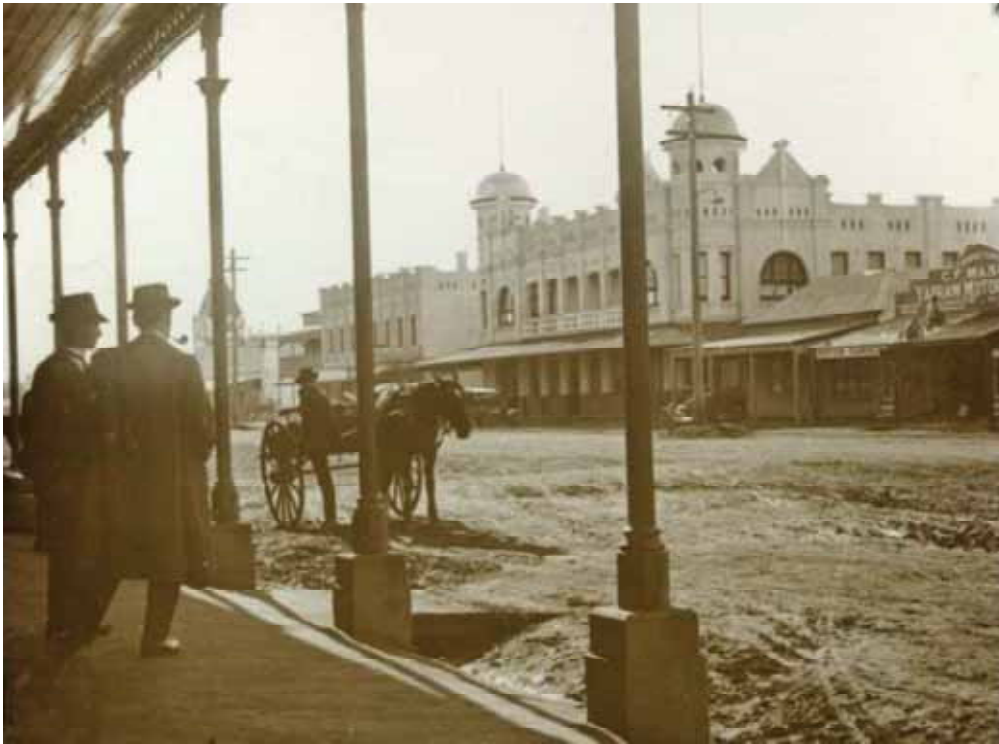
Figure H2. This 1914 photo showed the facade and south elevation of the Yarram Club Hotel at a distance, soon after it was completed. The two-storey facade with its parapets, pediments, corner towers, recessed balcony to the first floor, and return cantilevered verandah appeared as they do in 2015, although one flag pole is missing and the application of light and dark colours is different. (SLV Id no. H92.150/354):

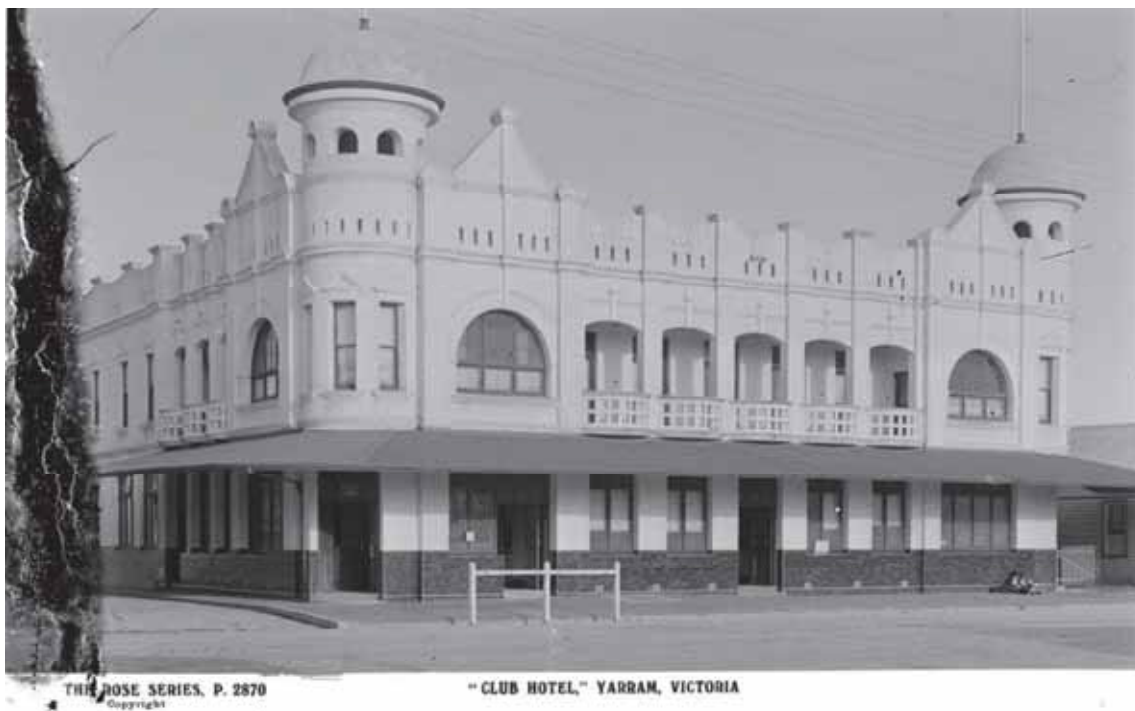
Figure H3. This photo dating between c1920 and c1954 showed the facade and north elevation of the Yarram Club Hotel in clear detail. The building above the verandah appeared as it does in 2015, although the colour application of light and dark is different. At ground level, there was an entrance at the north end (south of the corner entrance) that has since been closed, otherwise the openings were the same as those that remain in 2015 (SLV, H32492/4104).

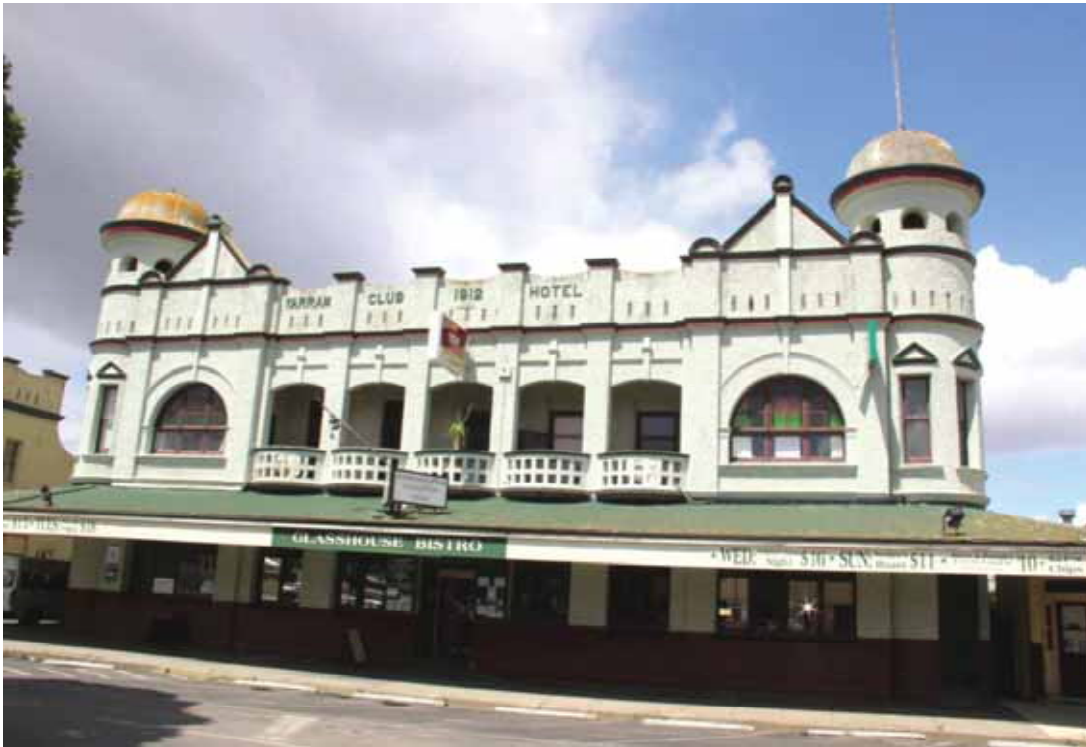
Figure D1. The substantial two-storey building has three main elaborate elevations with Classical details and prominent corner towers, and is highly visible throughout the town.

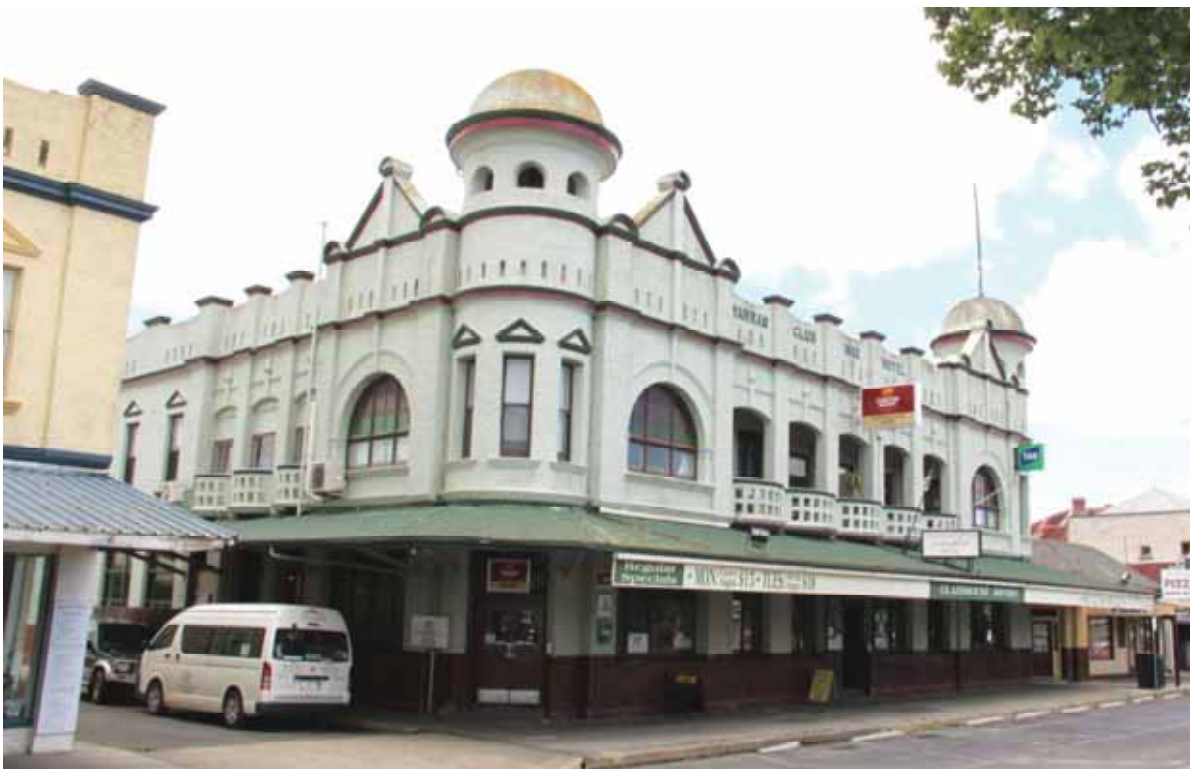
Figure D2. The form and detail to the facade is repeated on the side elevations, including the parapet and pediments, Diocletian windows and the balconies to openings.

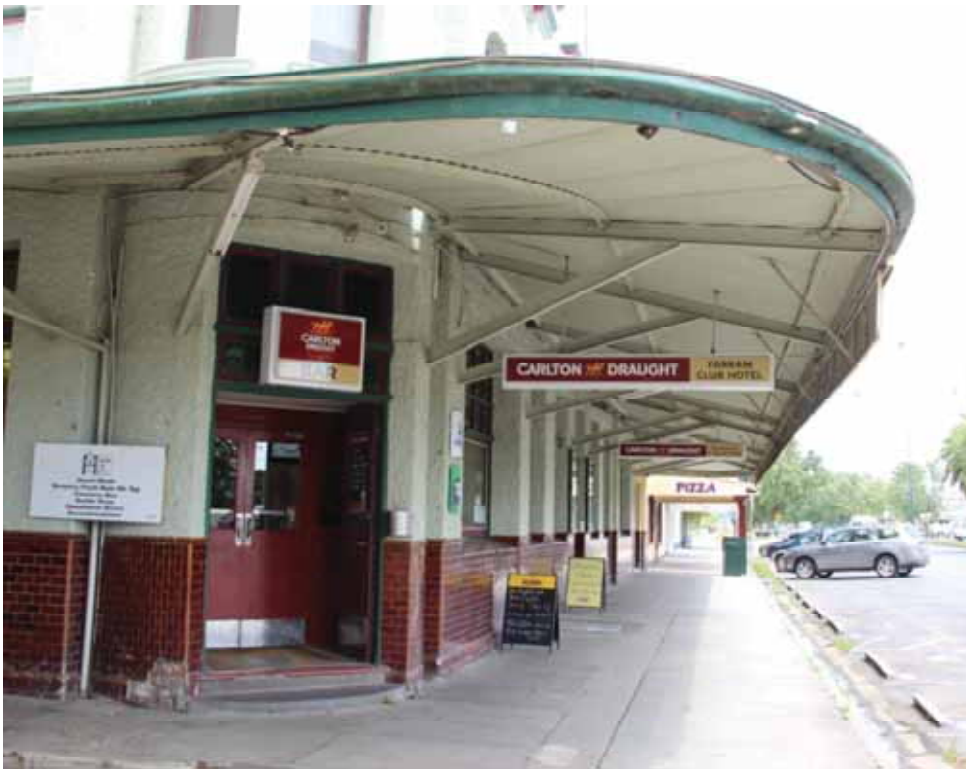
Figure D3. The wide cantilevered verandah runs across the facade and returns on part of the north elevation, with large rounded corners. It has corrugated iron cladding (overpainted) to the roof and retains the original metal support structure underneath. The ground floor has glazed brown tiles to the dado level with roughcast render to the top 2/3 of the wall (overpainted).

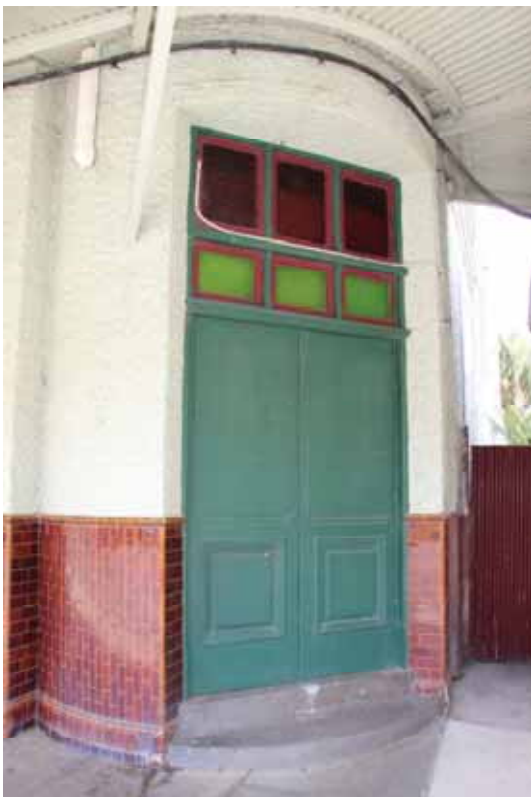
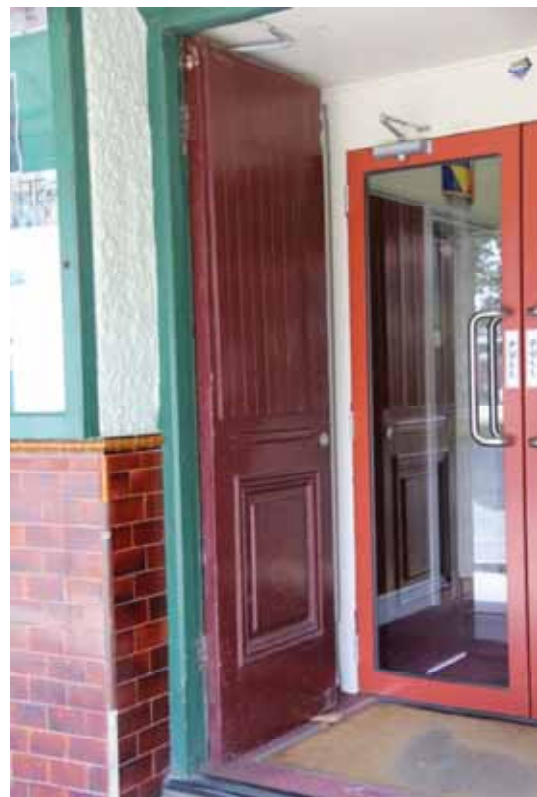
Figure D4. The southern entrance (left) at the base of the tower, and the central entrance to the facade (right). Both have the original timber panelled doors (that have had the top panel of glazing covered over).

Figure D4. There are three entrances at the ground floor to the facade; two corner, angled entrances (at the base of the towers), and a third at the centre of the facade. Each entrance has an alcove (the corner entrances have timber-lined roofs), entered by original timber panelled doors (that have had the top panel of glazing covered over). Above the corner entrances are large groups of timber square windows with coloured glass. The central entrance has a highlight (with modern glass).

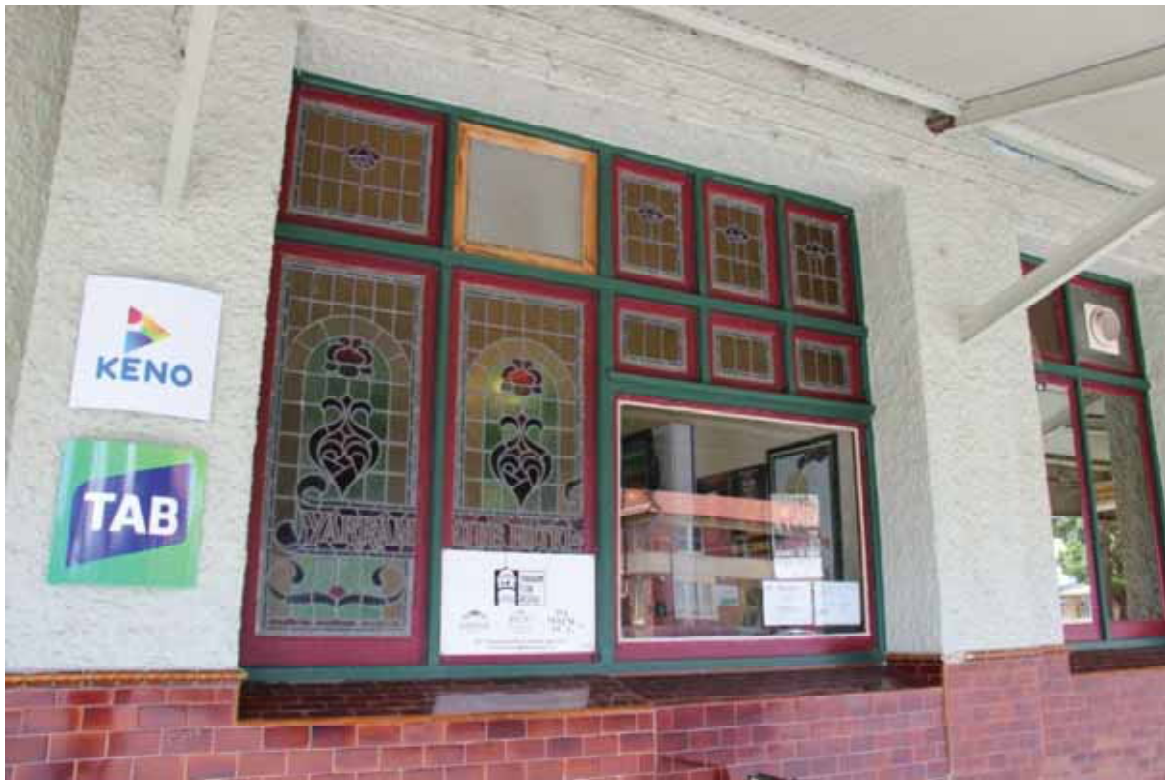
Figure D5. This photo shows the leadlight window group to the south (right) of the northern corner entrance. This is the only altered opening to the facade, as it originally had an entrance door in the right half (since closed over sympathetically). The leadlight to this window contains the words 'YARRAM CLUB HOTEL'.

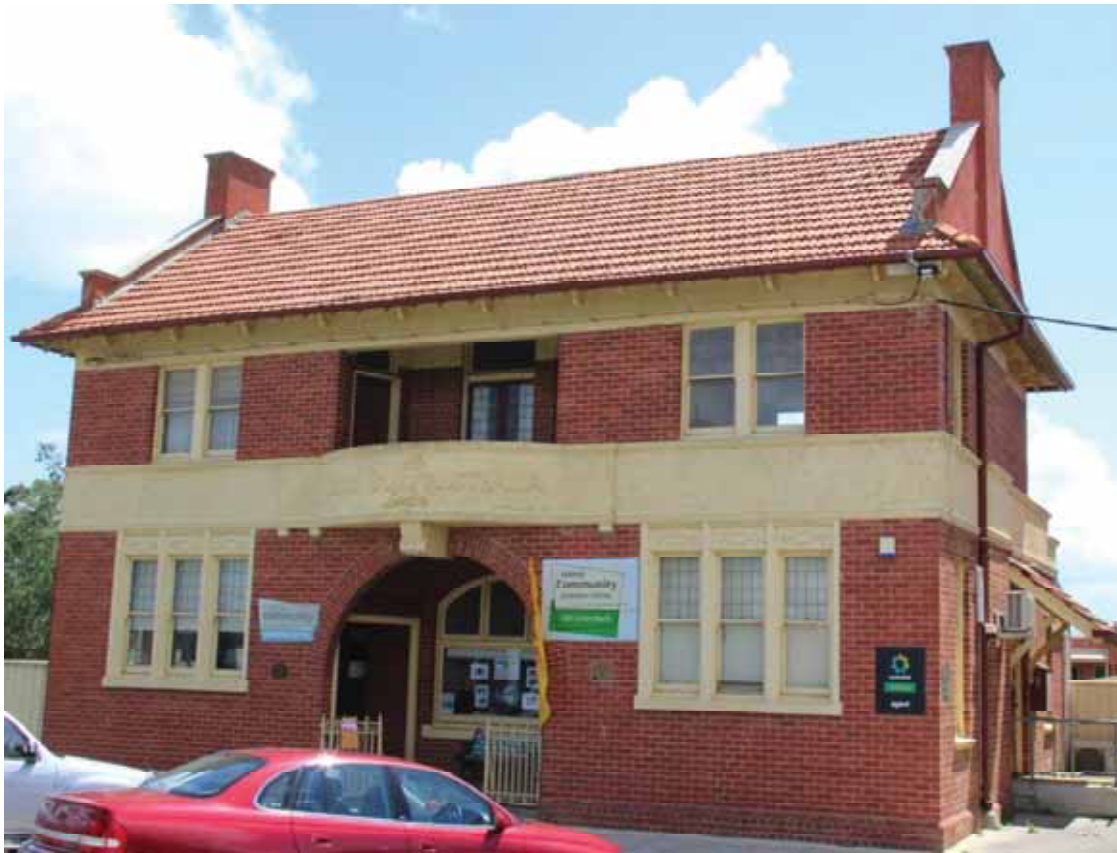
Figure D1. The facade of the bank with the predominantly gabled roof clad with terracotta tiles, exposed eaves, a pair of parapeted gable ends which have small hipped extensions for the continuation of the eaves and central semi-circular red brick arched entrance and wide bank of (over painted) render.

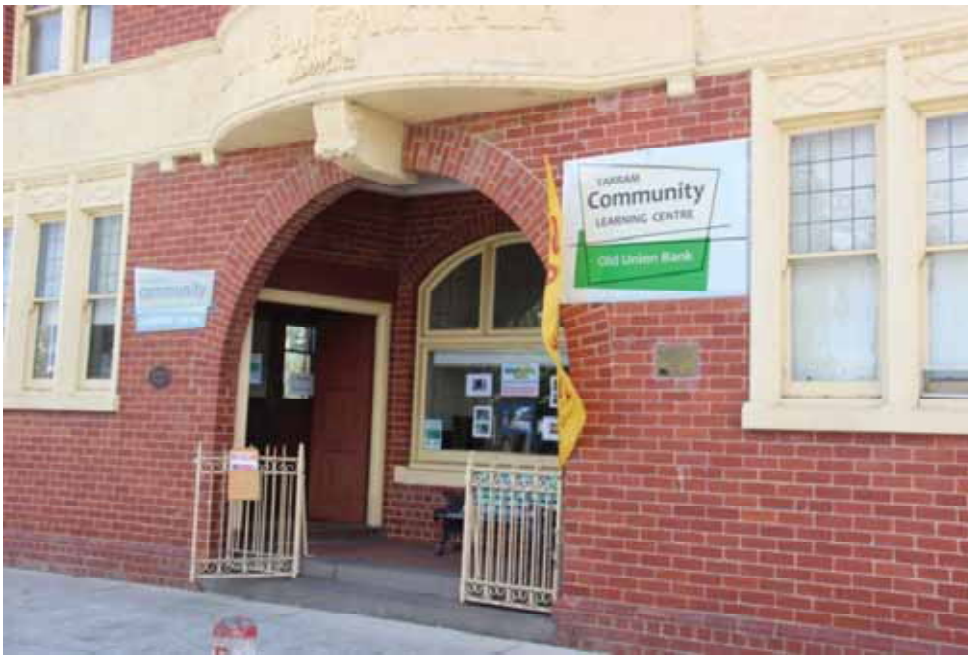
Figure D2. A detail of the entrance with its large semi-circular red brick arch and (c1950s) wrought-iron gates, in front of the large window with geometric leadlight, which is also evident in the other timber-framed windows.

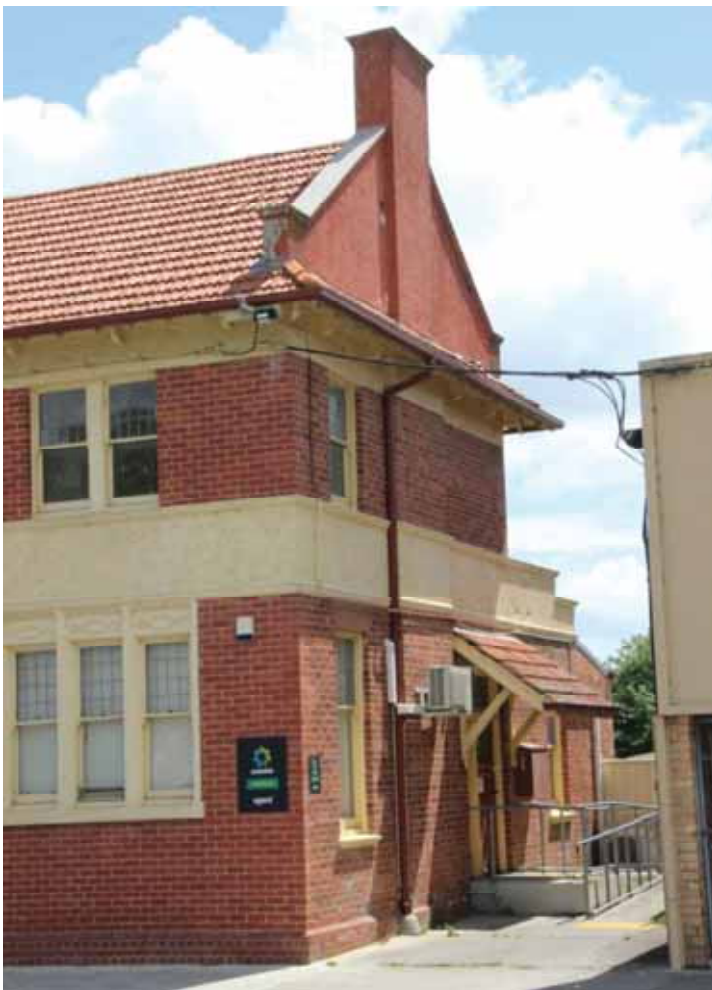
Figure D3. The north elevation with the domestic entrance porch and recently added concrete ramp for access.

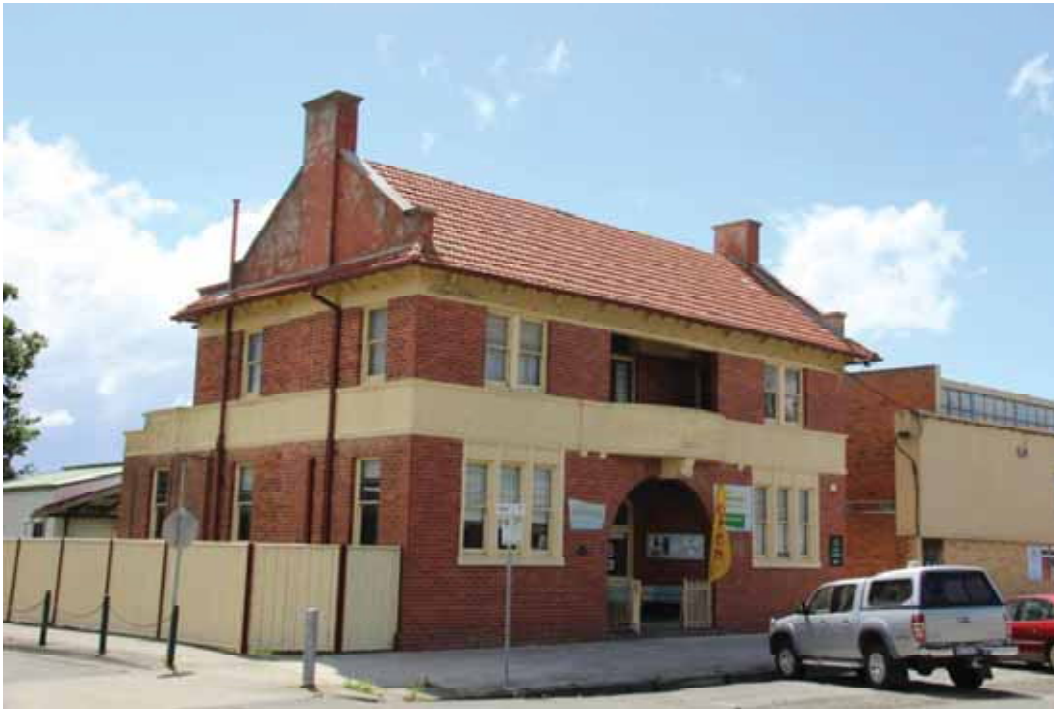
Figure D4. The facade and south elevation, showing the single-storey section to the rear and modern skillion verandah.

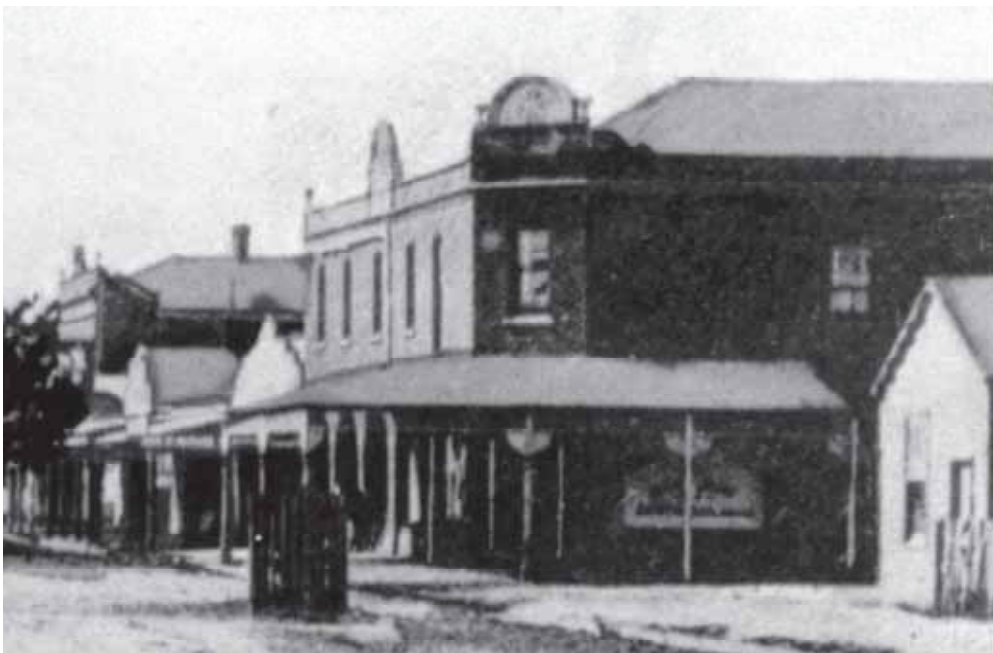
Figure H3. A photo of the Coffee Palace with both sections built. At this date the two-storey Yarram Club Hotel had not been built to the north (1912) which confirms that the second section was built pre-1912. On the west elevation of the coffee palace was a full length opening to the ground floor (for the anticipated balcony) (Stone n.d.:20).

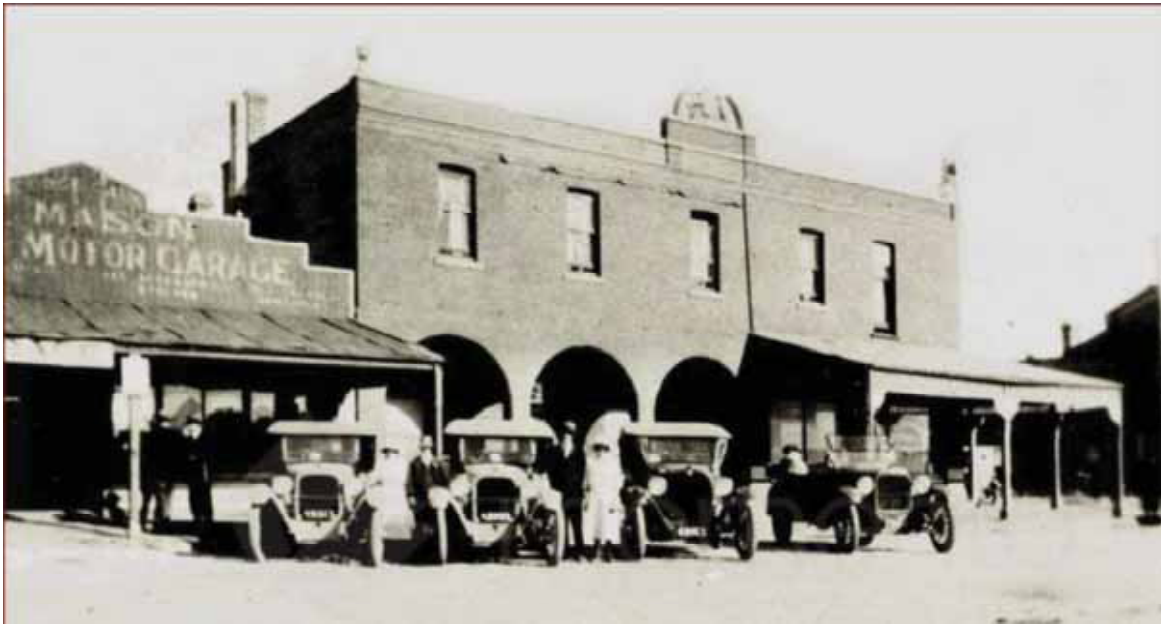
Figure H4. A photo taken after c1914 (when the Strand Hall was built to the south) The full extent of the west elevation was evident, with the return verandah to the shopfront (Stone n.d.:31).

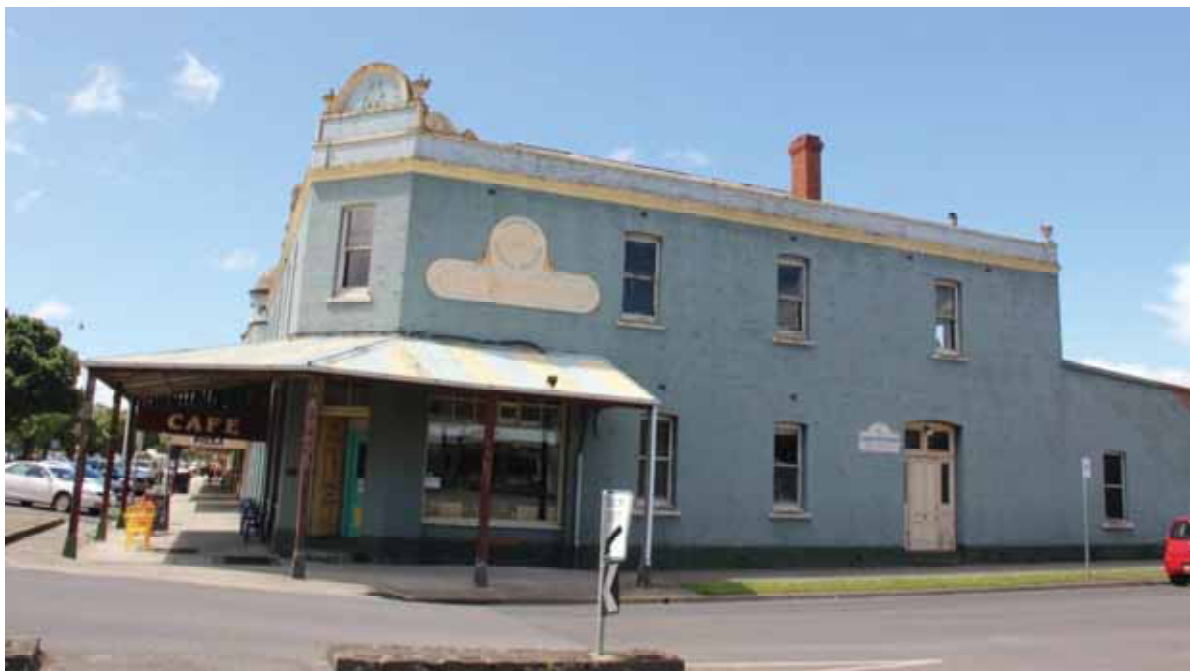
Figure D1. The two-storey building has a hipped roof clad with corrugated iron, and is constructed of handmade tuck pointed red-bricks (overpainted), with a brick plinth. Both main elevations have a rendered (overpainted) parapet above a bold cornice moulding; the southern elevation retains the urn at the end.

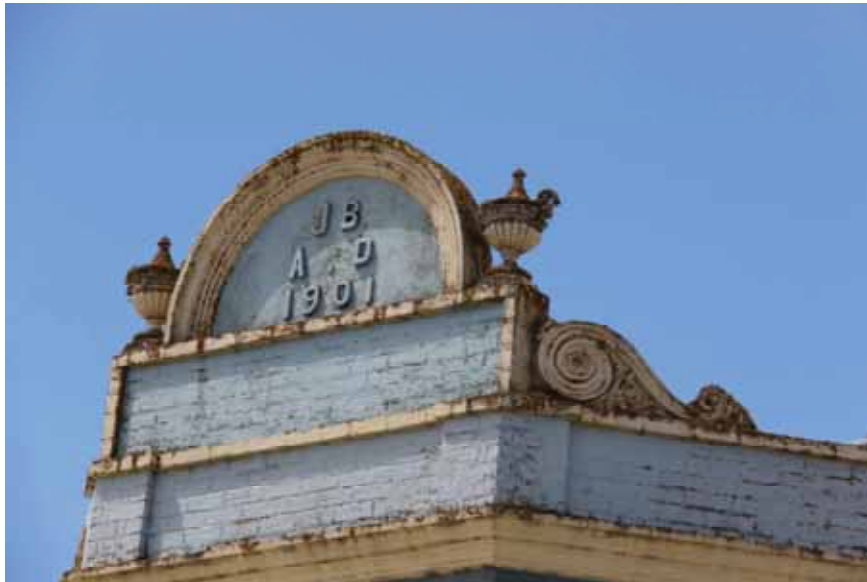
Figure D2. The chamfered corner entrance has a round-arched section above the parapet, with consoles and urns either side. The face of the arch bears the words 'JB A.D 1901' in relief.

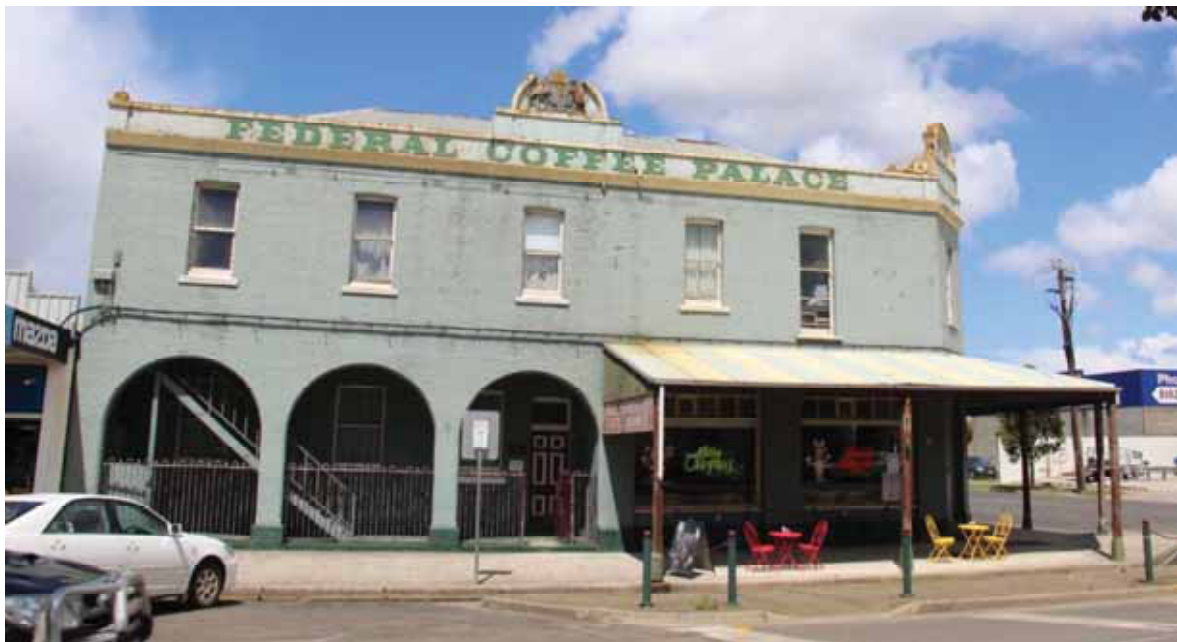
Figure D3. The west elevation comprises the 1901 section (with the verandah) and c1905 section (loggia with the round arches to the ground floor). Above the centre of the parapet is a projecting section that holds the coat of arms.

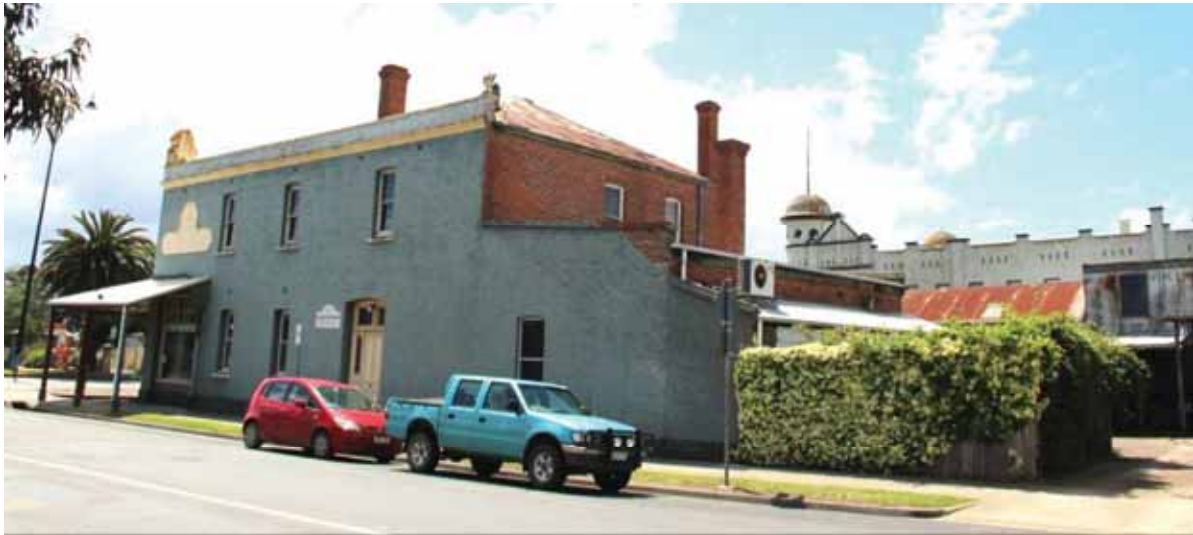
Figure D4. The rear (east) elevation has a small modern addition off the 1901 single-storey section (on the south boundary). Outbuildings (shed and carports) are located along the northern boundary to the rear.

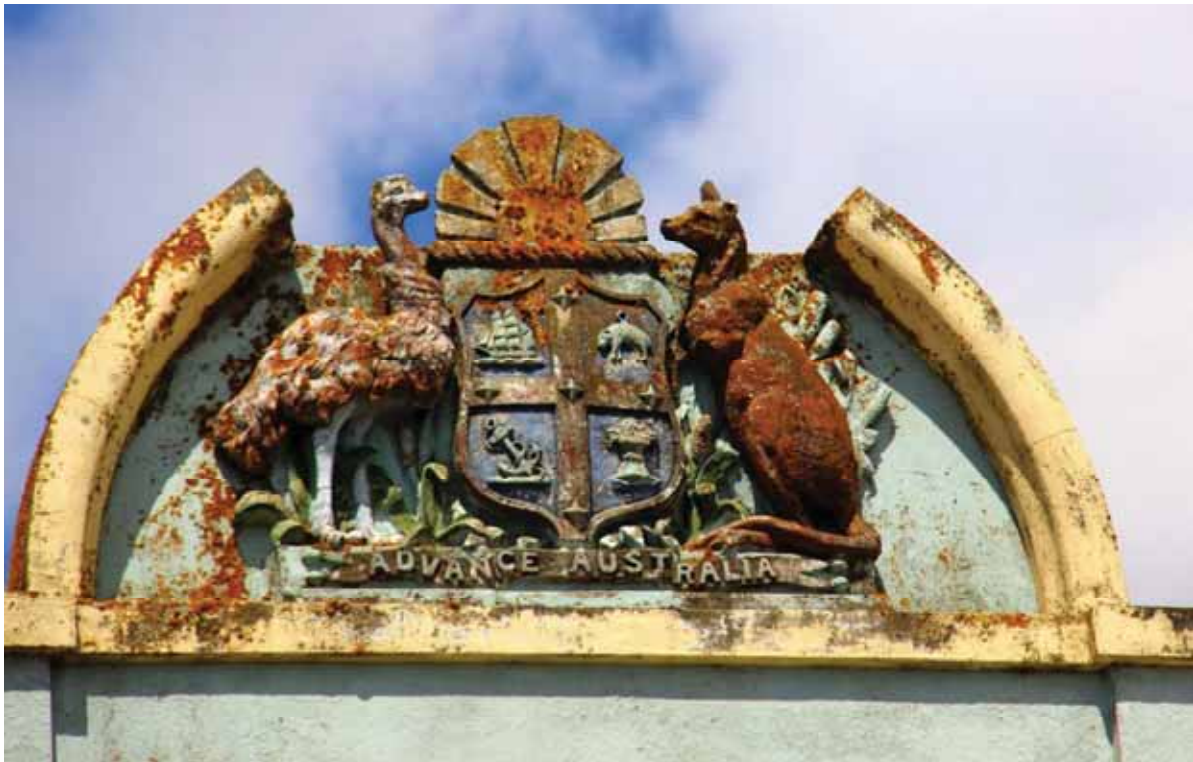
Figure D5. The patriotic Coat of Arms of Australia, located on top of the parapet facing Commercial Road, in the c1905 section of the building, not long after Federation. The kangaroo is on the right and the emu on the left, which is opposite to the first coat of arms for the Commonwealth of Australia granted by King Edward VII in 1908).

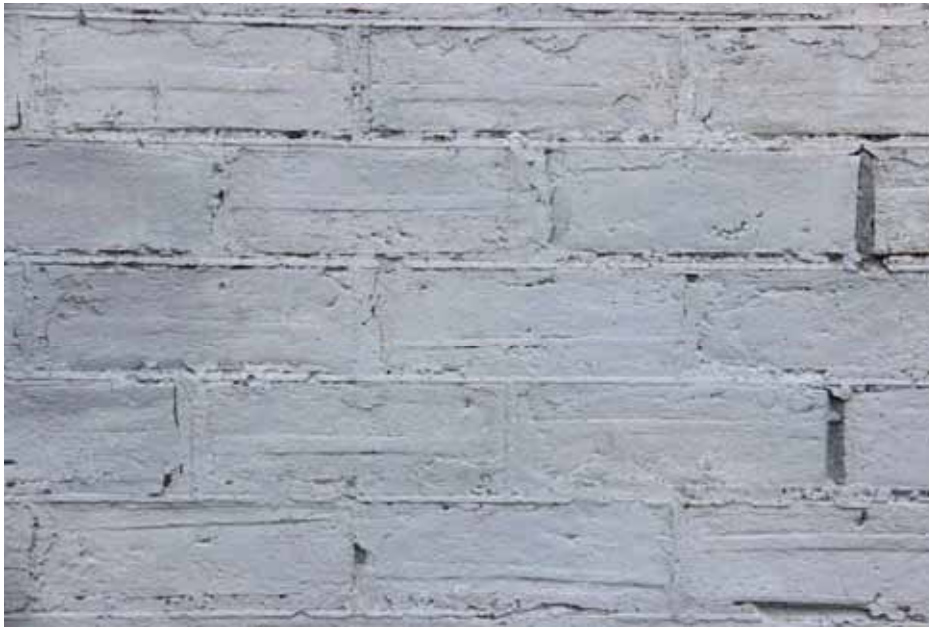
Figure D6. Detail of brickwork with highly skilled craft of tuck pointing (the fine, thin, straight lines in the middle of the mortar joints). Some of the tuck pointing has come off over time. The mortar between the red brickwork would have been coated with a red oxide wash, and the white tuck pointing ribbons applied over the top to give a crisp and precise finish.

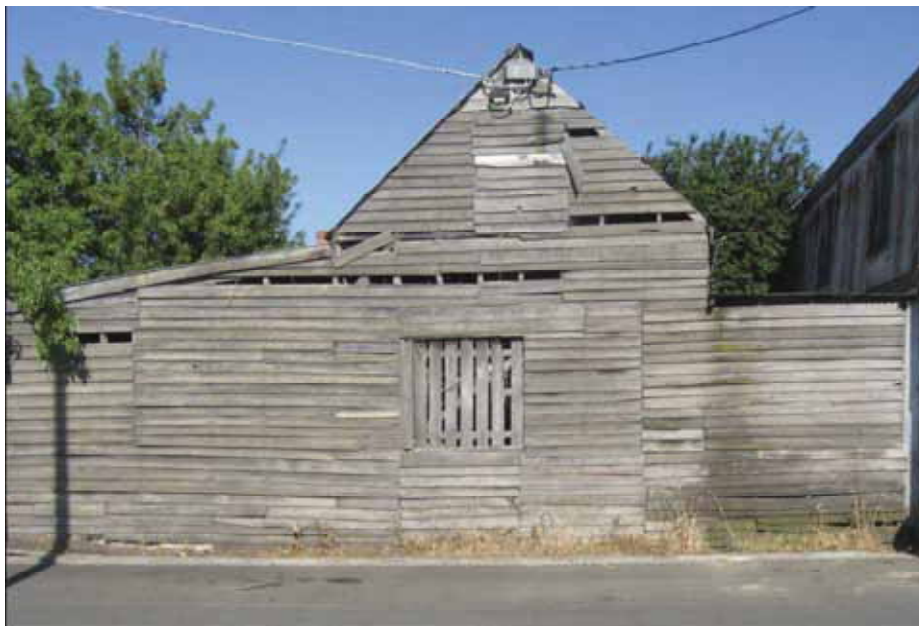
Figure D7. A timber outbuilding remains on the east boundary, which is an early stable (date not confirmed). It has a gabled roof with a filled in opening in the gable end, and another one below, and skillion additions off the long elevations.
