Locality: BRIAGOLONG
Place address: 1 AVON STREET
Citation date 2016
Place type (when built): Church
Recommended heritage protection: Local government level
Local Planning Scheme: Yes
Vic Heritage Register: No
Heritage Inventory (Archaeological): No

Place name: St Patrick's Catholic Church

Architectural Style: Federation Gothic
Designer / Architect: T. A. Payne
Construction Date: 1905

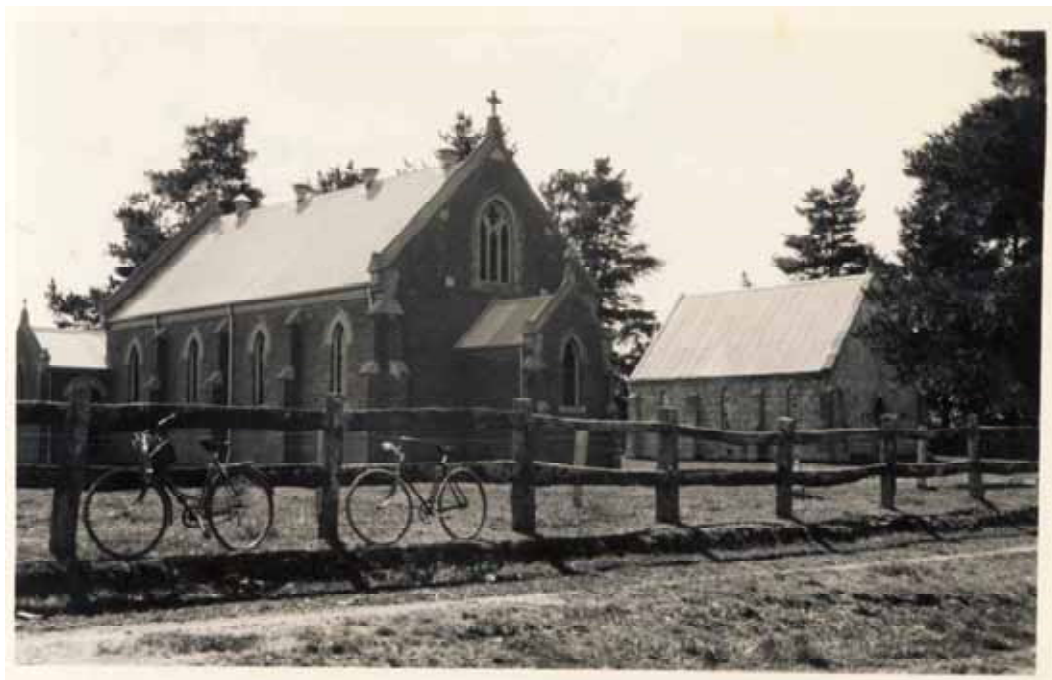
Figure H1. A photo dating to 1918 that showed the existing brick church and the original 1878 Catholic Church constructed of stone, since removed. Mature exotic trees were evident in the background (since removed), and a post and rail fence ran along the front boundary (since removed) (MDHS, ID. P03789VMFF 1918).

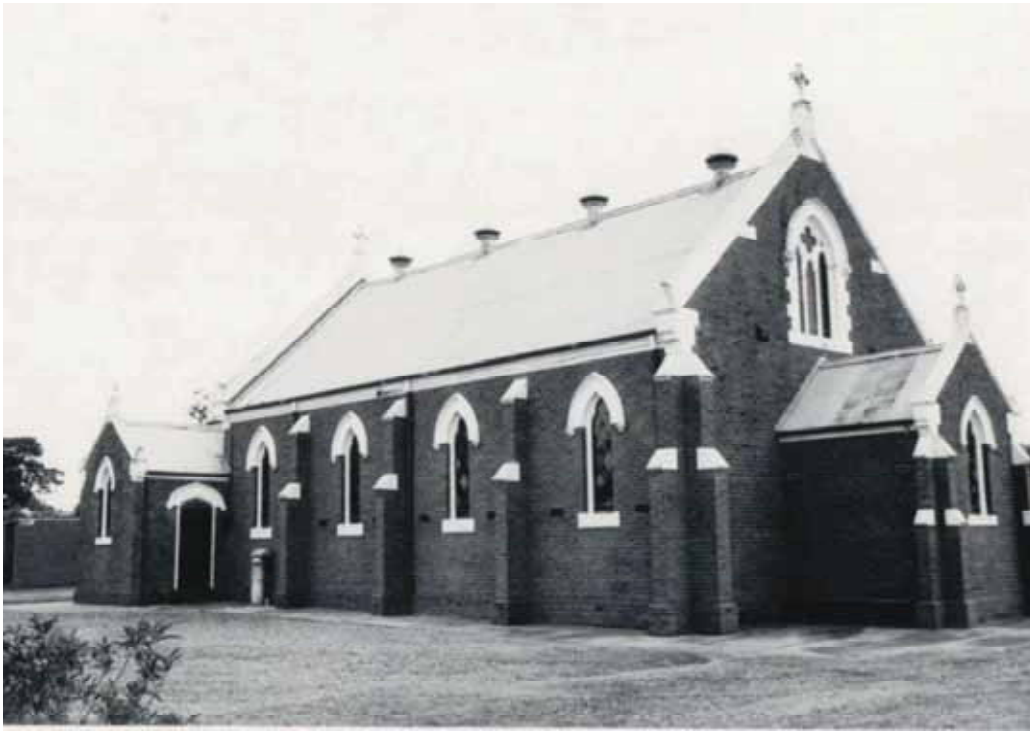
Figure H2. Photo dating to 1976, showed the vents along the ridge of the roof remained at this date and the rendered decoration had been overpainted (MDHS, ID. P02790VMFF 1976).

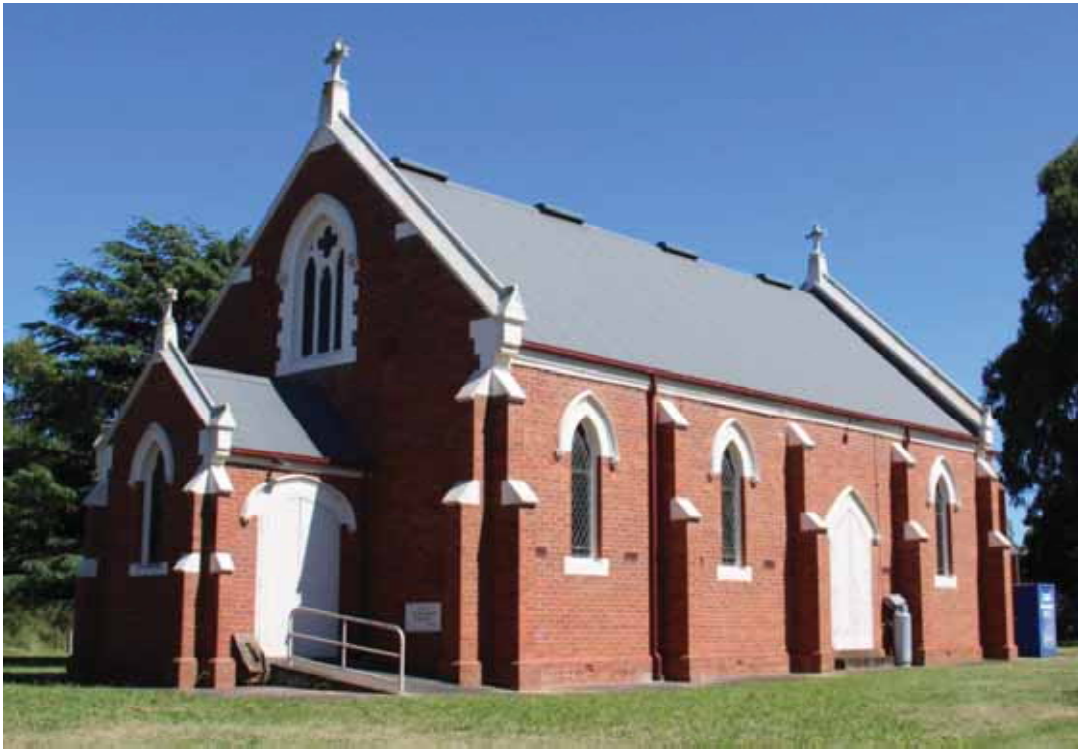
Figure D1. The church constructed of handmade red bricks, with its gabled roof and central entrance porch. Decorative render and coping is a decorative element of the Federation Gothic design, overemphasised by the recent white paint.

- 4.3.1. It is recommended to paint the exterior timber elements of the building using original colours (paint scrapes may reveal the colours) to enhance the historic architecture and character.
- 4.3.2. Paint removal: It is strongly recommended that the paint be removed chemically from the rendered elements, (never sand, water or soda blast the building as this will permanently damage the bricks, mortar and render. Never seal the bricks or render as that will create perpetual damp problems). Removal of the paint will not only restore the elegance of the architecture, but it will remove the ongoing costs of repainting it every 10 or so years.
- 4.3.3. However, if it is decided to repaint the render, it should be one colour only, (do not paint the base a different colour) and closely resemble the light grey colour of 'new render'.

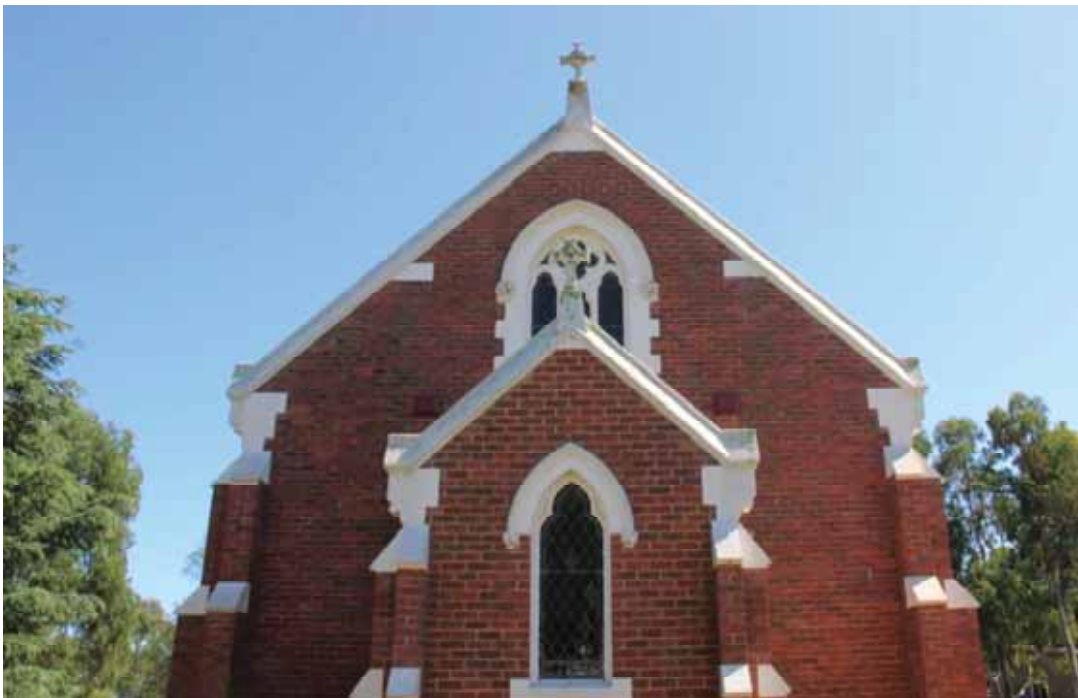
Figure D2. The church has pointed-arch window openings with a label moulding stopped by rosettes and a rendered sill. Recessed within each opening is a leadlight window (of coloured glass in a diaper pattern) which finishes at the top in a trefoil motif.

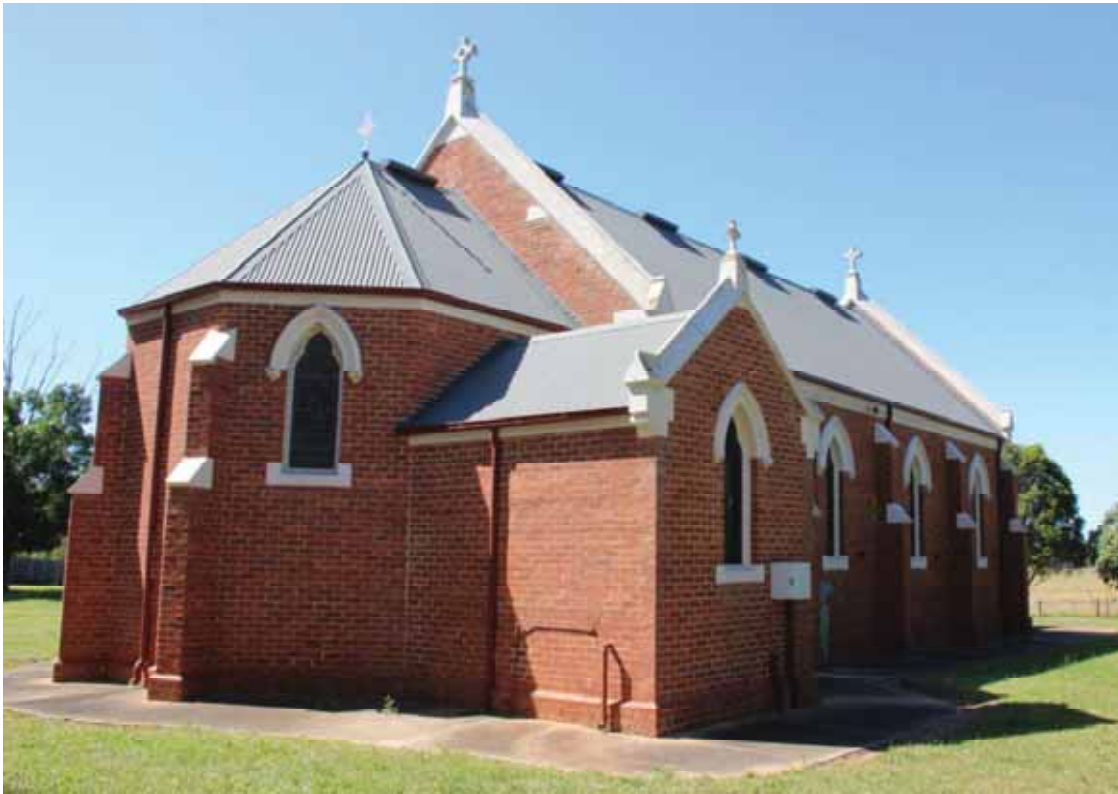
Figure D3. The side elevations form four bays, divided by five buttresses (all with rendered coping). At the (rear) chancel end of the church is a faceted bay with smaller windows at a raised height. Projecting off the west of this is a small vestry with a gabled roof.

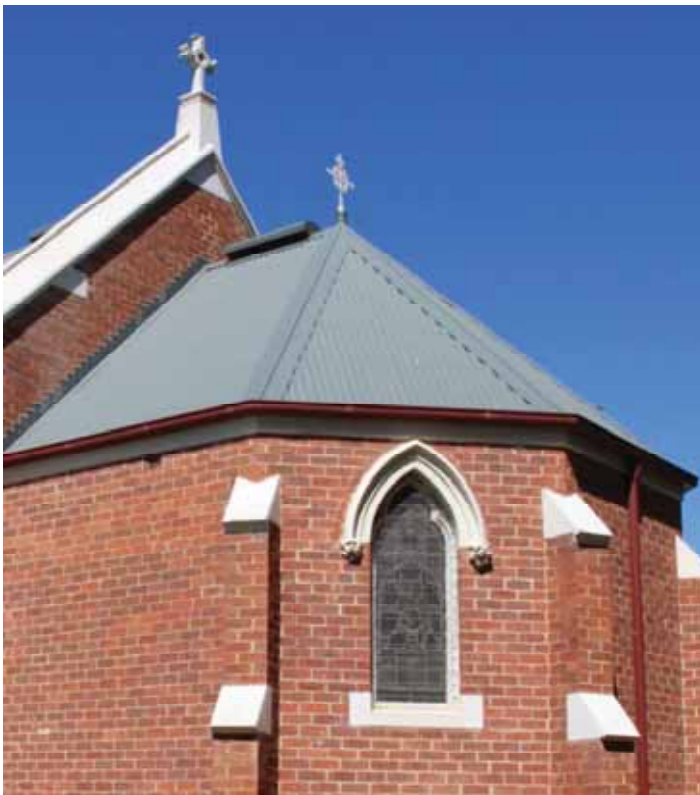
Figure D4. The windows to the bay at the chancel end have ornate leadlight.

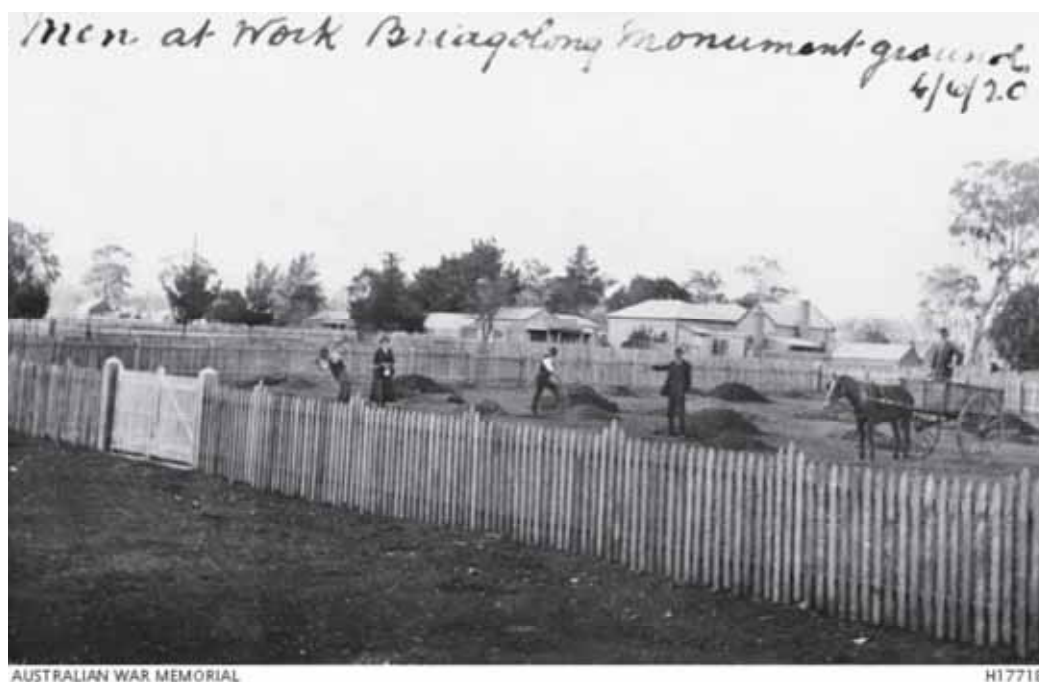
Figure H1. Picket fence, gates(the gates are facing Blundy St), preparing the grounds for the memorial and trees in June 1920. (AWM)

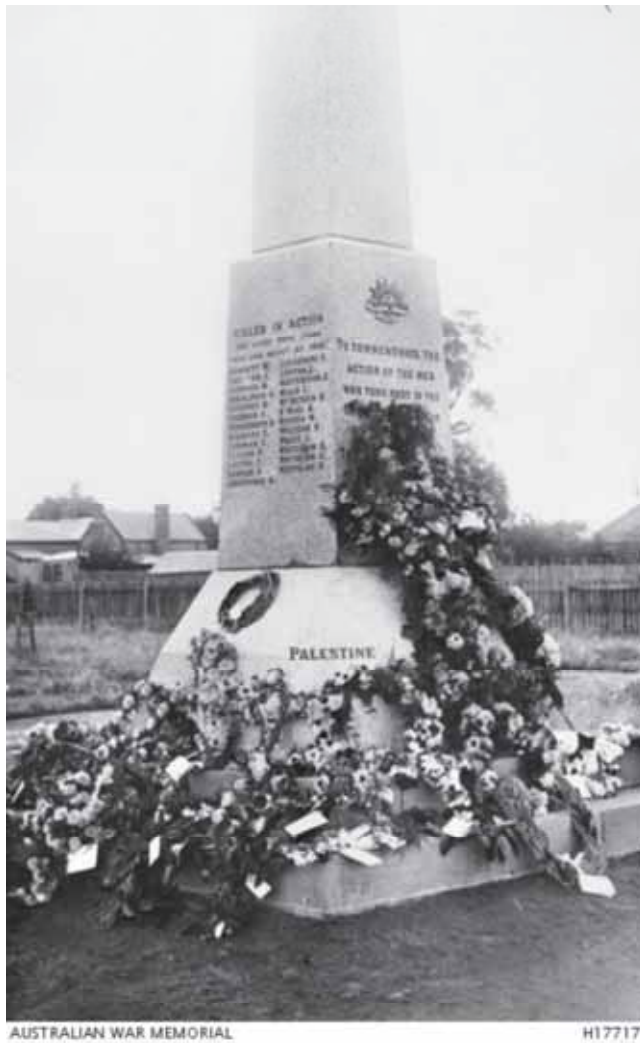
Figure H4. The Briagolong memorial, post-1921, showing trees with supporting stakes in the background (AWM).

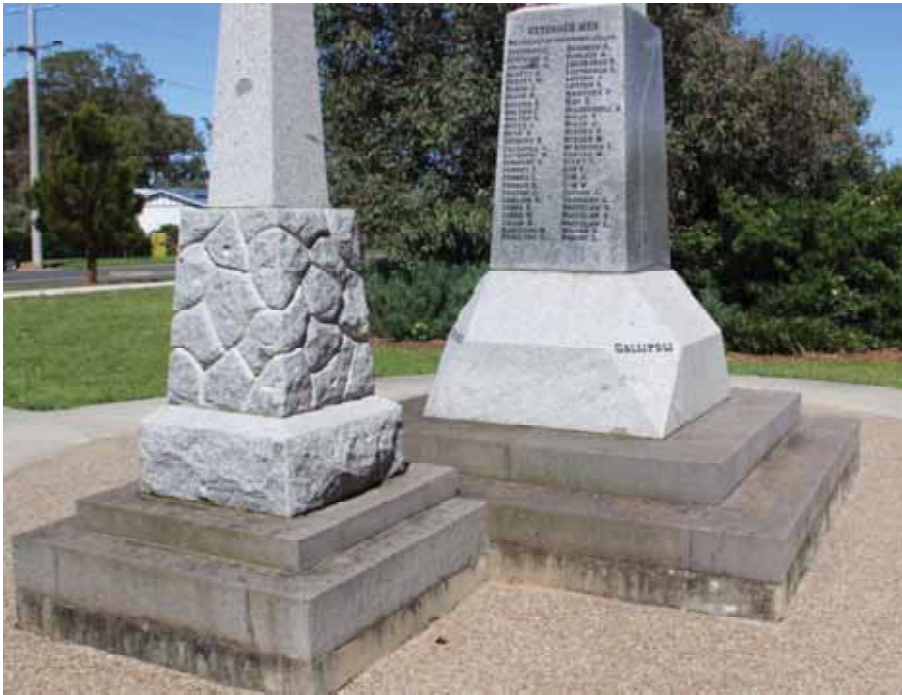
Figure D1. The base of the 1920 memorial on the right and the 1940s memorial on the left.

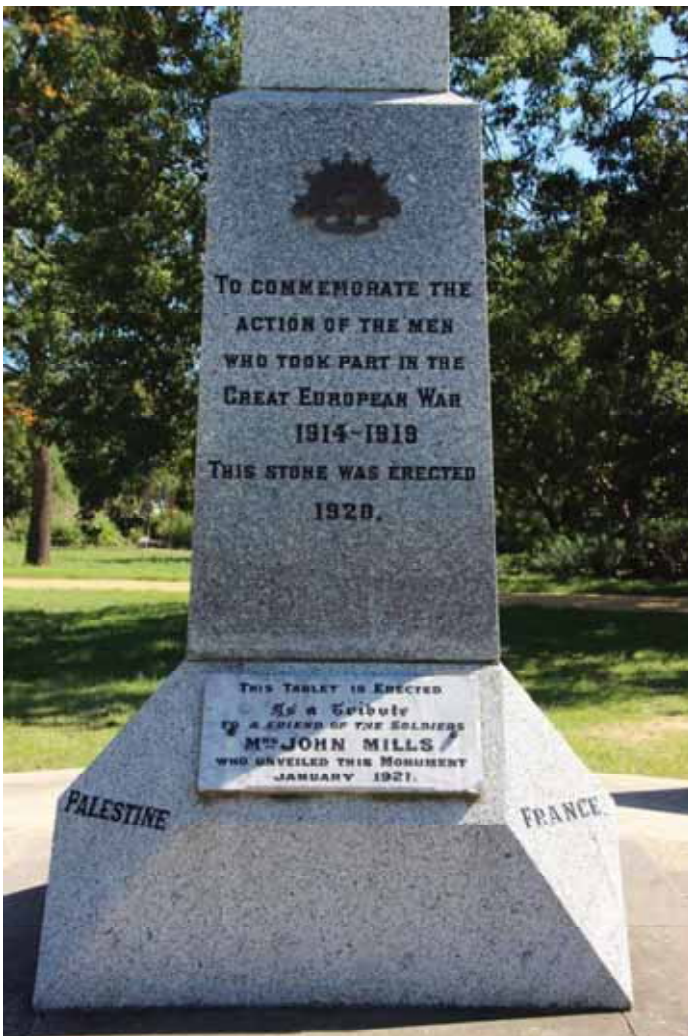
Note the hand tooled faceted granite base, with a white marble tablet fixed onto one facet (which has a damaged surface; may have been by acid washing) and the polished granite pedestal above that. The lettering in the polished granite appears to be incised into the stone and painted black, whereas the lettering on the marble tablet appears to be lead lettering painted black. There are a small number of metal (bronze?) decorative motifs such as the rising sun.

Figure D2. Detail of lettering and materials on the base of the 1920 memorial.

- 2.2. The biggest risk to memorials is permanent damage by the use of cleaning materials, agents and methods. E.g. Acid washing dissolves the marble which cannot be undone, sand and water blasting remove the stonemasons skilled decorative works, the polished surfaces and lettering and details.

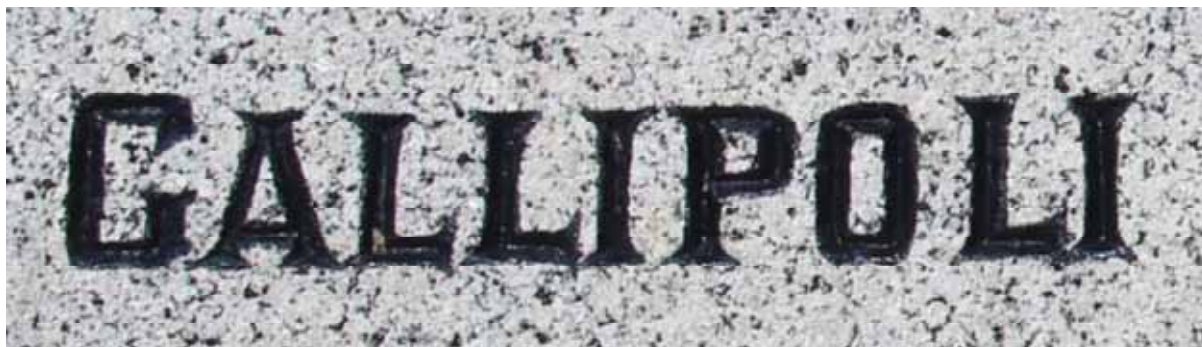
Figure D3. Lettering detail on the base of the tall 1920 monument.

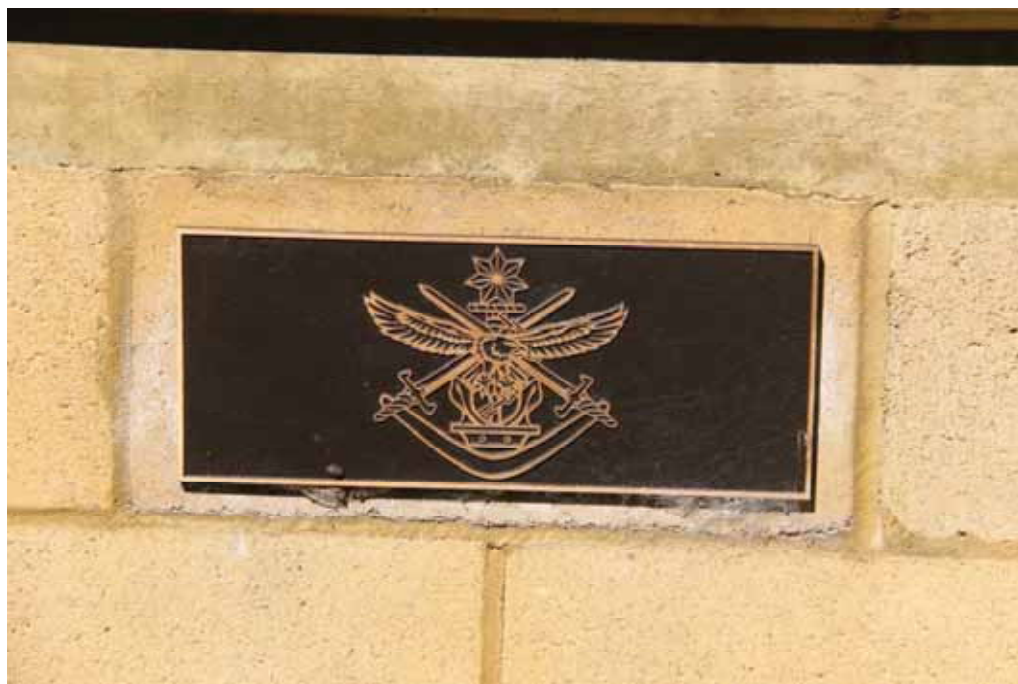
The low walls to the rear of the obelisks were constructed after 2003, of machine-made concrete blocks and modern paint and bronze plaques. The contrasting design, materials and colours of the recent memorial walls provide a back drop and 'enclosure' for the earlier memorials.

Figure D4. Detail of a plaque on the recent low walls to the rear of the earlier monuments.

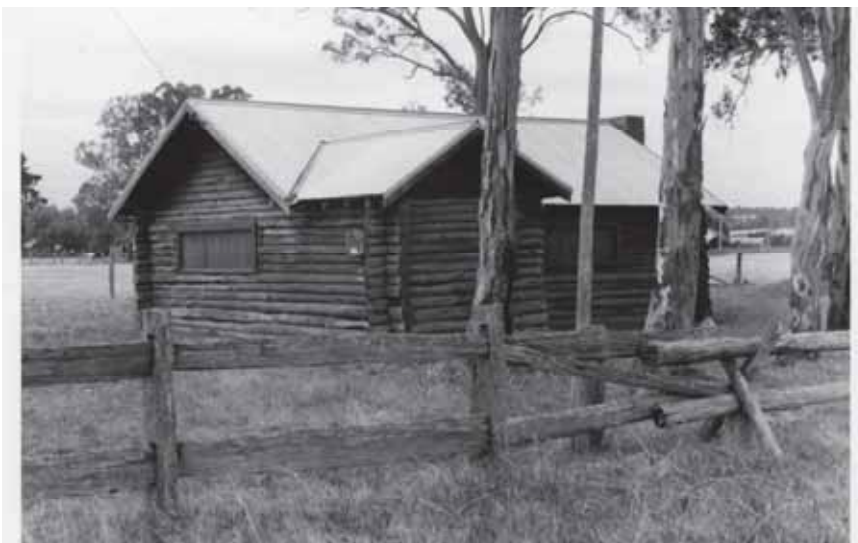
Figure H5. The west elevation of the cabin. Photo probably also dates to c1968 (SLV).

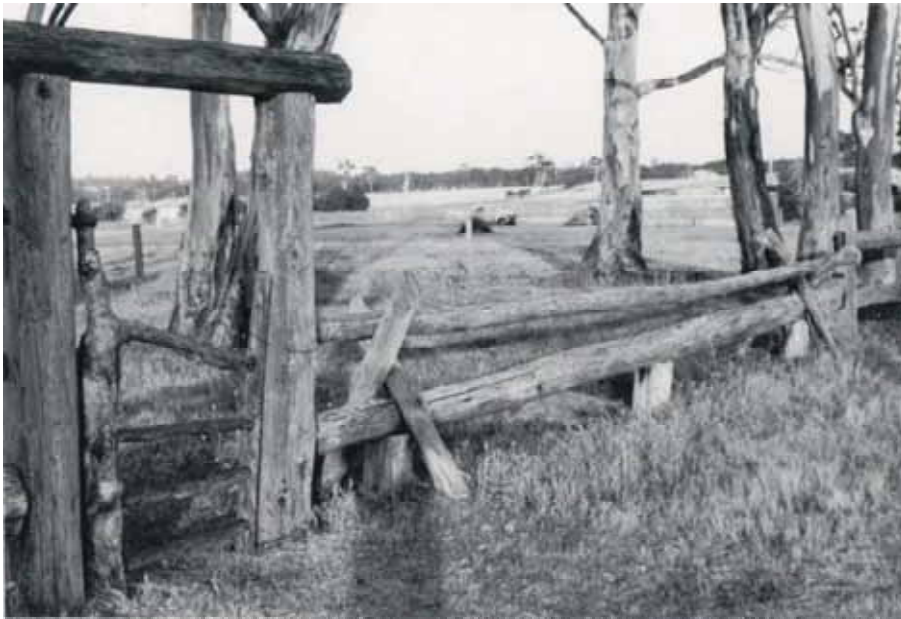
Figure H6. A photo dating to c1968, showing the original fence and Gillio's Gate at this date (Briagolong History facebook page No. MDHS 02797VMFF).

- 4.3.1. Replace/reconstruct the existing fence with the original bushman's fence design.

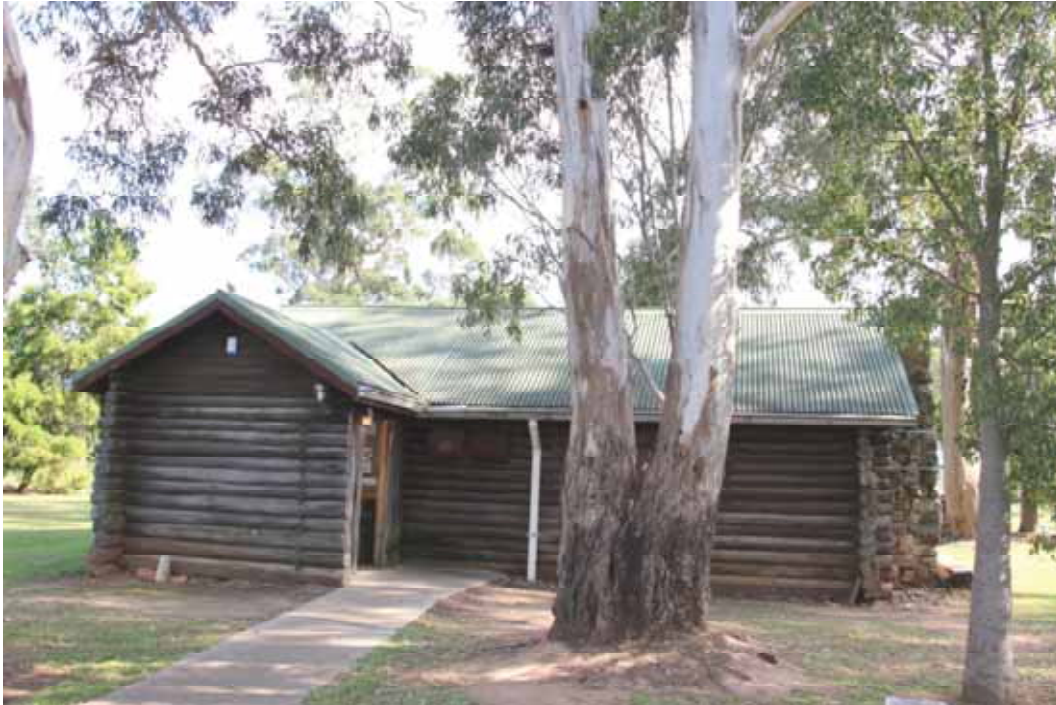
Figure D1. The south elevation of the cabin, which faces Avon Street. The entrance is off the east side of the entrance porch, to the left of the building.

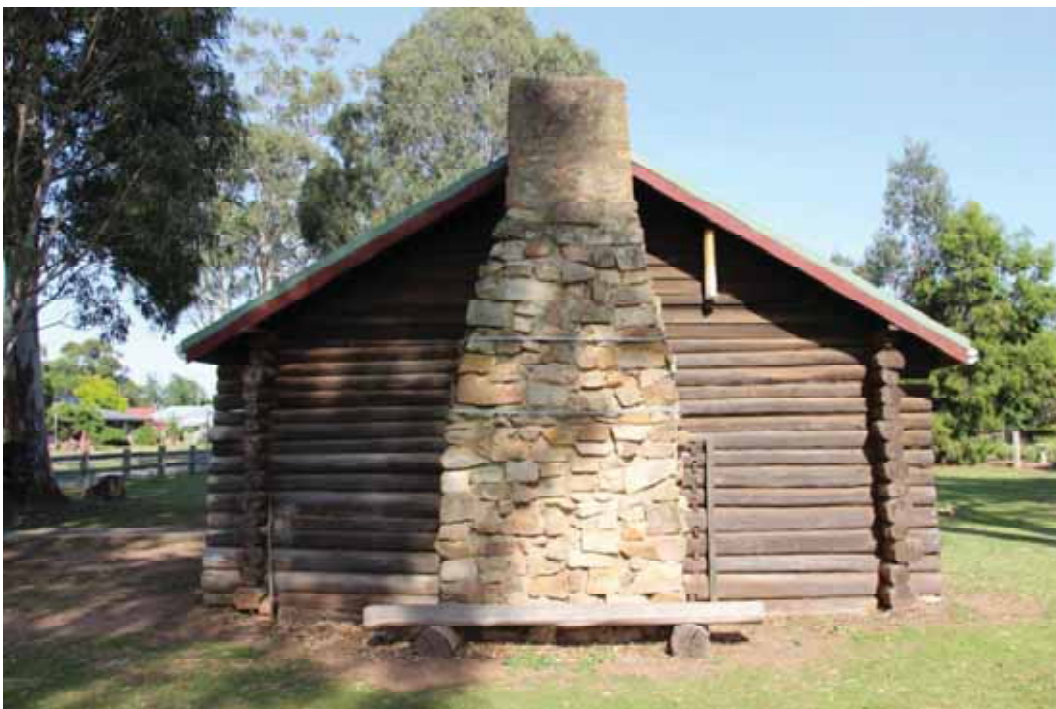
Figure D2. The east elevation with the large stone chimney stack, with a red brick top.

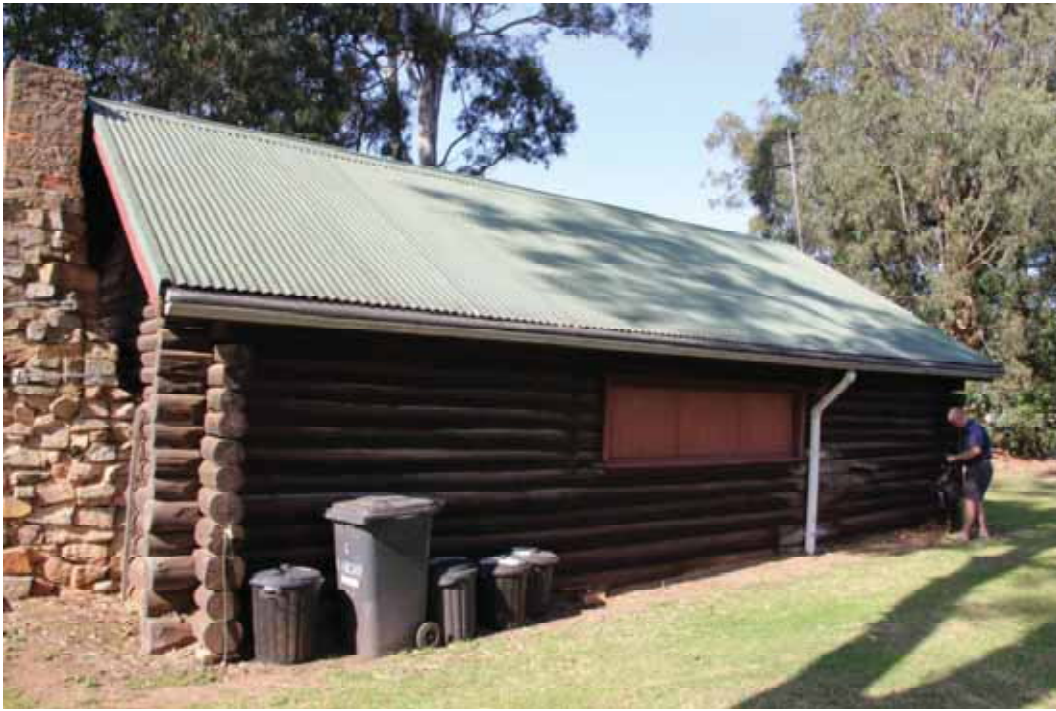
Figure D3. The north elevation with its wide timber-framed window with its original timber shutters (like the main elevation).

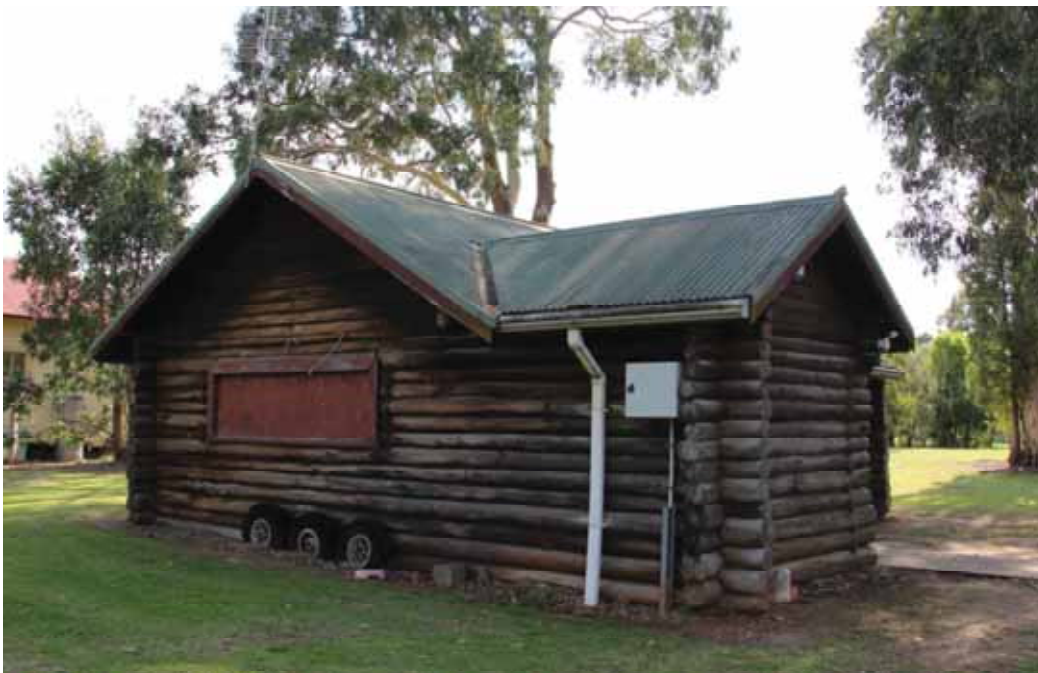
Figure D4. The west elevation and its shorter version of the timber-framed window.

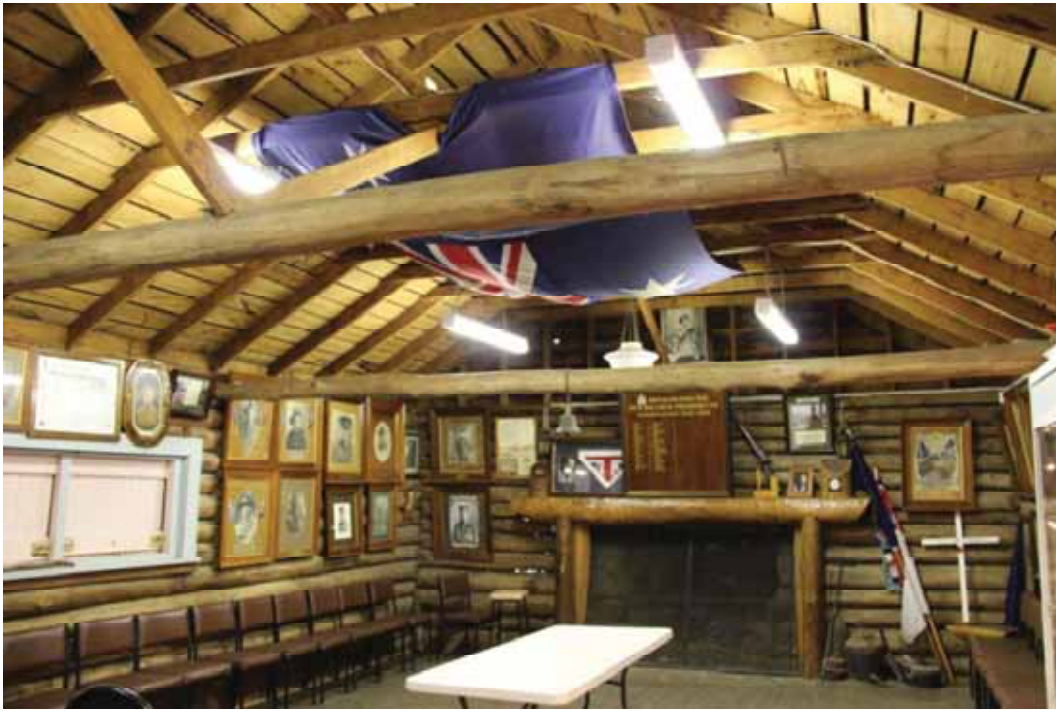
Figure D5. The interior of the log cabin is in very good condition and has a very high level of integrity, retaining its original timber elements. The interior walls are not lined, with the Yellow Stringybark logs evident.

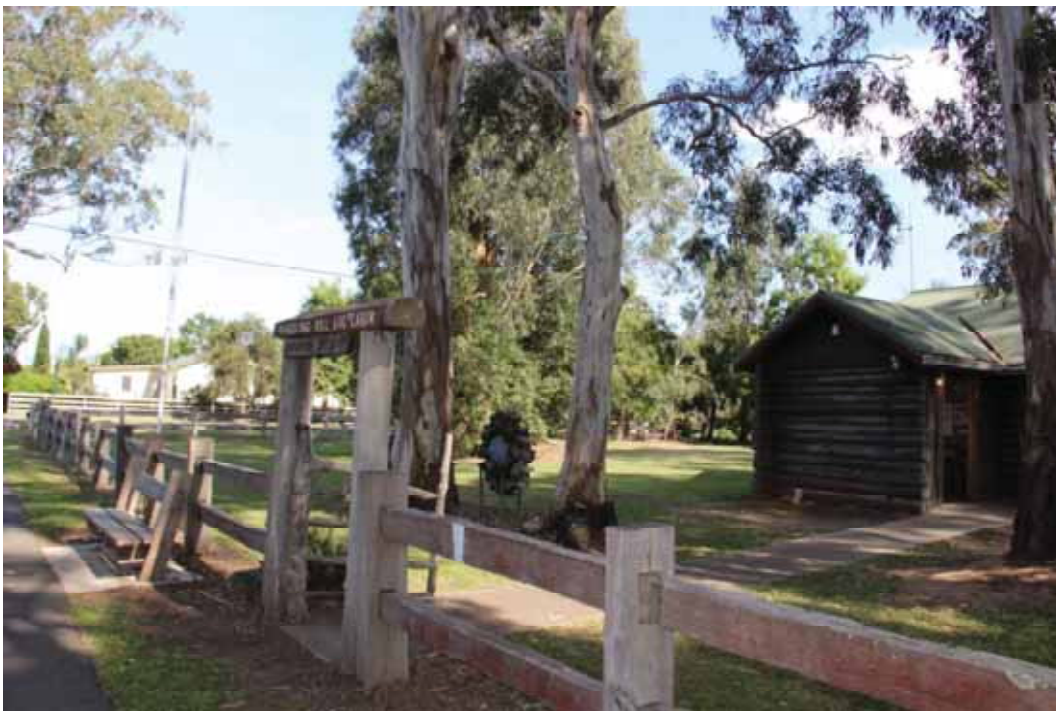
Figure D6. The original gate, 'Gillio's Gate' and the c1980s archway and timber fence. Inside the fence are a collection of aeroplane engine parts.

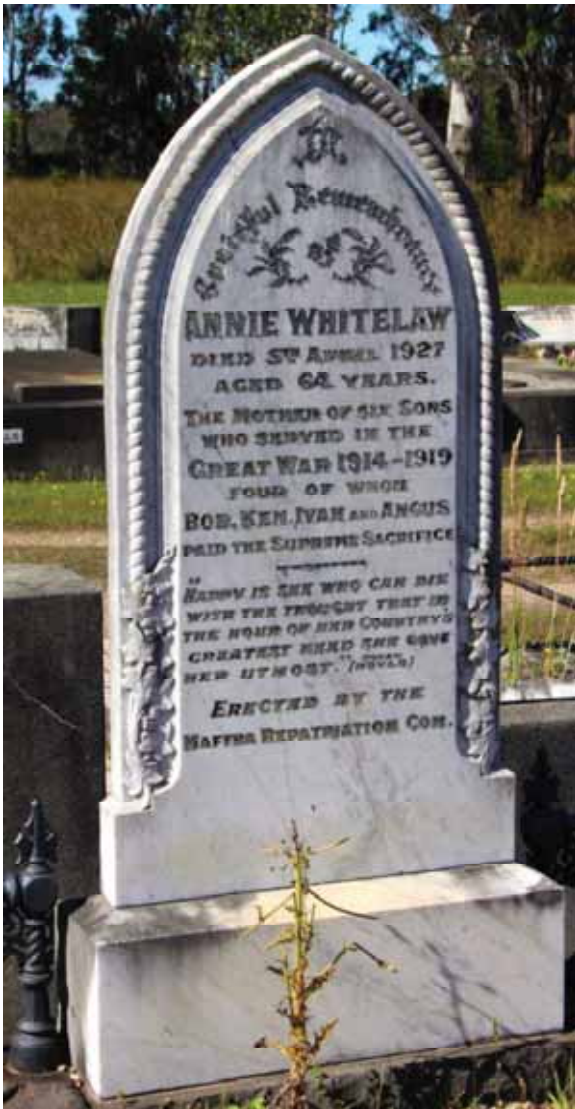
Figure D1. View of the front of the gothic memorial headstone and base, both made of marble with hand carving and lead lettering.

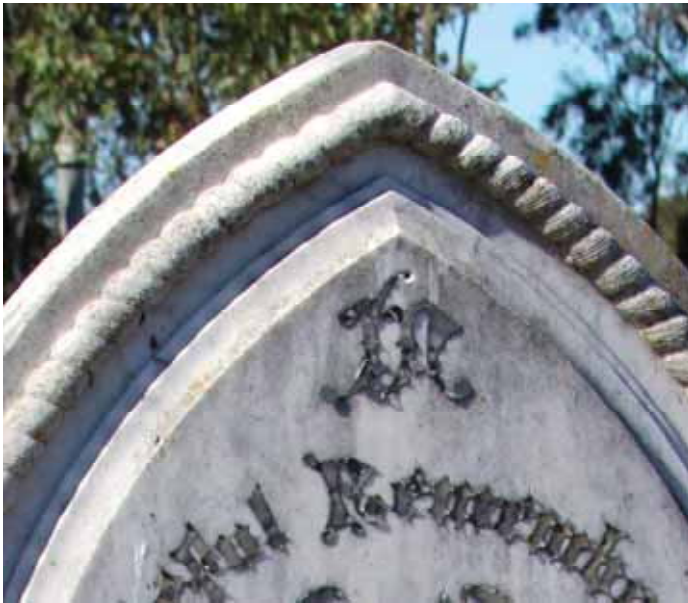
Figure D2. Detail showing the carved 'rope', gothic pointed arch, and deteriorating lead lettering on the marble memorial headstone.

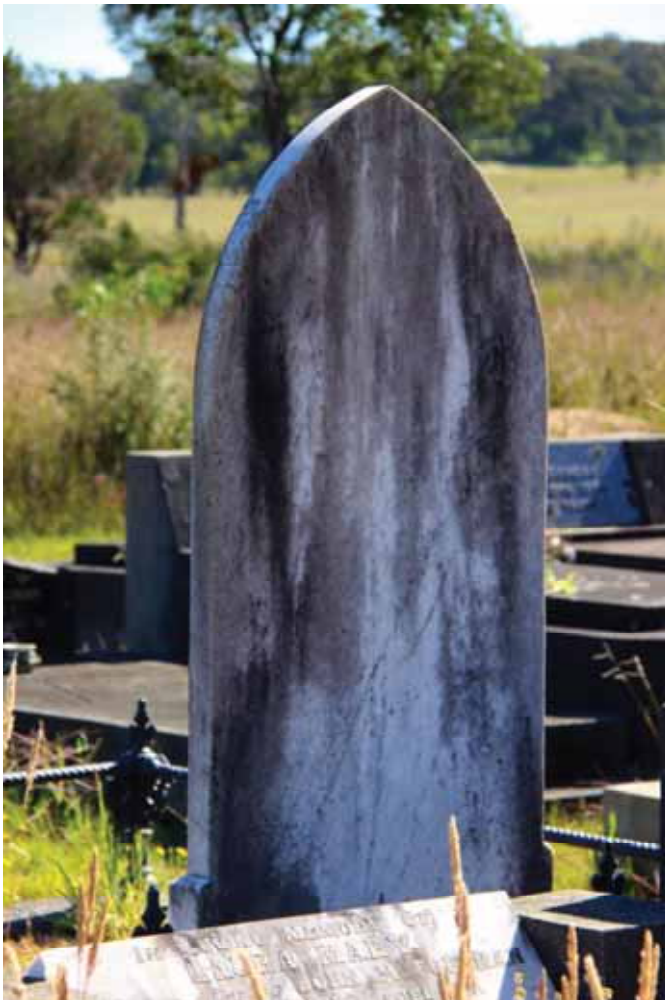
Figure D3. Back of the gothic memorial headstone showing black algae growth.

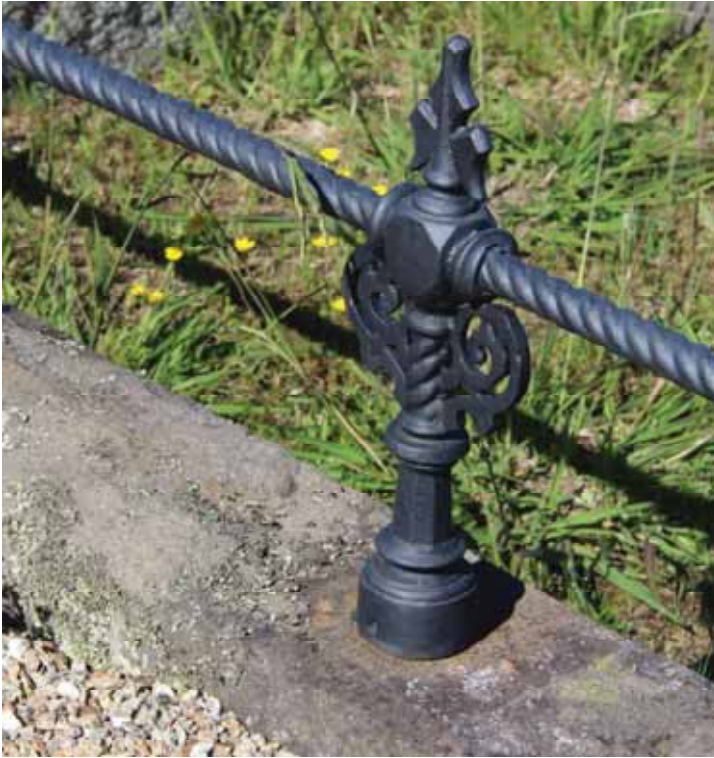
Figure D4. Detail showing lichen on the bluestone plinth, and 'restored' cast iron rail and post.

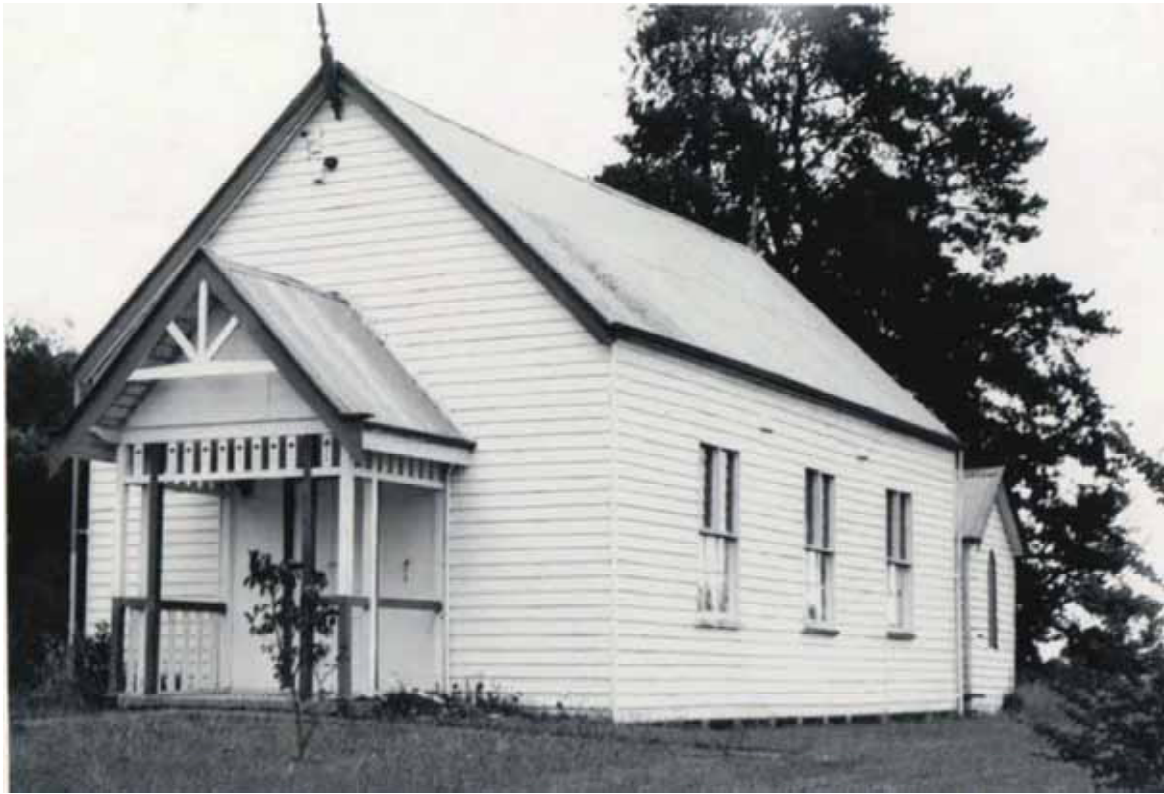
Figure H1. The church in 1976. The original porch with a pointed arch window had been relocated to the rear, and a c1970s porch added at the front. The top sashes of the side windows have been replaced with louvres. The finials to the roof evident here, have since been removed. (MDHS, ID. P02788VMFF 1976).

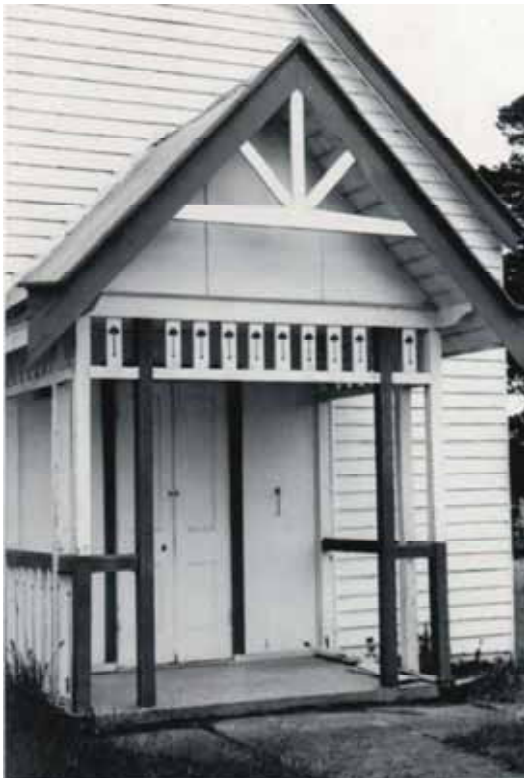
Figure H2. Detail of the porch in 1976, which probably dates to the early 1970s (MDHS, ID P02787VMFF 1976).

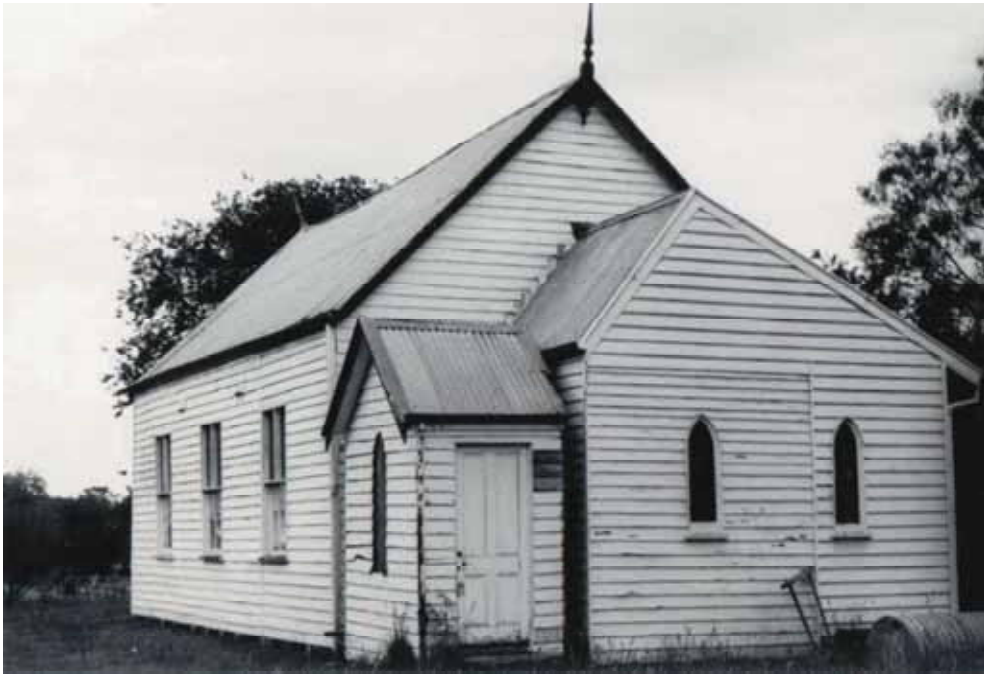
Figure H3. The rear elevation in 1975, showing the 'relocated original front porch' on the left (since removed), and an early addition to the right with similar pointed-arch windows (MDHS, ID P02785VMFF 1976).

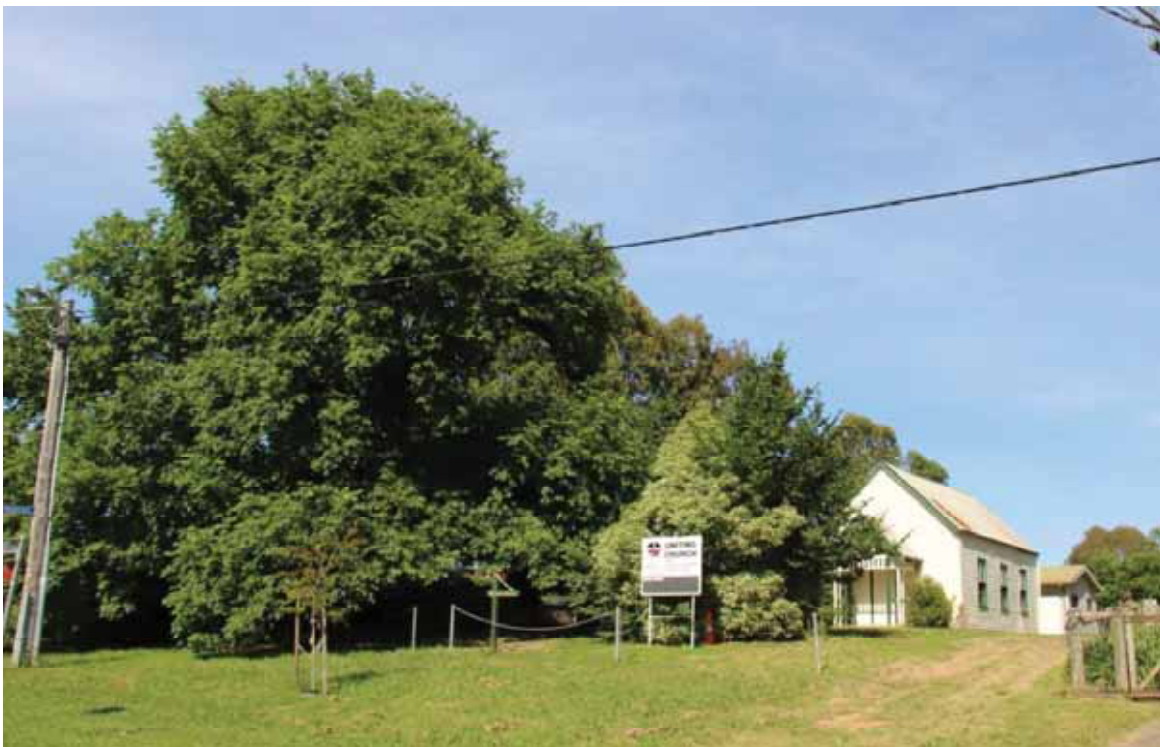
Figure D1. The picturesque church has a deep setback and is located on a slight rise, behind a mature Elm on the front boundary. A modern chain fence runs along the front (east) boundary.

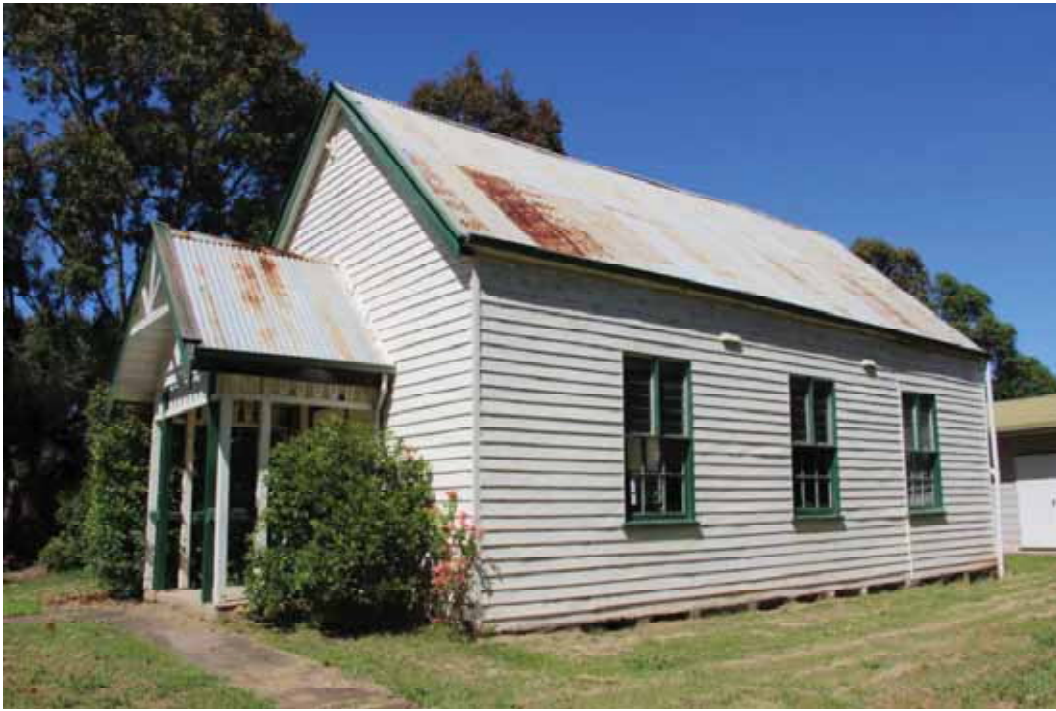
Figure D2. The modest weatherboard church has a gabled roof clad in corrugated iron, with simple bargeboards to the gabled ends, reflecting a simplified version of a Carpenter Gothic church. The side elevations consist of three windows, with six-paned sash windows to the bottom half, with a pair of modern louvered windows above.

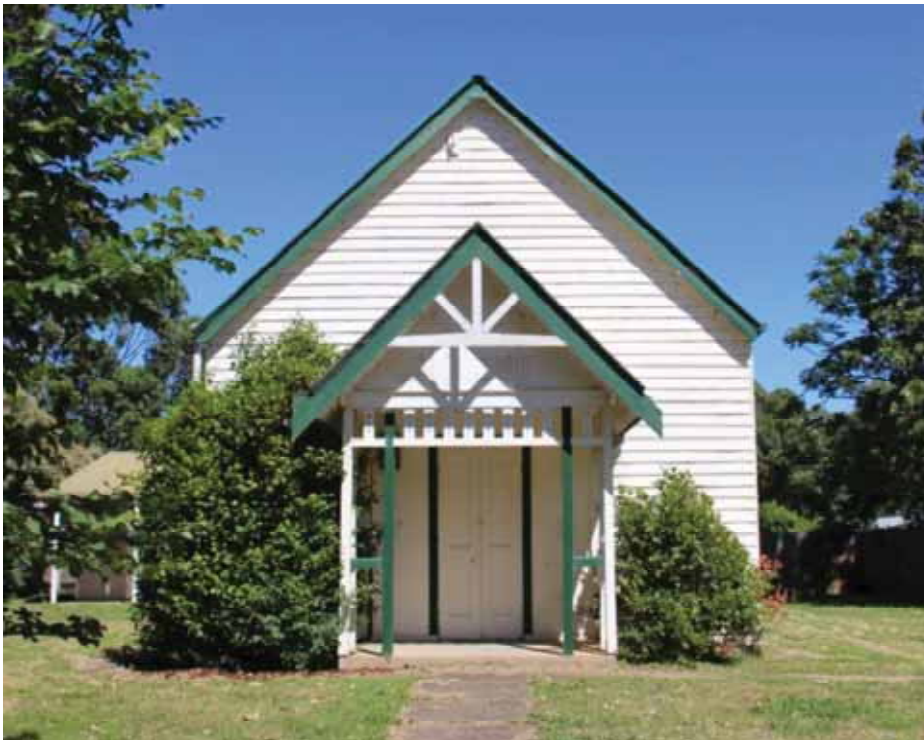
Figure D3. The façade has a c1970s central entrance porch.

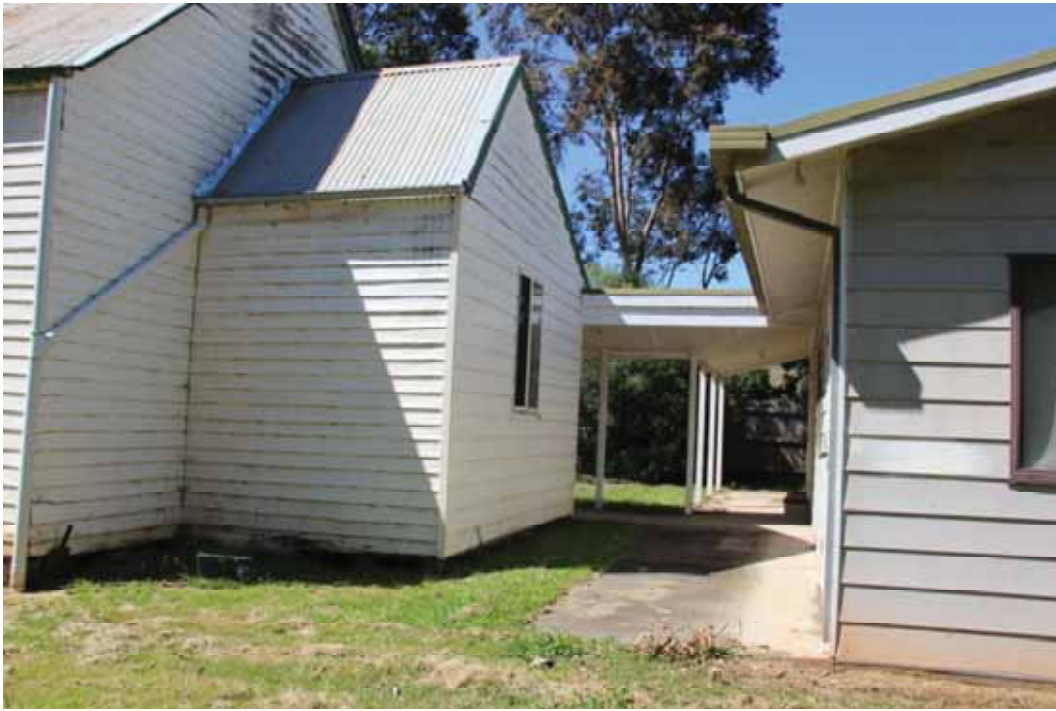
Figure D4. At the rear (west end) of the church is a small timber addition with a (uneven) gabled roof. To the west of the church is a modern weatherboard building.
