Locality: BRIAGOLONG
Place address: 1 AVON STREET
Citation date 2016
Place type (when built): Church
Recommended heritage protection: Local government level
Local Planning Scheme: Yes
Vic Heritage Register: No
Heritage Inventory (Archaeological): No

Place name: St Patrick's Catholic Church

Architectural Style: Federation Gothic
Designer / Architect: T. A. Payne
Construction Date: 1905

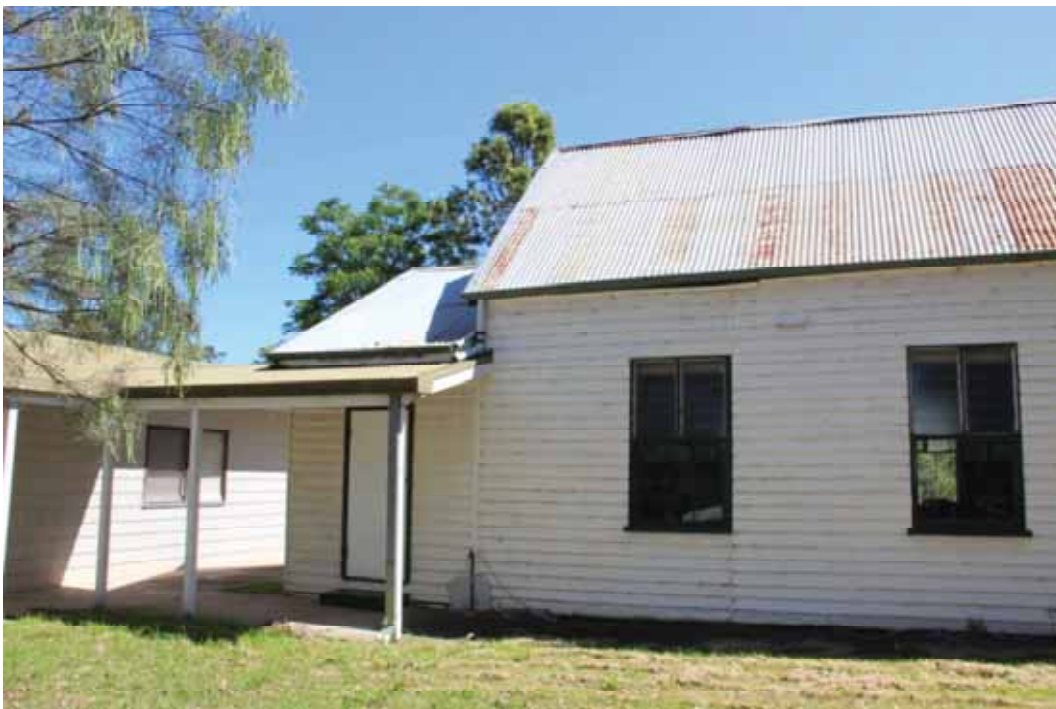
Figure D5. The rear section of the southern elevation. The modern weatherboard building to the rear of the 1874 church is connected to the smaller weatherboard room attached to the rear of the church by a modern breezeway that covers an entrance to the church off the southern elevation.

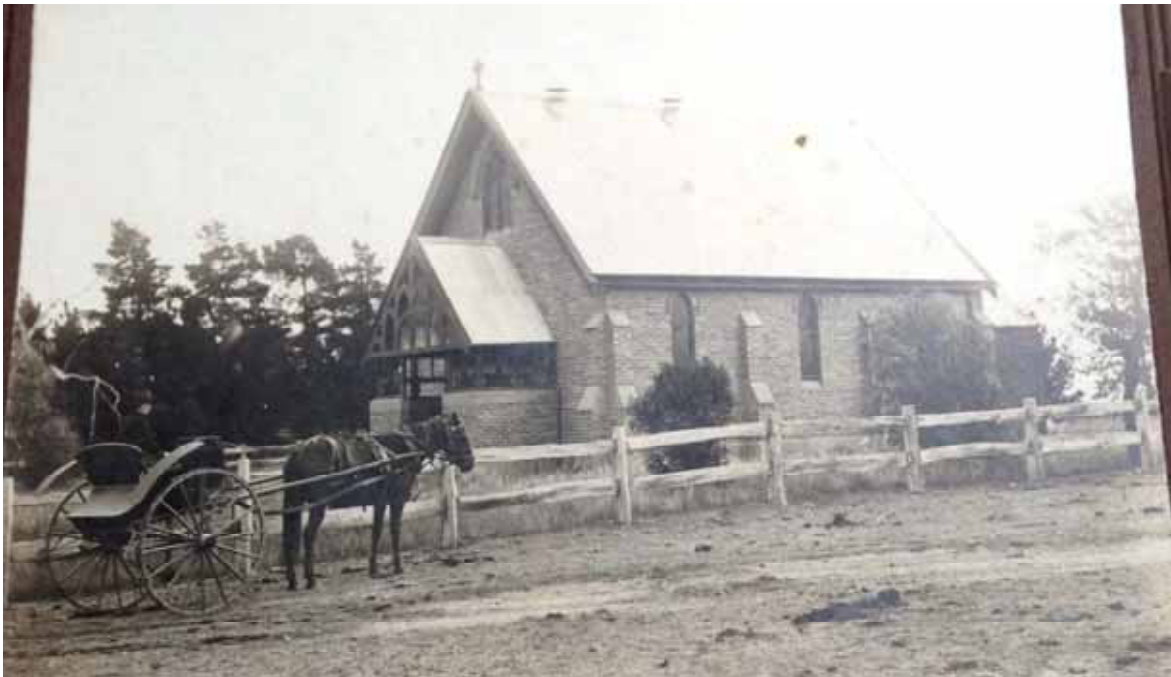
Figure H1. An early photo (date not known) of the church and its original timber work to the gabled end of the entrance porch. The rendered dressings appear to have been unpainted at this date (MDHS facebook page, photo posted by Janne Blacker).

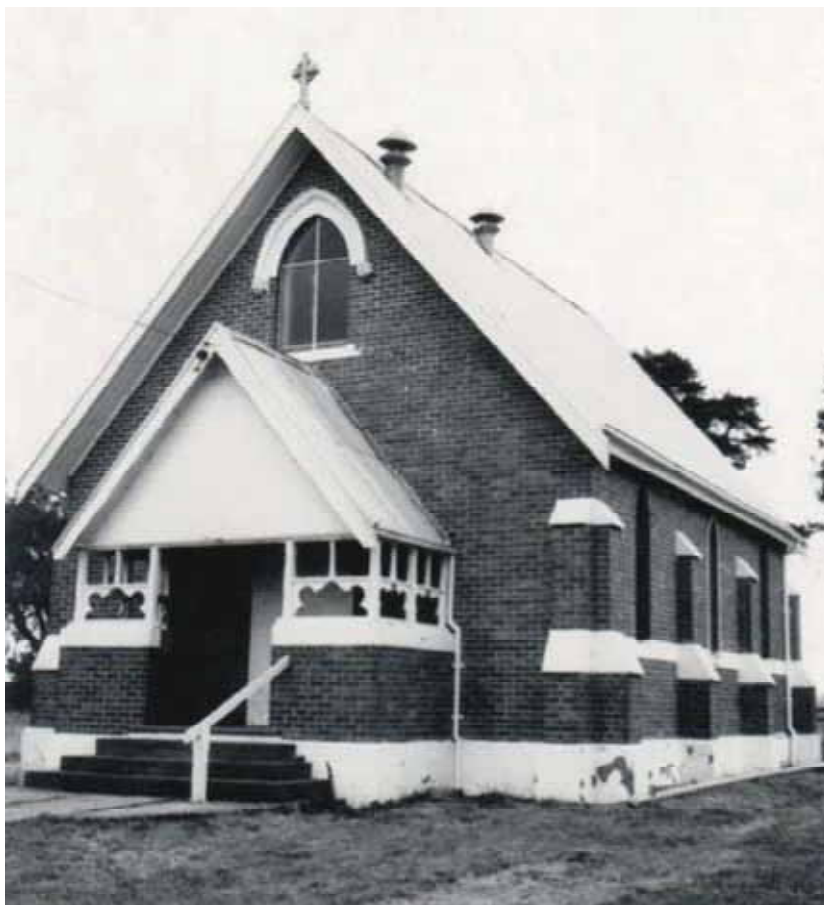
Figure H2. The facade and north elevation of the church in 1976, with the entrance porch and its plain gabled-end and single timber balustrade to the steps (MDHS, ID. P02783VMFF 1976).

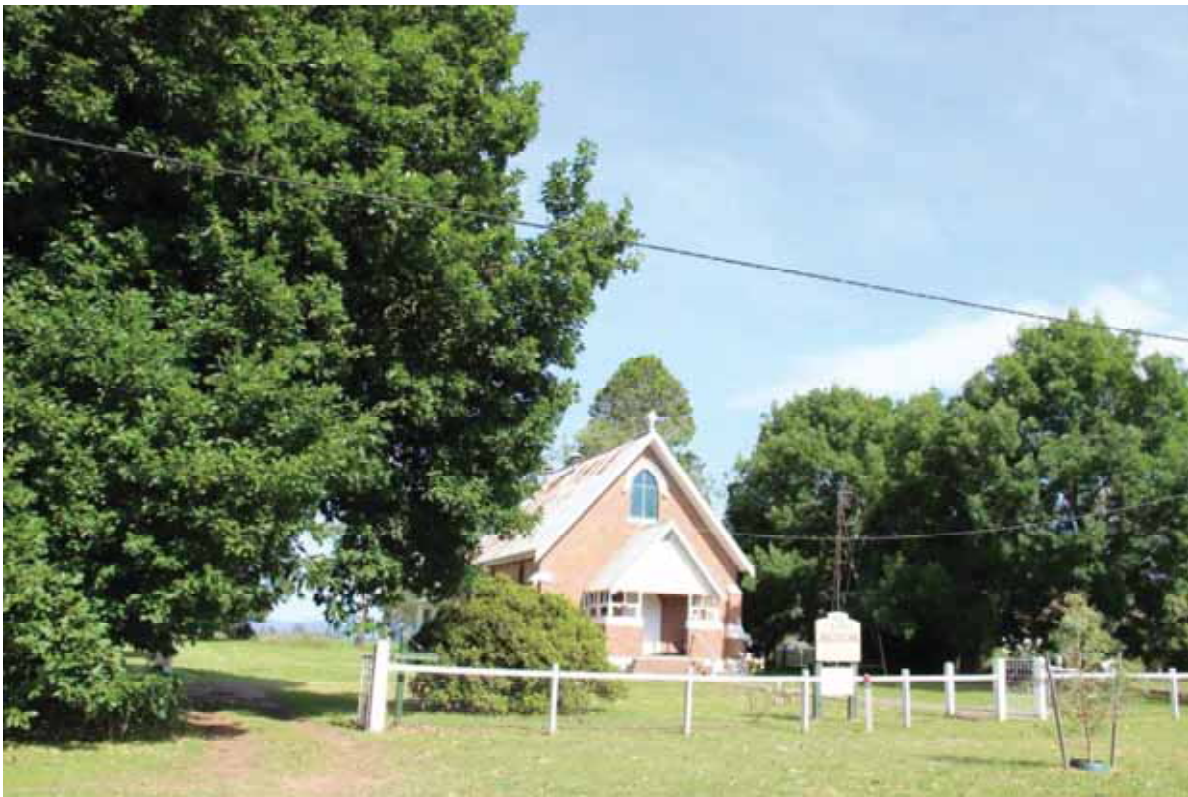
Figure D1. The picturesque setting of the church complex. The church has a deep set back, behind an early (in part) fence and gates. The boundary is lined with a number of mature exotic trees. The church has a steep-pitched gabled roof and is constructed of red brick with rendered (overpainted) dressings and coping to the buttresses on the side elevations. A dominant feature is the large entrance porch at the centre of the facade, with timber tracery.

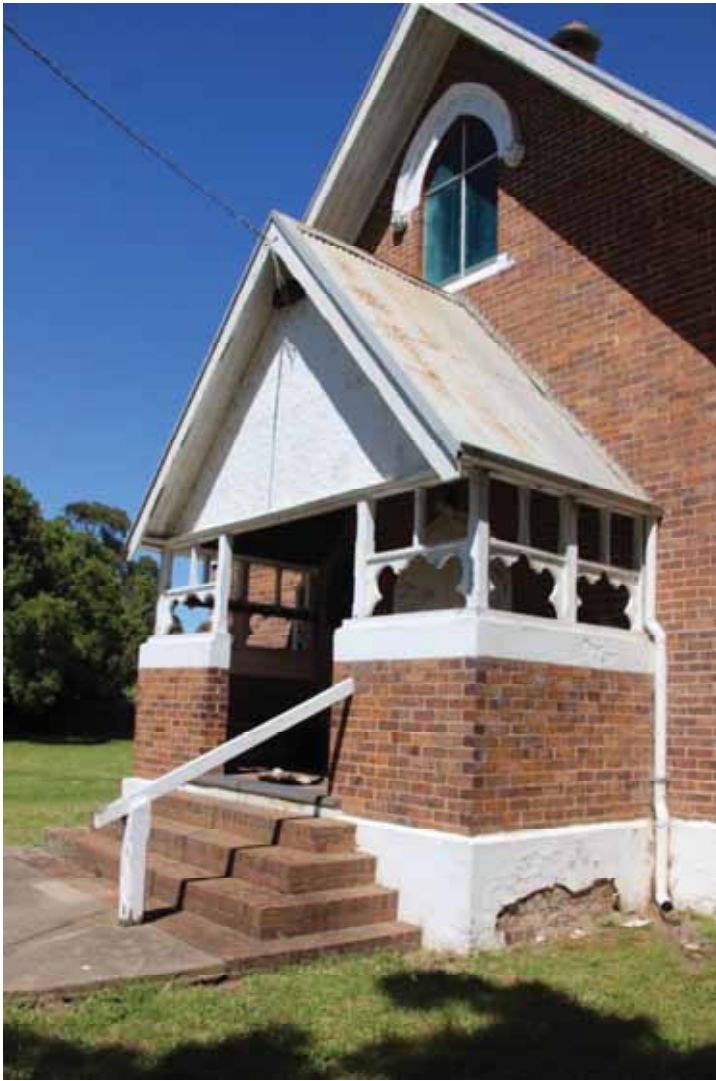
Figure D2. The entrance porch with the pressed metal cladding to the gabled end imitating a rough-cast render, timber tracery and brick balustrade. Note the damp damage to the render of the plinth.

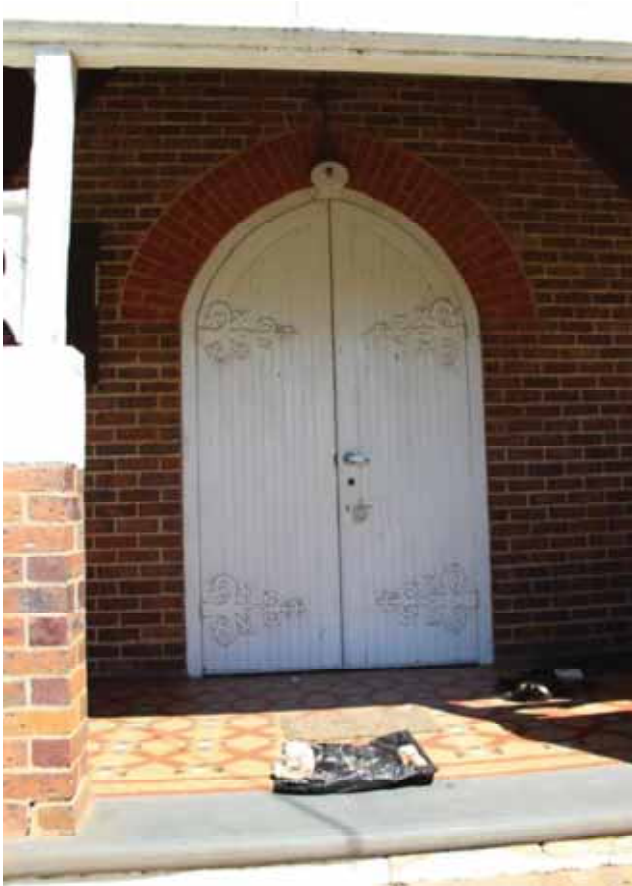
Figure D3. The entrance porch has the original tessellated tile floor. The entrance doors are pointed arched double timber ledged doors, framed by a slightly pointed-arch of radiating tuck pointed red-brick voussoirs above.

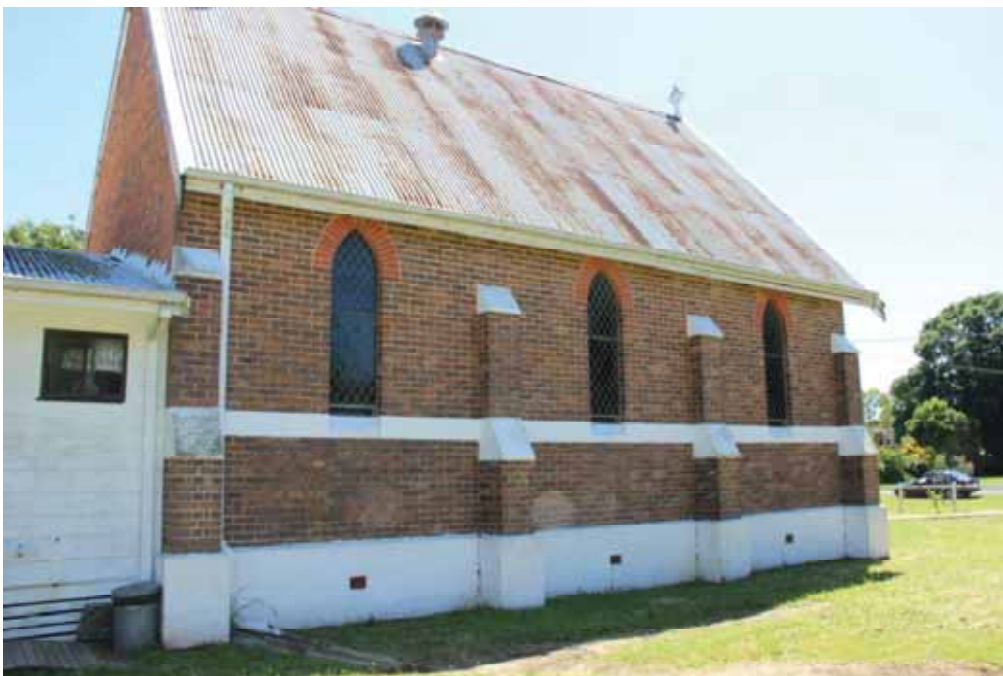
Figure D4. The side elevations of the 1908 brick church are divided into three bays by four buttresses with rendered coping. Pointed-arch windows have diaper-pattern leadlight of coloured glass, with red-brick voussoirs above. Note the lapped galvanised corrugated iron roof with original ventilators.

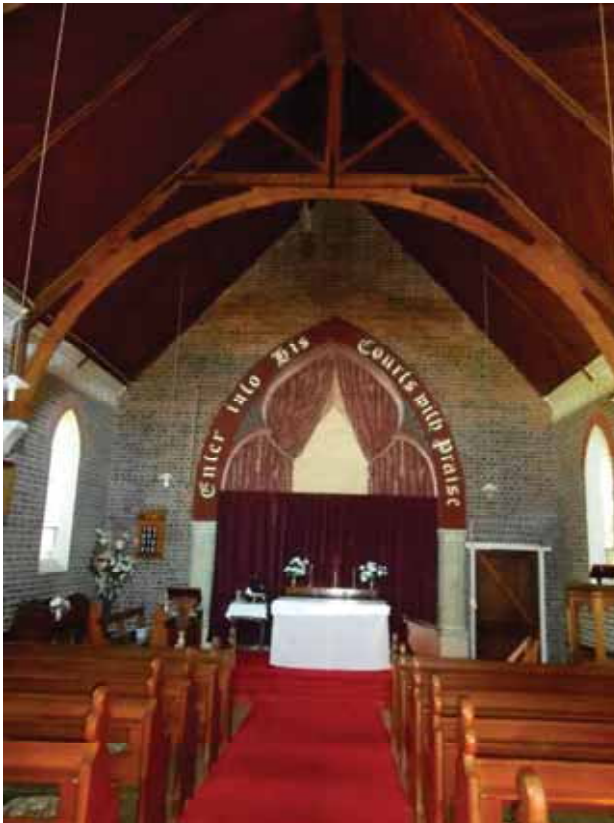
Figure D5. The interior of the church with its tuck pointed face-brick walls, decorative cornices and exposed timber roof trusses (MDHS).

- 4.3. Brick Walls
 - 4.3.1. Mortar. Match the lime mortar, do not use cement mortar. Traditional mortar mixes were commonly 1:3, lime:sand.
- 4.4. Tuck pointing is now a rare craft and expensive to repair or reconstruct, which makes caring for the existing remnants particularly important.

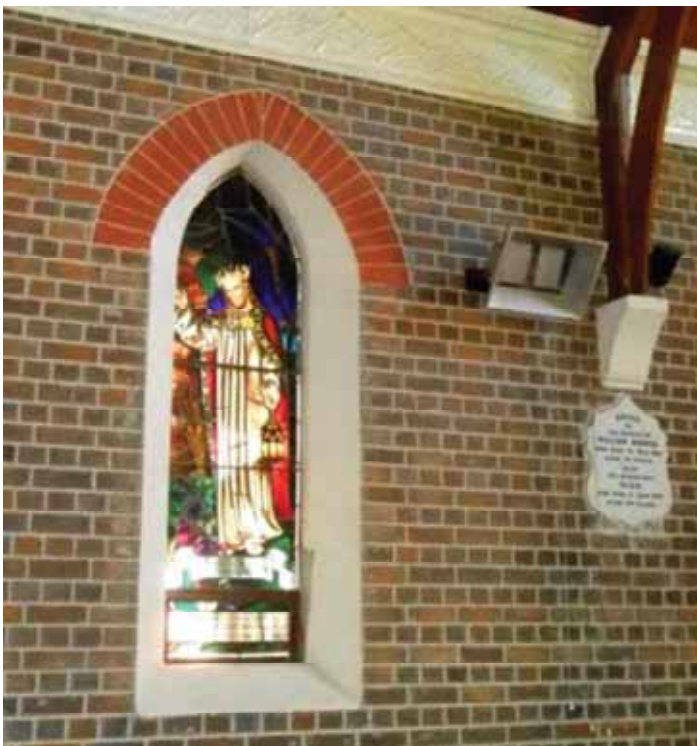
Figure D6. The memorial window to John James Freeman and plaque in memory of William Browne and his wife Eliza dated 1919 (MDHS).

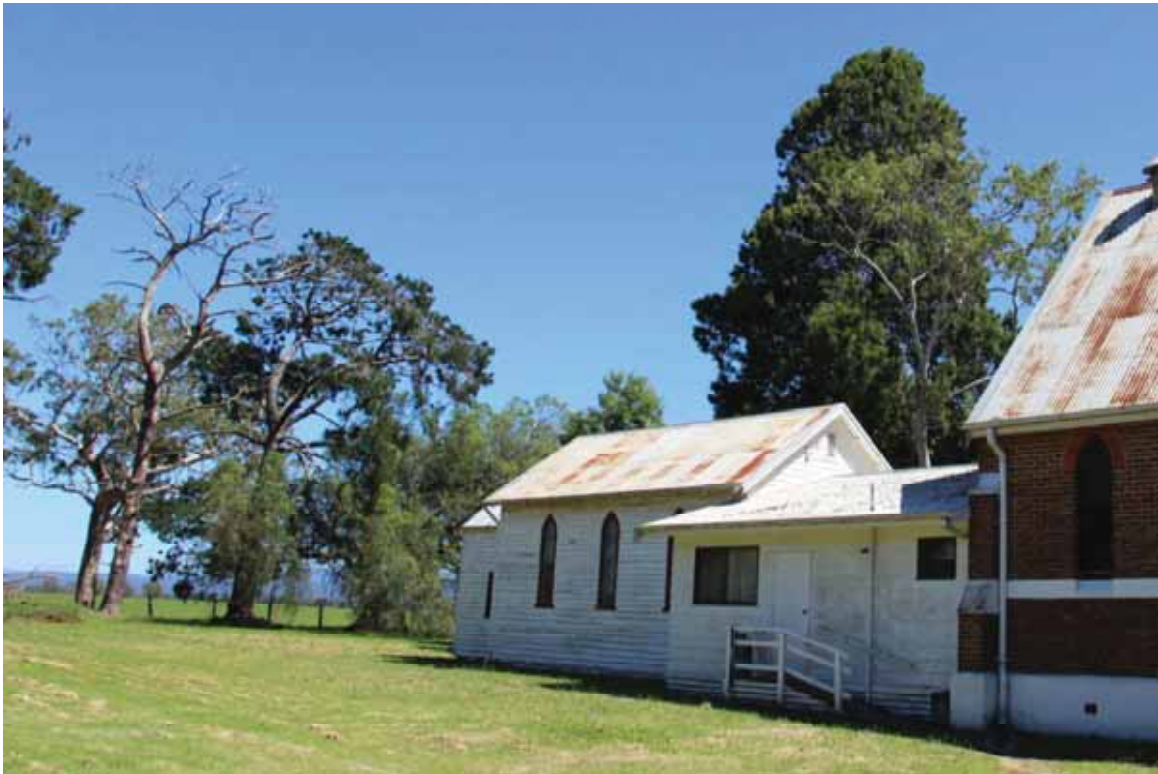
The 1884 former church and original small weatherboard vestry are in fair condition yet retain a very high level of integrity.

Figure D7. To the west of the 1908 brick church is a (right to left) modern weatherboard building, the 1884 church building relocated to this site in 1978 from The Heart, and the small weatherboard building that was the original vestry for All Saints. The mature exotic trees on the boundaries in the background are not good examples of the varieties.

NOTE: The blue shaded area is the preferred location for additions and new development. The 1885 former timber church and the former timber vestry should **not** be demolished, but could be relocated within the blue area if needed.

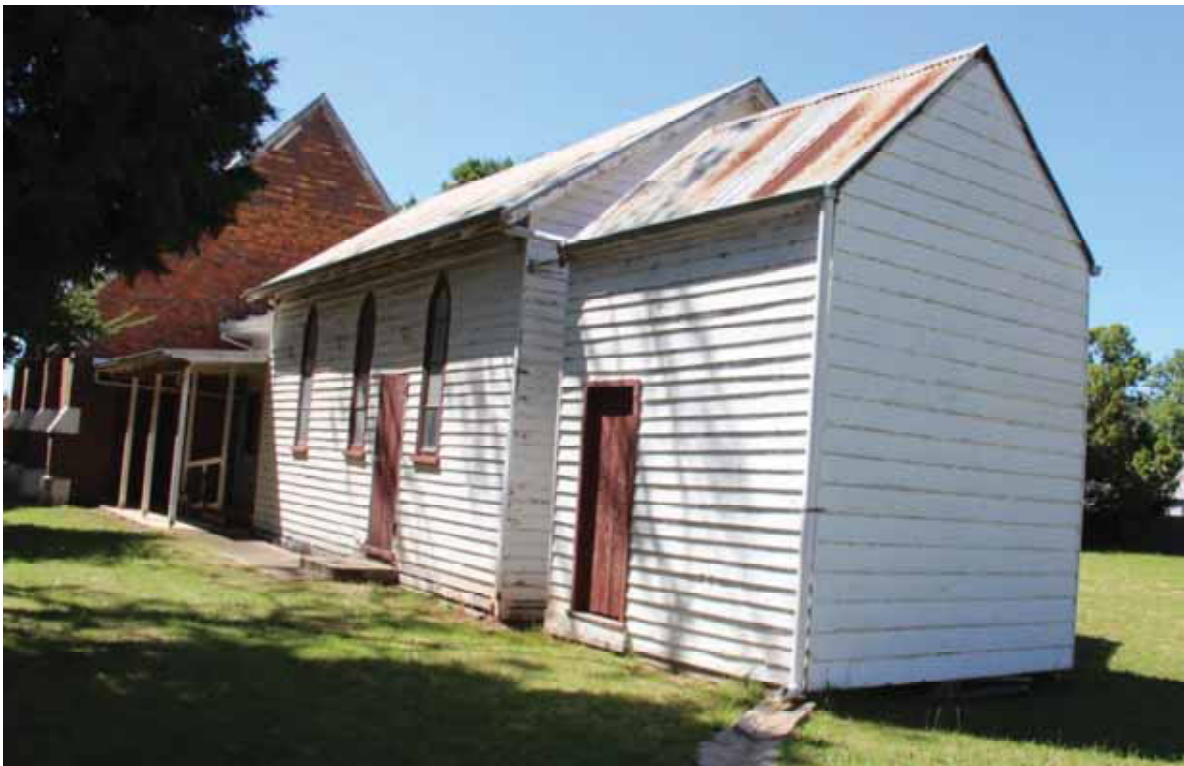
Figure D8. The north elevations of the weatherboard buildings to the rear of the 1908 brick church.

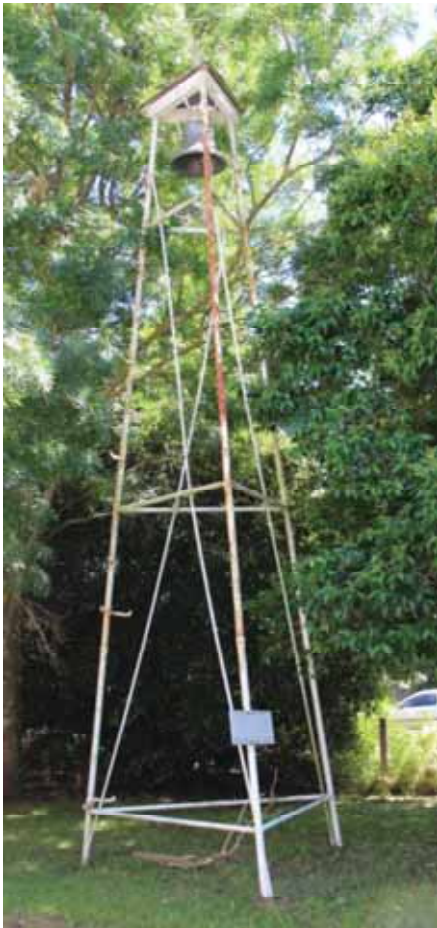
Figure D9. The steel belltower and bell to the north of the church (1929).

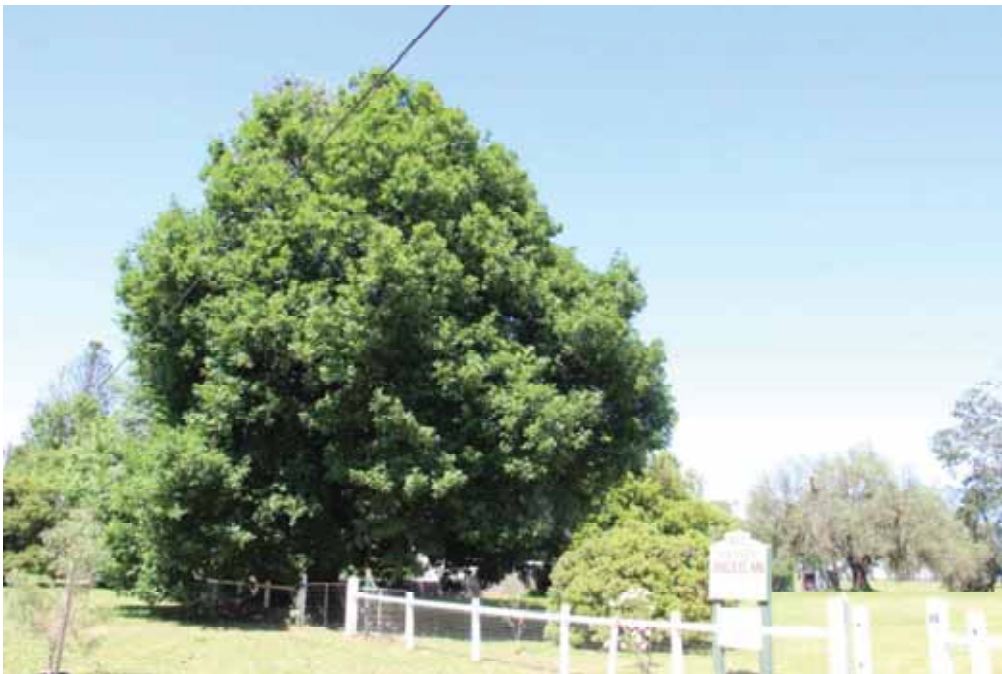
At the south-east corner of the property is a large mature Algerian Oak (*Quercus canariensis*) and a Blue Cedar (*Cedrus atlantica* f. *Glauca*) (Figure D10). These are in good condition and are good examples of the varieties.

Figure D10. The large Algerian Oak (*Quercus canariensis*) on the front boundary is a good example of the species. The Blue Cedar (*Cedrus atlantica f. Glauca*) is out of view in this photo, behind the Oak. An early timber framed fence (with later wire) runs along the front (east) boundary, with interwar pedestrian and vehicular gates

- 4.6. Fences
 - 4.6.1. Remove the later wire fencing material and replace with unpainted woven wire material to match that used in the gates, across the front boundary.

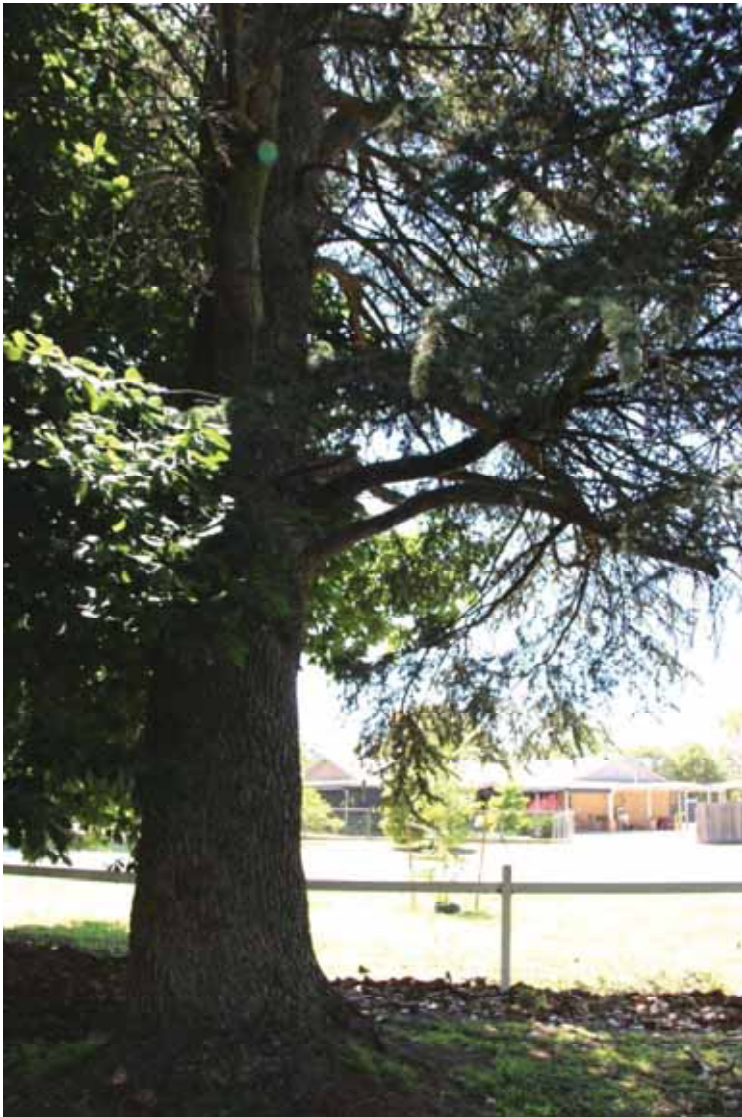
Figure D11. Next to the oak on the front boundary is a Blue Cedar (*Cedrus atlantica* f. *Glauca*). It is a good example of the variety and is in good condition.

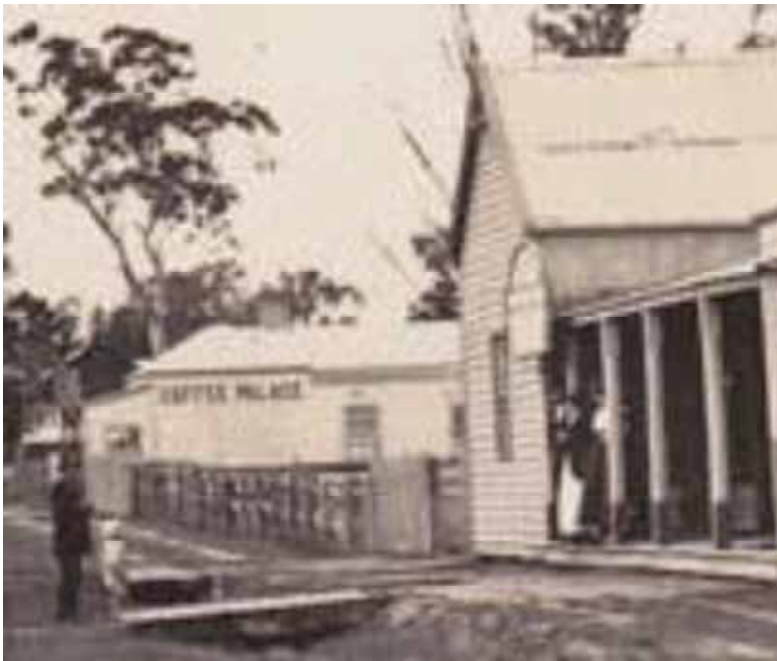
Figure H1. An early photo (date not known) shows the weatherboard building in the background, at a distance from the south, with ‘COFFEE PALACE’ painted on the south elevation of the front section. The section to the rear had two openings (MDHS, ID. P03799VMFF).

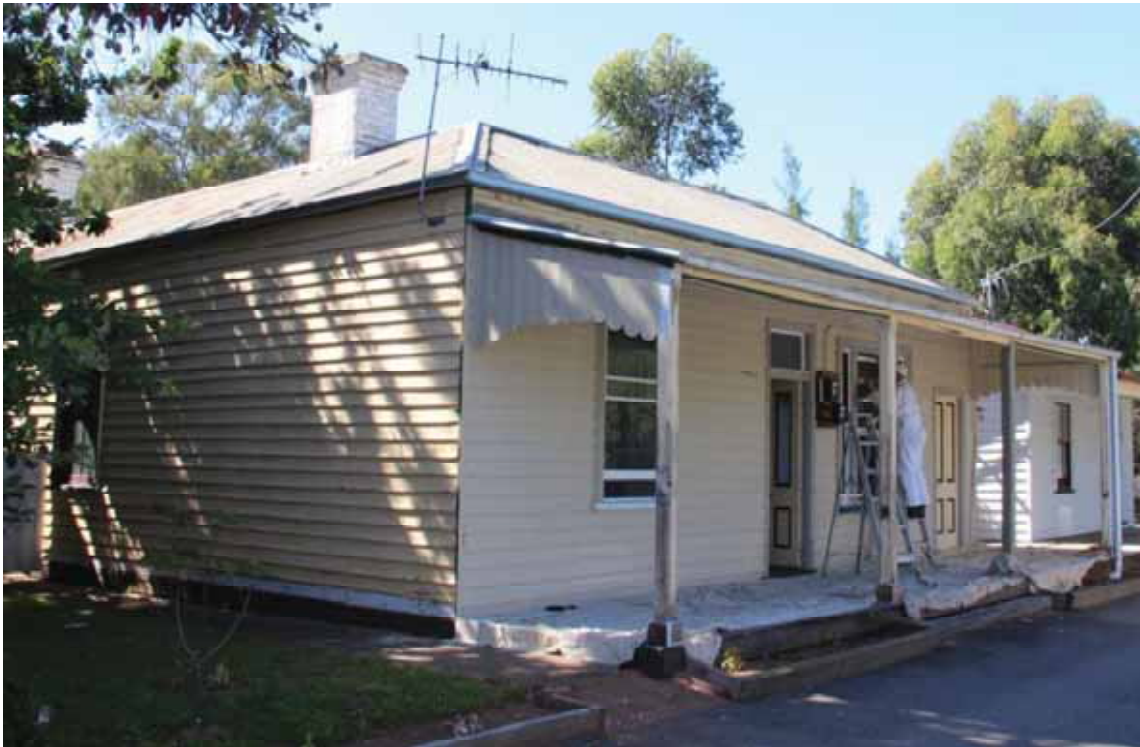
Figure D1. The asymmetrical facade has a skillion-profile verandah clad with (recent) corrugated iron and timber (round-edged) palings to the sides, supported by stop-chamfered timber posts with timber bases. The facade has a central entrance, two different types of windows and a second entrance at the southern end.

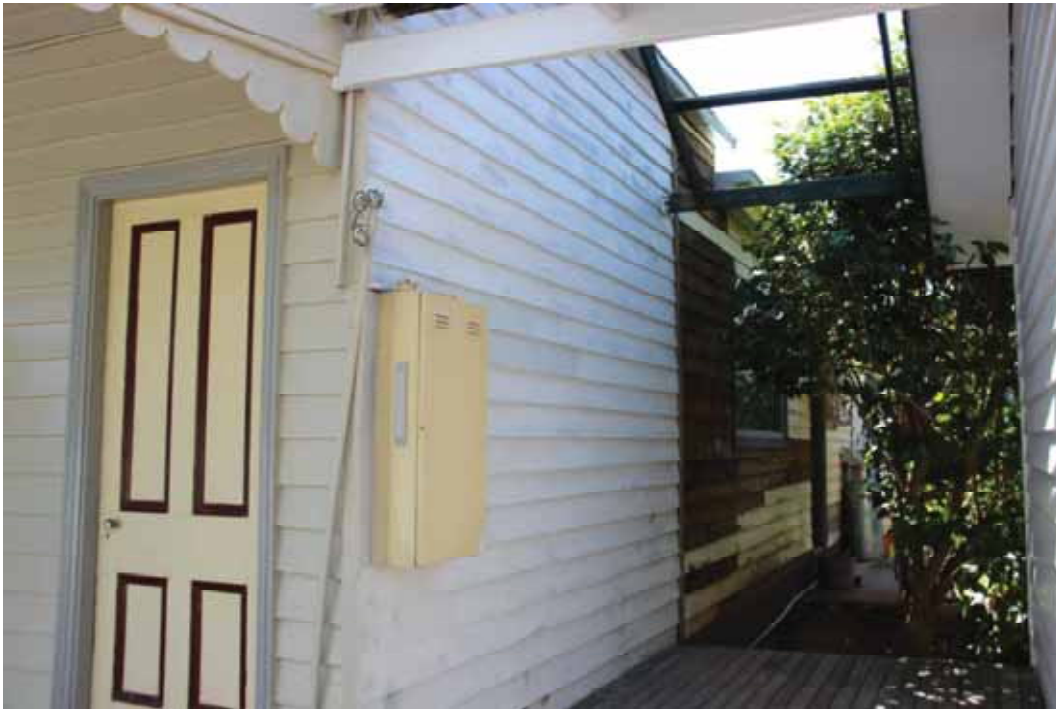
Figure D3. The south elevation has no windows to the original c1891 section. To the rear is a modern weatherboard addition.
