FACILITY CONDITION ASSESSMENT

SACRAMENTO CITY UNIFIED SCHOOL DISTRICT
5735 47th Avenue
Sacramento, California 95824

NICHOLAS ELEMENTARY SCHOOL
6601 Steiner Drive
Sacramento, California 95823

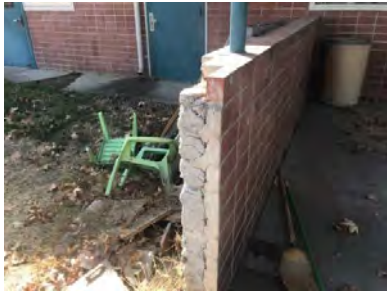
Exterior Wall in Poor condition.

Brick Veneer, 1-2 Stories
003 Classrooms 9-12 Building Exterior

Damaged section of brick on north side of building. - AssetCALC ID: 1445005

Uniformat Code: B2011
Recommendation: **Replace in 2020**

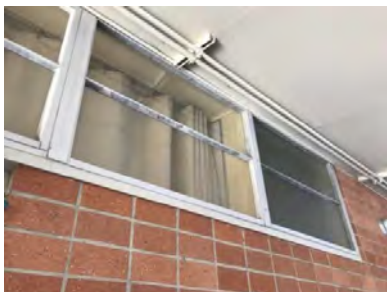
Window in Poor condition.

12 SF
001 Main Building Exterior

Antiquated with deteriorated appearance and damaged seals. - AssetCALC ID: 1444855

Uniformat Code: B2021
Recommendation: **Replace in 2021**

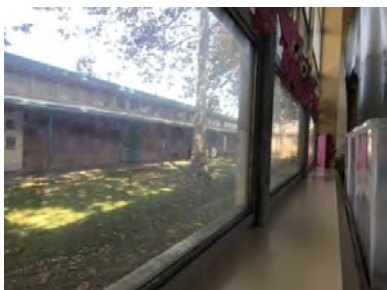
Window in Poor condition.

24 SF
002 Classrooms 3-7 Building Exterior

Antiquated with deteriorated appearance and damaged seals. - AssetCALC ID: 1444381

Uniformat Code: B2021
Recommendation: **Replace in 2021**

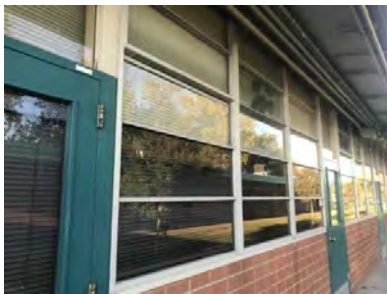
Window in Poor condition.

24 SF
001 Main Building Exterior

Antiquated with deteriorated appearance and damaged seals. - AssetCALC ID: 1444866

Uniformat Code: B2021
Recommendation: **Replace in 2021**

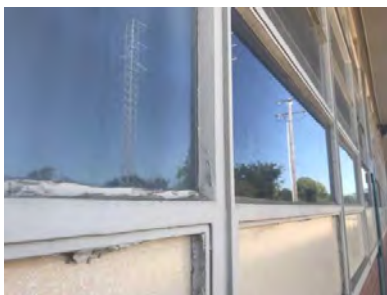
Window in Poor condition.

24 SF
003 Classrooms 9-12 Building Exterior

Antiquated with deteriorated appearance and damaged seals. - AssetCALC ID: 1444997

Uniformat Code: B2021
Recommendation: **Replace in 2021**

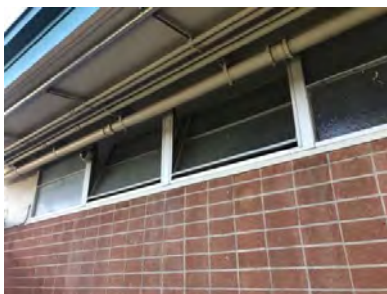
Window in Poor condition.

12 SF
002 Classrooms 3-7 Building Exterior

Antiquated with deteriorated appearance and damaged seals. - AssetCALC ID: 1444396

Uniformat Code: B2021
Recommendation: **Replace in 2021**

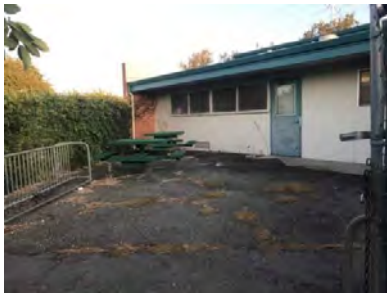
Asphalt pavement at the campus appears to be deteriorating throughout with isolated areas of heavy alligator cracking and damage. Re-seal and striping is recommended and anticipated every 5 years to maintain the integrity of the pavement. The irrigation system appears to have issues with isolated areas of dead grass.

Parking Lots in Poor condition.

Asphalt Pavement
Site

Asphalt pavement has significant areas cracking, heavy weathering, and other deterioration. - AssetCALC ID: 1445711

Uniformat Code: G2022
Recommendation: **Mill & Overlay in 2020**

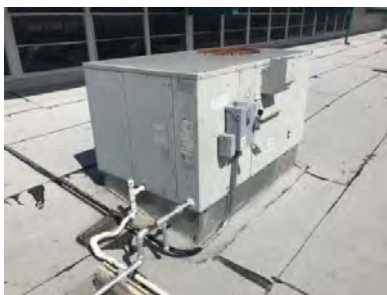
Packaged Unit (RTU) in Poor condition.

3 TON
001 Main Building Roof - Kitchen

Vandalized coils visible from the ground and corroded components. - AssetCALC ID: 1444895

Uniformat Code: D3052
Recommendation: **Replace in 2020**

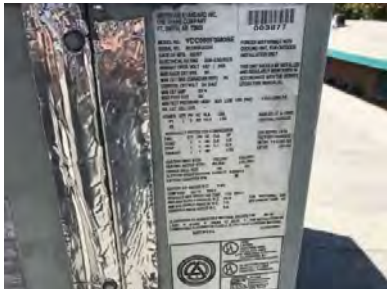
Packaged Unit (RTU) in Poor condition.

5 TON
001 Main Building Roof

Vandalized coils visible from the ground and corroded components. - AssetCALC ID: 1444854

Uniformat Code: D3052
Recommendation: **Replace in 2020**

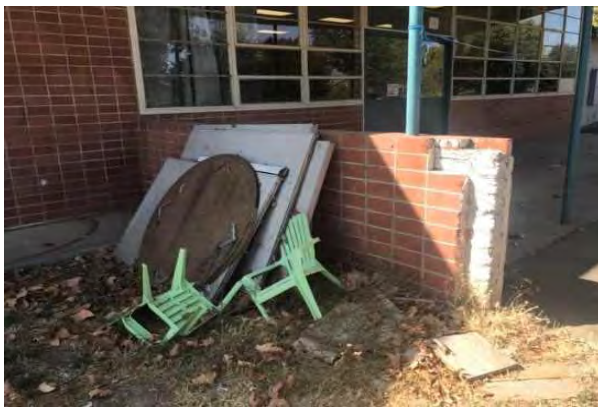
#27	DAMAGED BRICK
-----	---------------

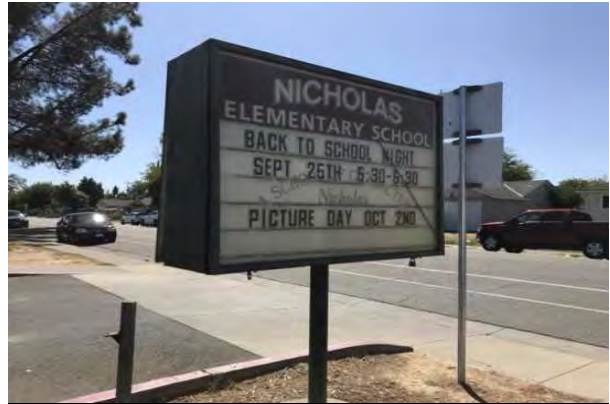
#80	PROPERTY SIGNAGE
-----	------------------
