FACILITY CONDITION ASSESSMENT

SACRAMENTO UNIFIED SCHOOL DISTRICT
5735 47th Avenue
Sacramento, California 95824

PONY EXPRESS ELEMENTARY SCHOOL
1250 56th Avenue
Sacramento, California 95831

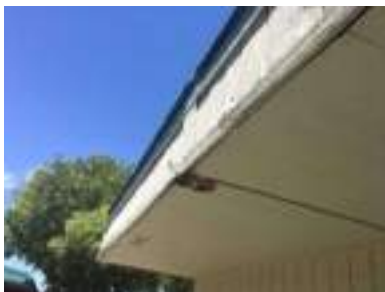
Wood Fascia Board Siding and Fascia
4th R 285-P06-Building Exterior

Exterior Wall in Poor condition.

The fascia board has water damage and cracks along the south entrance of the building. - AssetCALC ID: 1317617

Uniformat Code: B2011
Recommendation: **Repair in 2019**

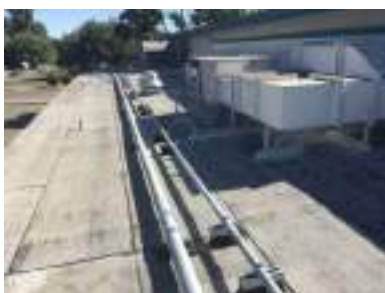
Modified Bituminous
Multipurpose Room and Kitchen 285-002-Roof

Roof in Poor condition.

There were multiple blister and cracks on the older roof surface. Some bubbles were also observed. - AssetCALC ID: 1328972

Uniformat Code: B3011
Recommendation: **Replace in 2020**

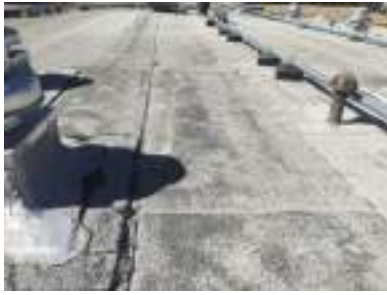
Modified Bituminous
Administration, K-1 and K-2 285-001-Roof

Roof in Poor condition.

There were multiple blister and cracks on the older roof surface. Some bubbles were also observed. - AssetCALC ID: 1317620

Uniformat Code: B3011
Recommendation: **Replace in 2020**

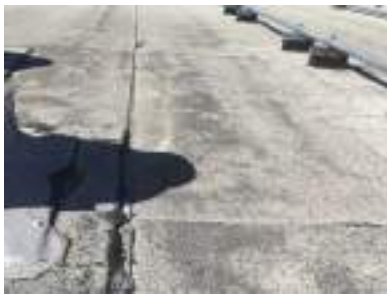
Modified Bituminous
Classrooms 3, 4, 5, 6 & 7 285-003-Roof

Roof in Poor condition.

There were multiple blister and cracks on the older roof surface. Some bubbles were also observed. - AssetCALC ID: 1328959

Uniformat Code: B3011
Recommendation: **Replace in 2020**

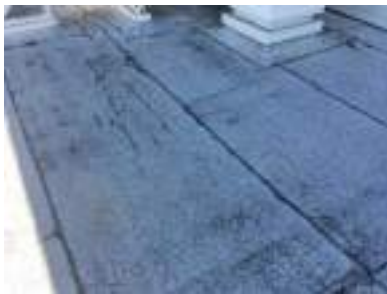
Modified Bituminous
Classrooms 8, 9, 10, 11 & 12 285-004-Roof

Roof in Poor condition.

There were multiple blister and cracks on the older roof surface. - AssetCALC ID: 1328966

Uniformat Code: B3011
Recommendation: **Replace in 2020**

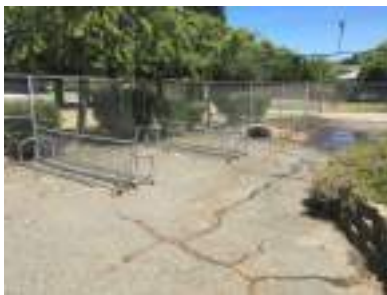
Asphalt Pavement, Full Depth (includes sub-base)
Site 285- Adjacent to play structure and K-2

The asphalt pavement and concrete pavement are in fair condition. However, section of asphalt near Building 001-Y002 and asphalt walkway near the play structure are in poor condition. There are uneven surfaces and multiple cracks which can be a trip hazard.

Parking Lots in Poor condition.

The walkway section near the north side of the play structure and near 0001 is in poor condition. There were multiple cracks and uneven pavement. - AssetCALC ID: 1329253

Uniformat Code: G2022
Recommendation: **Repair in 2019**

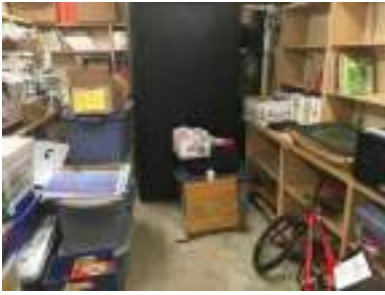
12,000 BTUH
Classrooms 3, 4, 5, 6 & 7 285-003-S001

One storage room, 285-003-S001, has had a computer server rack installed. The room was very hot during the site visit, approximately 105 deg F. The room also stored books and lots of paper. No vents, louvers, or cooling were present. The room should have a combination of cooling, venting, and airflow in order to prevent damage or fire to the server equipment.

Packaged Terminal Air Conditioner (PTAC)

Uniformat Code: D3051
Recommendation: **Install in 2019**

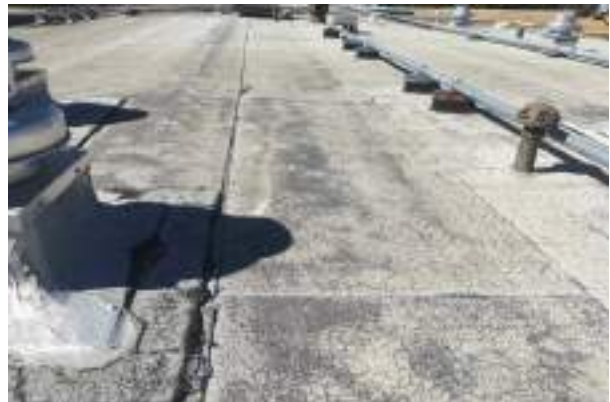
#12	MODIFIED BITUMINOUS ROOF WITH BLISTERS AND CRACKS
-----	---

The fascia board at the back of portable (P06) has been severely damaged and needs to be replaced. Installation of new gutters and downspout is also recommended for the area. The older bituminous membrane roofing section near the covered walkway in Building 001, 002, 003, 004 is in poor condition. Various areas on the roof show signs of alligatoring, cracking, and blistering. Replacement is recommended in the near future.

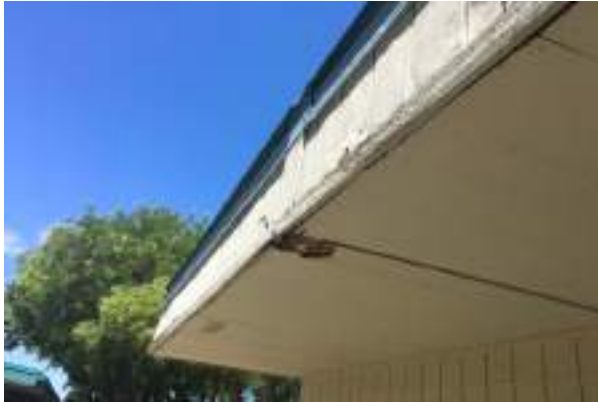
#13	DAMAGED FASCIA BOARD AND SOFFIT ON 4R PORTABLE
-----	--

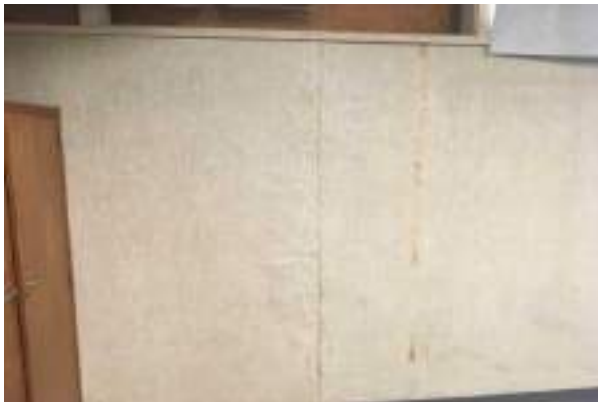
#17	WALL PAPER DAMAGED
-----	--------------------

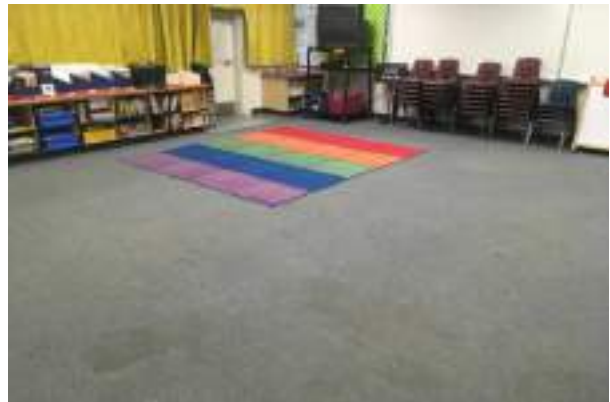
#18	CARPET DAMAGED
-----	----------------

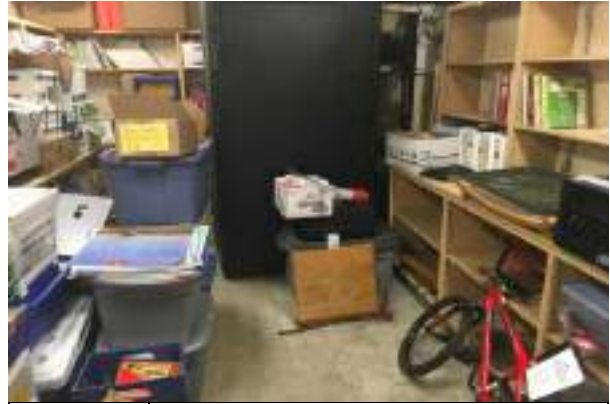
#32	STORAGE ROOM; SERVER ADDED BUT NO HVAC OR VENTING
-----	---

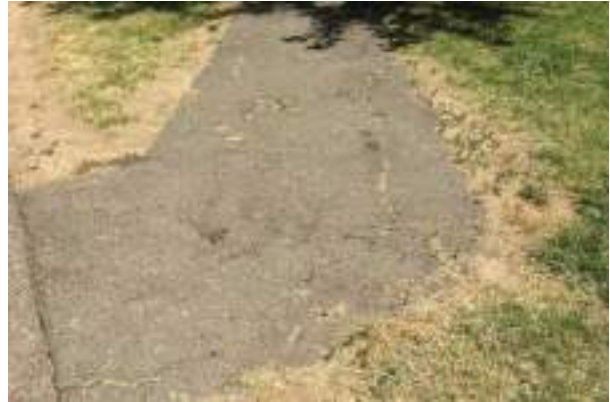
#44	ASPHALT PATH WITH CRACKS NEAR MAIN PLAYGROUND
-----	---

Key Issues and Findings	Repair asphalt walkway near play structure and Building 001-Y002.

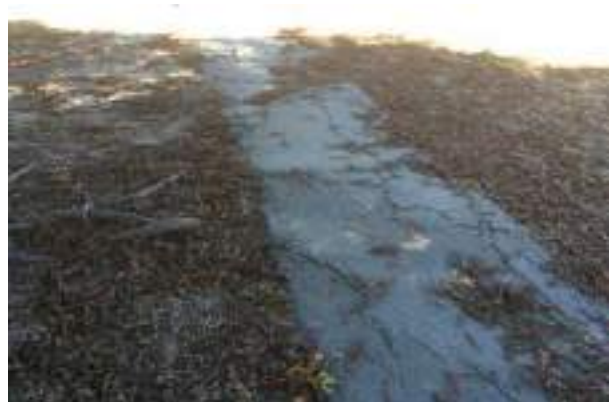
#48	CRACKED PAVEMENT NEAR PLAY STRUCTURE
-----	--------------------------------------
