Shim Seats – Wear and effect on insert life

- **The following slides show wear on shim seats that leads to premature insert failure**
- **The form of the insert seating surface is pressed into the surface of the shim.**
 - **Typically this is caused by long term usage of the shim in demanding applications**
 - **It is especially prevalent in interrupted cuts and heavy feed rate applications**
 - **This effect also happens in more moderate operations, although it takes longer to appear**

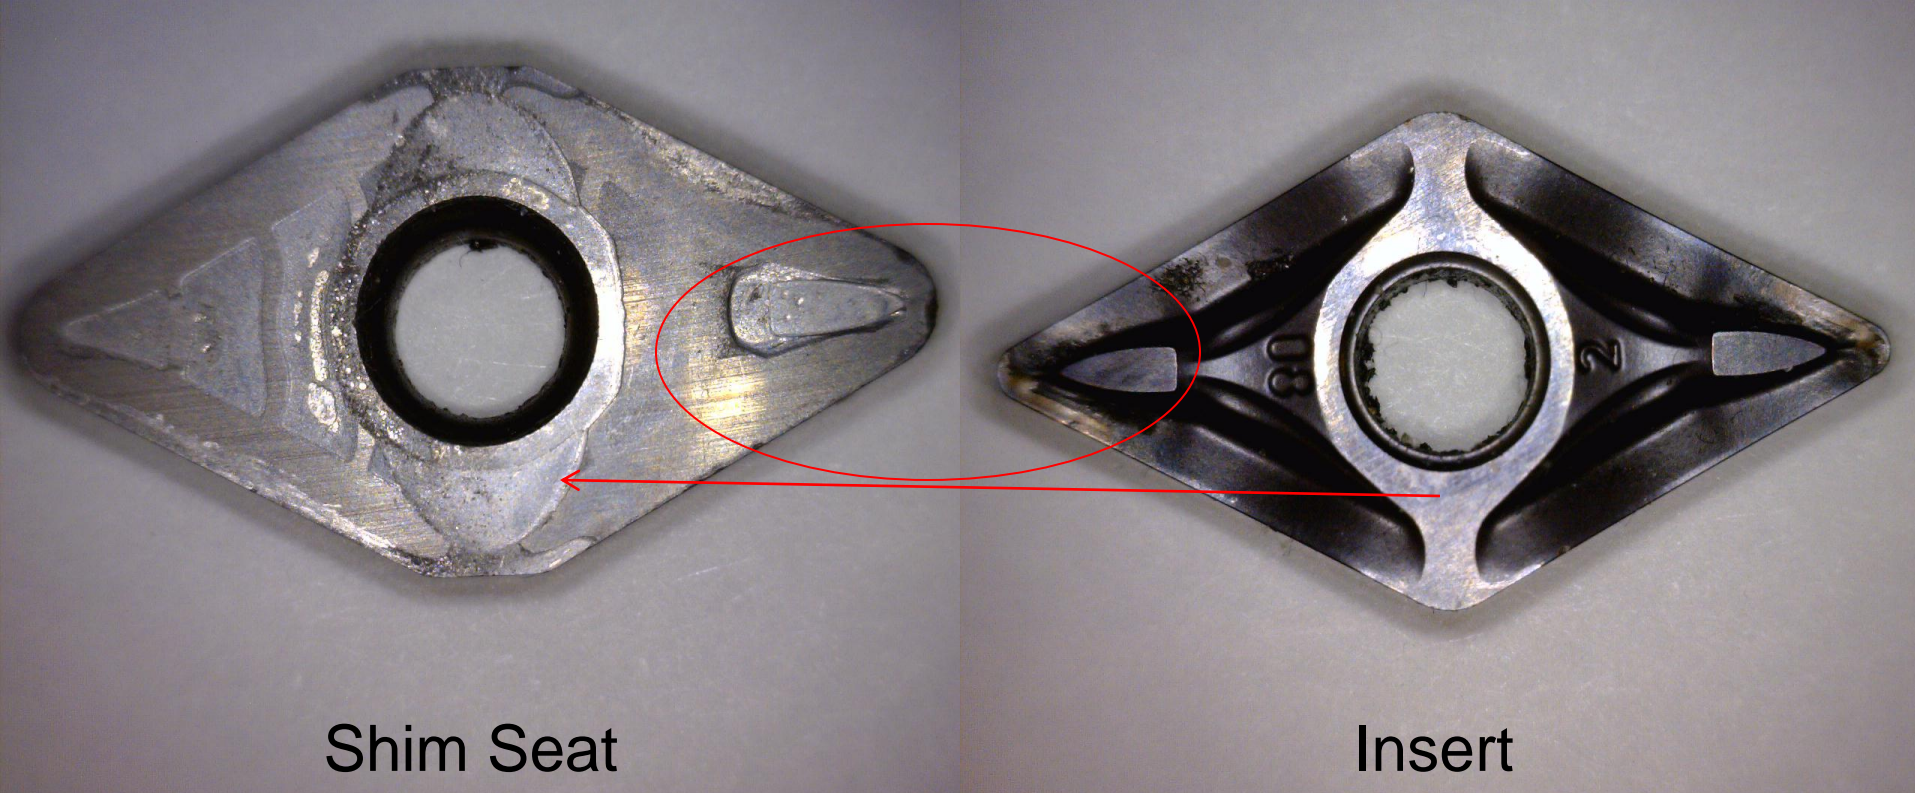
Shim Seat

Insert

There is a Mirror image of the insert impression on the Shim Seat. This will cause breakage due to mis-location of the insert. It may not seat flat in the pocket and properly locate & lock down against the walls of the insert pocket.

- **Recommendation - the set-up technicians and operators should review the shim seat after each insert indexing and replace shims regularly.**
- **This issue can cause size and surface finish problems on the part as well as premature failure of the cutting edge.**

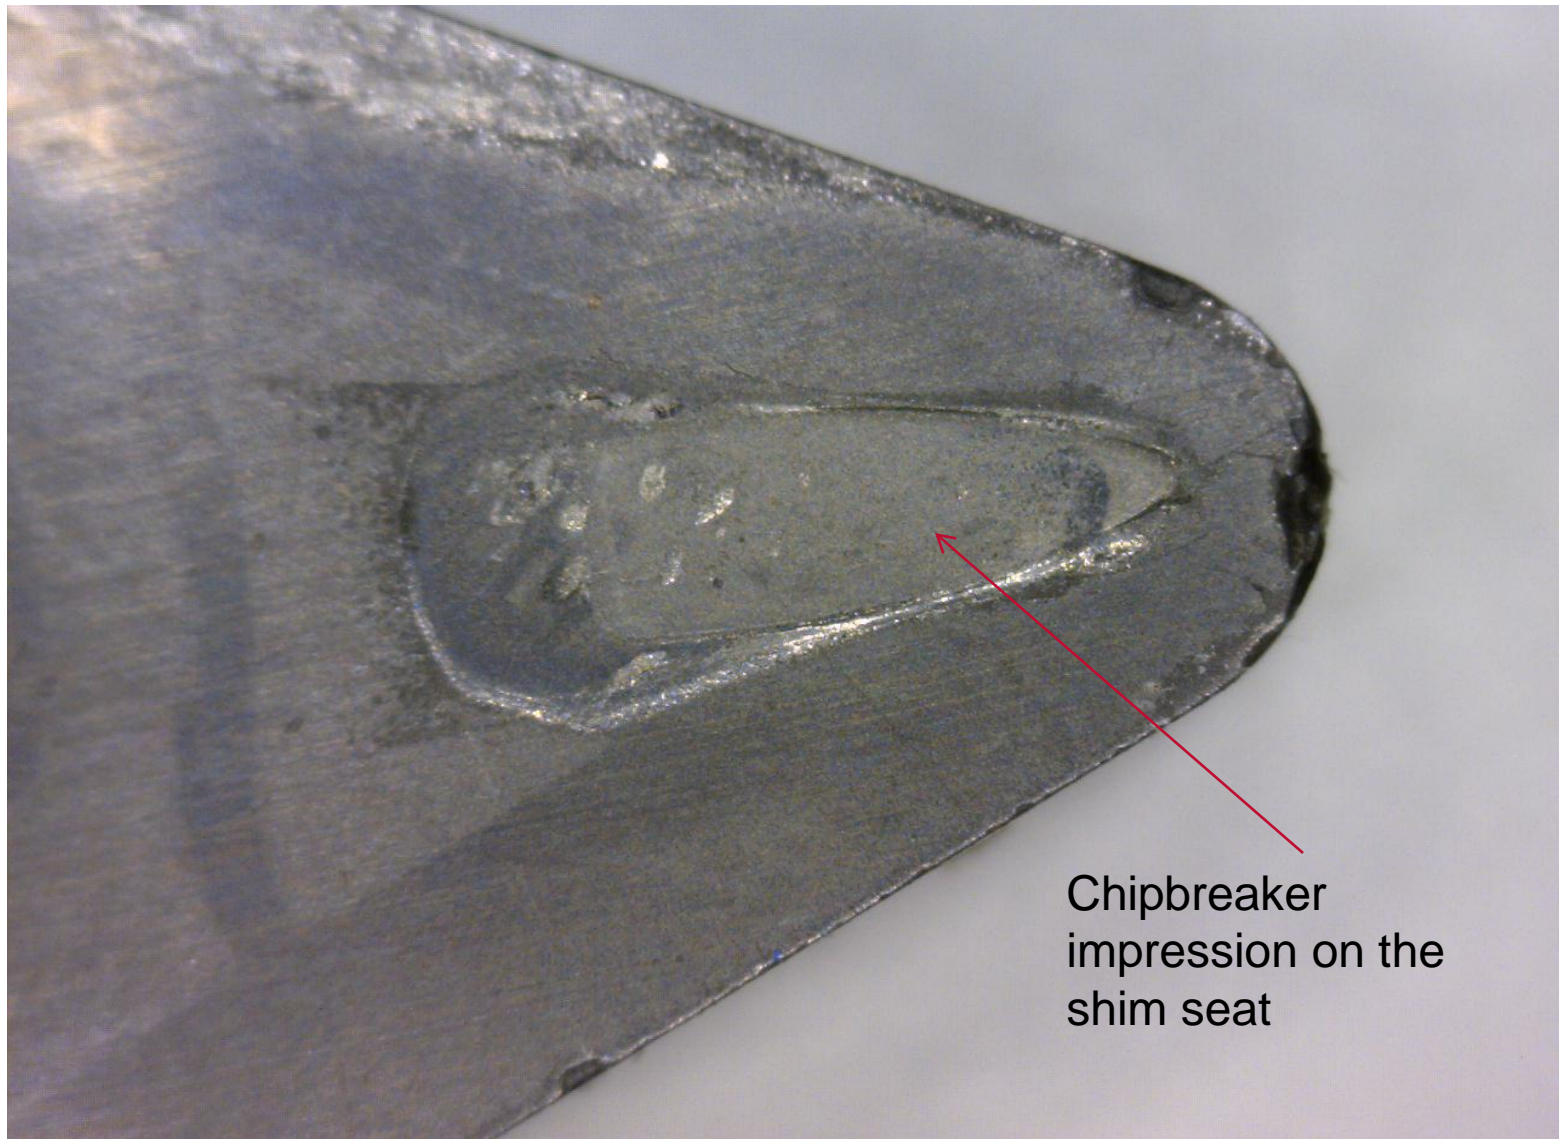
Chipbreaker
impression on the
shim seat

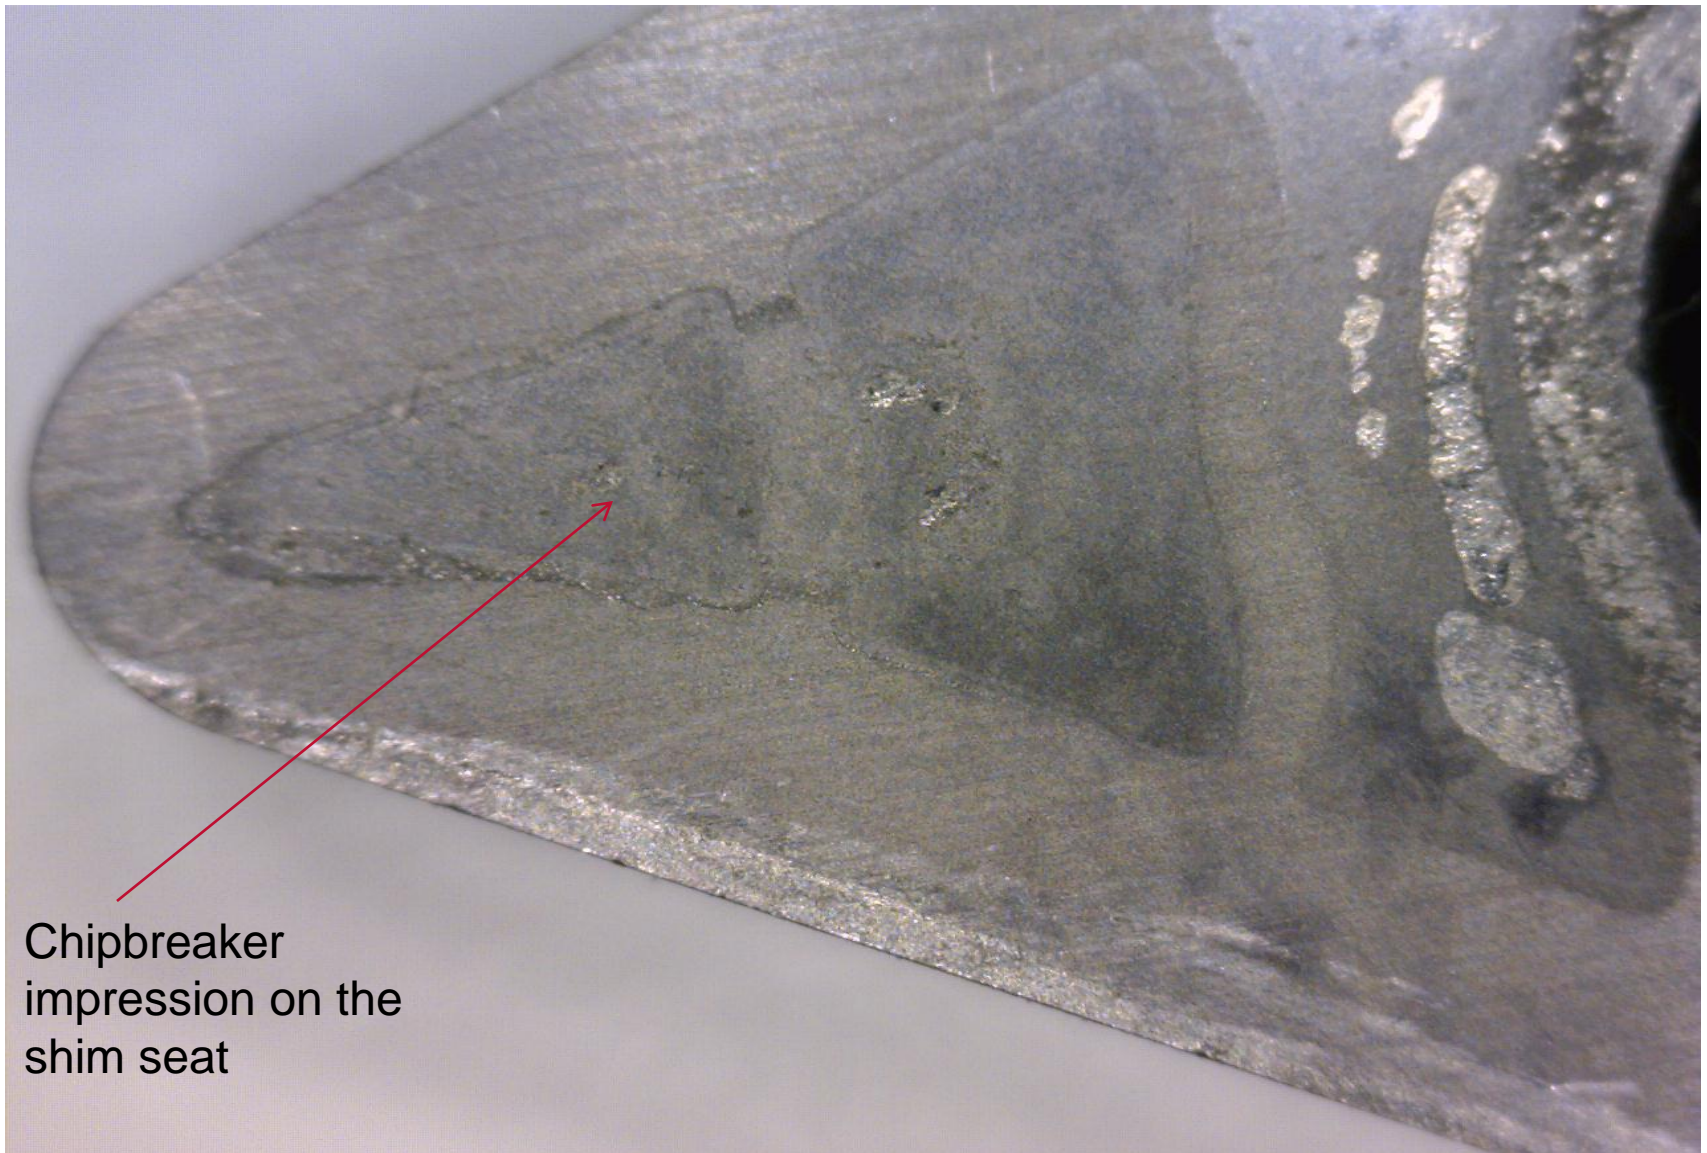
Chipbreaker
impression on the
shim seat

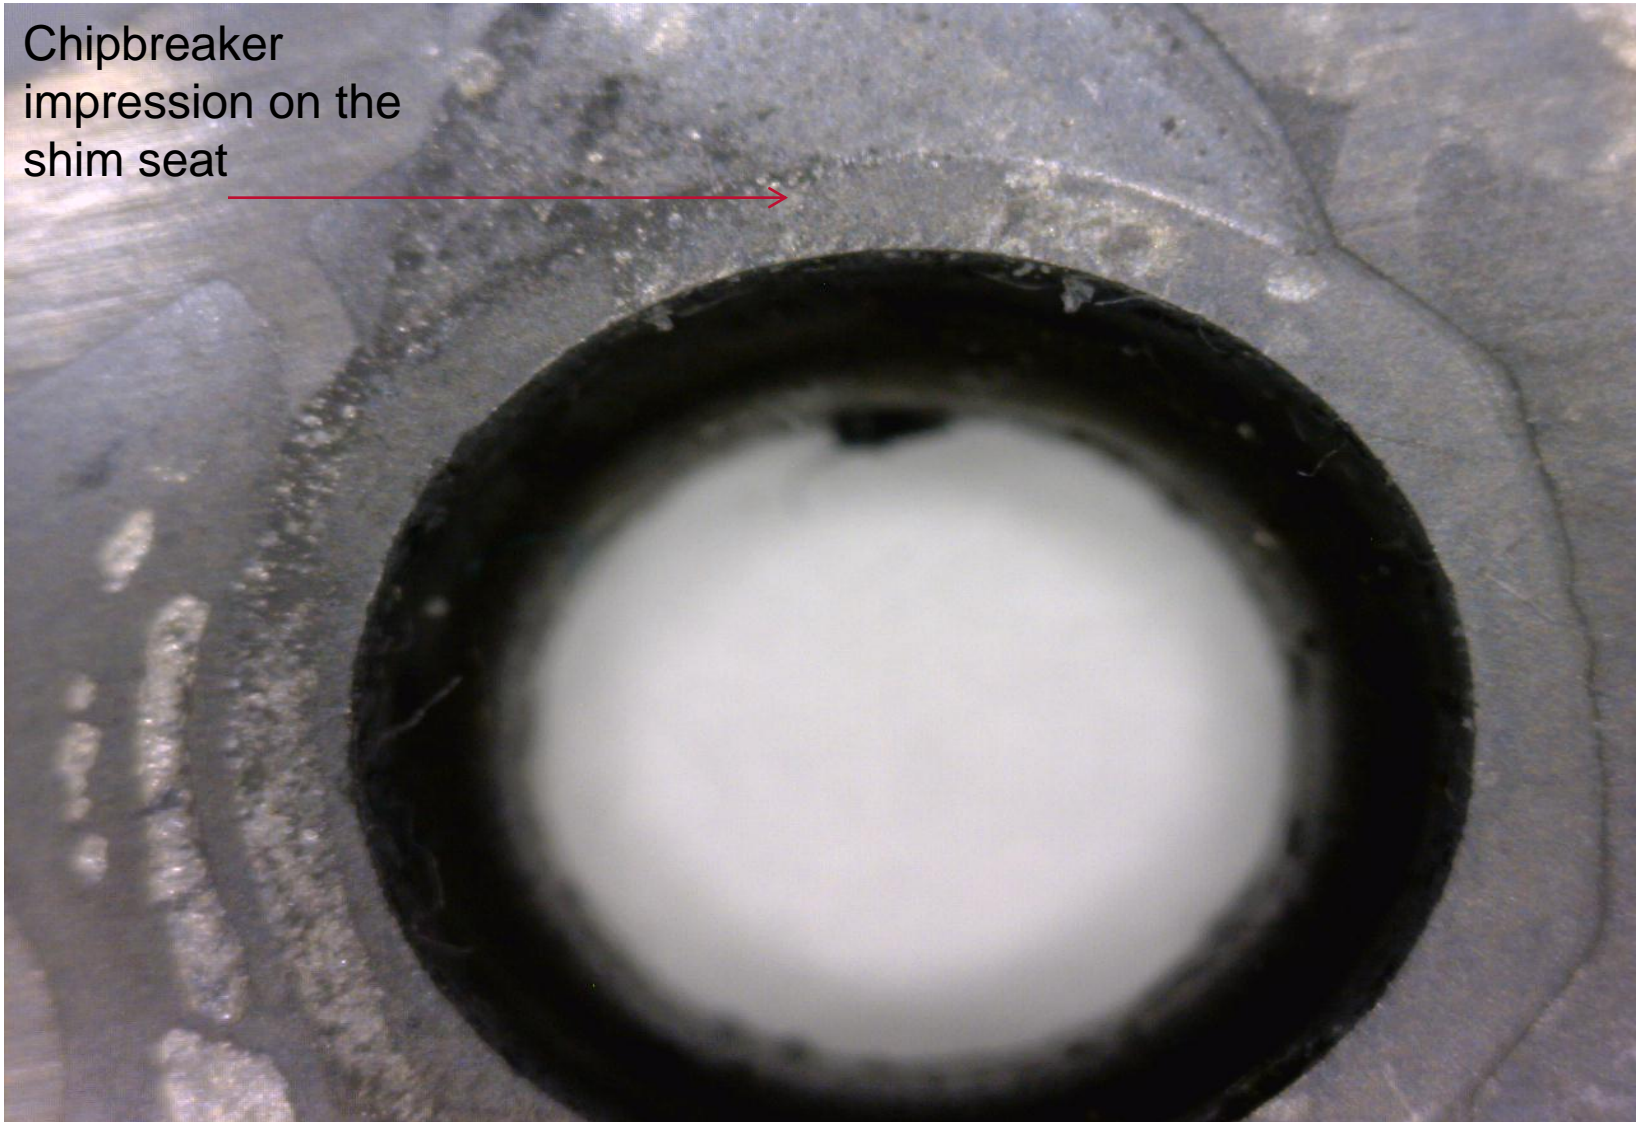
Chipbreaker
impression on the
shim seat

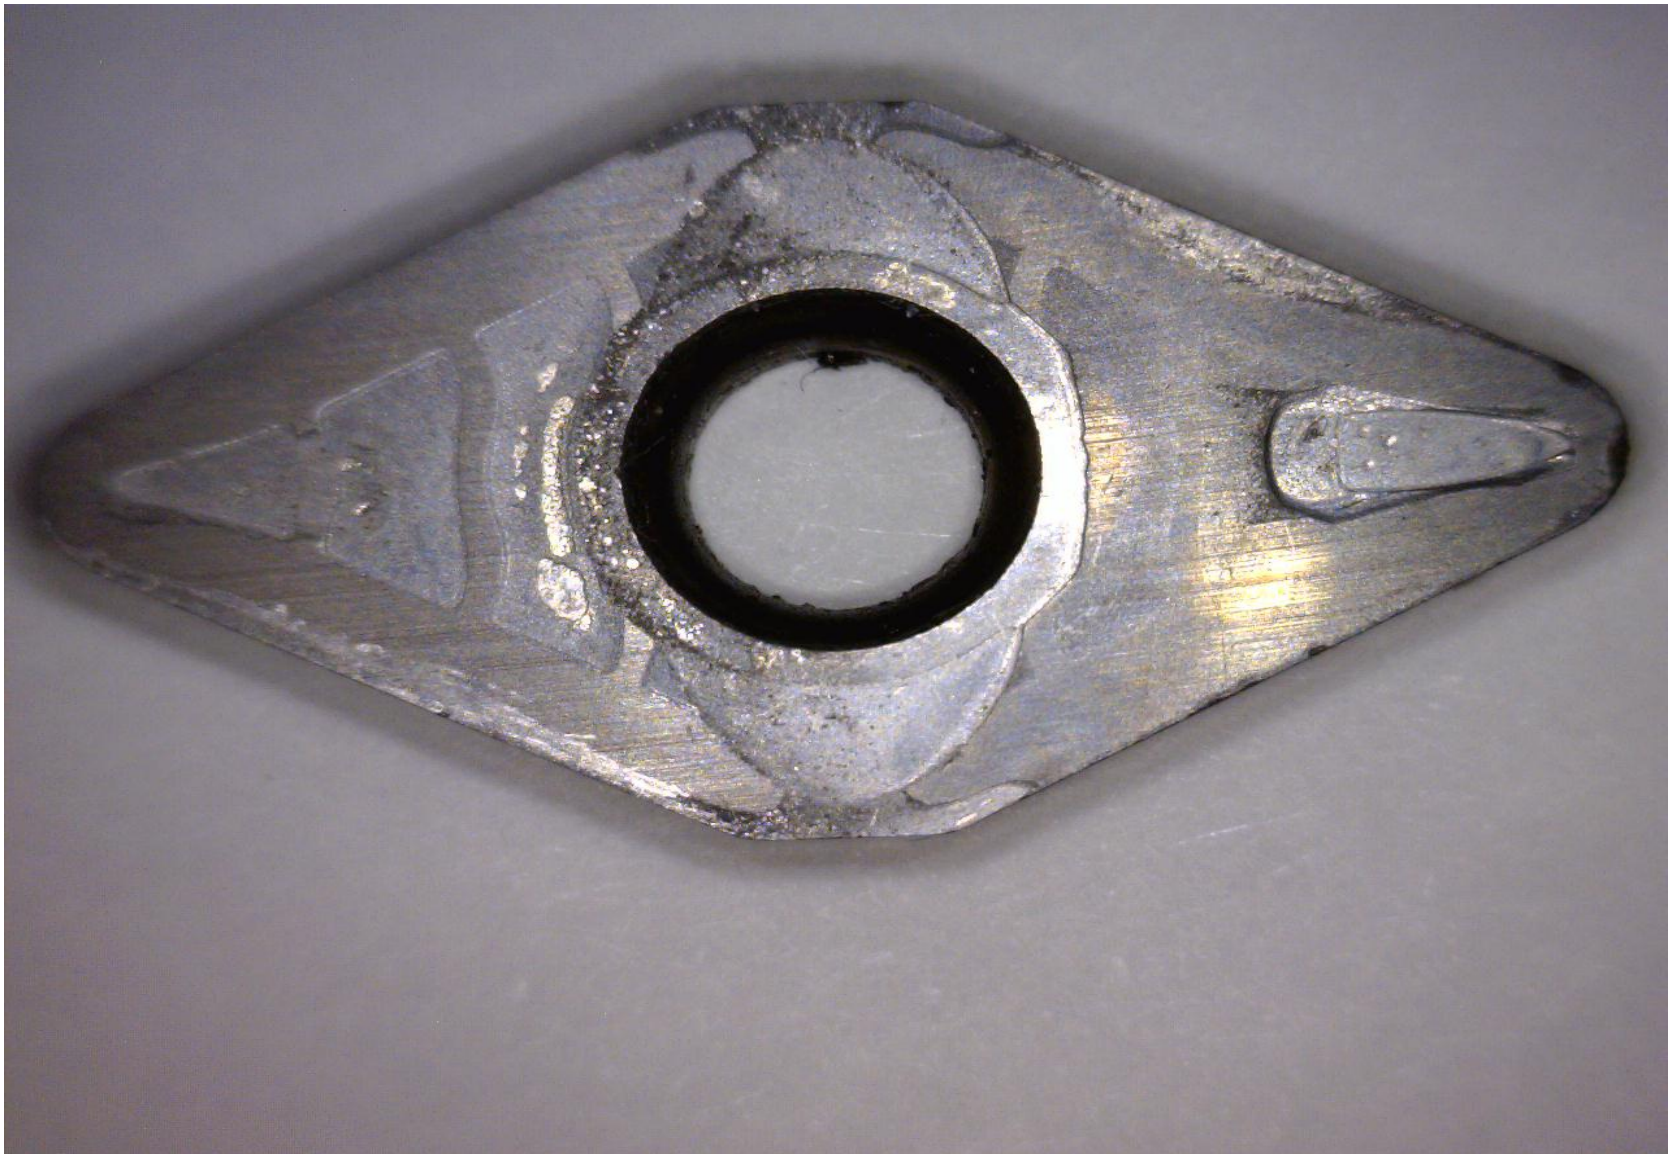
Bad Shim Seat

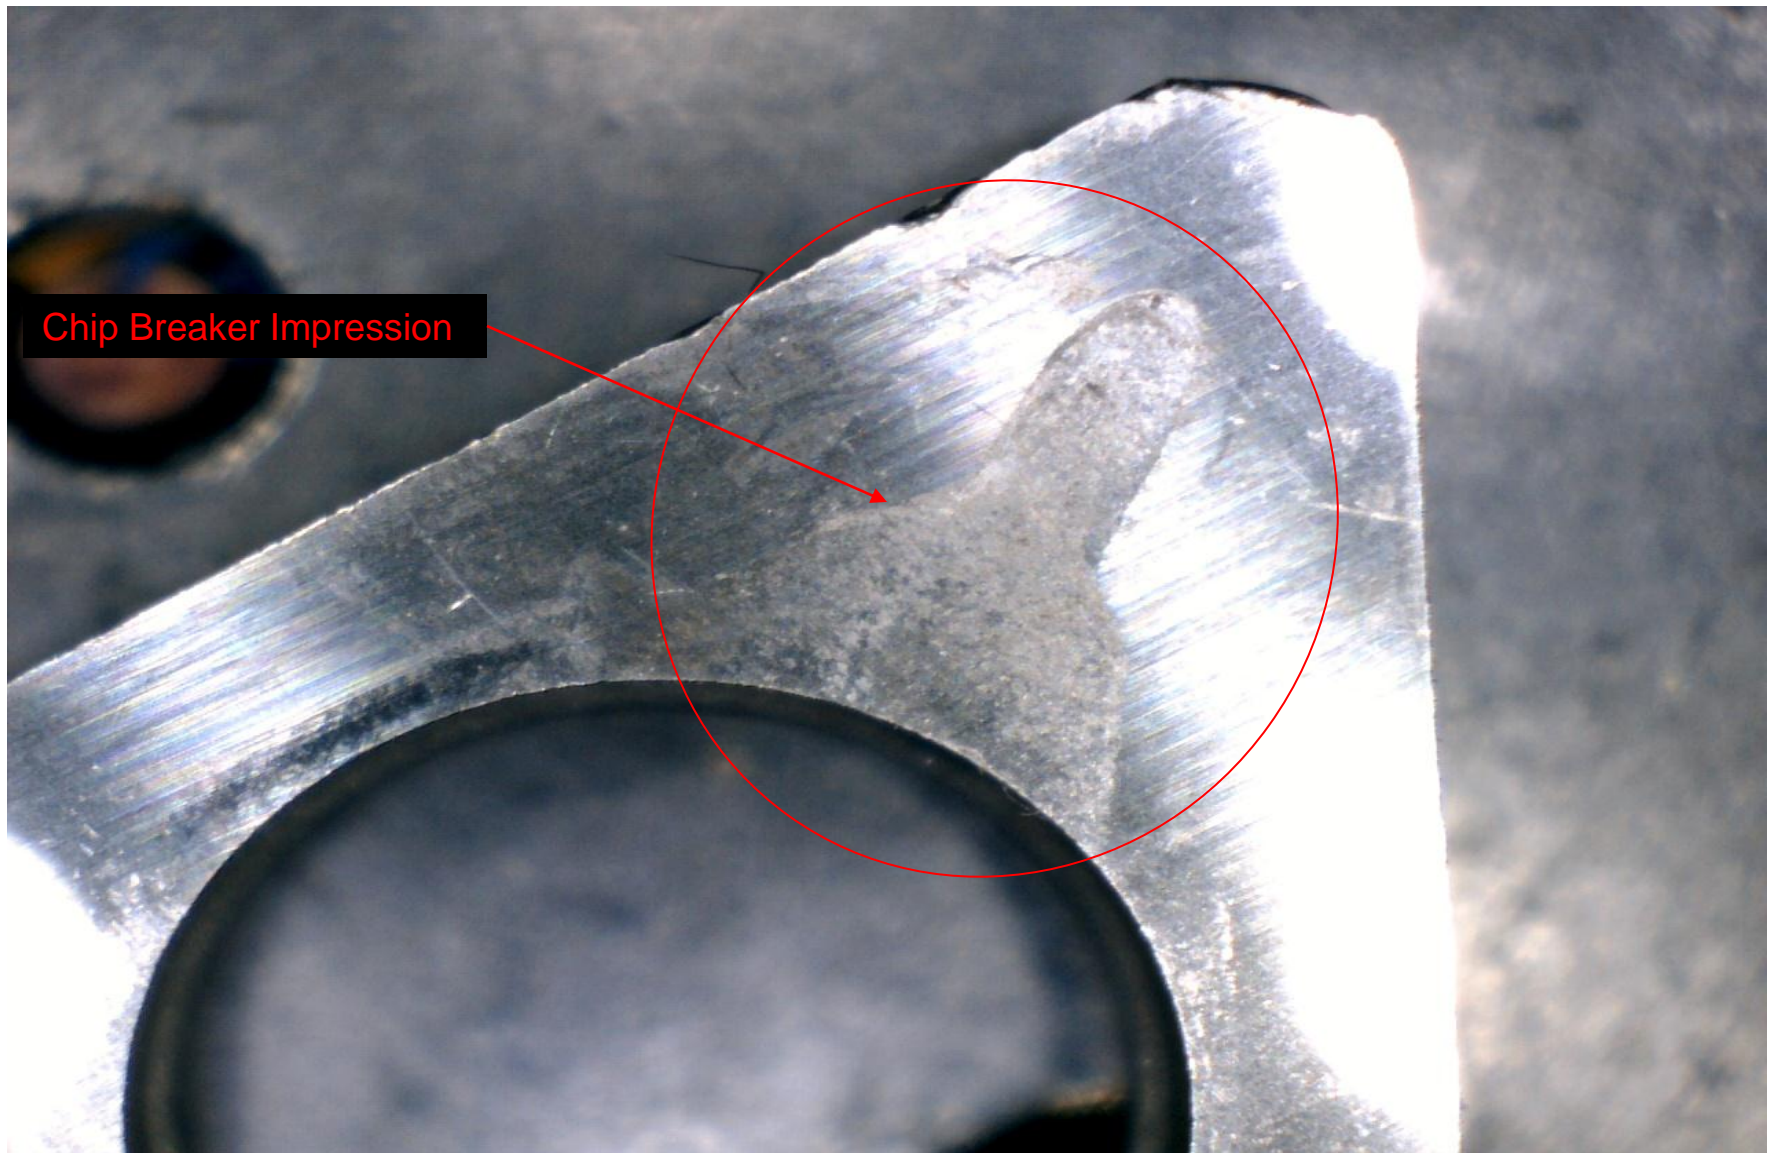
Bad Shims
