SEAWALL REPAIR ON LAKEFRONT PROPERTY

RESIDENTIAL

RAM JACK WEST

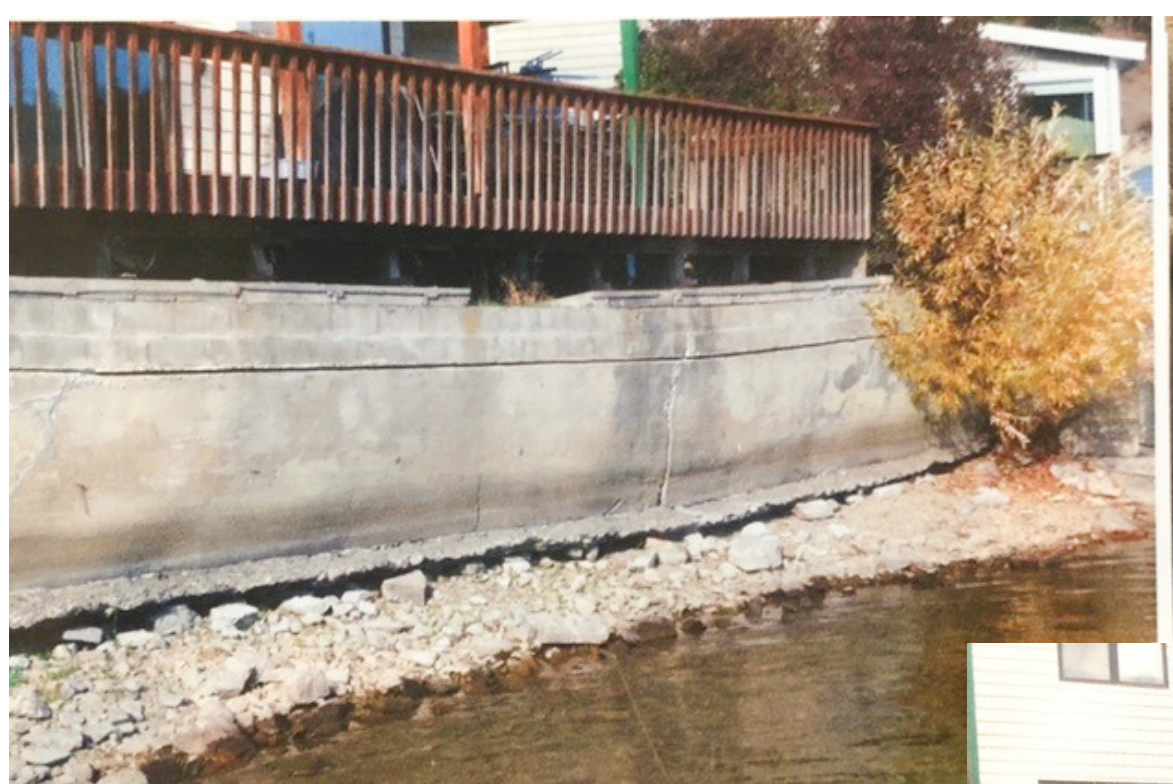
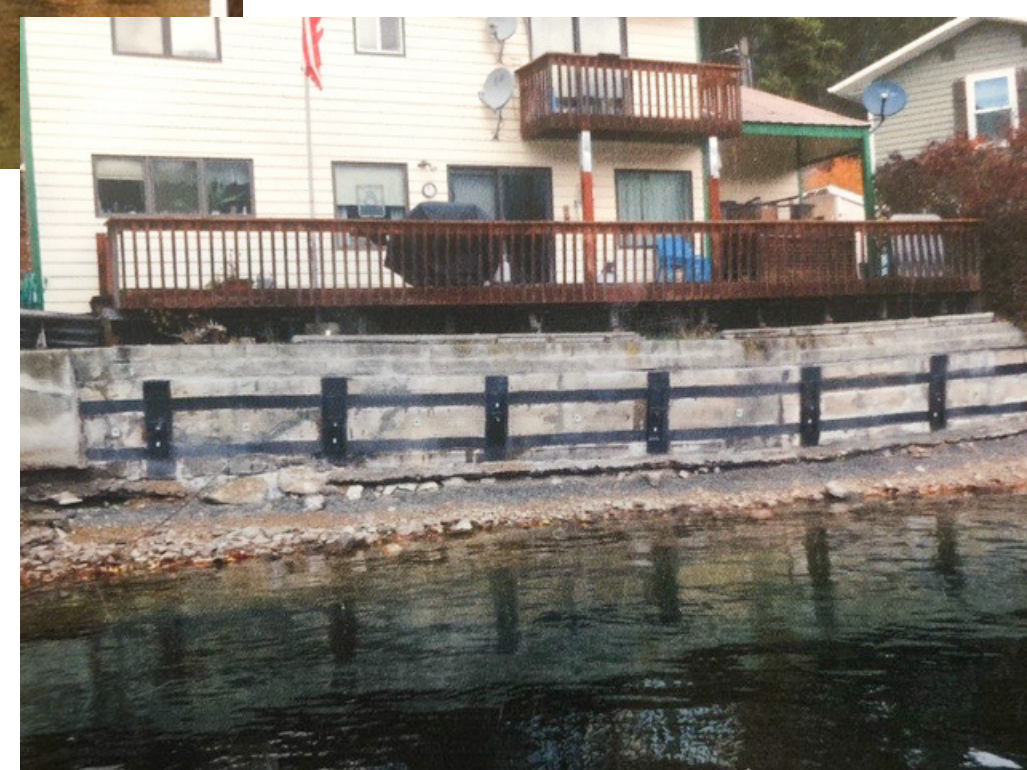
A homeowner in Seattle, Washington hired Seawall Repair Network member contractor Ram Jack West to make repairs on their deteriorating bulkhead. Loss of soil caused voids behind the wall, which undermined the stability of the structure resulting in bowing at the midspan and cracks in the concrete. The seawall was only about 30 years old, with plenty of lifespan left if repaired properly.

First, the crew installed the helical tiebacks, which were required due to a failure of the original Deadman Anchor. Next, they injected SW-RP1 stabilization/water cut-off material behind the structure for permanent support. Then, they installed pressure release technology to regulate any hydrostatic pressure caused by future water build-up behind the wall. (In addition, this contractor installed carbon fiber reinforcement on the outside of the wall.)
