**TEST REPORT No.: 18.0278 - 88**

Test: **Dust explosion**

Tested Subject: **XP DRUM KIT**

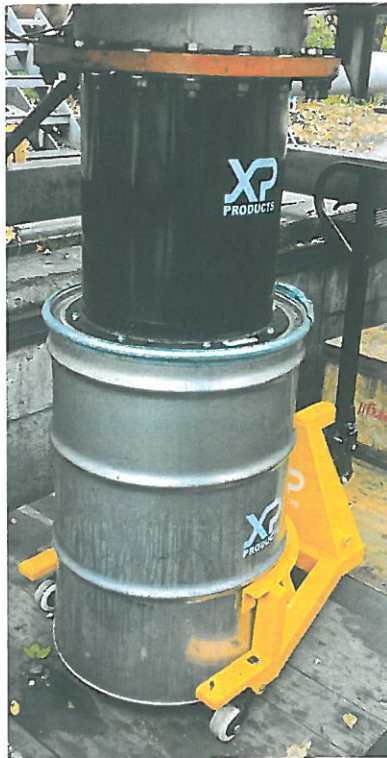
Kit assembly front view

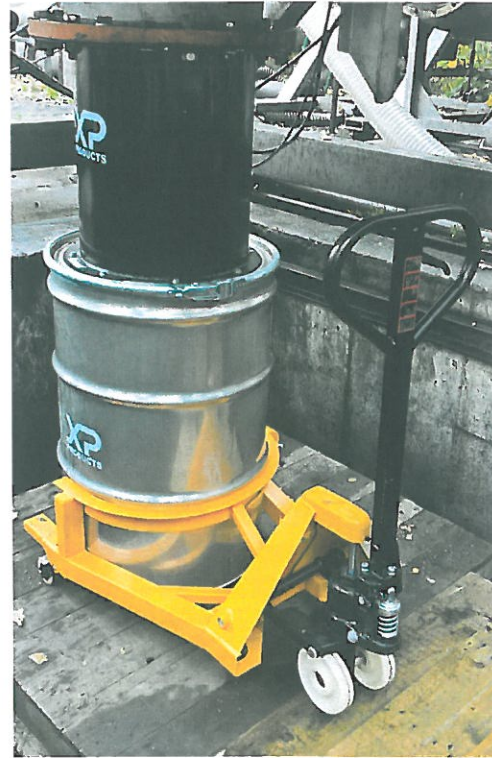
Kit assembly rear view

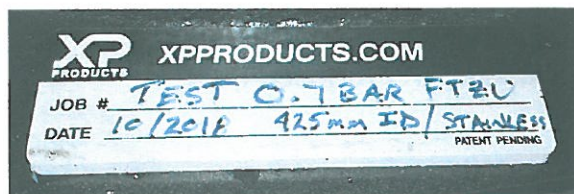
Drum plate

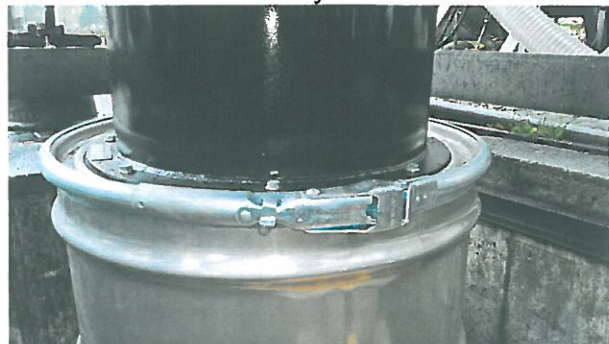
Cover lid and clamp with rubber gasket

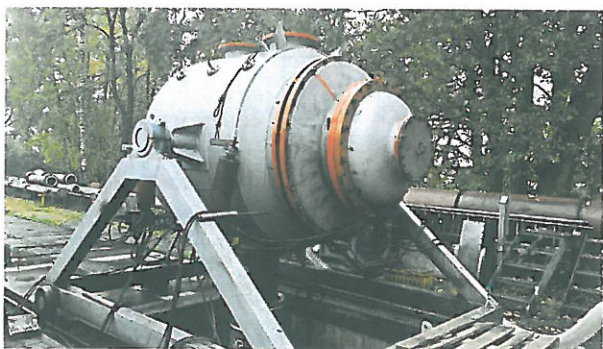
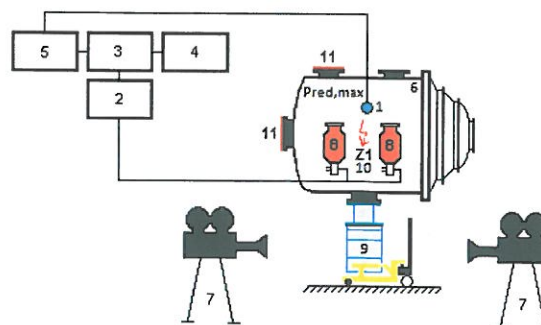
**Test Apparatus Arrangement:**

Dust specification: St1, Brown coal  
 $K_{st}=190$  bar·m/s,  $P_{max}=7,6$  bar  
 Explosion vessel:  $6,0\text{m}^3$  (L/D=1,1)  
 Ignition position: Z1 (center), energy 10kJ  
 Kit position during tests: Underneath explosion vessel

1. Pressure transducer Kistler 701A	Reg.No.026
2. Timer / control unit FTZU 002	
3. Transient memory ADAM	Reg.No.230
4. PC computer EVA with plotter	Reg.No.230
5. Charge amplifier Kistler 5011	Reg.No.030
6. Test vessel FTZÚ6 m <sup>3</sup>	
7. 2x Video Camera (30fps, 250fps)	
8. Dust injectors (4 qty.)	
9. XP-Drum Kit	
10. Ignition position	
11. Venting location	
12. Thermometer ALMEMO 2290-3	Reg.No.165
13. Set of weights	Reg.No.237

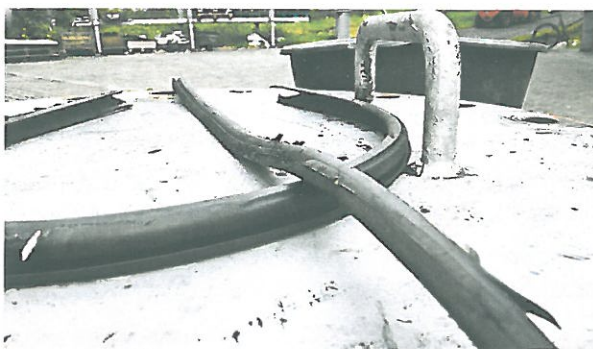
Gasket removed out from Cover lid and Clamp (before Test No.5)

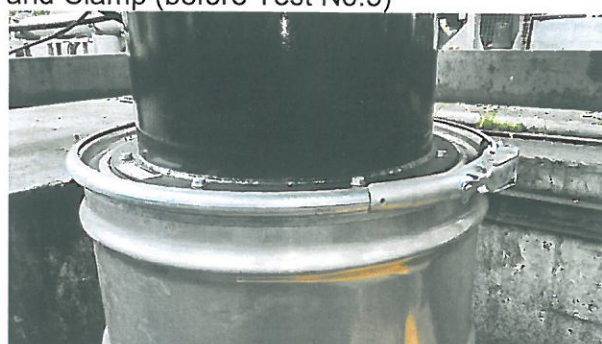
After Test No.5

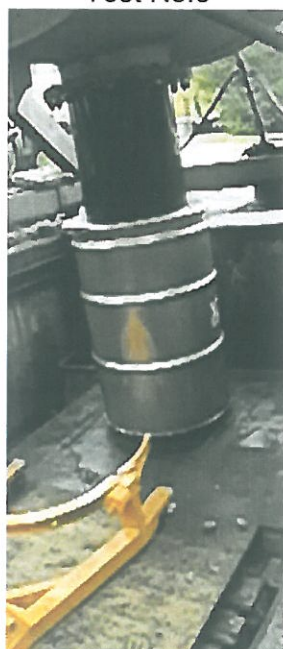
No truck lift support before Test No.6 / 7
