Field Experience with a Redesigned Electronic Downhole Corrosion Monitoring System and Coupon Module

White Paper

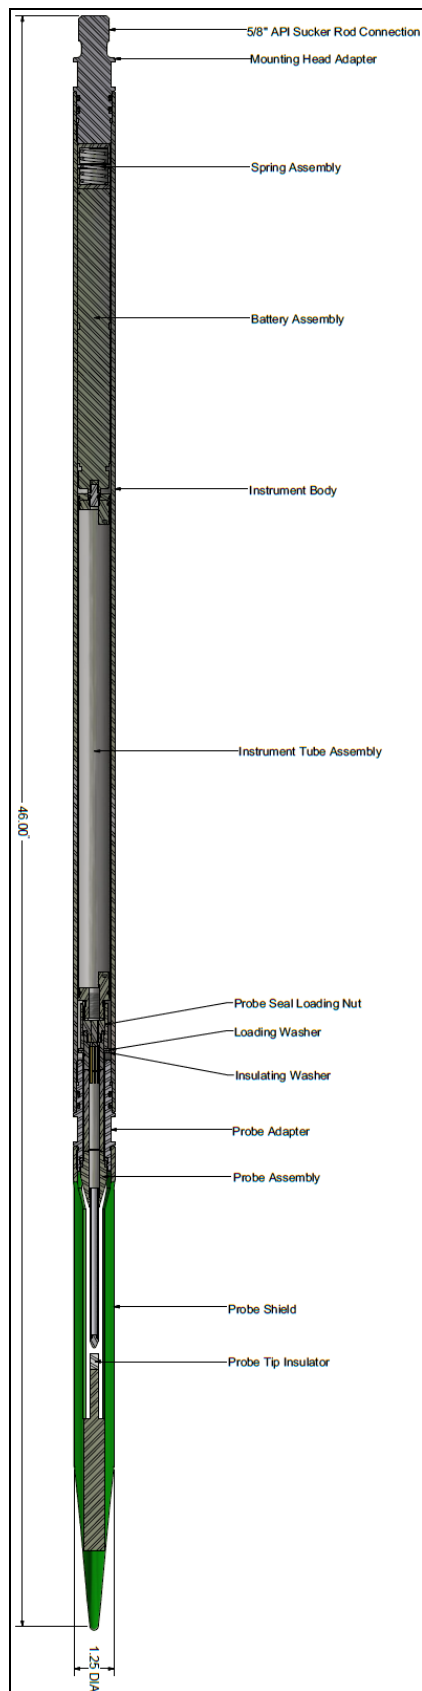
Figure 3
Cross sectional view of DCMS

up to 120 days of data at 4 hour (1024 readings) and operates in very high temperatures. Figure 3 shows a standard schematic of the DCMS.

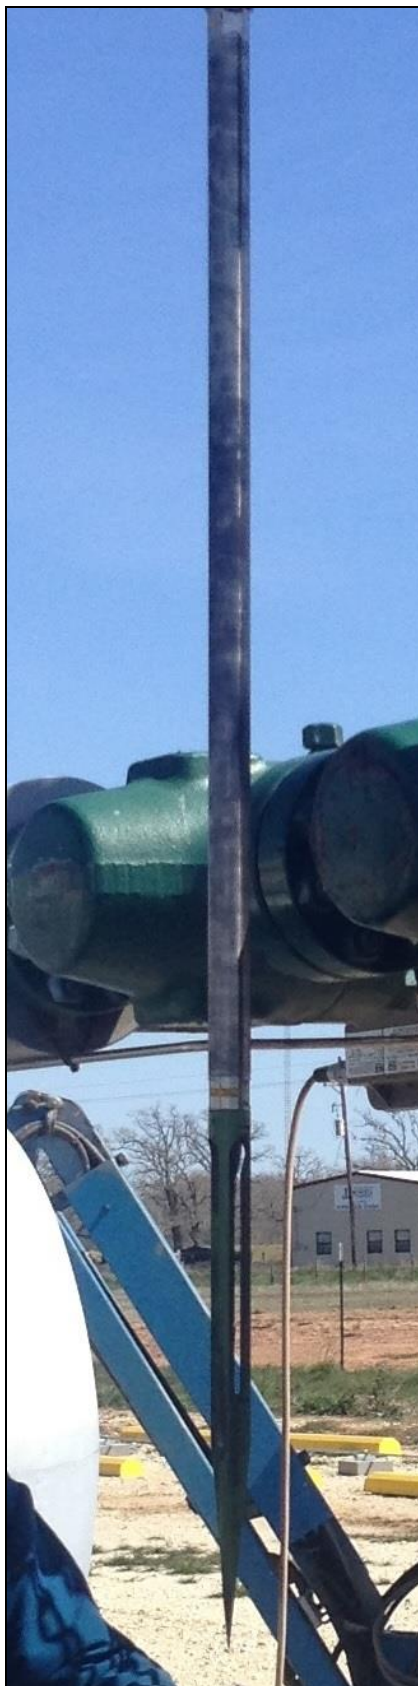
Figure 4
Field Installed DCMS

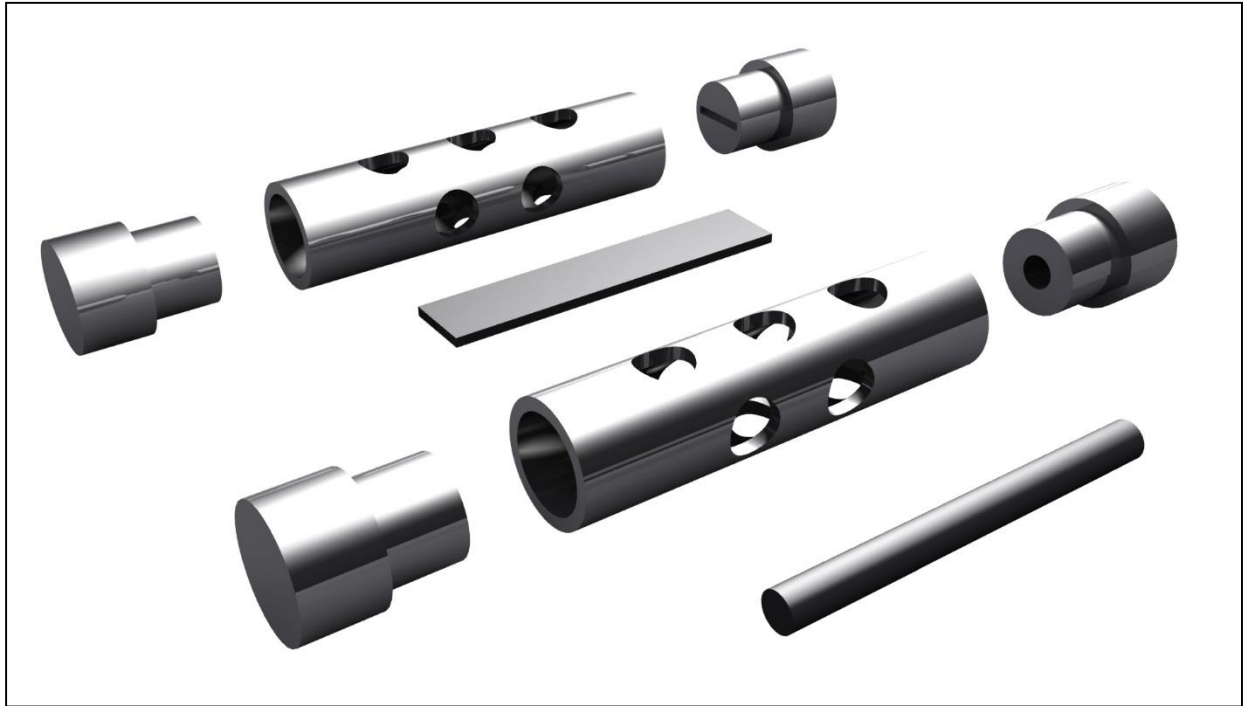
Figure 6
Strip Corrosion Coupon and Tensile specimen rod Coupon Holder

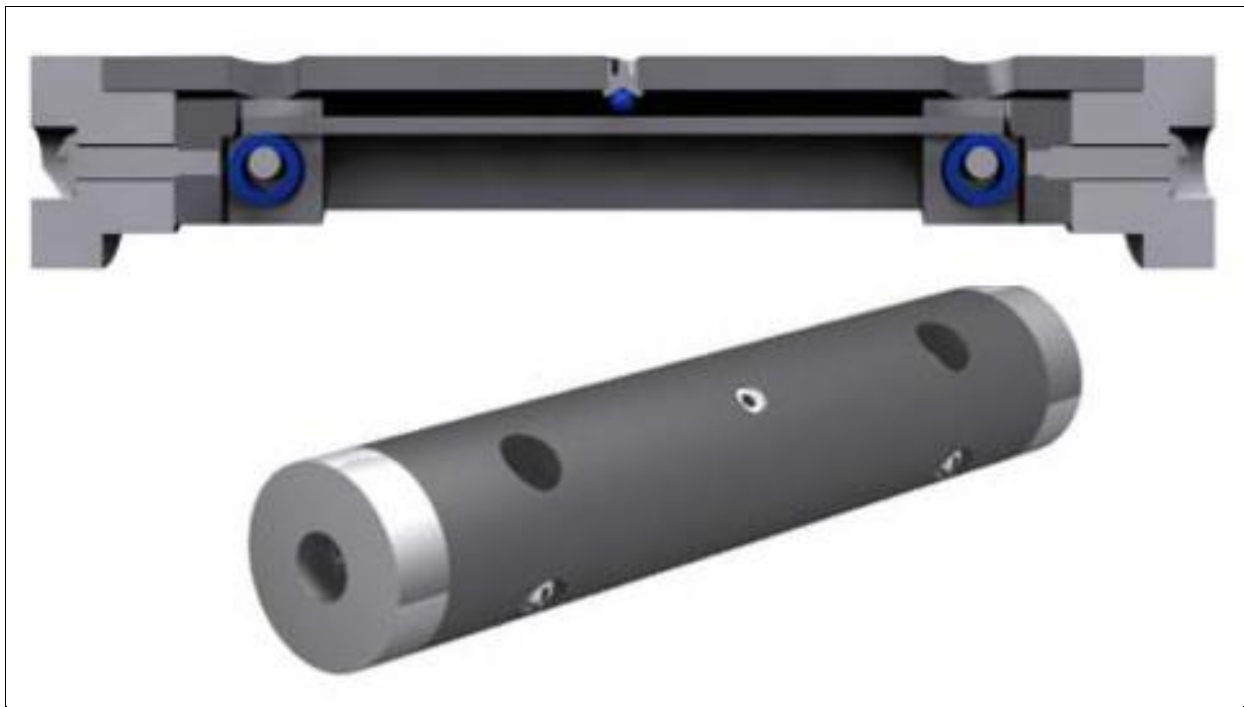
Figure 7
Pre-Stressed Bent-Beam Coupon Holder

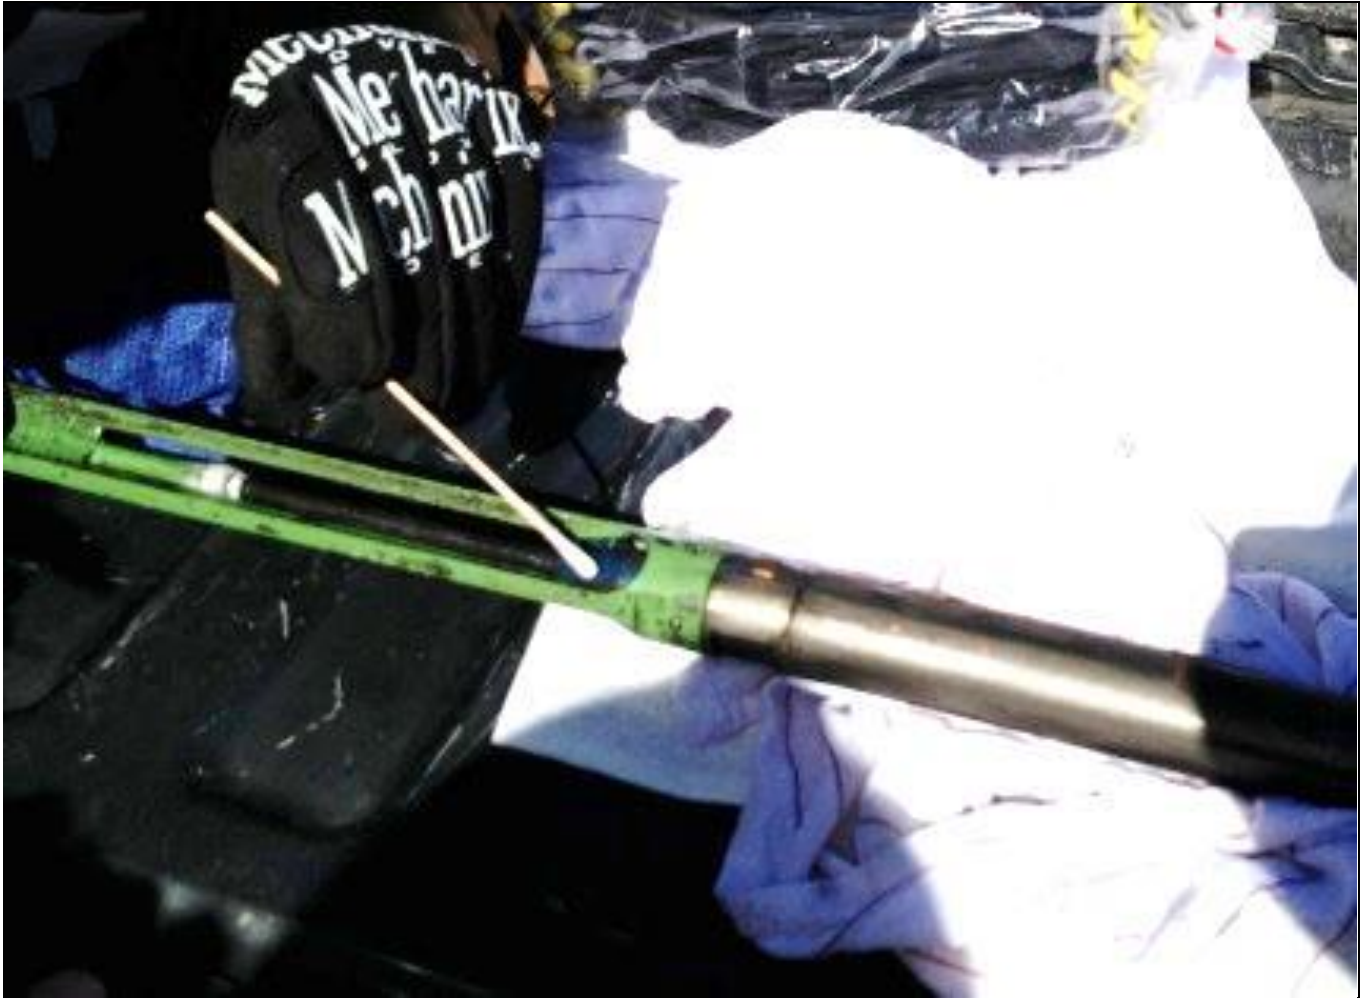
Figure 9
Bacterial analysis from DCMS probe

- Inhibitor Selection/Effectiveness and Film Persistence
- Material Selection/Effectiveness
- Determining General Corrosion/Erosion effects
- Bacterial Swabbing of Probe after retrieval (Figure 9)
- Pitting Analysis of Probe after retrieval

The client required an accelerated five-week study for each well. One week with no treatment, one week with chemical at 0.5x their recommended dose rate, one week at recommended rate, and finally at 2x the recommended rate. The bacterial analysis was to be done first after a scraper tool was run to collect solids from the wellbore for scale depositions. The scraper tool is also recommended to be run prior to any DCMS or DCHA installation, to clear out of any potential debris that could get the tools caught while running in the hole. Bacterial analysis of samples taken from the DCMS probe would also be taken (Shown in Figure 9), once retrieved from downhole.

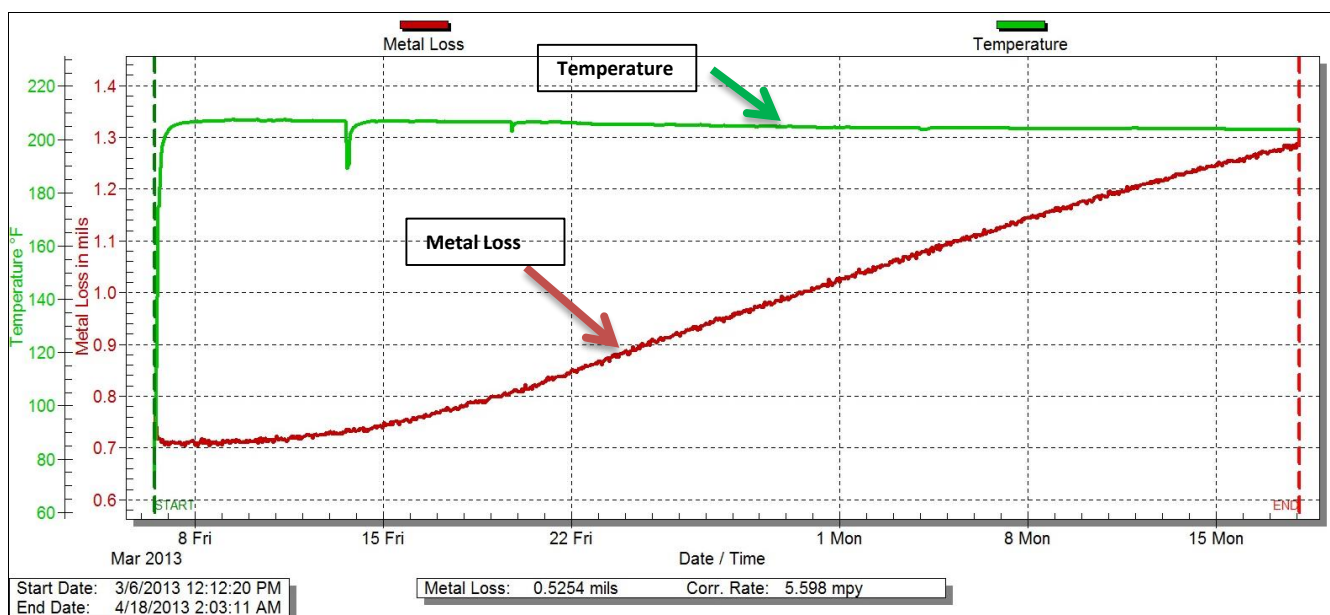
Figure 10

Texas DCMS - Metal Loss & Temperature vs. Time

The second cycle of five week testing for the same wells produced similar results. This time, the DCHA was also included directly attached behind the DCMS, and was able to validate the data recorded by the DCMS. Figures 10 and 11 clearly indicate a corrosion rate of < 10 mpy for those particular trials. The coupon analysis validated with an average corrosion rate of < 3 mpy. As expected the stainless steel coupons were more corrosion resistant than the carbon steel coupons. The temperatures were fairly consistent near 200°F (≈93°C).

The DCMS clearly revealed the limits of having only a coupon holder. Figures 10 and 11 of the DCMS data demonstrated a more interactive response and reaction of the chemical treatment and dosage from week to week.

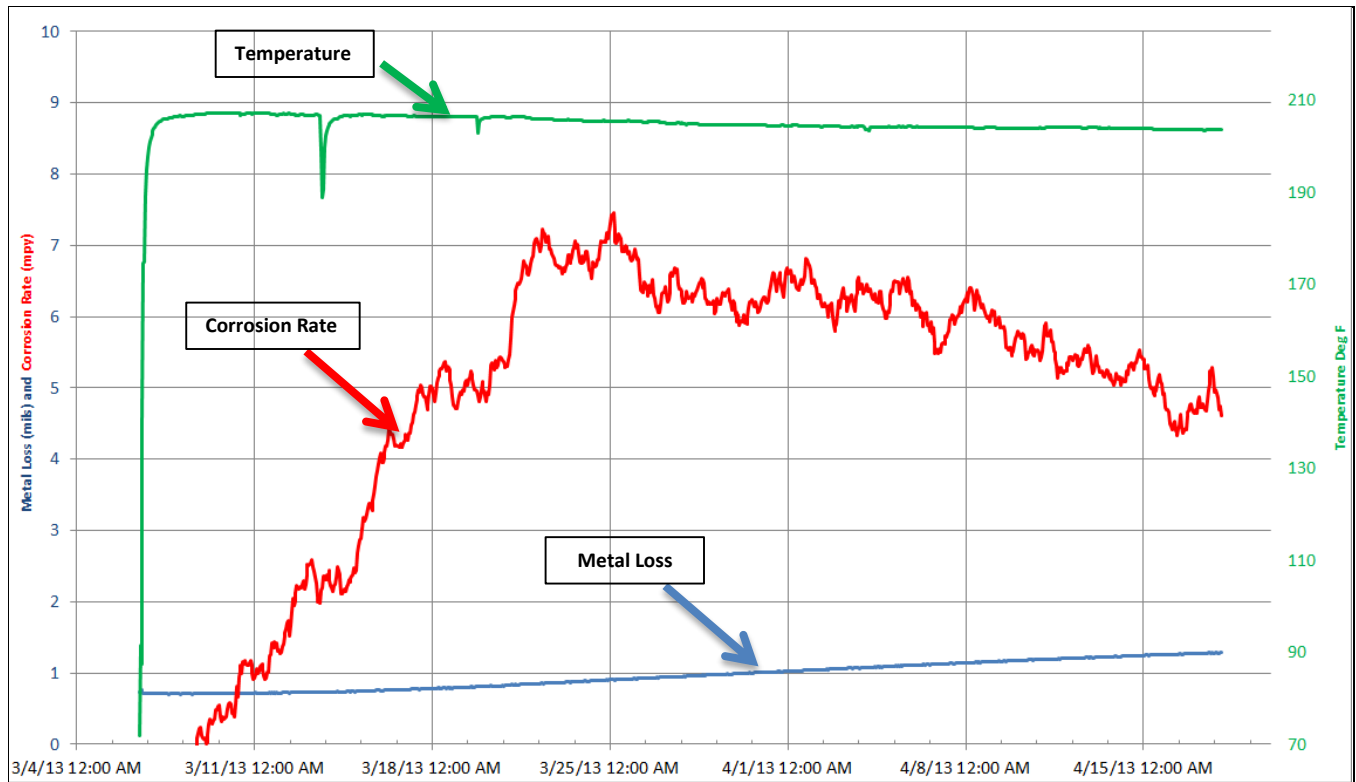
Figure 11

Texas DCMS 5 Mil Probe Span - Corrosion Rate, Metal Loss, and Temperature vs. Time

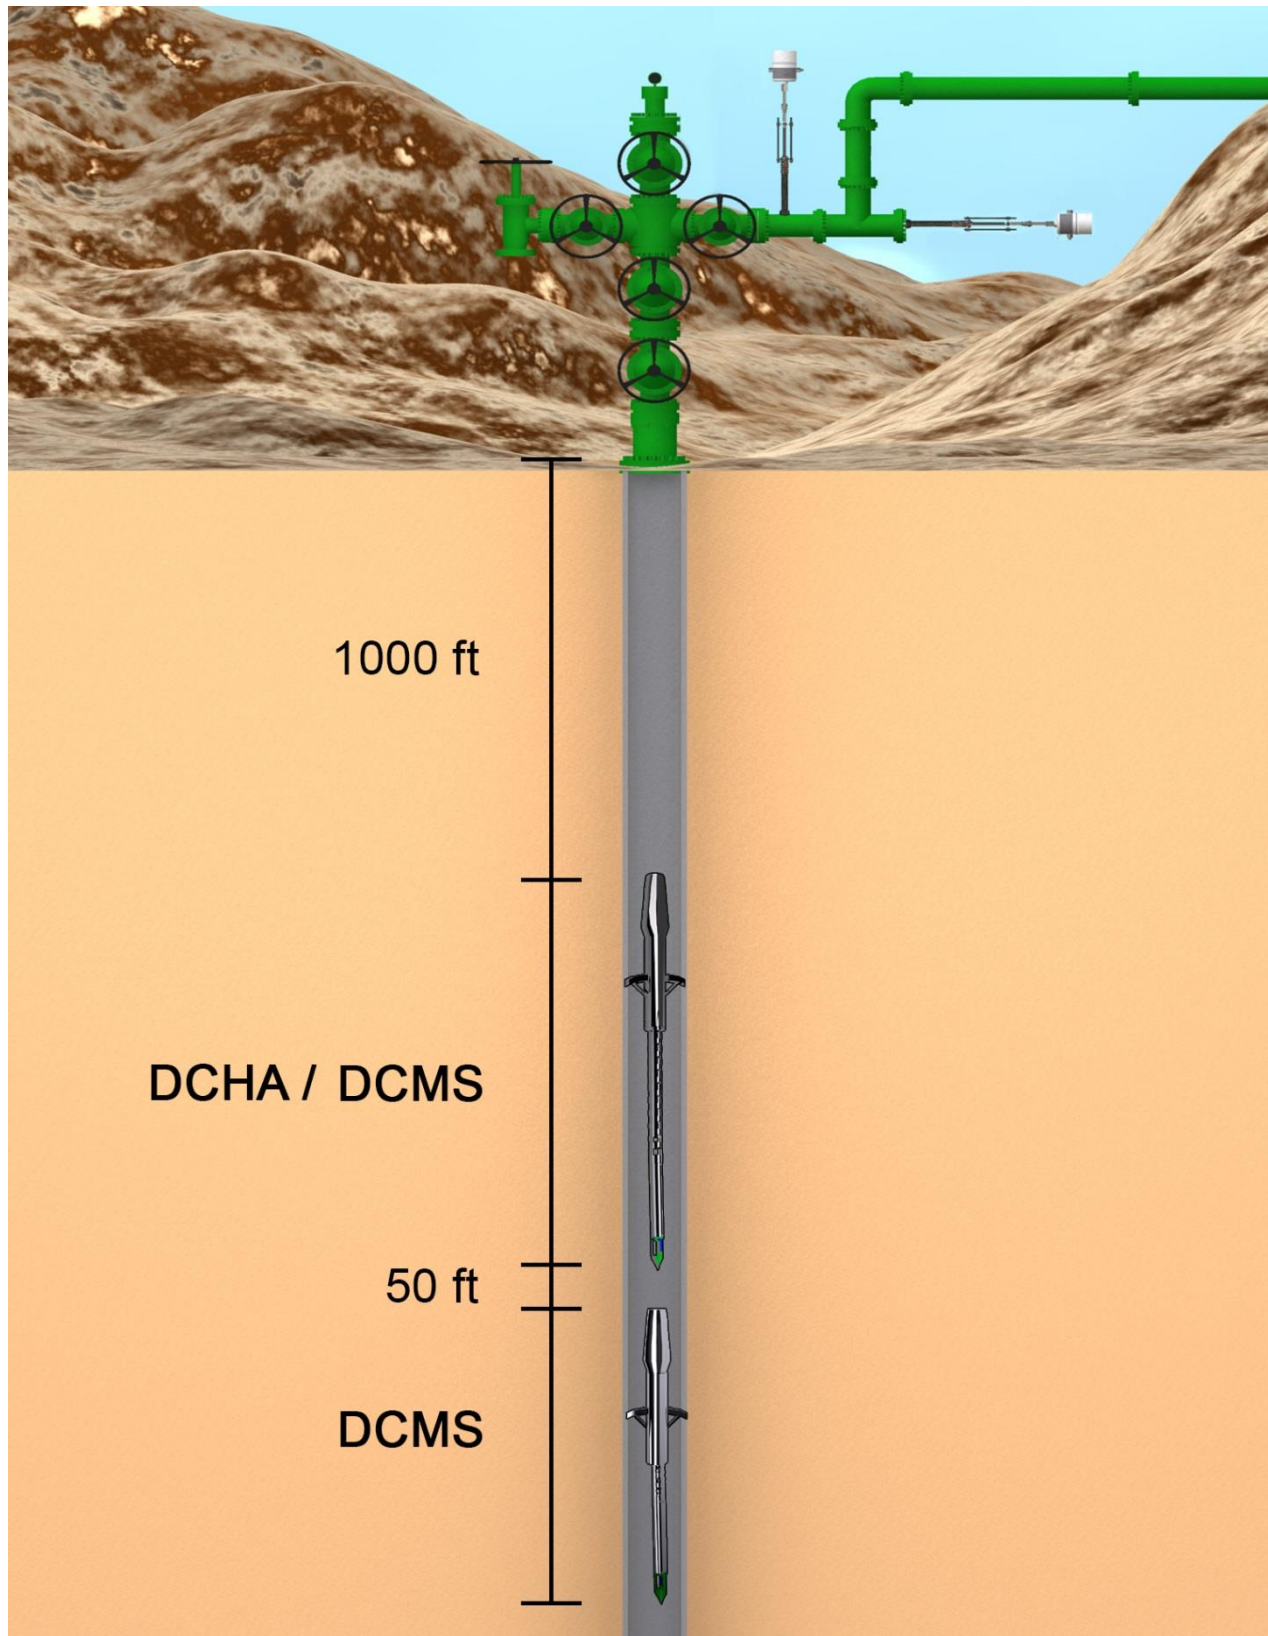
Figure 12
Colorado Downhole Configuration

The trials were run, both using Figure 12 configuration. The initial trial used standard coupons for the DCHA, mostly carbon steel. The second trial had many more unique alloys in the coupon holder. The decision there was to see how different alloys react to the type of corrosion in the well, and then using this well to characterize other wells in the area. The second trial on this well is currently in progress at the time of this report.

Two separate trials were run. The first used all three instruments (DCMS, DCHA and Microcor Dataloggers on surface) arranged similar to the downhole configuration in Figure 12. The data (Figures 13-16) confirmed that corrosion was aggressive, to the extent that the probes were either completely consumed by general or localized corrosion.

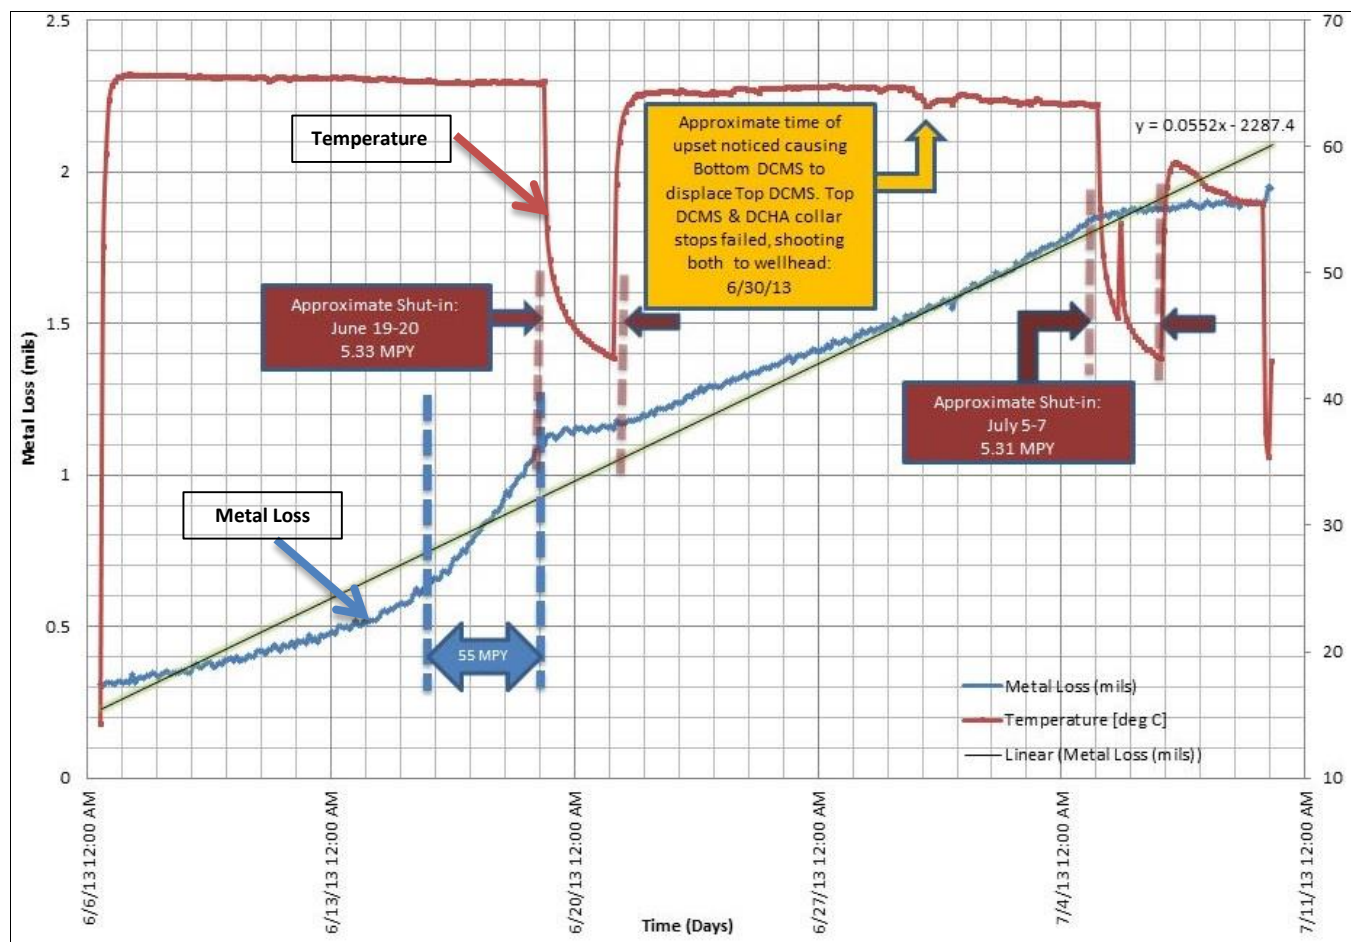
Figure 13
Colorado Trial 1 Bottom DCMS 10 Mil Probe Span – Metal Loss and Corrosion Rate vs. Time

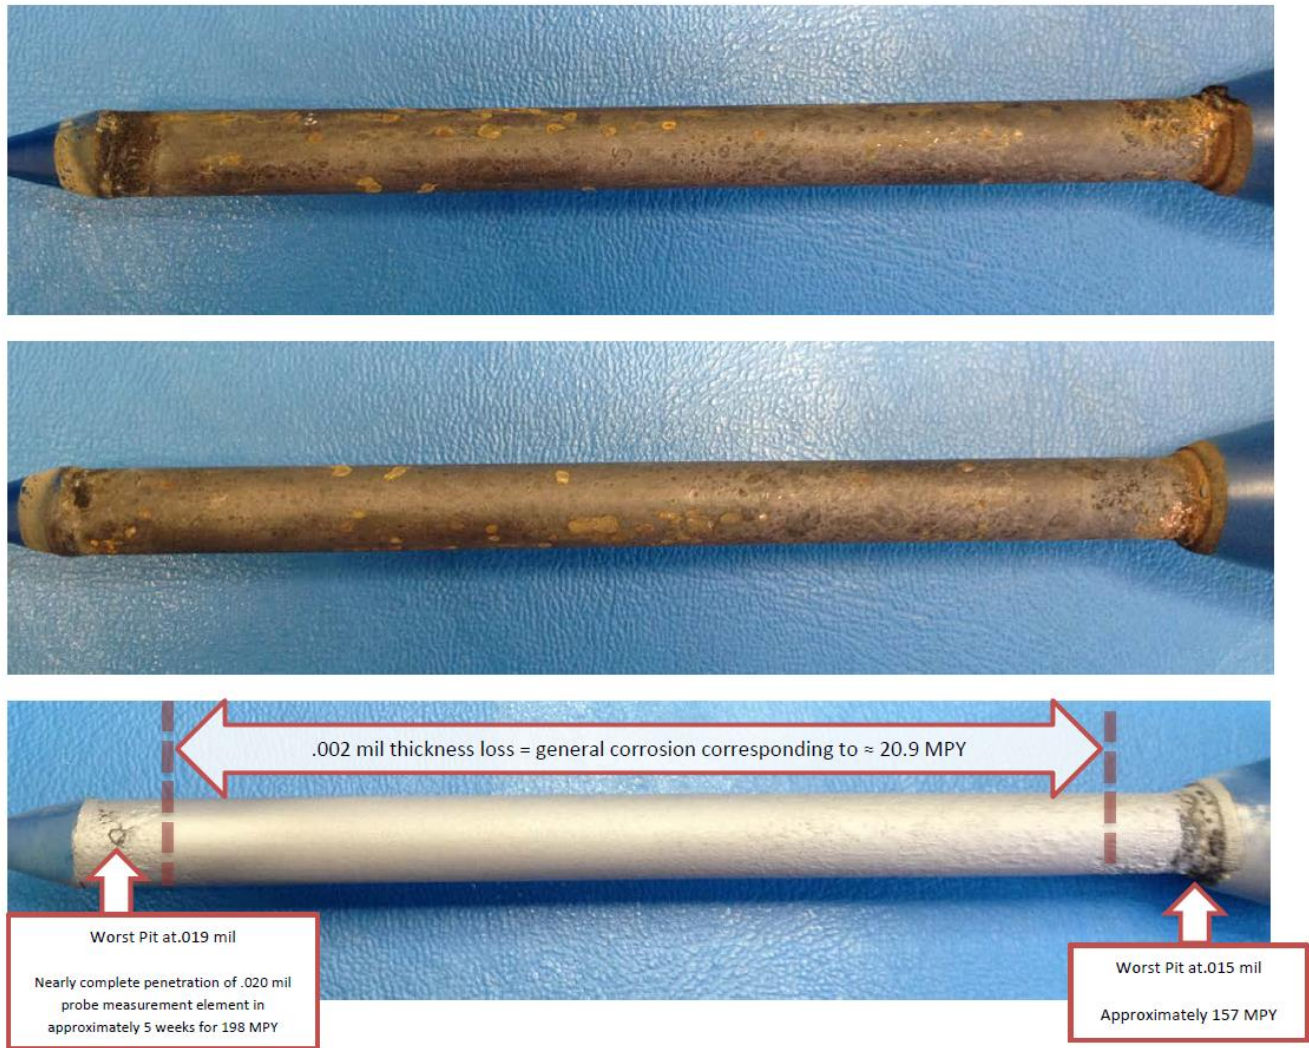
Figure 14
Colorado Trial 1 Bottom DCMS – 10 Mil Probe Span

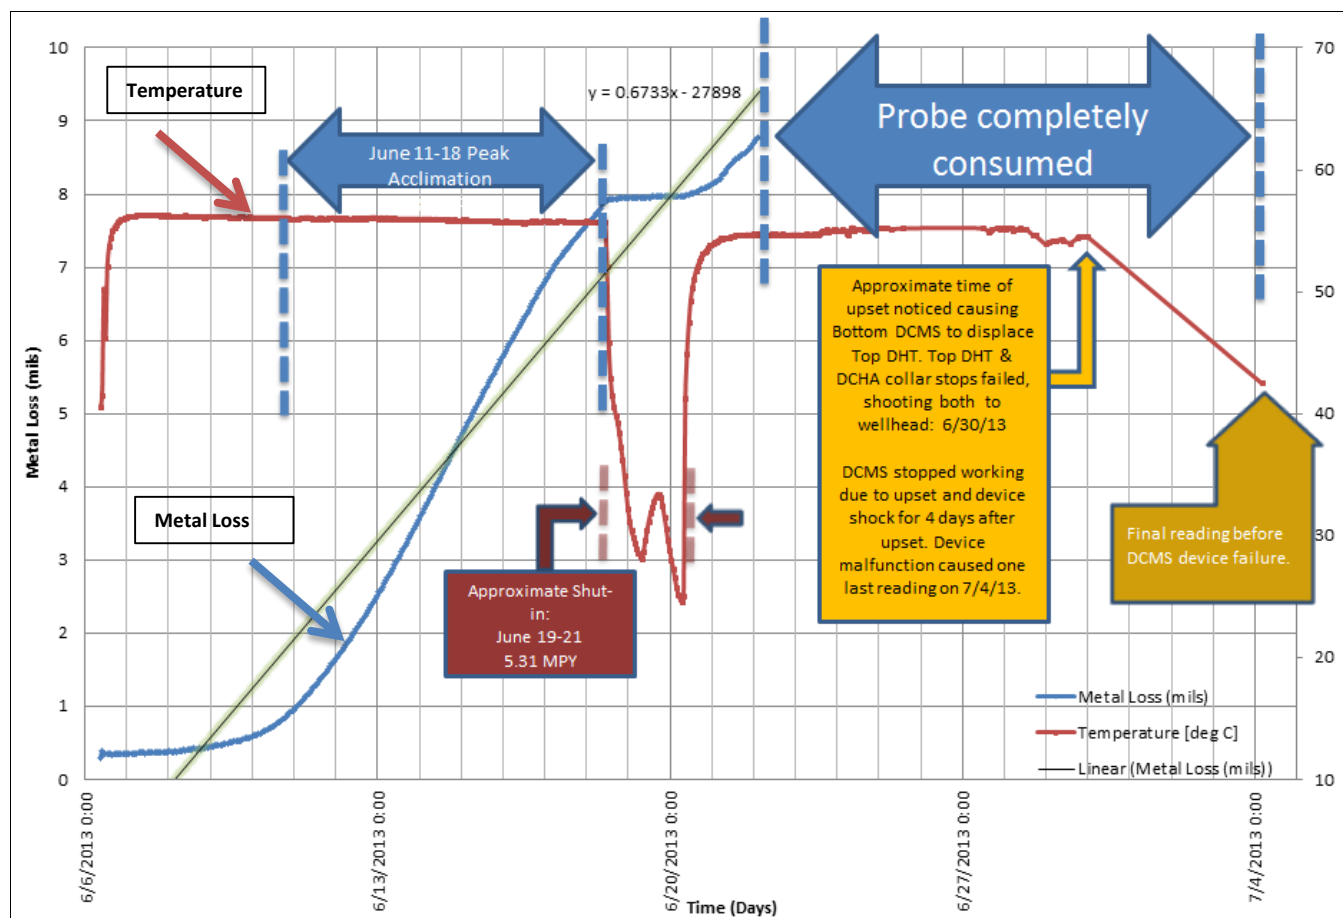
Figure 15
Colorado Trial 1 Top DCMS Mil Probe Span – Metal Loss and Corrosion Rate vs. Time

For Colorado Trial 1, the corrosion was so aggressive that the setting tool dogs holding the top DCMS and DCHA tools in place. Immediately after the setting tool dogs corroded through, both tools shot up to the surface. That event was later evident, once the tools were retrieved and were noticed to be sitting near the top of the well bore. Figure 15 approximates when that upset may have occurred. Figure 16 gives a visual on an actual probe break.

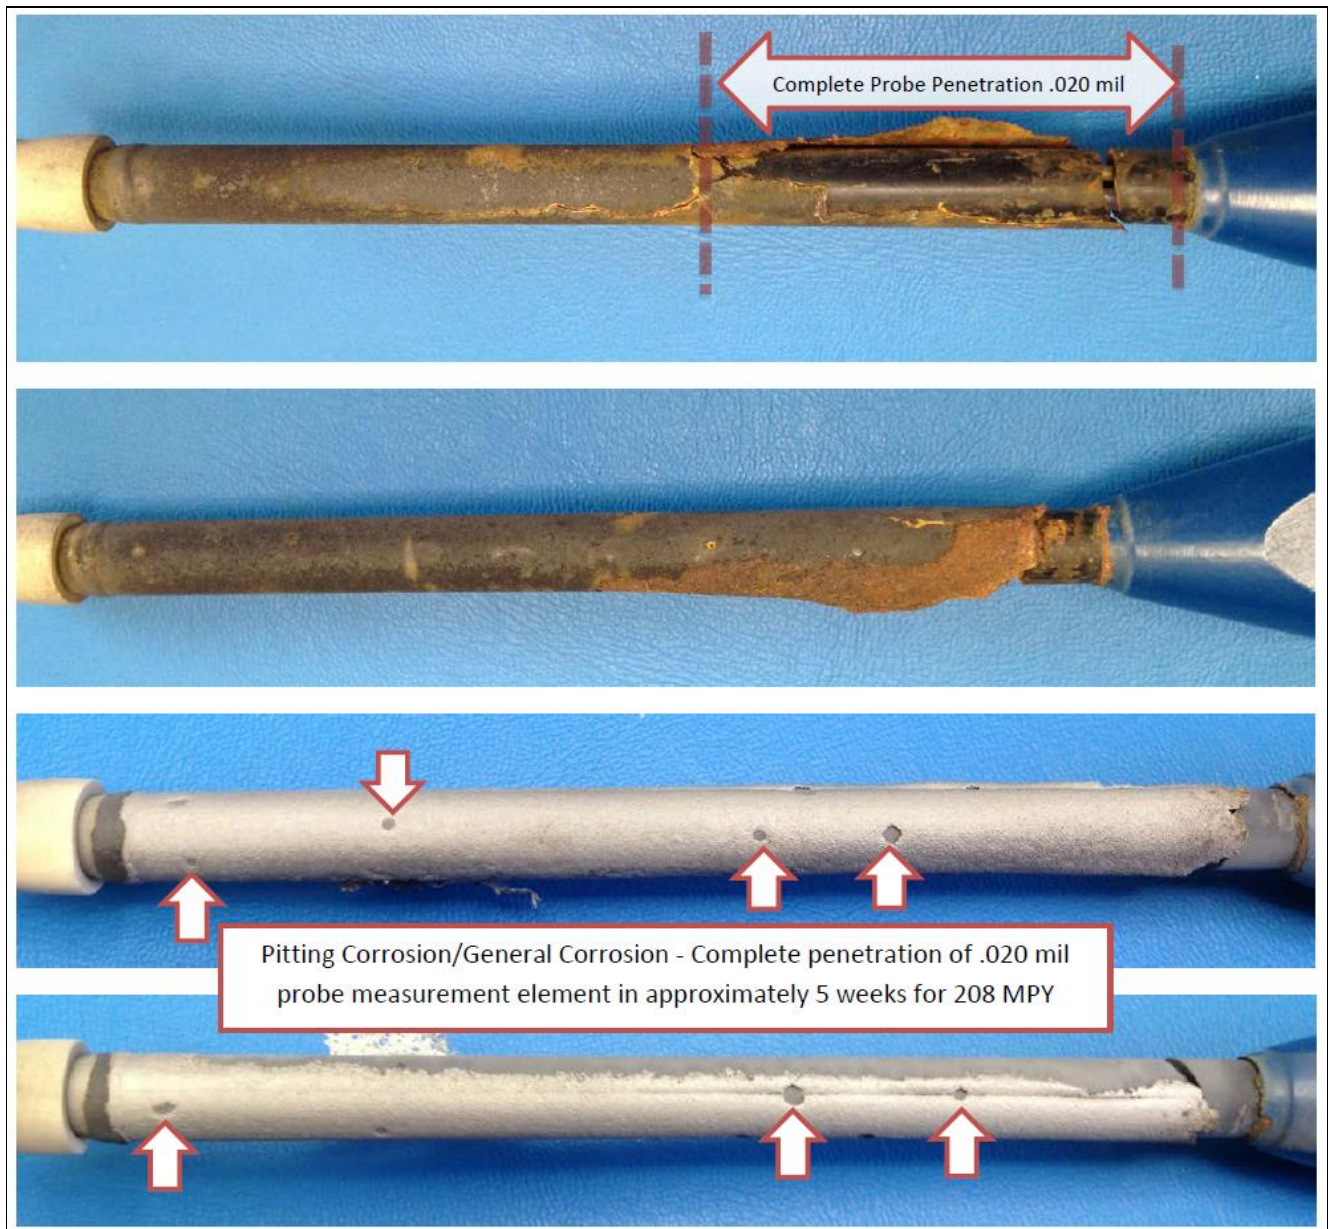
Figure 16
Colorado Trial 1 Top DCMS – 10 Mil Probe Span

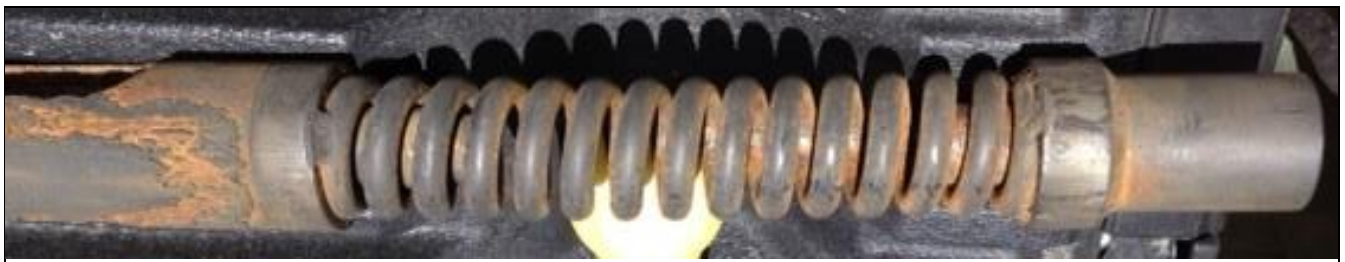
Figure 17
Corroded Collar Stop Wireline Tool

The Colorado study indicated high corrosion rates as anticipated. The corrosion at 1000ft was found to be extremely aggressive, and at times so aggressive, it caused not only the probes to be completely consumed, but also damage to the wireline tools holding the instruments in place to corrode as seen in Figure 17.

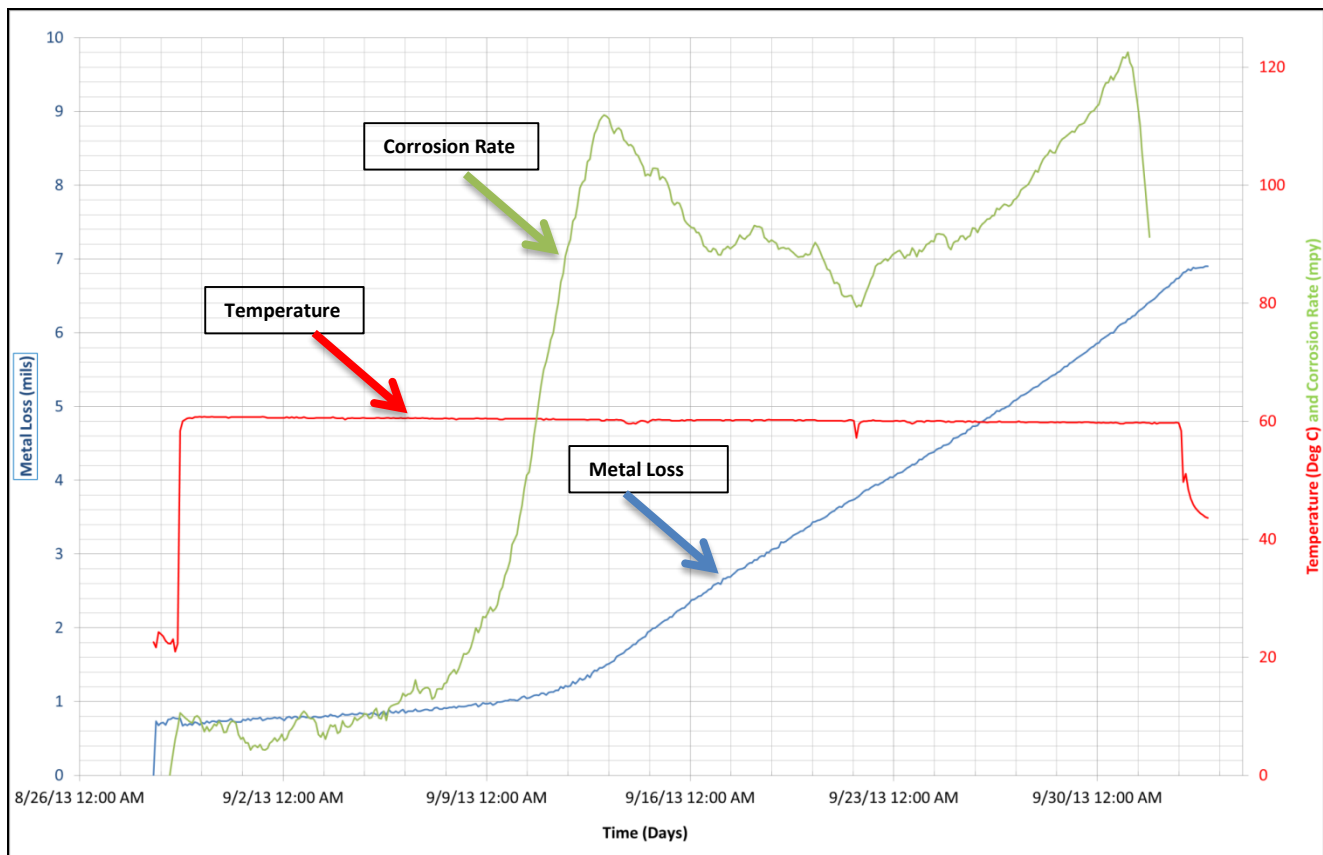
Figure 18
Colorado Trial 2 Top DCMS 10 Mil Span – Metal Loss Corrosion Rate, and Temperature vs. Time

Colorado Trial 2 was done in two stages. While the tool arrangements were exactly the same as for the first trial, DCMS and DCHA were both retrieved after about one month. The Figure 19 plot was truncated due to complete probe consumption. The second DCMS (Bottom) was targeted to hold two months of data. The client separated the retrievals in two parts to see the effectiveness of a treatment they were to start in the middle of the trial. The original intended date for injection was delayed by an injection problem. It was later found that even if treatment had begun as intended, it would have been too late to be monitored as the DCMS had already been consumed (Figures 18-21). The same trial is being repeated on a shorter time scale to monitor the treatment.

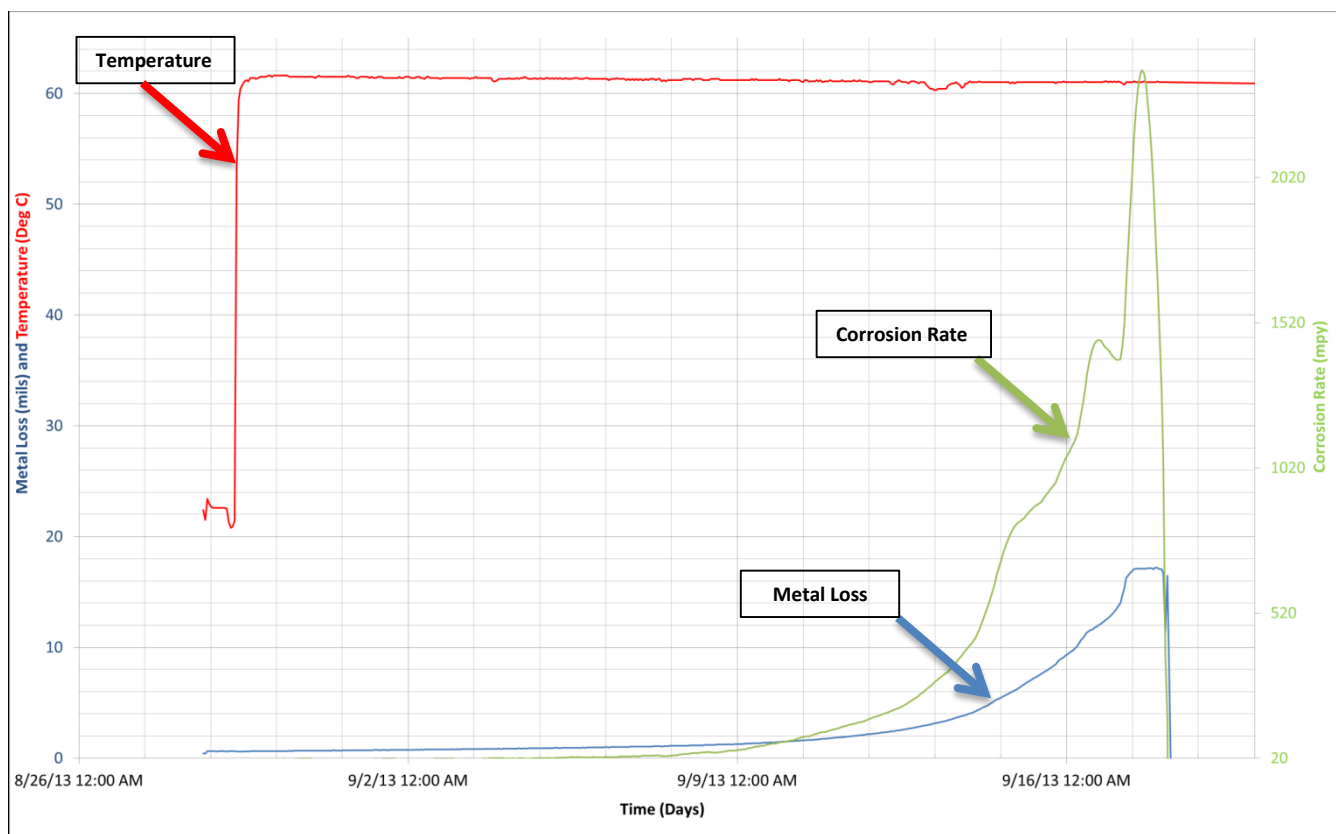
Figure 19

Colorado Trial 2 Bottom DCMS 10 Mil Span – Metal Loss Corrosion Rate, and Temperature vs. Time

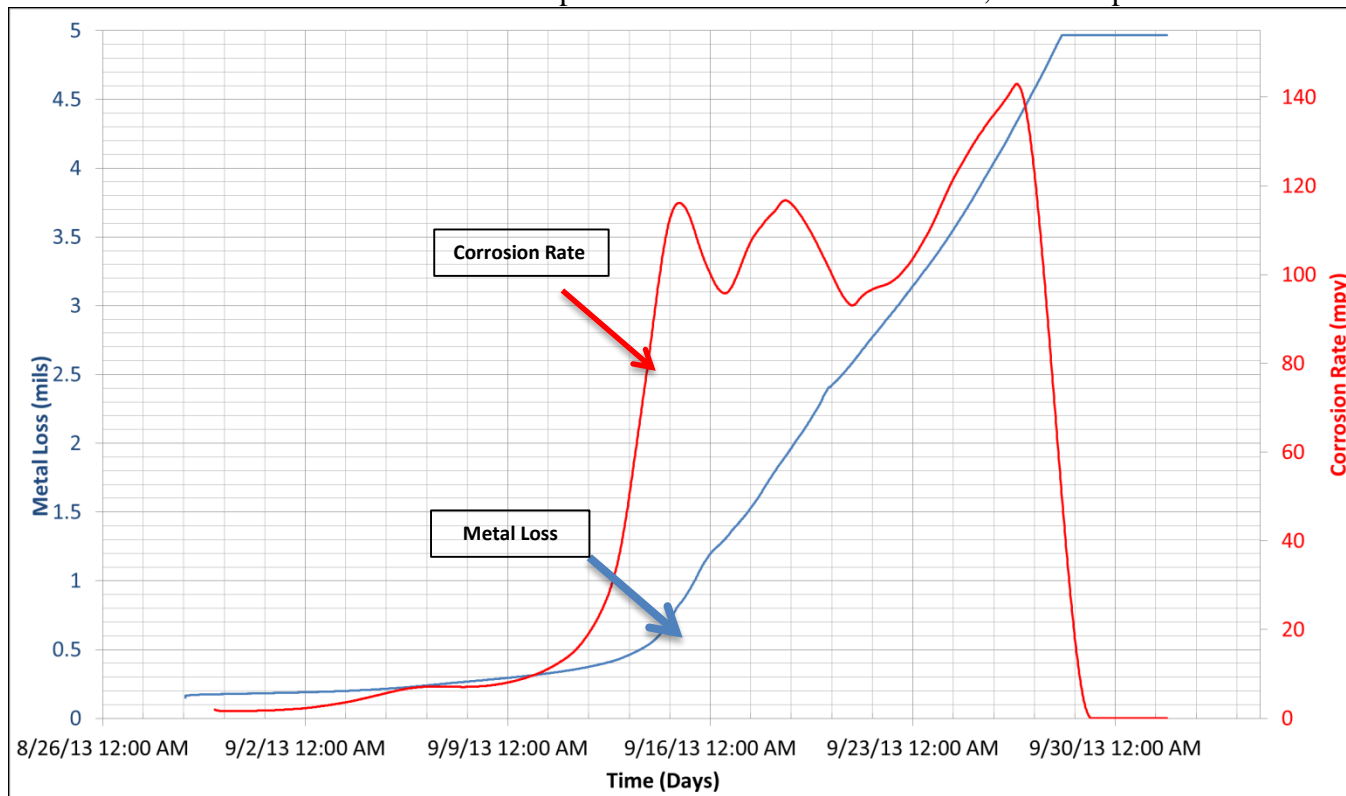
Figure 20

Colorado Trial 2 Horizontal Surface ER Probe 5 Mil Span – Metal Loss and Corrosion Rate vs. Time

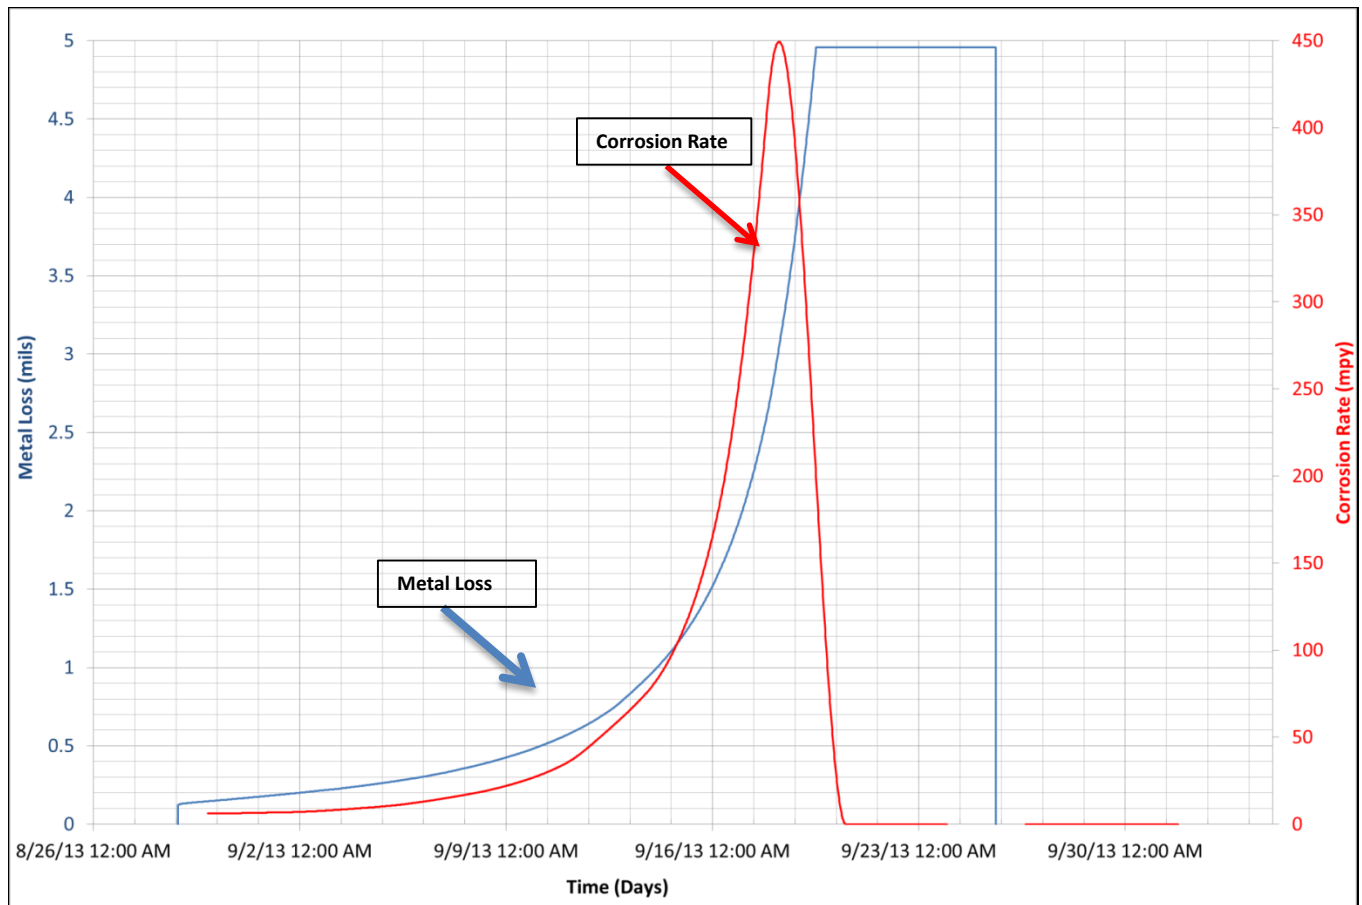
Figure 21
Colorado Trial 2 Vertical Surface ER Probe 5 Mil Span – Metal Loss and Corrosion Rate vs. Time

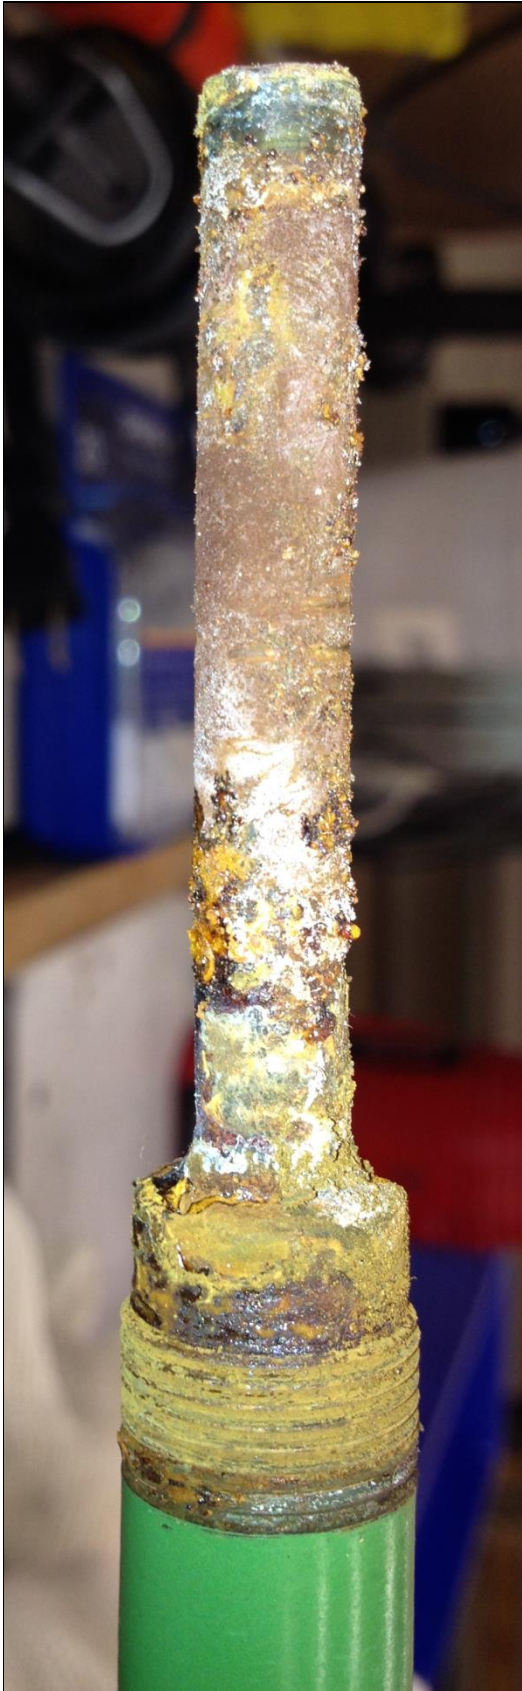
Figure 22
Horizontal Surface ER Probe

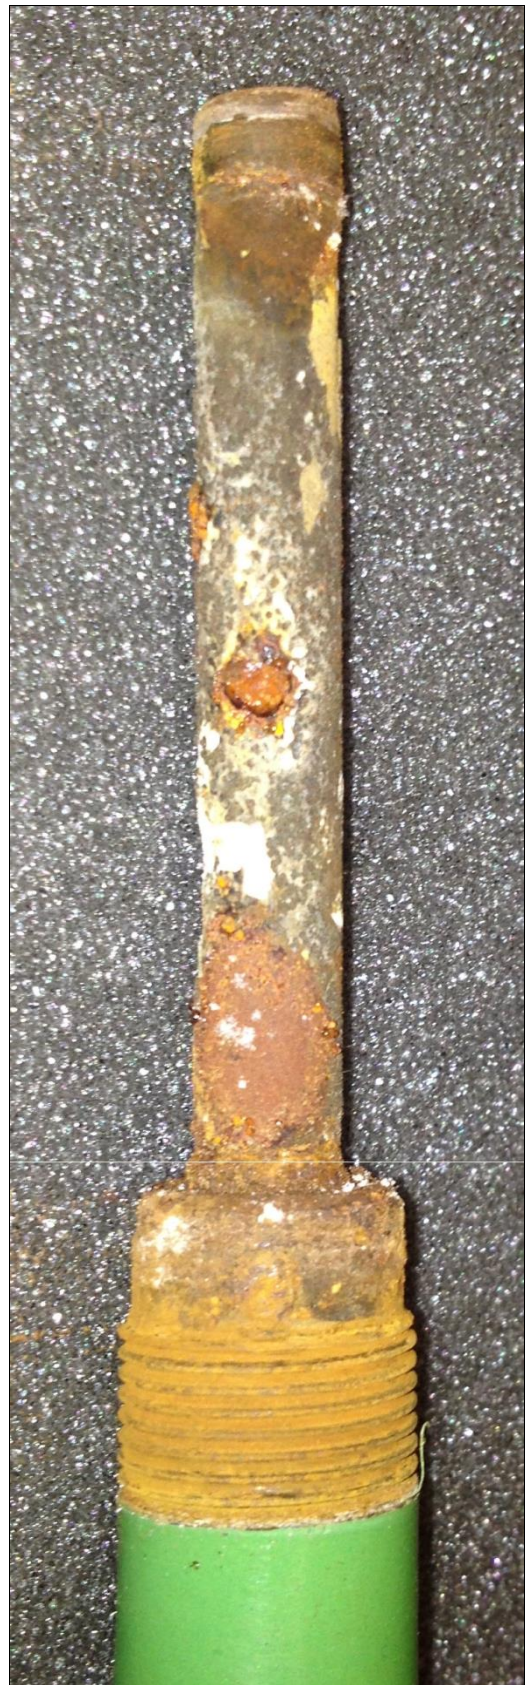
Figure 23
Vertical Surface ER Probe

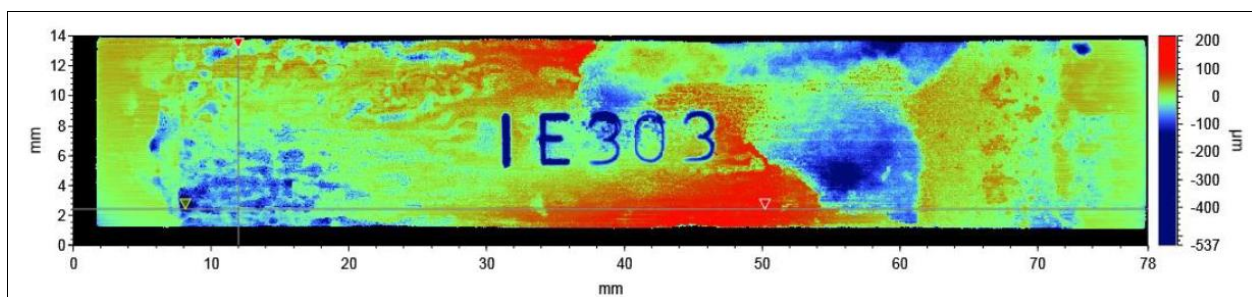
Figure 24
Colorado Trial 2 Sample White-light Interferometry Capture of IE303

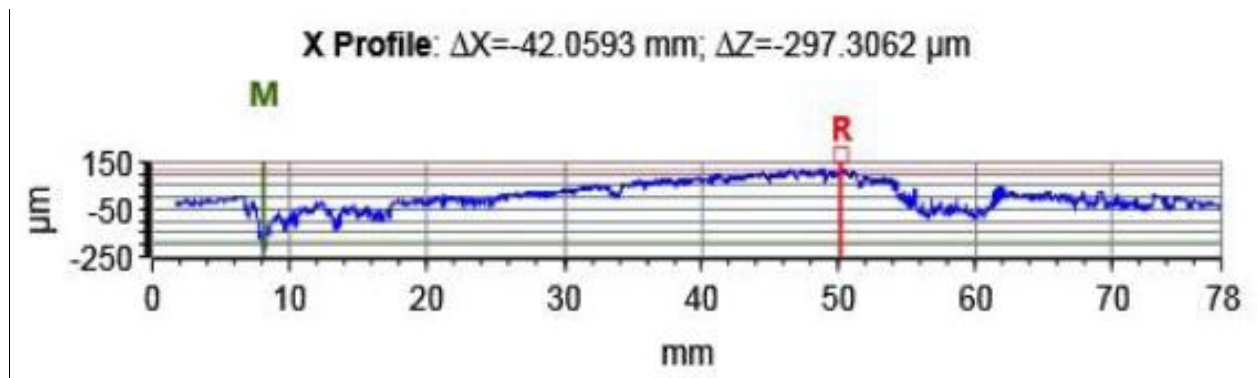
Figure 25
Colorado Trial 2 White-light Interferometry Pitting Analysis of IE303, 297 μm \approx 120mpy
