Speedy containership repair

It should have been a regular scheduled day for unloading of container cargo. However, when a Panamax container vessel was waiting to berth outside a US port it faced a rudder steering failure.

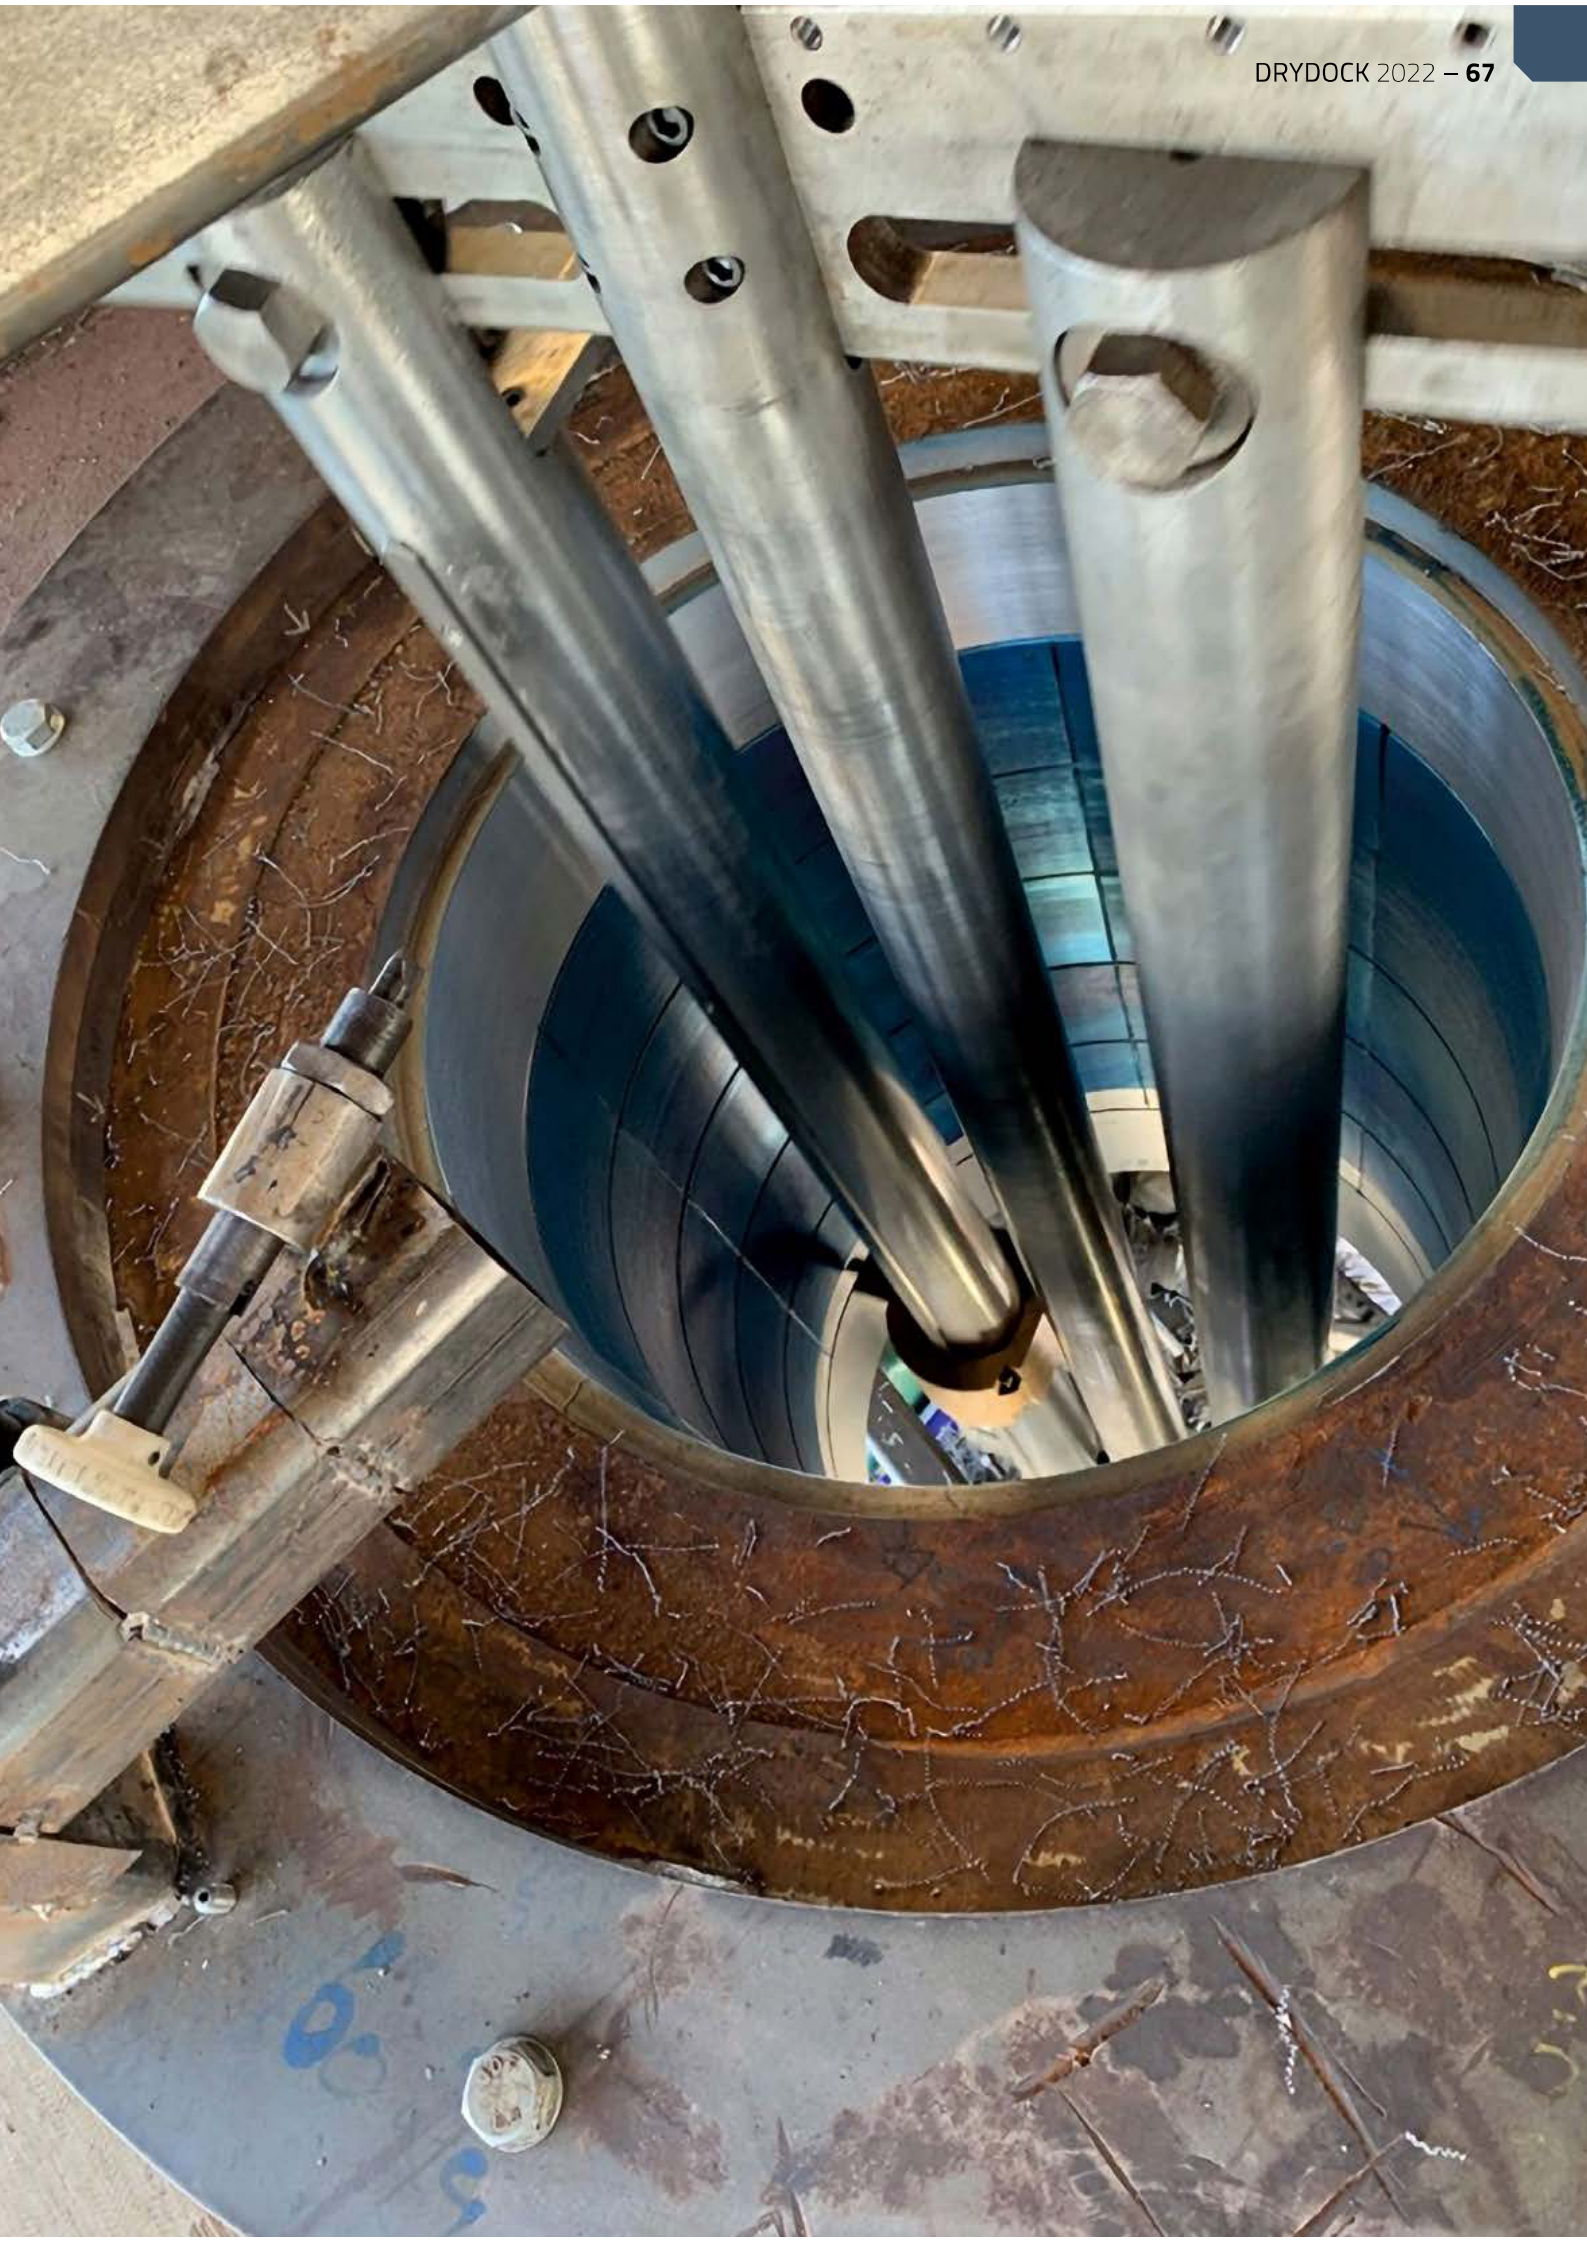
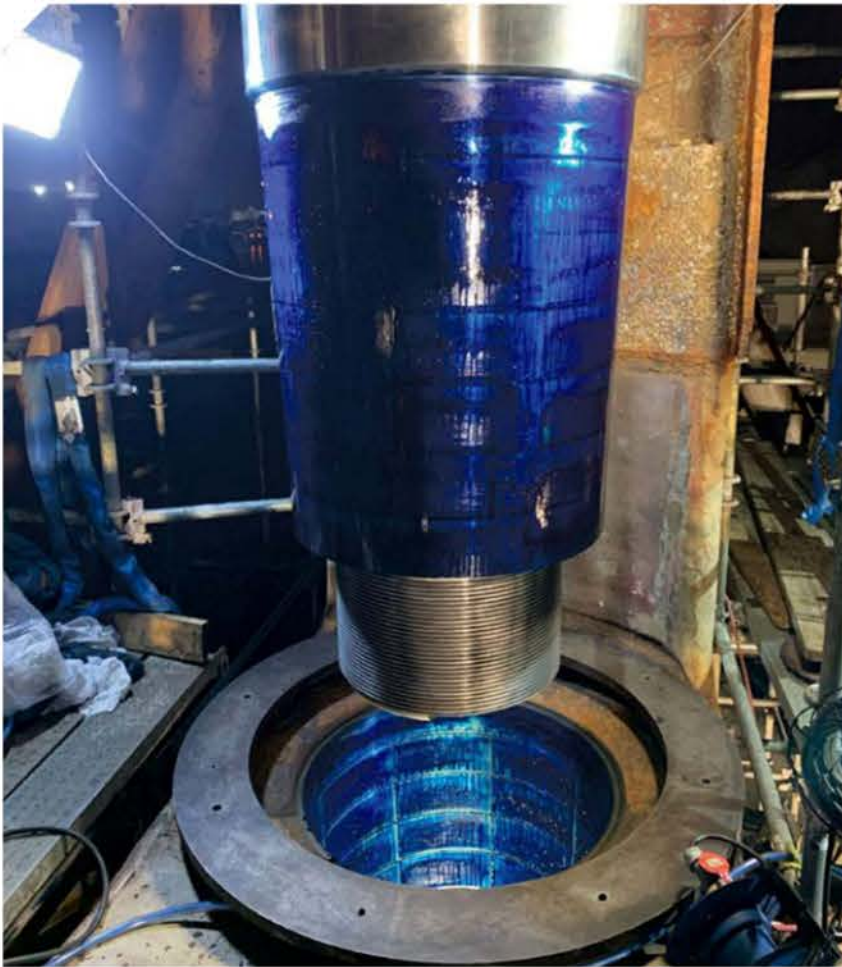
The new rudder stock was delivered with 4 mm oversize and the pintle with 10 mm oversize on the cone

The new rudder stock was delivered with 4mm oversize and the pintle with 10mm oversize on the cones. The reason for this was to have sufficient material to machine in the rudder blade cones and be able to adjust the rudder blade cones if any misalignments were measured.

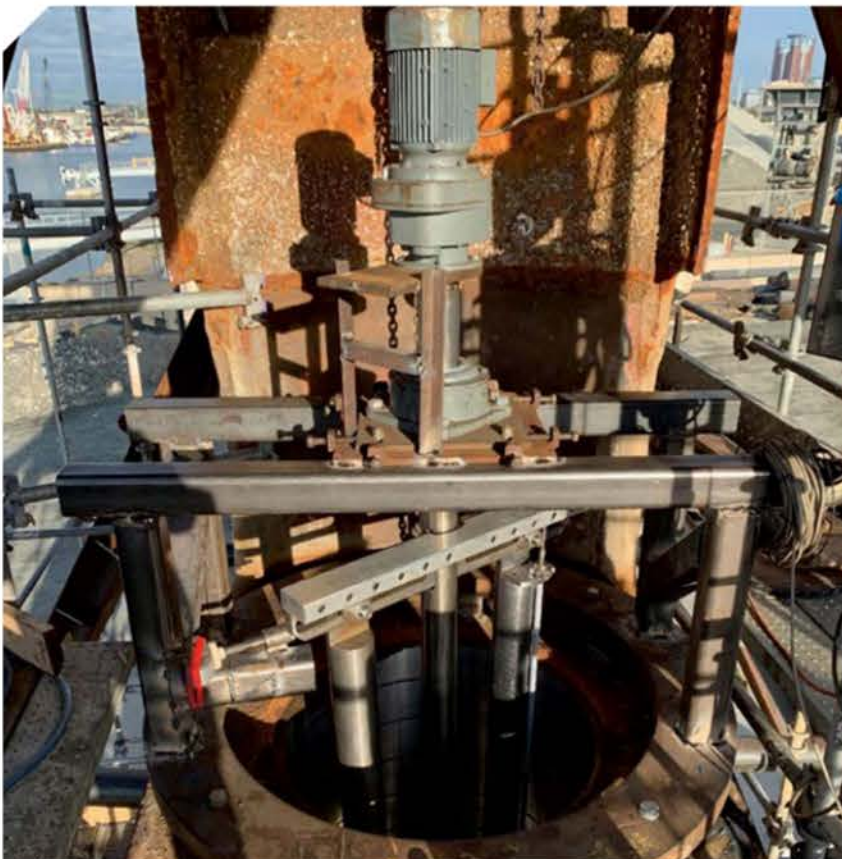
MarineShaft carried out the laser alignment of the pintle bush to ensure a straight line through the rudder bearings

For the in-water repair of the rudder horn pintle bearing, it was necessary to build and set up a cofferdam. In cooperation with a local workshop and the underwater service company, MarineShaft assisted with replacing the pintle bush in the rudder horn. It also carried out the laser alignment of the pintle bush to ensure a straight line through the rudder bearings.
