The **big 3Rs** of rudder repairs afloat

Can you undertake drydock-like services such as rudder removal, repair ashore, and reinstallation (the big 3Rs) whilst in water, ask *Harun Duzgoren (top), Chief Commercial Officer* and *Kevin Peters (bottom), Director, Technical Sales and Environmental Services for Subsea Global Solutions LLC.*

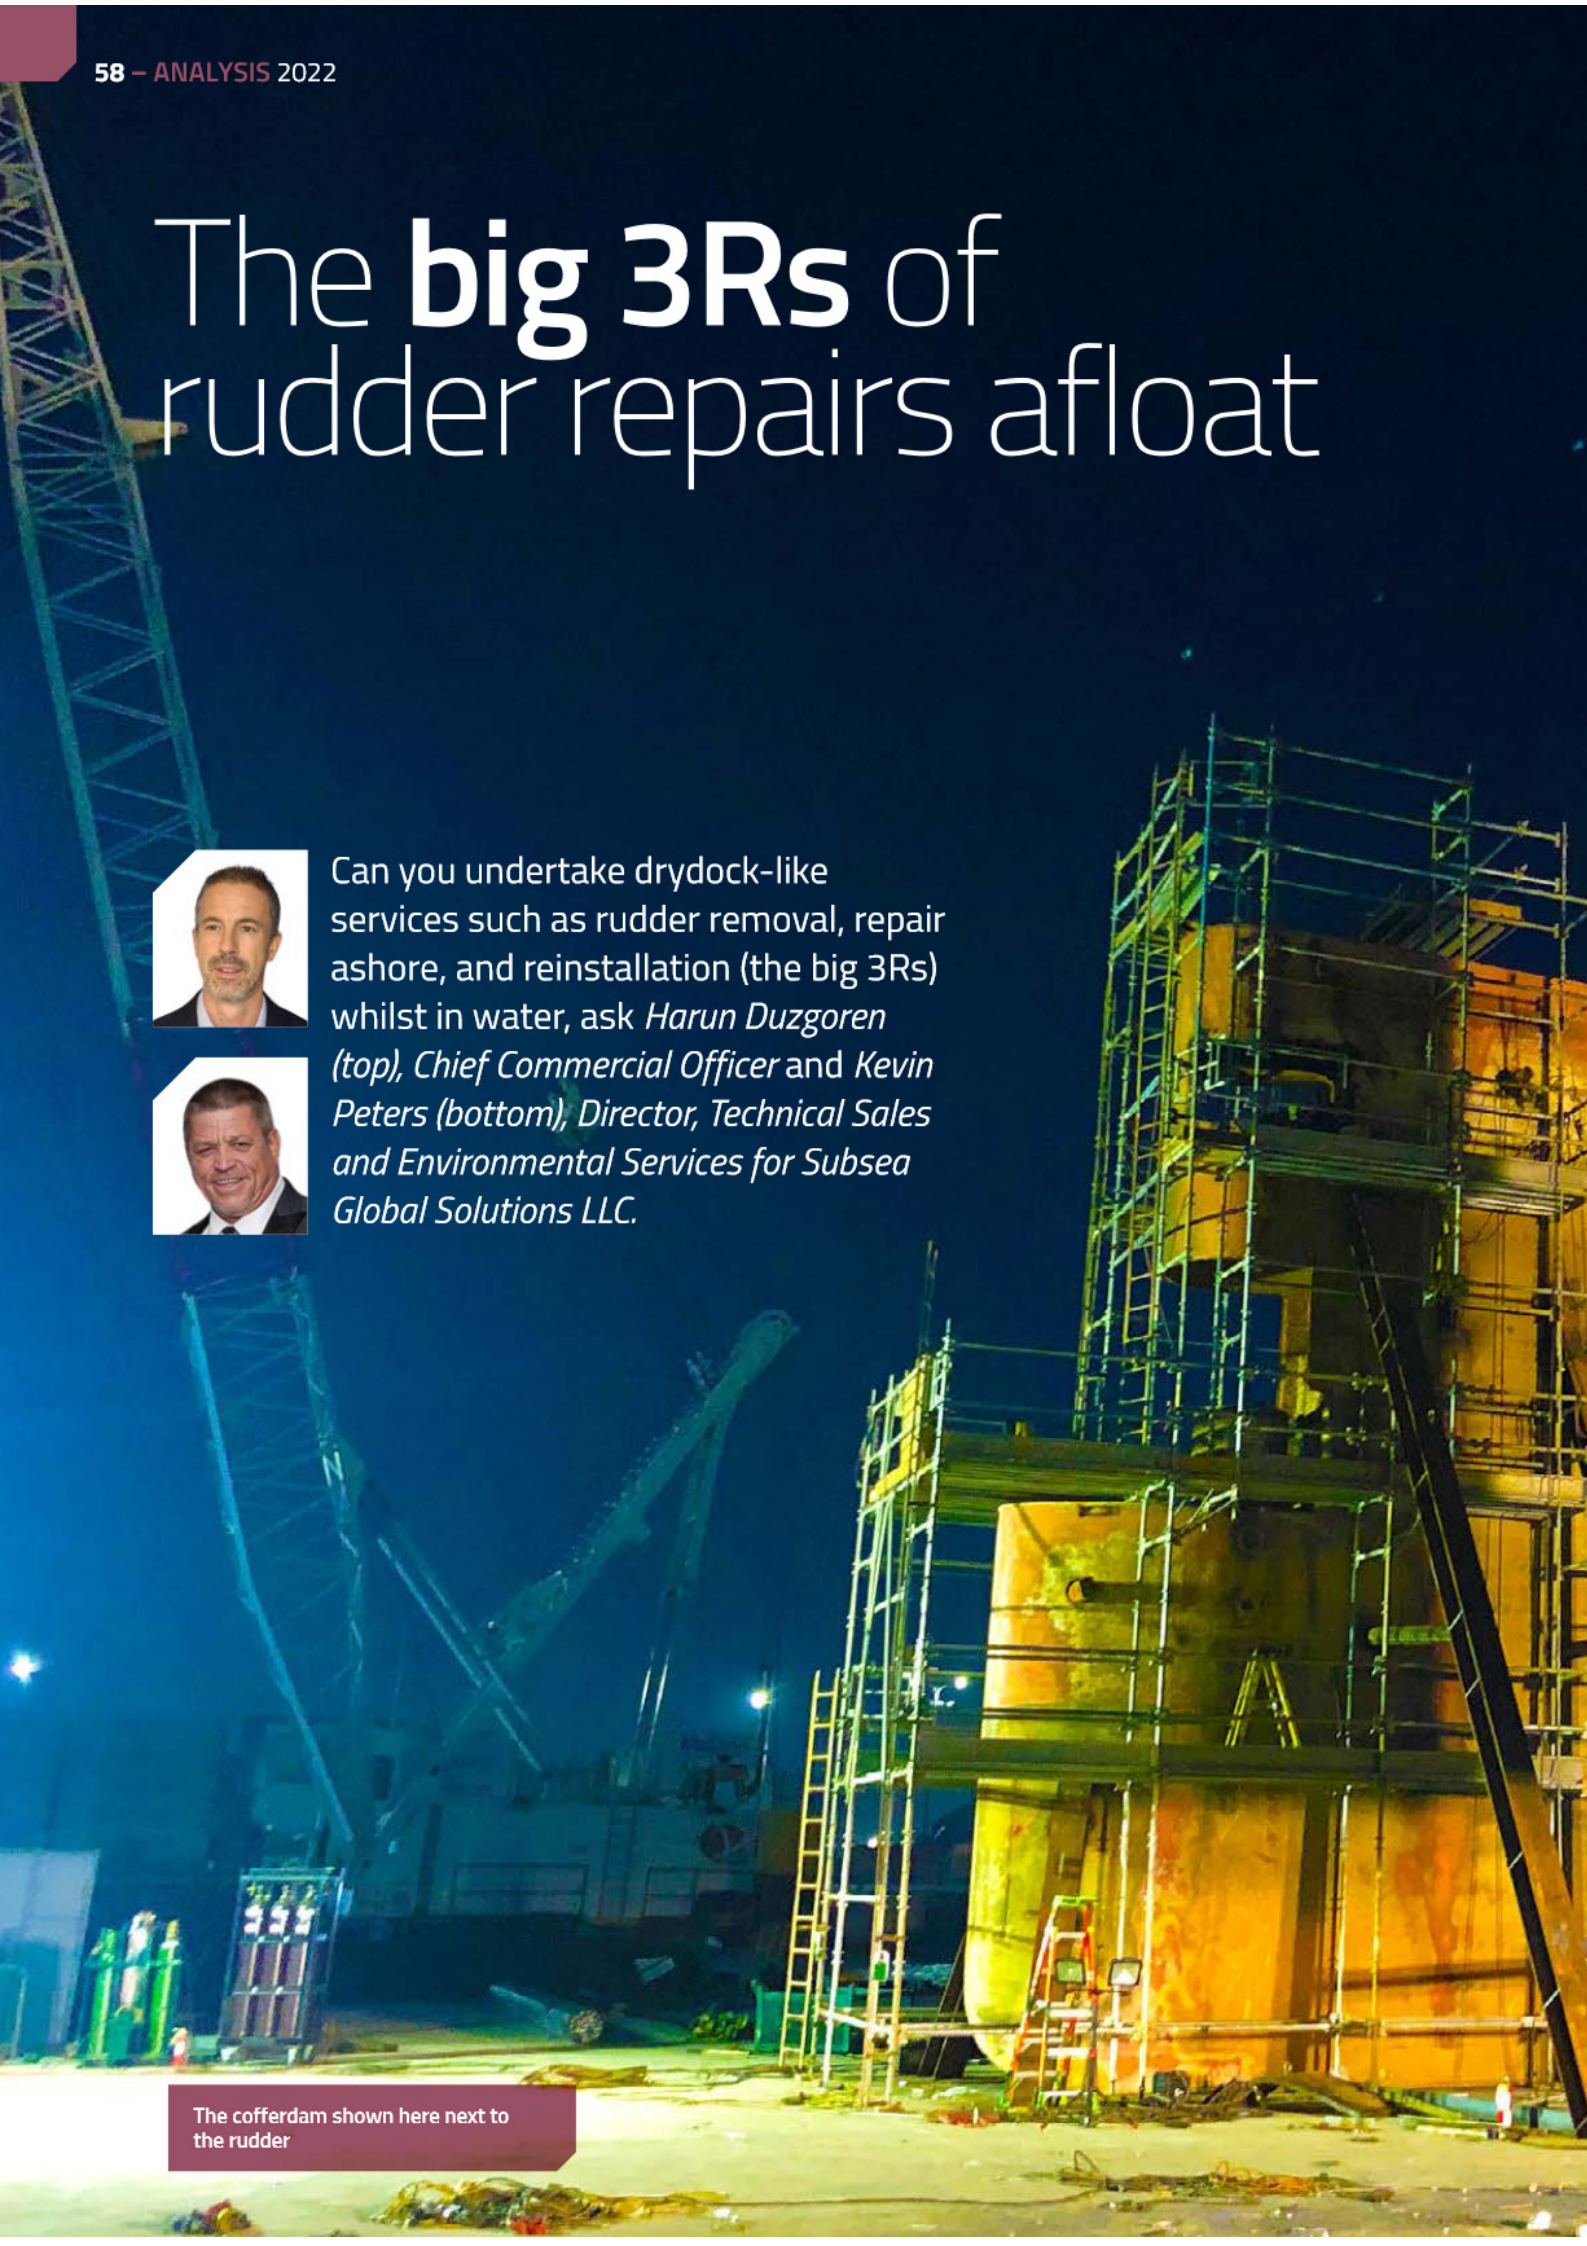
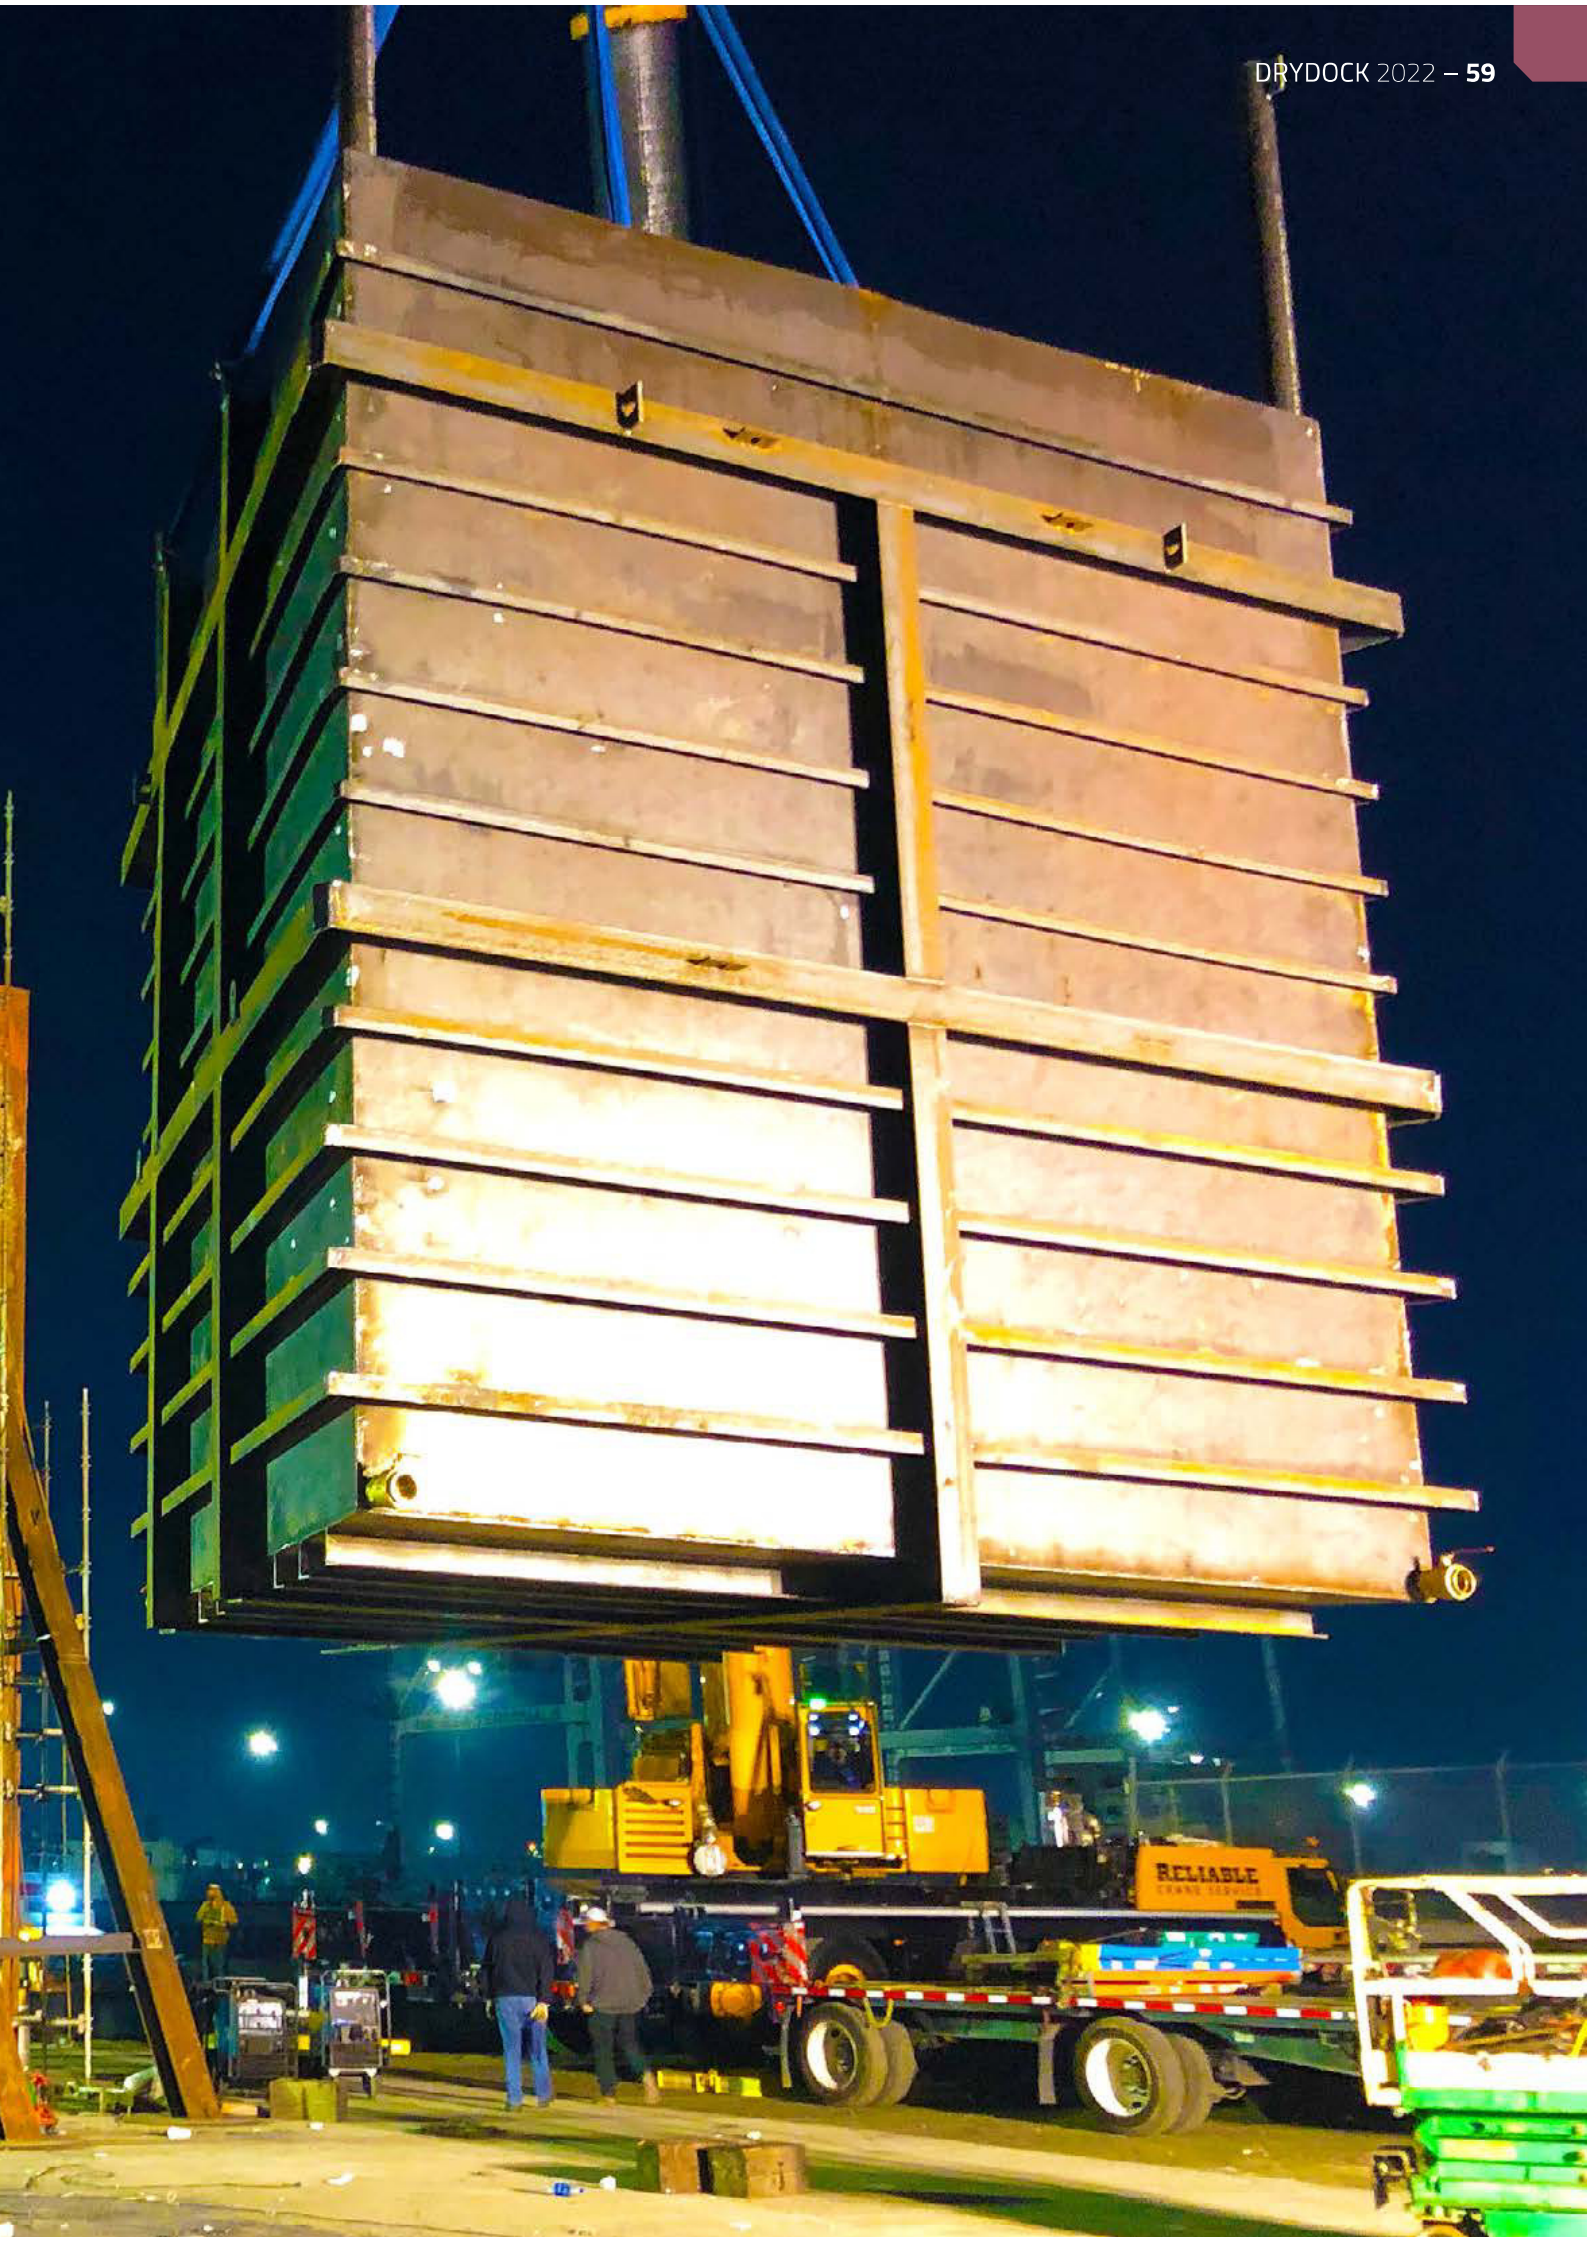
The cofferdam shown here next to the rudder

At the same time some of our coded welders fabricated a properly sized cofferdam onsite, tapered to fit around the rudder horn. Weighing 19 tons, the cofferdam was hoisted and tripped under the vessel's stern to mate to the hull. The cofferdam was installed and de-watered; this gave us full access to the rudder horn, allowing us to make repairs to the neck and pintle bushings.

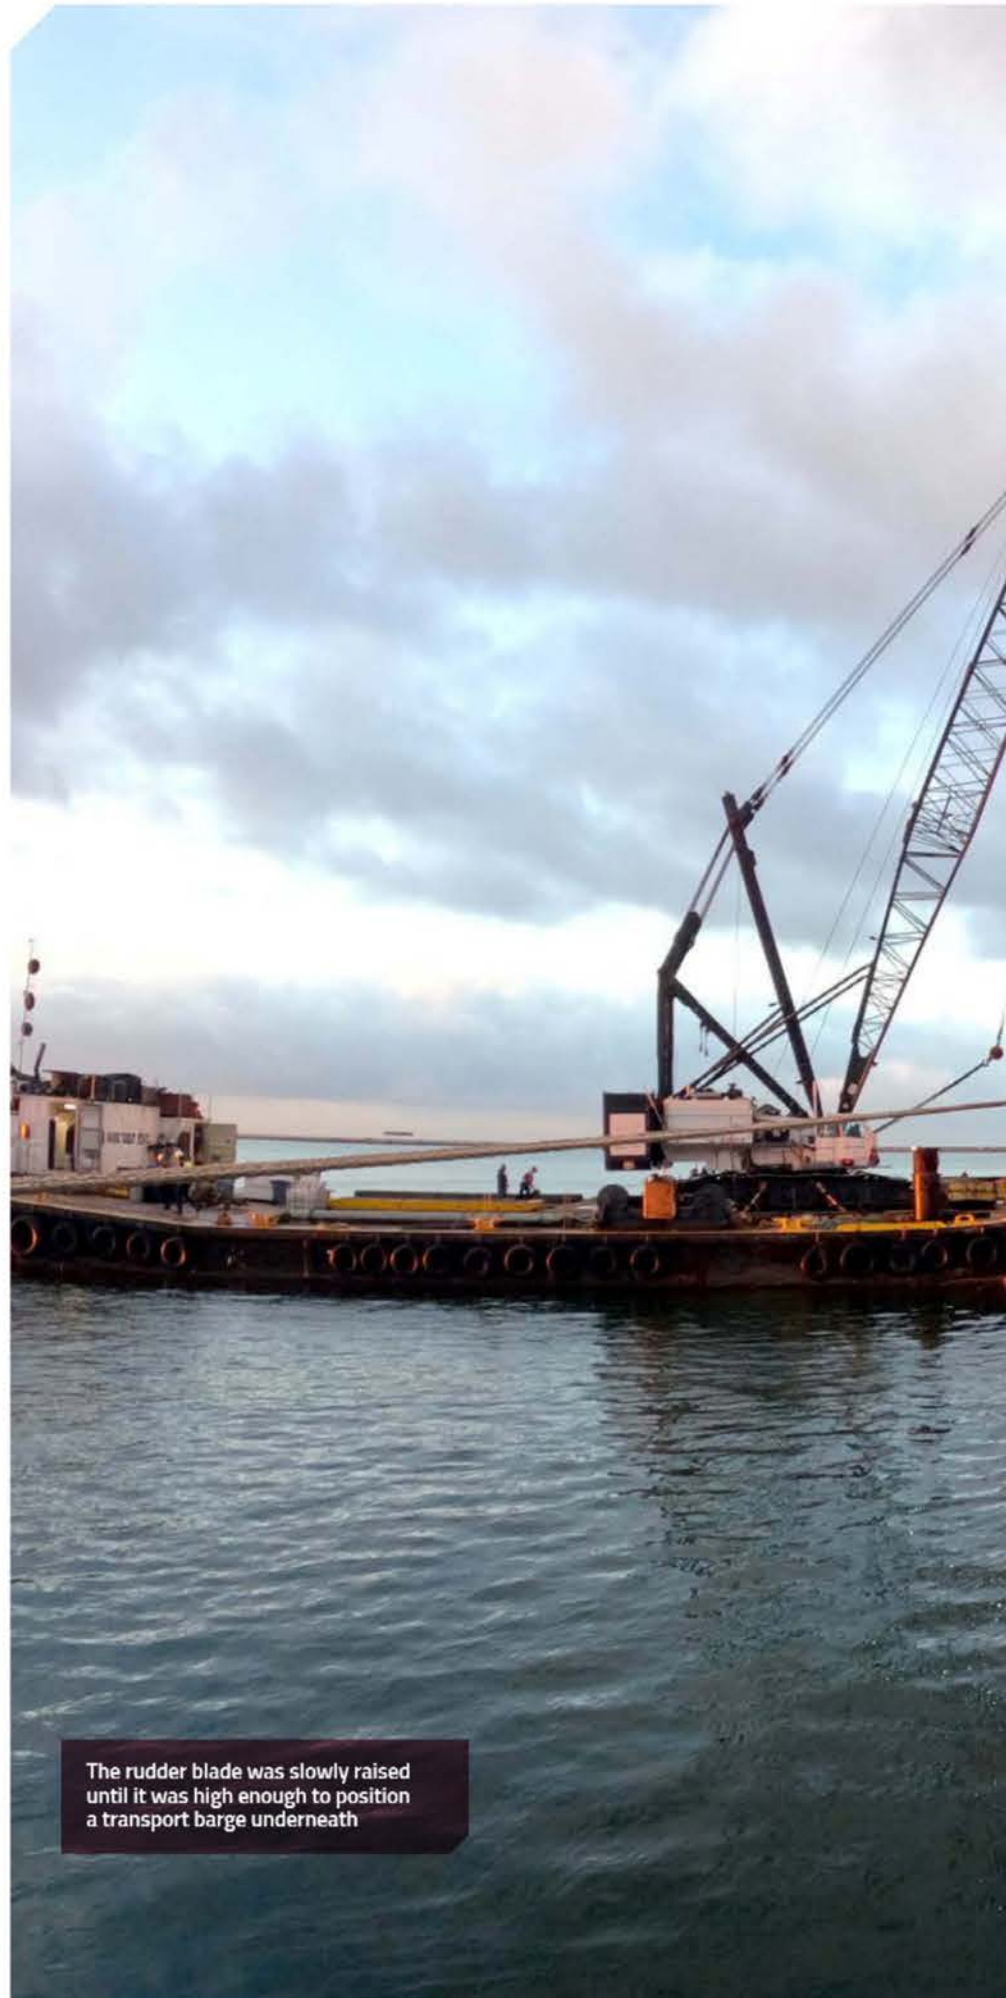
The rudder blade was slowly raised until it was high enough to position a transport barge underneath

Once in ready position, with divers clear, the rudder blade was slowly raised above the water high enough to position a transport barge underneath. Now lowered on pre-positioned dunnage, the blade was transported to our local SGS pier-side yard in Long Beach and hoisted ashore for repair.

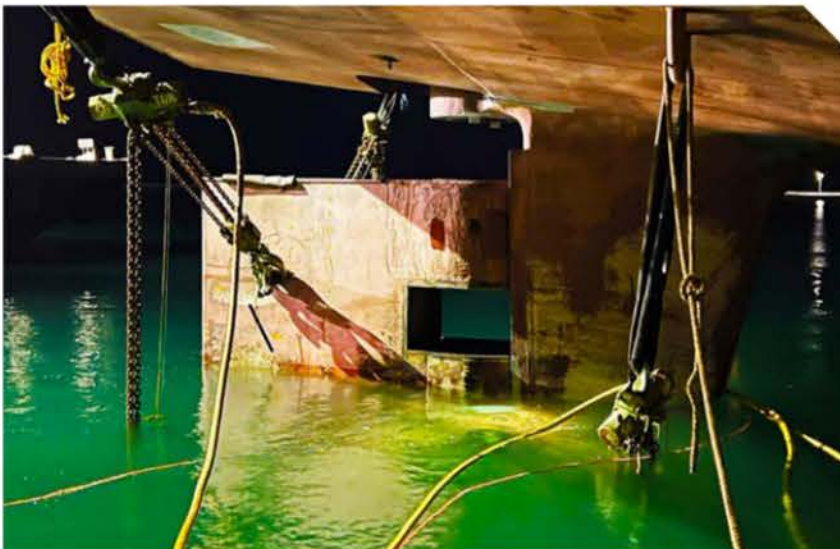
Once the rudder was in position, the stock was installed and hydraulically-tightened pilgrim nuts and tiller arm were reinstalled

Once the rudder was in position, the stock was installed and hydraulically-tightened pilgrim nuts and tiller arm were reinstalled. A final inspection was completed and the vessel was free to sail with no conditions of class and a happy client. ■
