# HALFDAN CRANE BOOM REPLACEMENT TOTAL DENMARK

On the Total Halfdan Platform in Denmark, the existing crane boom needed to be replaced because it was corroded, and its capacity has been downgraded. Conbit was awarded the contract to replace the boom without the use of a crane vessel.

Project Name  
Halfdan Crane Boom  
Replacement

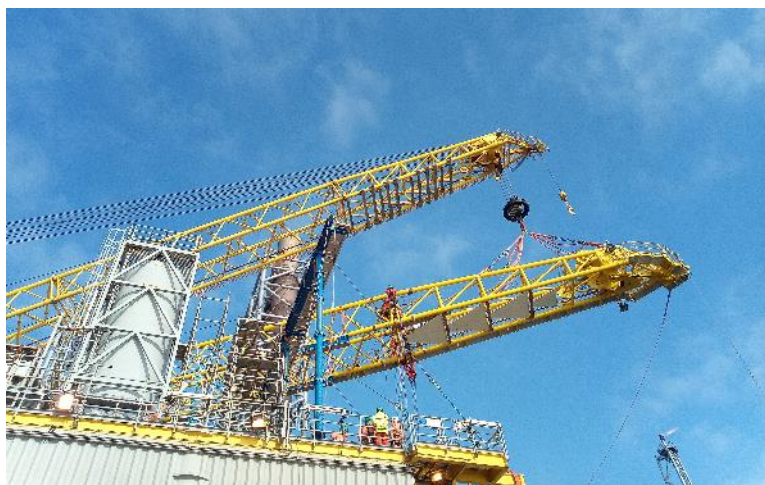
*Picture: New crane boom lift with the help of old crane*

The operation was started with installation of the gantries. The existing platform boom was used to lift the 3 new boom sections from the supply vessel that were positioned on the two Conbit gantries afterward. The existing crane boom was lowered onto the support gantries from where it was disconnected from the pedestal. This disconnection was carried out by lifting the boom base and disconnecting it from the pedestal. The new crane boom was skidded into position for connecting to the pedestal. Once connected, all crane blocks and wires were installed. The old crane boom was removed in reverse order by the use of the new crane as a last step of the operation. Both the Conbit crew and the operator were satisfied with the result. The tailor-made solution was delivered successfully without any shutdown days or any incident in challenging times due to weather conditions and the pandemic.

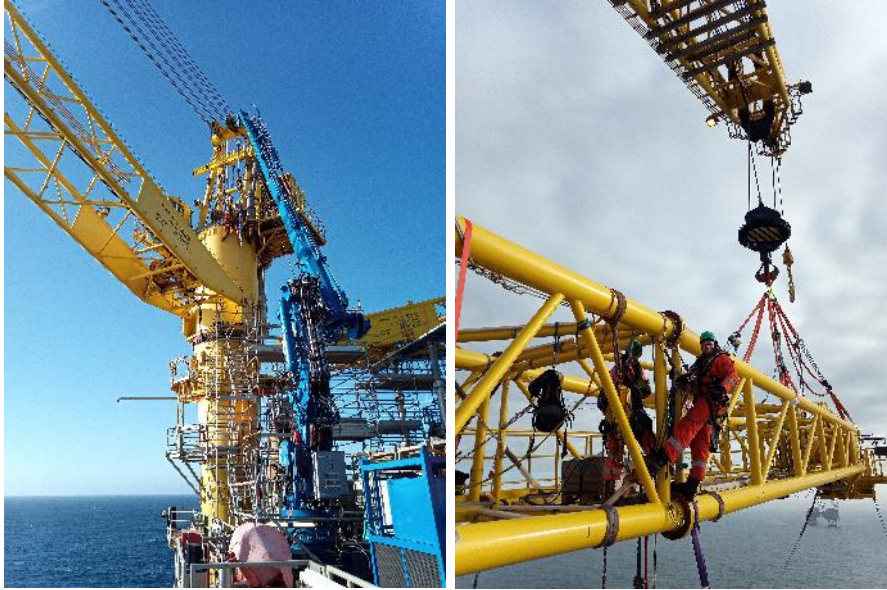
*Pictures: Knuckle boom crane in operation, rope access on crane*

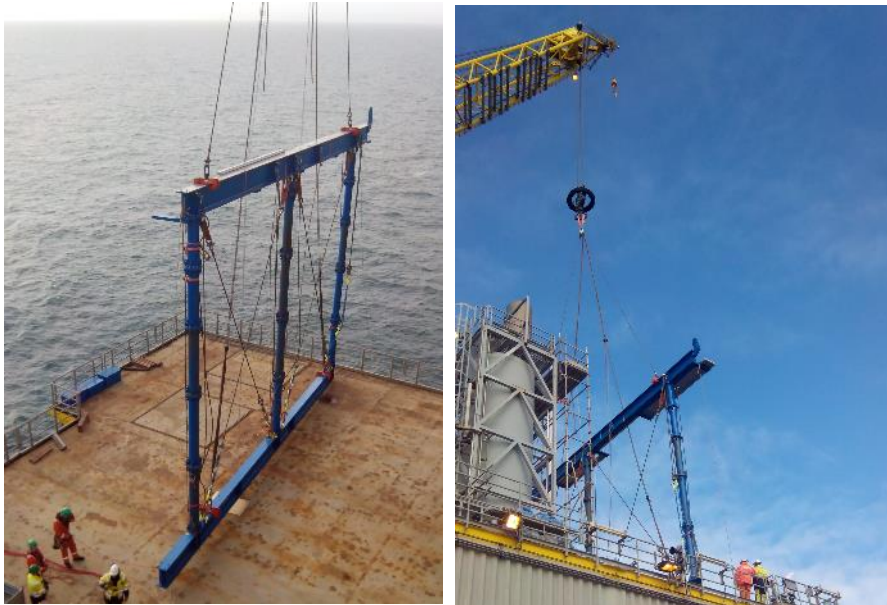
*Picture: North gantry lift with old crane boom*

After conducting a site survey and gathering the relevant information about the platform, two gantries were designed with the capacity to support the weight of both the existing and the new crane booms. The two crane booms shall be exposed to wind and other dynamic loads during the whole operation. This is why the structural load calculations for each phase of the project were a significant part of the preparation process. After meticulous preparation, a rock-solid project plan for the operation phase was ready.

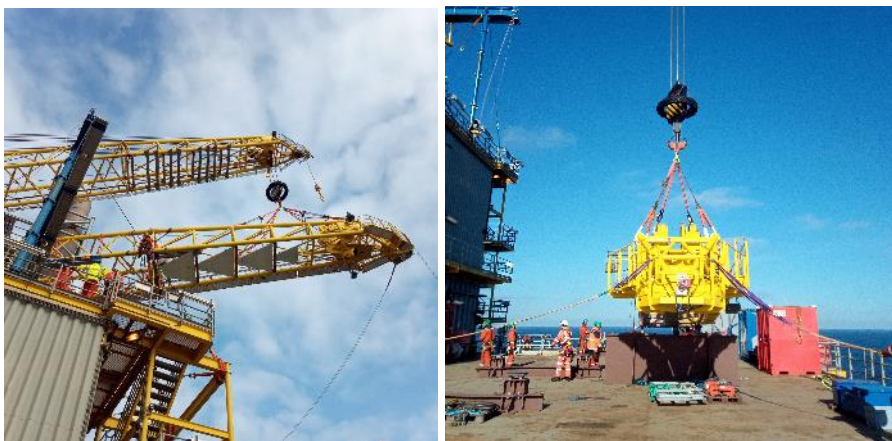
*Picture: Lowering old crane boom to the gantry, lifting new crane boom*
