# HALFDAN BD CRANE BOOM REPAIR, TOTAL DENMARK

Total Denmark started a project to repair a crane boom on their Halfdan platform and asked Conbit to contribute to the project by offering its special services. Conbit crafted a high-level technical concept for the offshore handling of the crane boom that fits best with the project.

Halfdan BD Crane Boom Repair

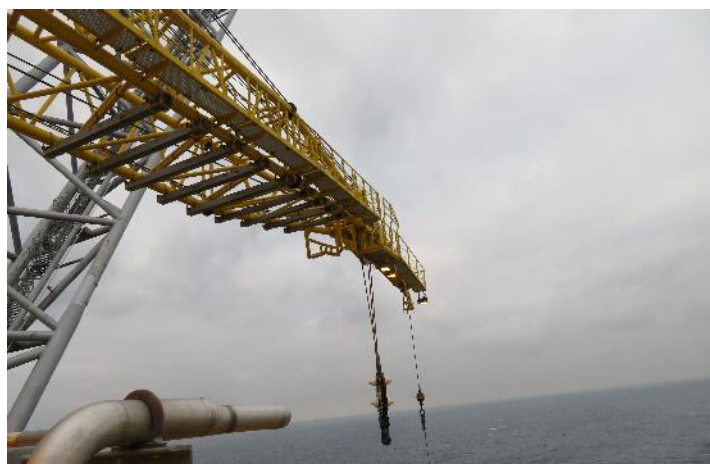
Picture: Old Crane Boom on Halfdan BD Platform

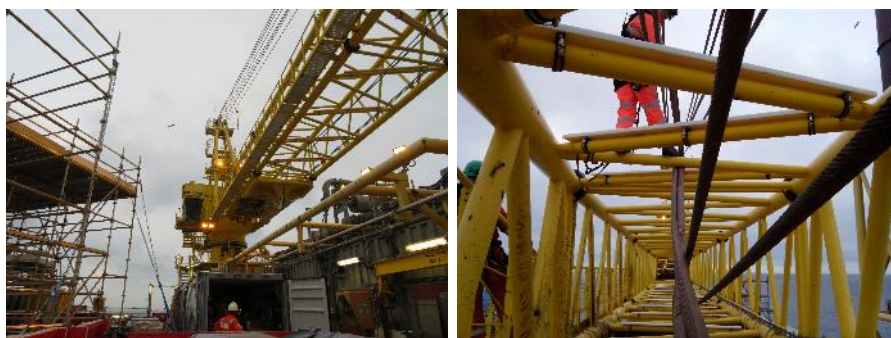
*Pictures: Crane boom and cords*

On Halfdan B processing platform (BD), the platform crane boom was damaged at one of the bottom-cord due to an impact at the crane boom rest. Liebherr analyzed the damaged area and proposed to replace a part of the bottom cord over a length of 4m together with some of the braces. According to the result of structural calculations, Conbit provided the client with related equipment and project-specific fabrications considering the structural integrity of the platform.

Conbit crew started the operation of the project by installing 2 portals that were built on the deck and lifted into position. In addition, Conbit installed a secondary luffing system which supported the boom tip to reduce the loads on the main cords during the repair process which allowed Liebherr to cut away the damaged part and renew them on the spot using scaffolding and a habitat. To allow for minor adjustments to the boom, Conbit included several hydraulic jacks in the supports so that it could lower, raise and twist the boom. Furthermore, rope access materials were used to hoist all rigging equipment required for the anchor onto the frame and a pulley system was used to reduce the strain on the crew. The project was delivered flawlessly on time and on budget without any incident.

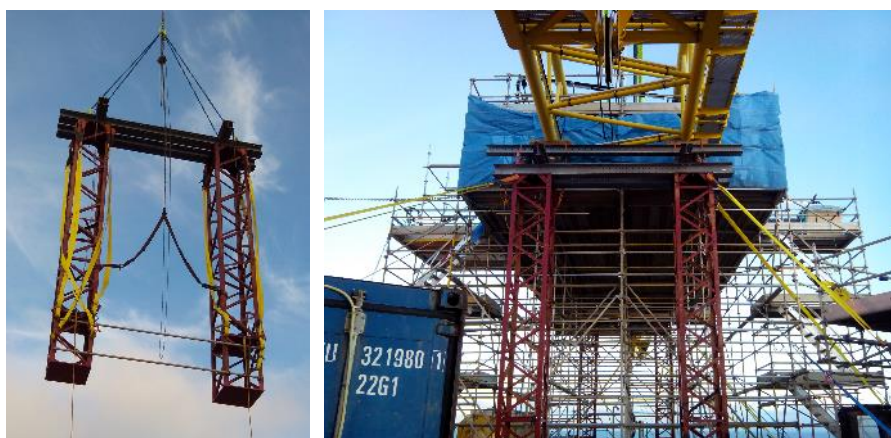
*Picture: Handling a frame, rigging a frame and lashes*
