TAQA ENERGY GUY WIRE REPLACEMENT

TAQA-operated Peak Gas Installation (PGI), located in Alkmaar, the Netherlands, is an underground natural gas reservoir that's used to store and deliver natural gas to meet peak demand from the Dutch national grid.

TAQA required maintenance on the guy wires of their PGI vent stack. They contracted Conbit to replace the guy wires and earthing system, as well as to work on the vent tips. They chose Conbit due to our vast experience of working on the design, procurement, construction, installation, and maintenance of towers and stacks, as well as our detailed proposal for this particular project.

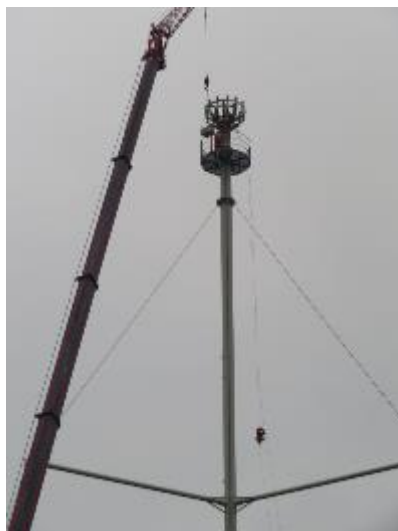
Picture: Rope access on tower and flare stack lifting

We used the installation crane provided by Mammoet and IRATA rope access techniques to manage the removal and reinstallation of the tip, as well as flange maintenance on the flare stack itself. Not only was this combined solution the best possible solution for the task, but it's also 100% compliant with the latest changes in Dutch OSH legislation. The whole maintenance process was carried out by a qualified Conbit and Mammoet crew consisting of rope access technicians, crane operators, and banksman. Conbit and Mammoet's extensive experience was crucial in leading this project to a successful outcome.

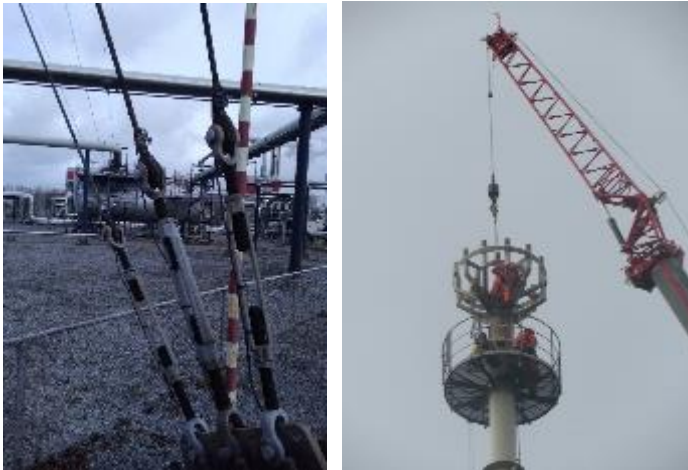
Pictures: Guy wire anchoring and flare stack lifting

In order to provide efficient tensioning, we took into account both the exact guy wire tension values provided by our engineers, as well as relevant environmental conditions like the wind and the temperature. Conbit technicians used hand-operated rigging tools in combination with a load meter to measure the tension in the line.

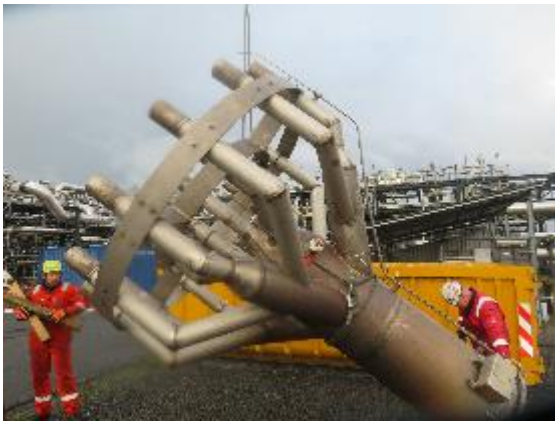
Pictures: Flare stack
