OFFSHORE CRANE TIP REPLACEMENT

Total E&P Netherlands BV awarded Conbit the contract to replace the tip of one of their deck cranes on the L7P platform. The scope of work consisted of preparing the method statement, load out assistance, offshore replacement works, bolting and load testing.

Project Name Offshore Deck Crane Replacement

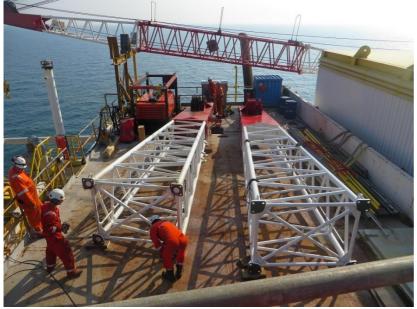
Picture: Offshore works

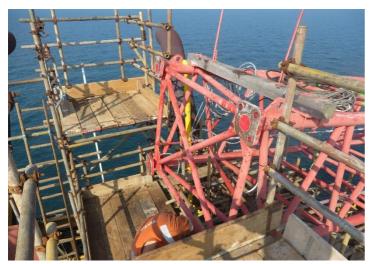
Photo: Deck crane without cane boom tip
