Ronick Entrance Remodel

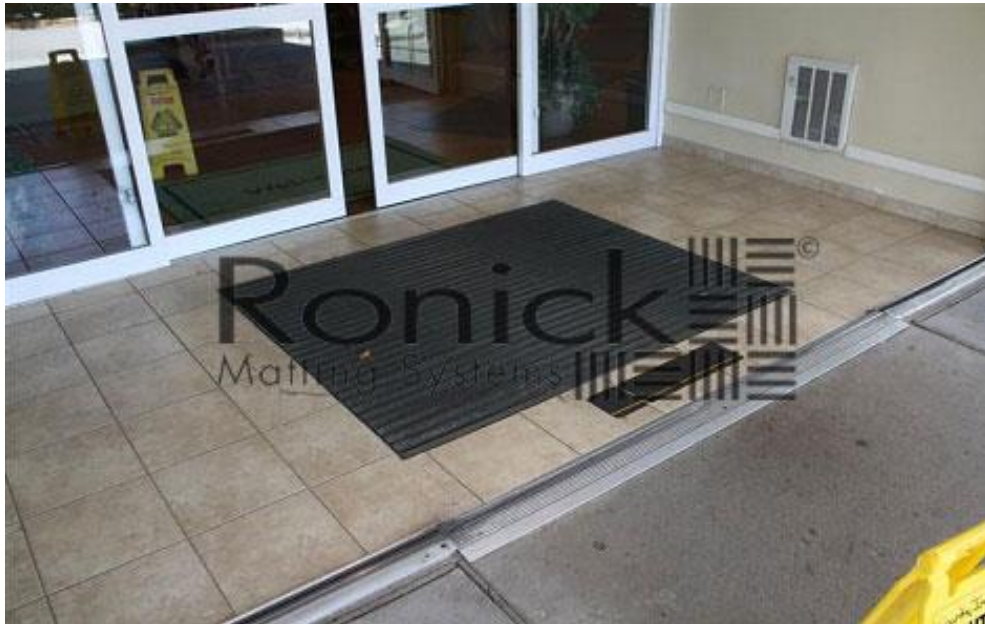
This entrance way is located in the front of a hotel by the Mall of America in Bloomington, MN.

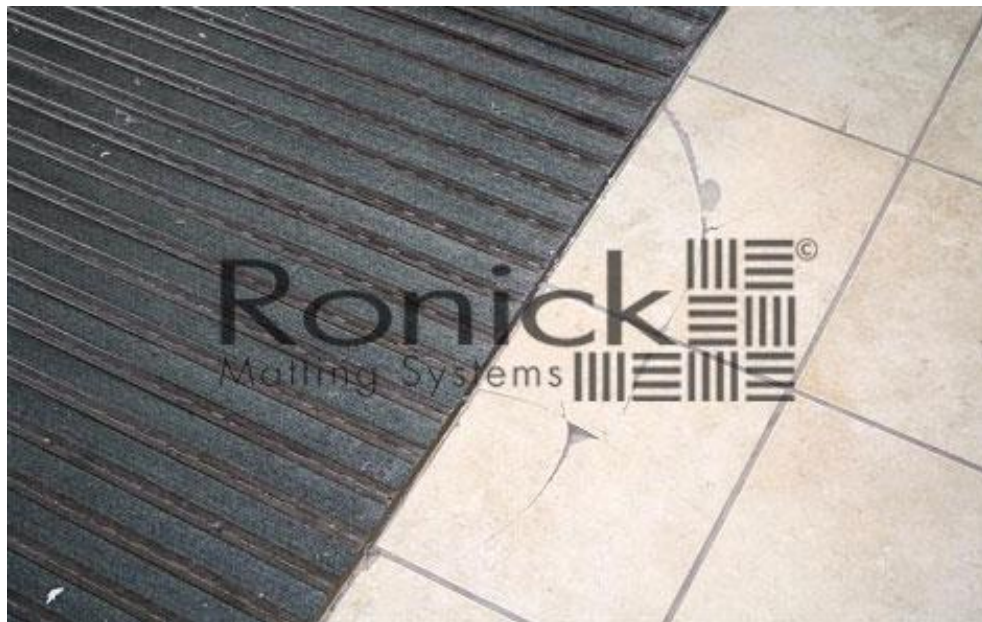
High Pedestrian traffic as well as ice melt and sand weakened the tile causing it to crack.
