# MICROCRACKS

ARE THEY REALLY A PROBLEM?

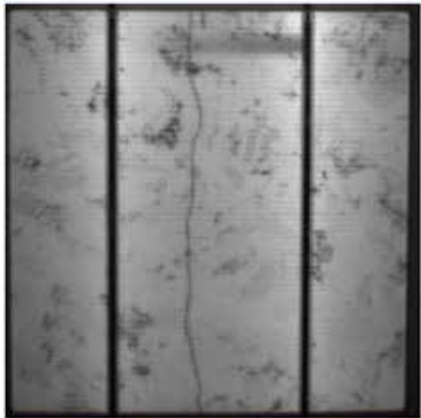
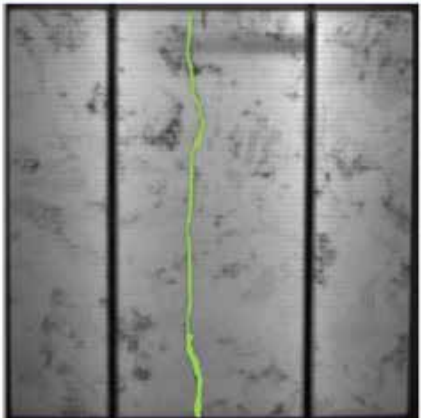
The example given here, which is taken from the MBJ Services Judgement Criteria, shows cracks within the inner zone of the cell meaning that, even if these cracks separated all of the grid fingers, current would still be able to flow to the adjacent busbar; there would be negligible effect on power output. In this case, this cell would be classified as a 'Non-Critical Crack.'

<b>Description</b> Cell break runs parallel between the 'bus bars'.

<b>Judgment</b> A further expansion of the cell break is not expected. Possible cell area disconnection 0%.

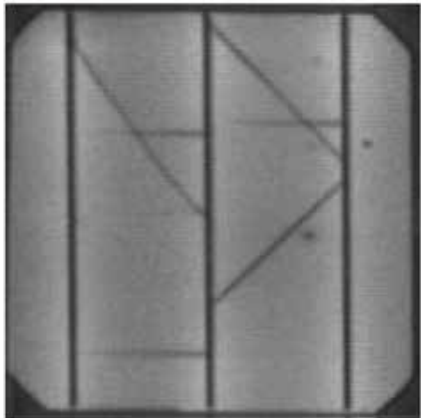
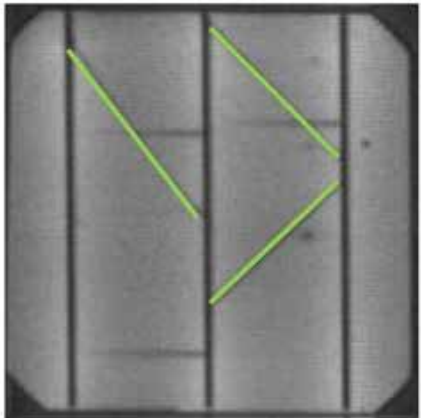
<b>Description</b> Various cell break run in a straight line between the 'bus bars'.

<b>Judgment</b> A further expansion of the cell breaks is not expected. Possible cell area disconnection 0%.

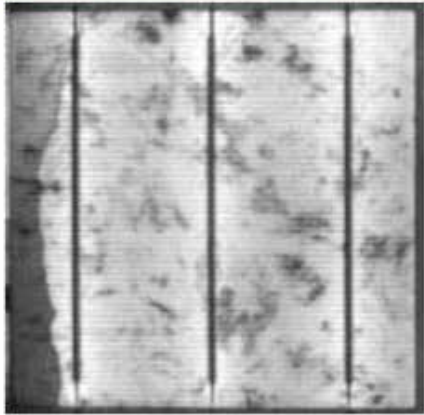
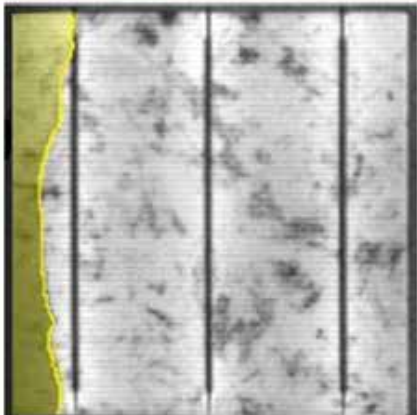
This example shows cracks positioned within the two outer zones of the cell and an isolated region within the inner zone of the bus bars. When the grid fingers separate, the areas isolated will not be able to generate power. This would be classified as 'Critical Cracks', as they are  $>0\% < 20\%$  of non-power producing cell area. If it was over 20%, the cell would warrant a 'Very Critical' classification.

<b>Description</b> Cell break between 'bus bars' and cell edge.

<b>Judgment</b> Disconnected cell area approx. 10%.

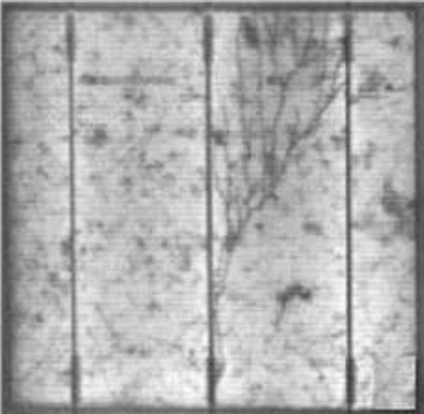
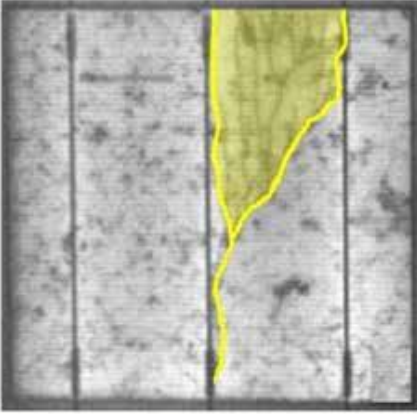
<b>Description</b> Branched cracks between the 'bus bars'

<b>Judgment</b> Possible cell area disconnection approx. 10%.
