*Lower Farmington River and Salmon Brook Watershed
Spring & Summer 2022 Chloride Monitoring*

Farmington River Watershed Association

*With funding from the Lower Farmington River and Salmon Brook
Wild & Scenic Committee*

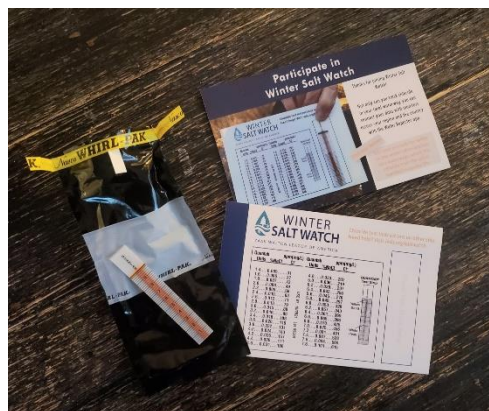
Figure 1: Izaak Walton League of America Salt Watch Kit

FRWA recently brought attention to road salts in the Farmington River Watershed through partnership with the Izaak Walton League of America (IWLA) on their Salt Watch program. The IWLA Salt Watch program has made chloride monitoring easily accessible to organizations and citizen scientists. FRWA monitored eleven sites in the Lower Farmington River watershed during winter of 2021-2022 by using the IWLA chloride kits. Eleven sites were monitored in spring, May 2022, and fifteen sites from June to August 2022. These sites were selected based on their potential to have high chloride or to monitor tributaries going to the Farmington River. Two sites on the Farmington River in Simsbury and Windsor were included.

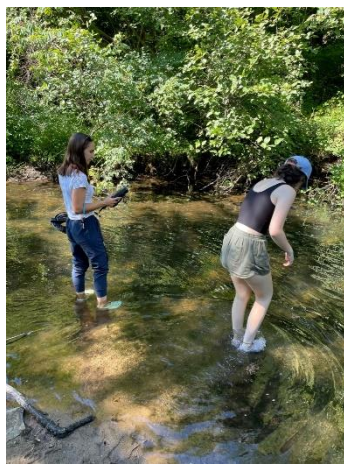
Figure 2: Meter and Salt Watch water sample.

Sites in the Lower Farmington River Watershed were selected based on their potential to have high chloride or to monitor tributaries and the Farmington River. Two sites were on the main stem of the Farmington River and the remainder were on tributaries that flow into the Farmington River. Eleven sites were monitored in spring of May 2022, and fifteen sites from June to August 2022. Data was collected using IWLA Salt Watch kits, and FRWA's YSI ProDSS meter. The IWLA Salt Watch kits included strips for determining chloride and salt concentrations, and all sites were supported with the use of FRWA's YSI ProDSS meter measuring chloride, temperature, dissolved oxygen, turbidity and conductivity. These measurements were used to understand the water quality of the sites in more depth in relation to chloride.

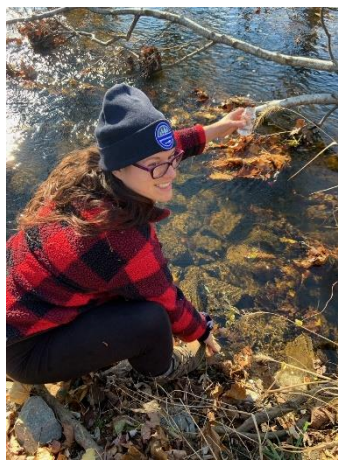
Figure 3: Salt Watch water sample.

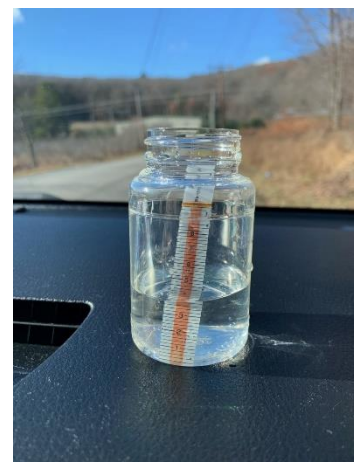
Figure 4: Chloride strip in water sample.

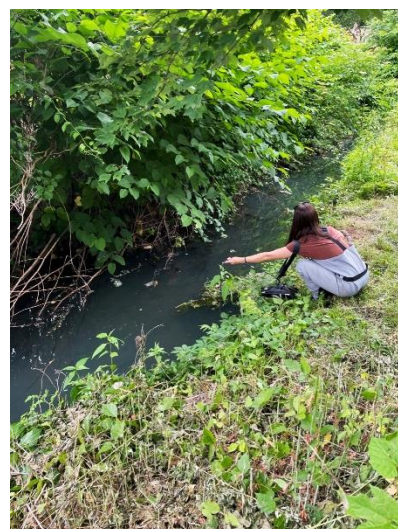
Figure 11: Rainbow Brook cloudy visual appearance

Rainbow Brook's headwaters start at Bradley International Airport (BDL) in Windsor and travel south to the Farmington River just below the Rainbow Reservoir dam. Rainbow Brook was monitored upstream of the culvert on Rainbow Rd. across from the Connecticut Cat Connection, and downstream from the highway. This site was added in June as an additional site to be monitored. Rainbow Brook instantly became a priority site upon first visit with high chloride values (figure 10), and by its cloudy visual appearance (figure 11). Rainbow Brook has remained between 157 and 170 mg/L from June through August 2022 (figure 12). Rainbow Brook's potential for winter chloride levels above 230 mg/L are high due to summer findings and will remain a priority site for chloride monitoring.

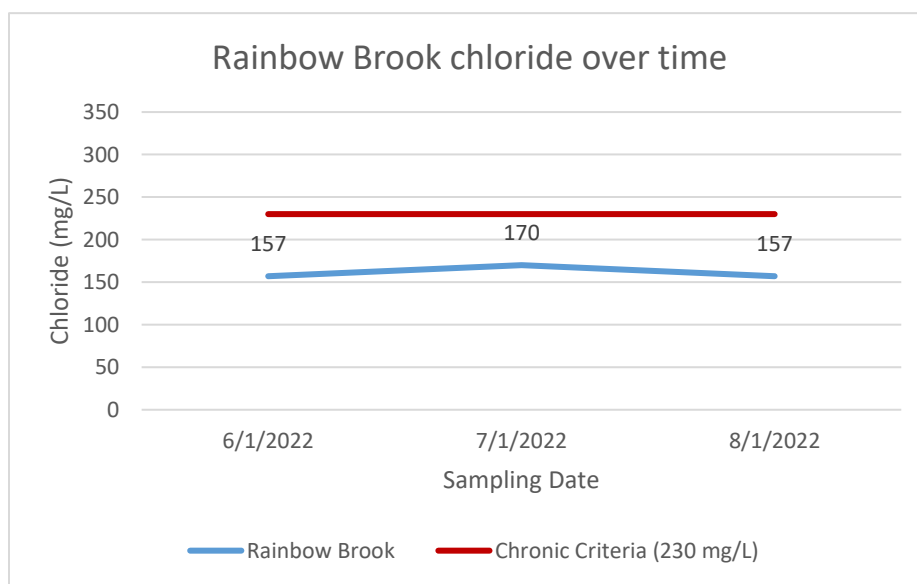
Figure 12: Rainbow Brook chloride over time

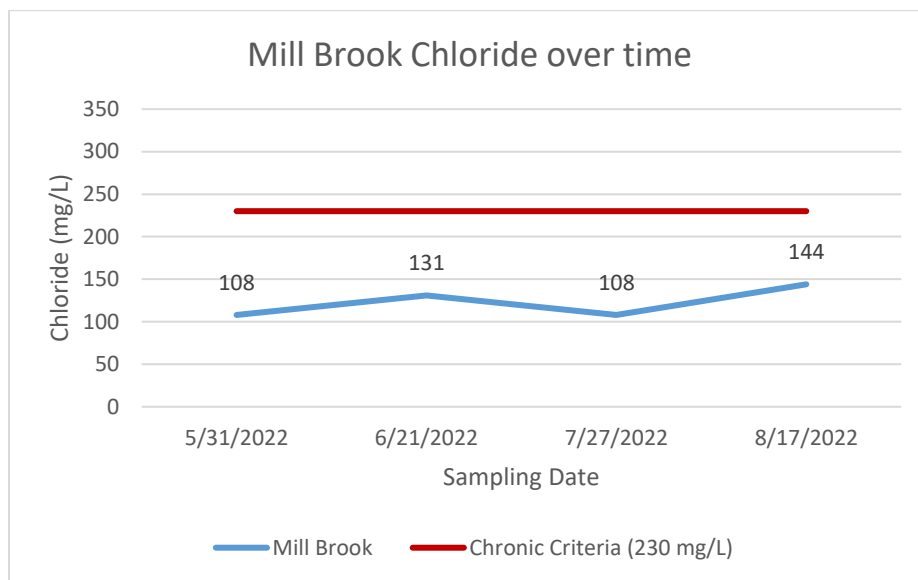
Mill Brook is located downstream of the East St. bridge. This site was added in June as an additional site to be monitored due to it being in an urban area of Windsor. All chloride values have remained over 100 mg/L for spring and summer months (figure 13), with the highest value in June 2022 of 131 mg/L (figure 14). Mill Brook was not monitored in winter months but has potential to have chloride levels above 230 mg/L in winter months when road salts are being applied.

Figure 13: Mill Brook chloride over time

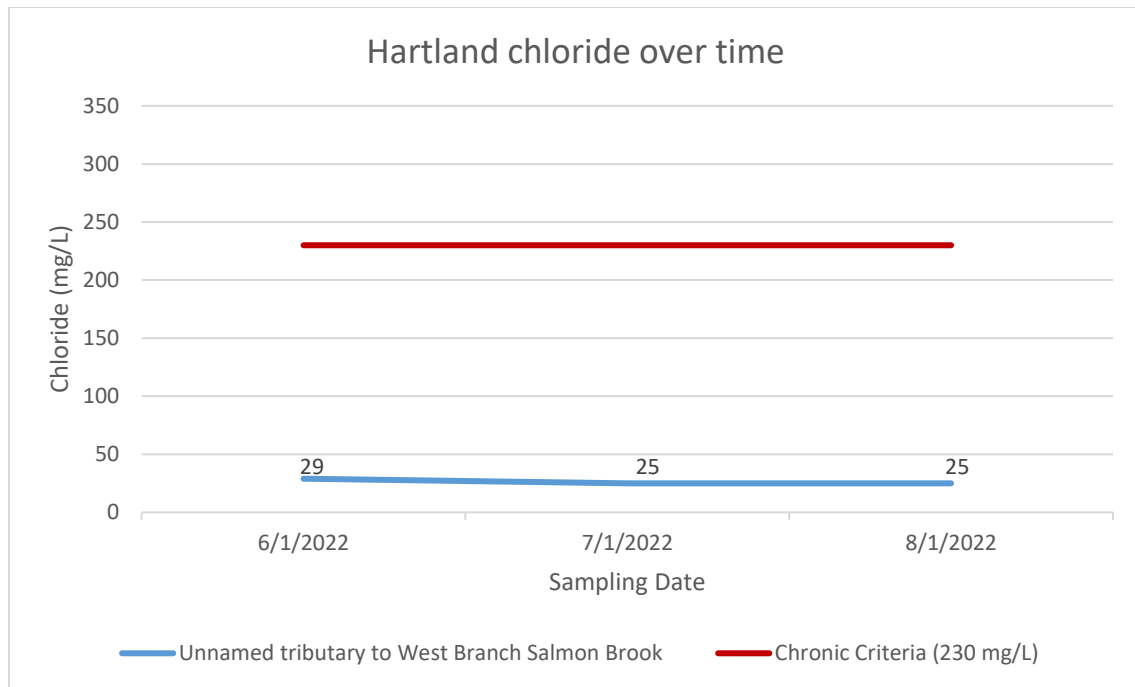
Figure A- 7: Town of Hartland: Unnamed Tributary to West Branch Salmon Brook chloride over time
