PROPERTY INSPECTION REPORT

1234 Main St.
Arlington, MA 02474

10/08/2019 9:00AM

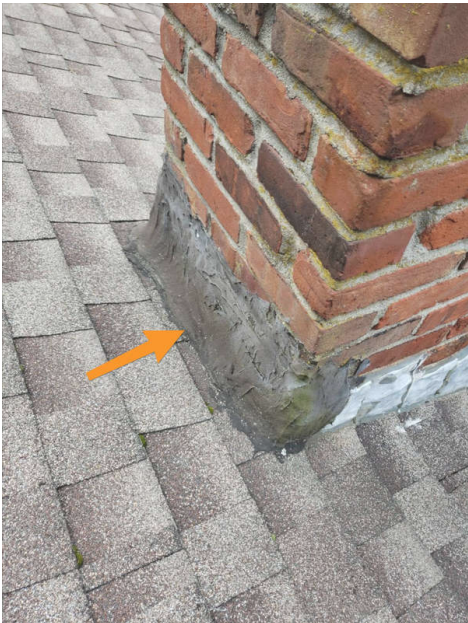
The chimney flashings are patched or covered in tar sealant. The flashing may have been tarred because of a leak at the chimney penetration through the roof or because flashing had become loose. This area should be monitored for future leakage and chimney re-flashed if leakage occurs.

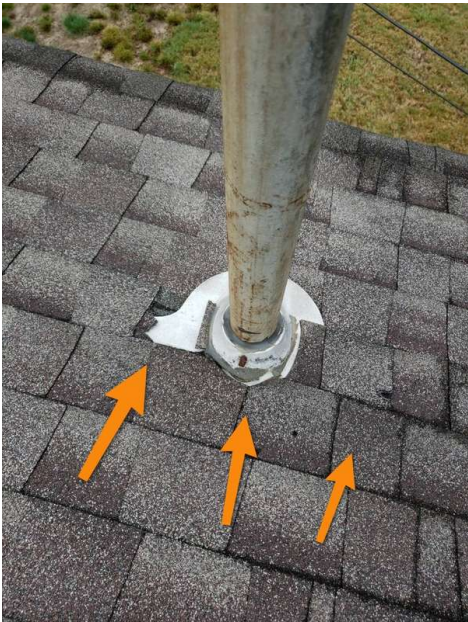
2.2.2 Roof Flashings and Penetrations

FLASHING BENT, LOOSE, DETERIORATED

Flashing install around the electrical conduit mast is not laying flat. This may become an issue as the roof ages. Monitor for leakage and repair as needed.

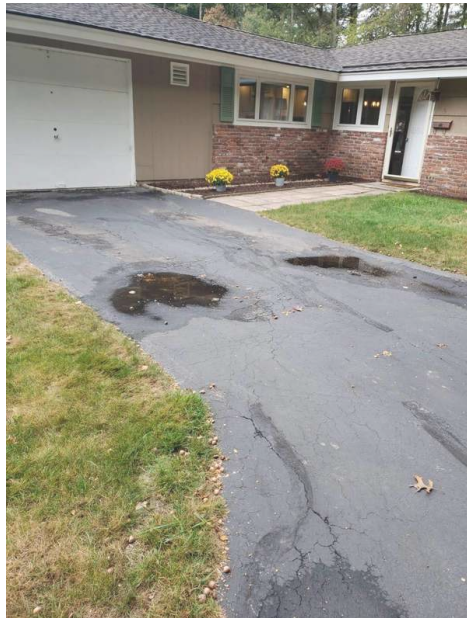
DIPS AND CRACKS TO DRIVEWAY

There are dips and cracks in the driveway. Water is puddling in areas due to depressions from car parking. While this is manageable at this time, it will likely worsen as driveway continues to age, requiring resurfacing in the near future. Expect to resurface in the near future.

Contact a qualified driveway contractor.

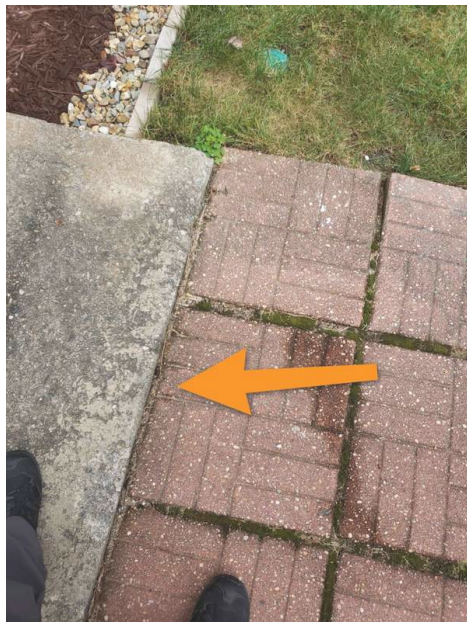
3.1.7 Vegetation, Grading, Site
Drainage, Driveways, Patio,
Walkways

The brick patio is uneven and heaved. Uneven bricks are a tripping hazard. Reinstallation of the brick patio is recommended.

Contact a qualified masonry professional.

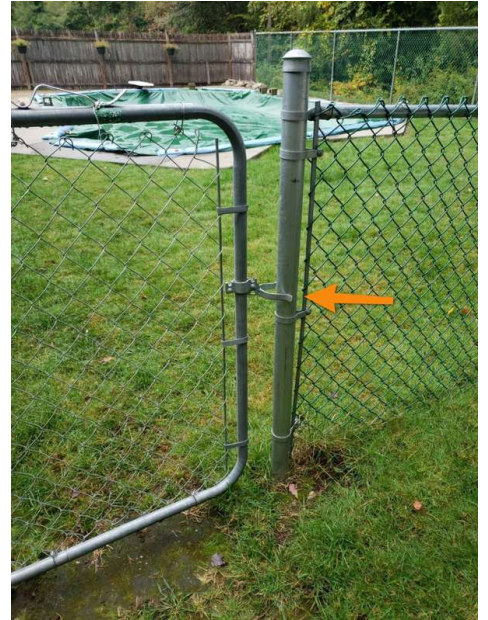
3.1.8 Vegetation, Grading, Site
Drainage, Driveways, Patio,
Walkways

The fencing is not secure at the gate. This is a safety hazard because children can get into the yard and into the pool unsupervised. Repair is recommended. Use an appropriate safety latch on this fence.

Contact a qualified professional.

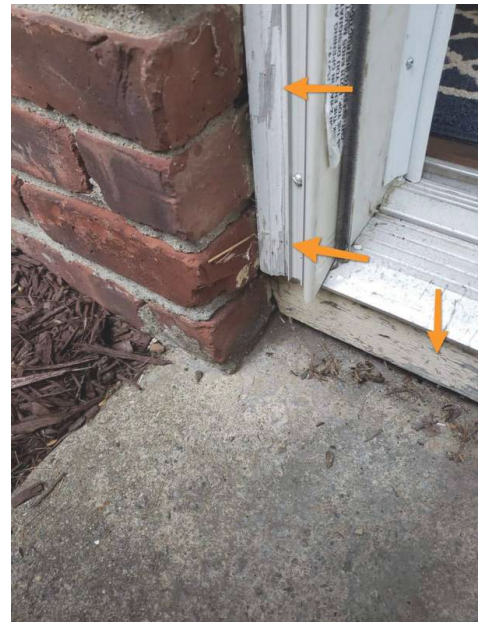
There are areas of the trim that have flaking and peeling paint. This condition can cause rot and deterioration to the trim. Scraping, preparation, and repainting of these areas of trim is recommended.

Contact a qualified painting contractor.

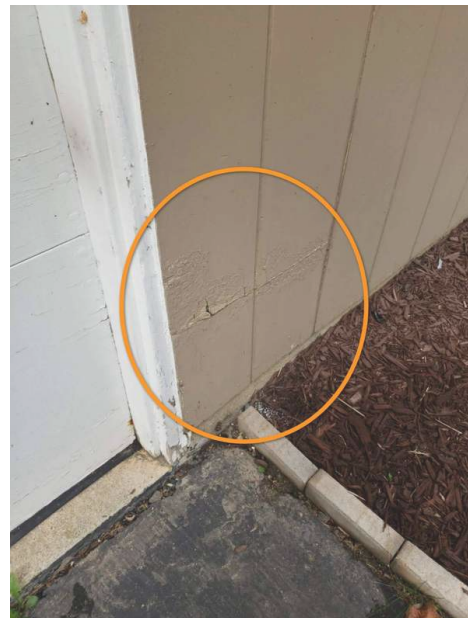
3.3.3 Wall Cladding/Siding, Trim, and Flashings

There are areas of the siding that have flaking and peeling paint, and areas where siding was removed for adding insulation. One area next to garage has damage to siding. This condition can cause rot and deterioration. Repainting of these areas of siding is recommended. Replace damaged siding next to garage door.

Contact a qualified painting contractor.

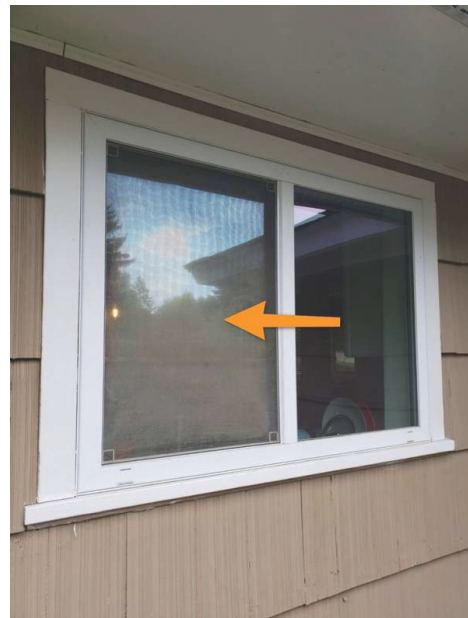
3.5.1 Windows

THERMAL SEAL FAILURE, ONE WINDOW

The window had a thermal seal failure. This condition is evident due to condensation and staining between the panes of glass. This condition causes the window to become fogged. This sash should be reglazed or replaced. Additionally, due to the nature of this defect, you should be aware that it is very possible that other windows of the same age may have thermal seal failures as well or may have them at any time in the near future.

Contact a qualified professional.

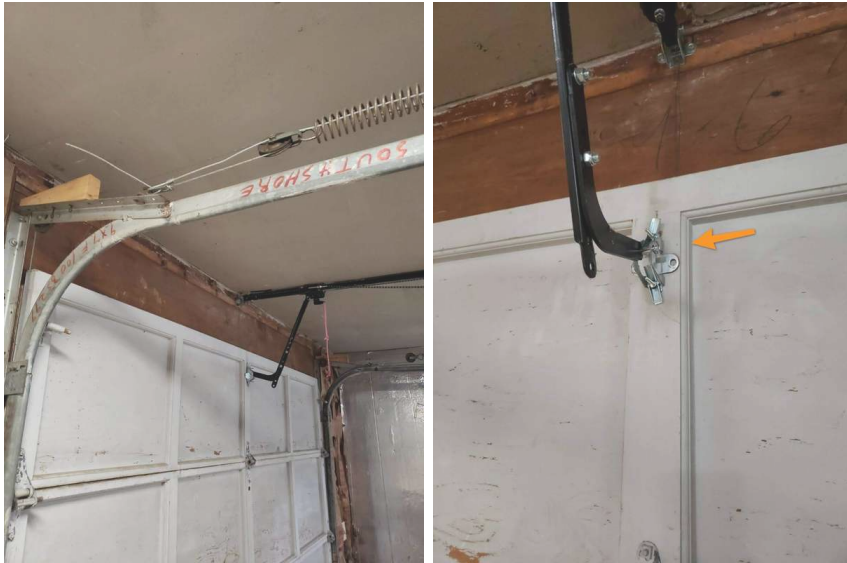
TUNE/ADJUST AND REPAIR DOOR OPENER

The door opener lurches and jogs on the opener track when operated. This opener needs adjustment. Additionally, the opener hardware is poorly attached to the door. Repair is recommended. Also cleaning, lubricating, and adjusting the opener is recommended.

Contact a qualified garage door contractor.

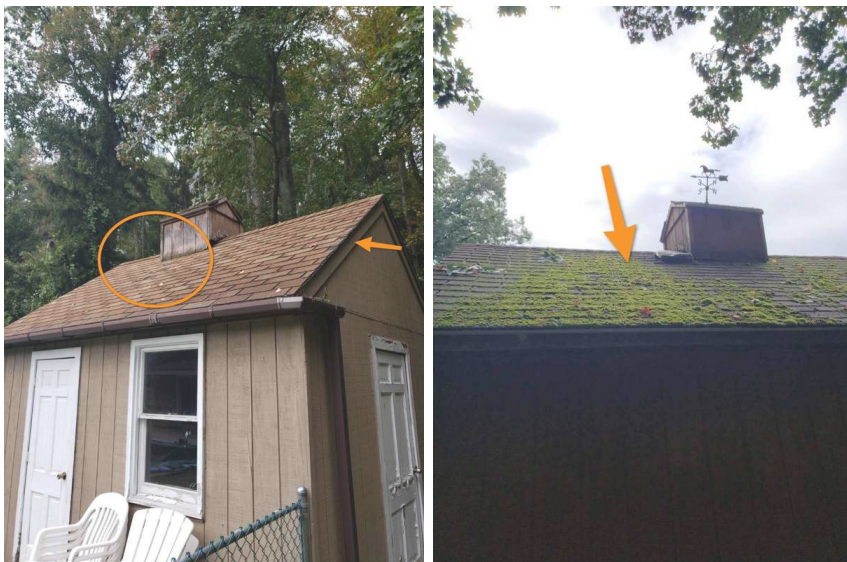
3.9.1 Detached Shed

ROOFING DETERIORATED, REPLACE

The roof covering is aged and deteriorated. It appears to have reached its average life expectancy. Replacement is recommended to prevent leakage and damage to the roof and other components.

Contact a qualified professional.

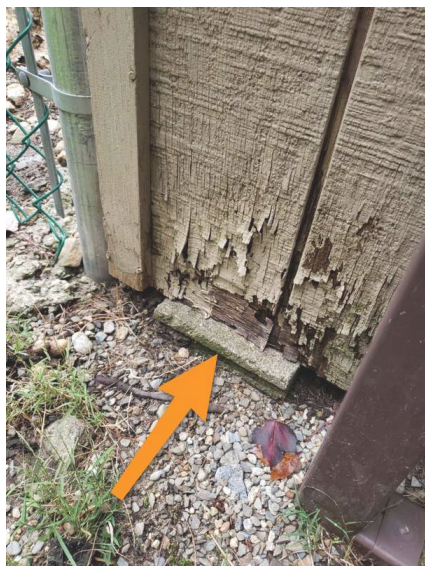
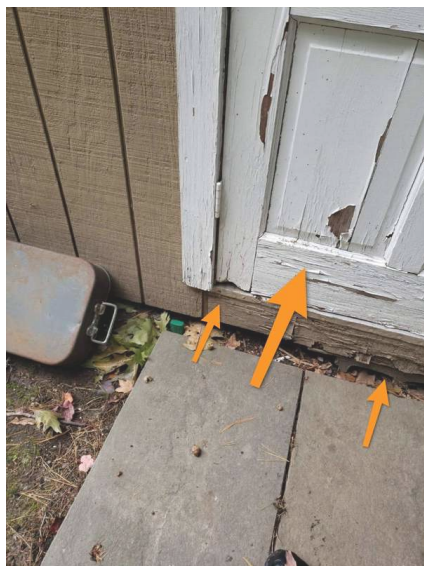
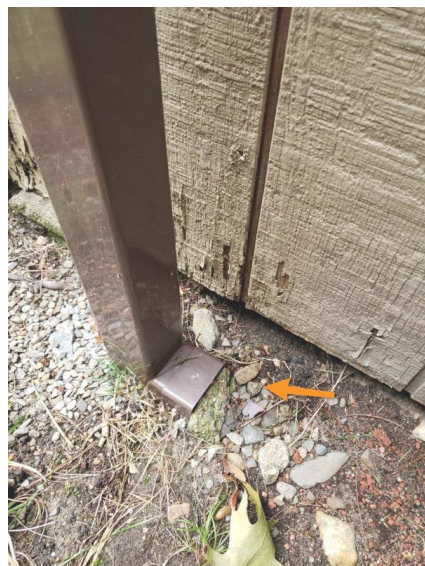
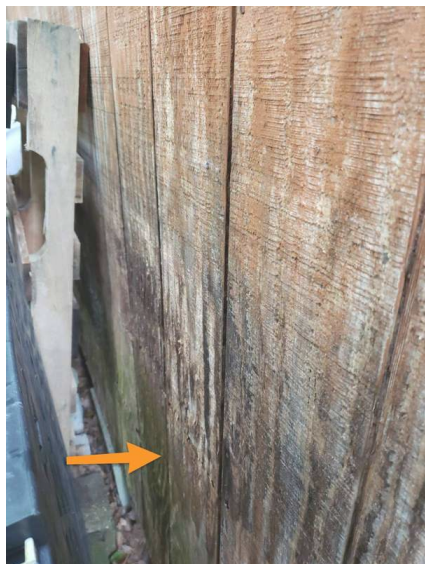
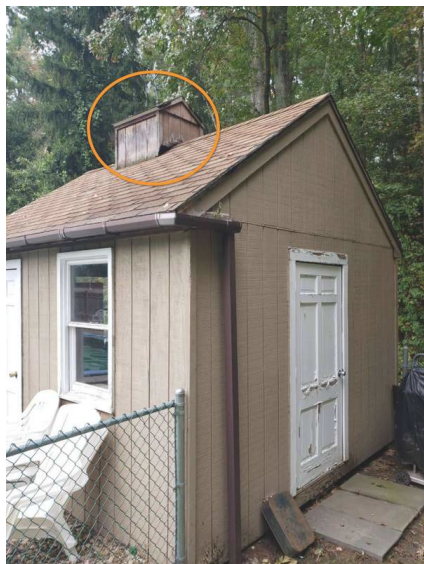
3.9.2 Detached Shed

SIDING AND TRIM DETERIORATED

The trim is flaking and peeling in places. Siding is rotted and flaking and peeling in several areas. The door has flaking and peeling paint, damage, and gaps and holes around the frame. Holes and gaps were also observed in other places, and the cupola on top of the roof is rotted in damage to. There is a hole where animal entry may be occurring. The gutter on the front is in poor shape, and there is no gutter on the rear. The structural supports for the shed are not installed properly. Repair is recommended.

Contact a qualified carpenter.

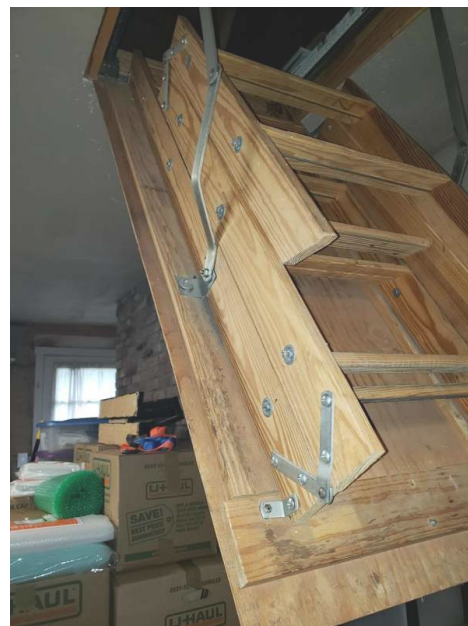
PULL DOWN STAIRS AGED, UNSAFE

The attic pull down stairs in the garage are aged, and have loose hardware. They do not fully close properly. They are also not fire-rated, and the opening is in the garage. This is a safety hazard and should be corrected. Replacement is recommended. Install a secure, safe, fire rated pull-down stair.

Contact a qualified carpenter.

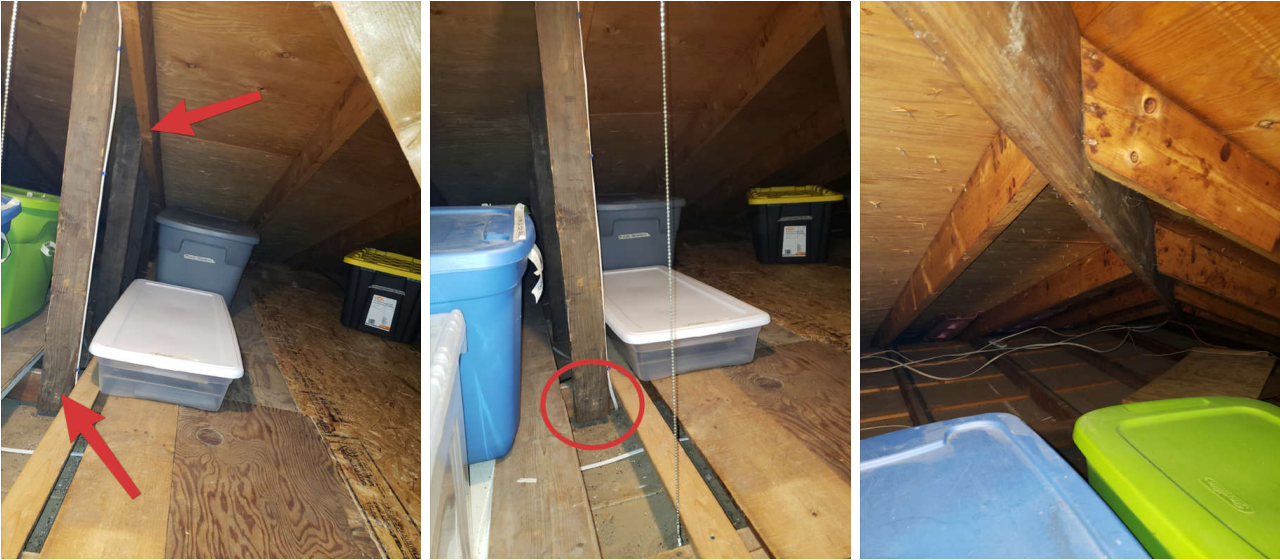
4.5.2 Roof Structure and Attic Access

RAFTER SPACING WIDE, GARAGE CEILING SUPPORT IMPROPER

Support structure for garage ceiling was poorly installed originally, and has been re-attached/repared using improper screws. It is recommended that the garage ceiling structure be reinforced now, and any additional reinforcement added as needed to prevent sagging to sheathing and/or framing.

Contact a qualified general contractor.

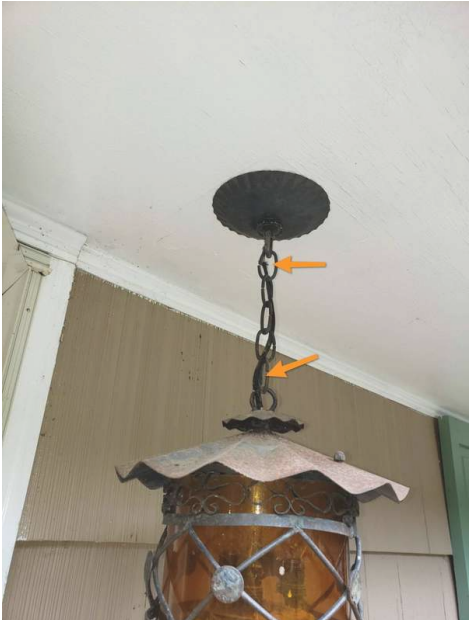
Old fixtures: There is an aged (very old) light fixture present. Old fixtures can have brittle wiring and poor insulation. Replacement or rewiring of aged fixtures is recommended.

Recommendation
Contact a qualified electrical contractor.

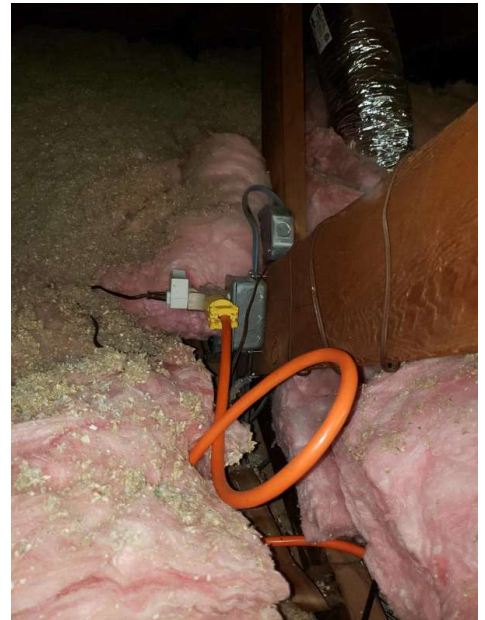
5.5.2 Connected Devices and Fixtures

There is makeshift wiring and switching for the light and the vent fan in the right side attic space. This is considered potentially unsafe and should be corrected.

Recommendation
Contact a qualified electrical contractor.

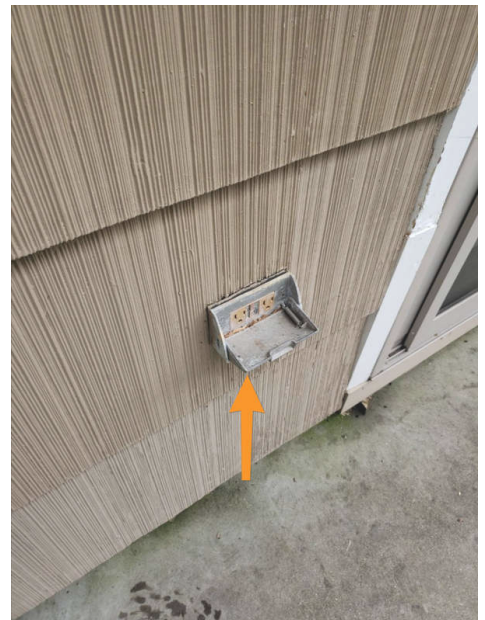
5.6.1 Exterior Receptacles

The exterior GFCI receptacle did not trip when tested. This condition is unsafe because the receptacle will not trip when there is a ground fault. This receptacle should be repaired or replaced.

Contact a qualified professional.

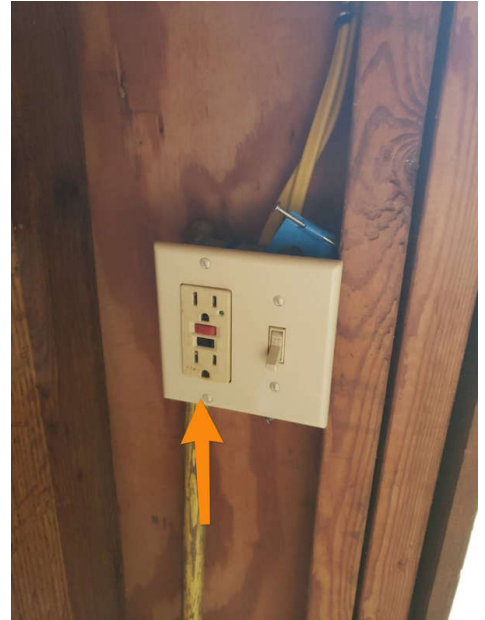
5.6.2 Exterior Receptacles

There is double GFCI protection for the receptacle. A different GFCI receptacle trips when tested. This can be confusing and is redundant protection. It is recommended that this be corrected.

Contact a qualified professional.

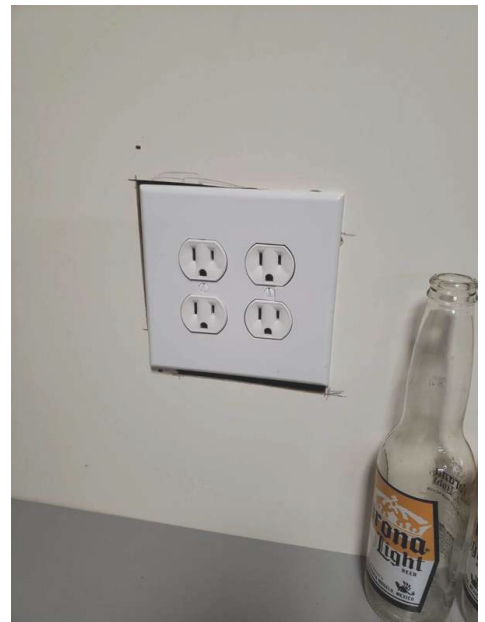
5.7.1 Interior Receptacles and Wall Switches

LOOSE RECEPTACLE

Receptacle loose in the wall. This condition can cause damage to the wiring and can be unsafe. Repair is recommended.

Contact a qualified professional.

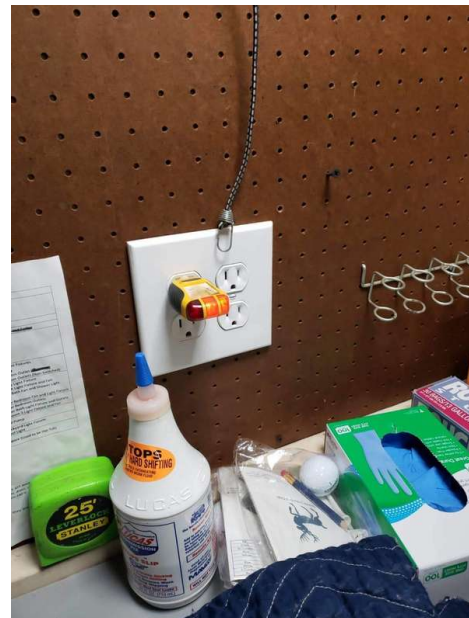
5.7.2 Interior Receptacles and Wall Switches

Receptacle is not GFCI protected in a potentially wet location. This is a safety hazard and should be corrected.

Contact a qualified electrical contractor.

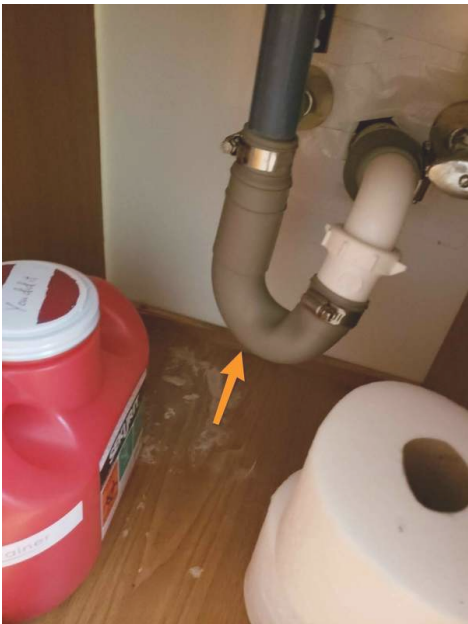
A temporary-use repair piping connection is present drain piping under the sink. This type of connection is prone to leakage. Replacement with fixed rigid piping is recommended.

Contact a qualified professional.
