65275/M-A

LABORATORY TESTING OF BUTTON- FIX
SYSTEM - TYPE 1 FLUSH - NYLON

BUTTONFIX LIMITED

16 July 2019

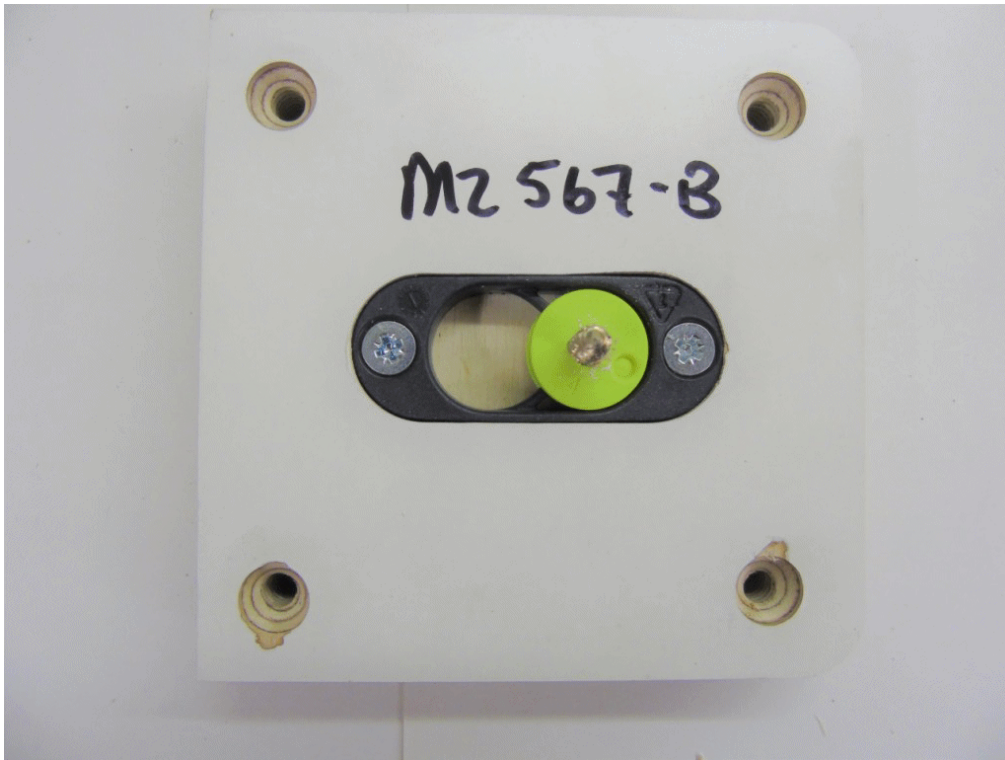
Photograph 1 A view showing the general condition of the fixing after a vertical shear test on a type 1 - nylon fixing.

Sample Reference	Load Direction	Maximum Failure Load (kN)	Comments
MZ 567-A	X - Vertical Shear Rebated	2.990 (304.9 kg)	Pulled out screw
MZ 567-B	X - Vertical Shear Rebated	2.765 (281.9 kg)	Pulled out screw
MZ 567-C	X - Vertical Shear Rebated	3.005 (306.4 kg)	Pulled out screw
MZ 568-A	Y - Horizontal Side Shear Rebated	2.480 (252.9 kg)	Pulled out screw
MZ 568-B	Y - Horizontal Side Shear Rebated	2.655 (270.7 kg)	Pulled out screw
MZ 568-C	Y - Horizontal Side Shear Rebated	2.530 (258.0 kg)	Pulled out screw
MZ 569-A	Z - Pull Out from Panel Surface Mounted	0.920 (93.81 kg)	Distortion of screw
MZ 569-B	Z - Pull Out from Panel Surface Mounted	0.799 (81.47 kg)	Distortion of screw
MZ 569-C	Z - Pull Out from Panel Surface Mounted	0.857 (87.39 kg)	Distortion of screw

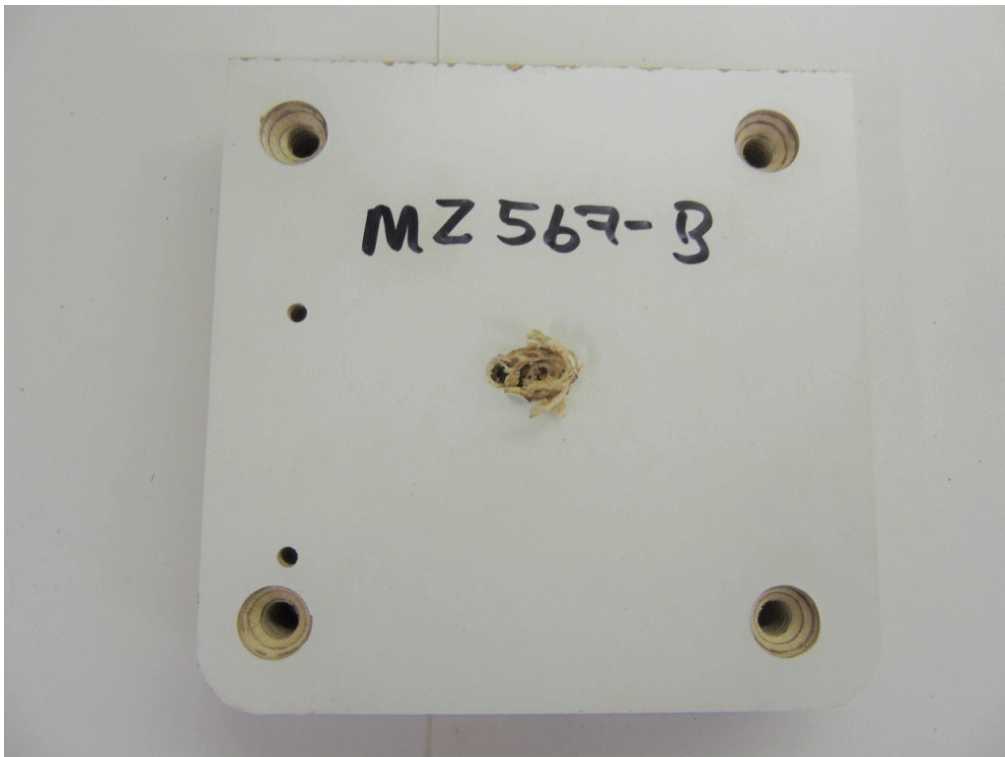
Photograph 2 A view showing the general condition of the button after a vertical shear test on a type 1 - nylon fixing.

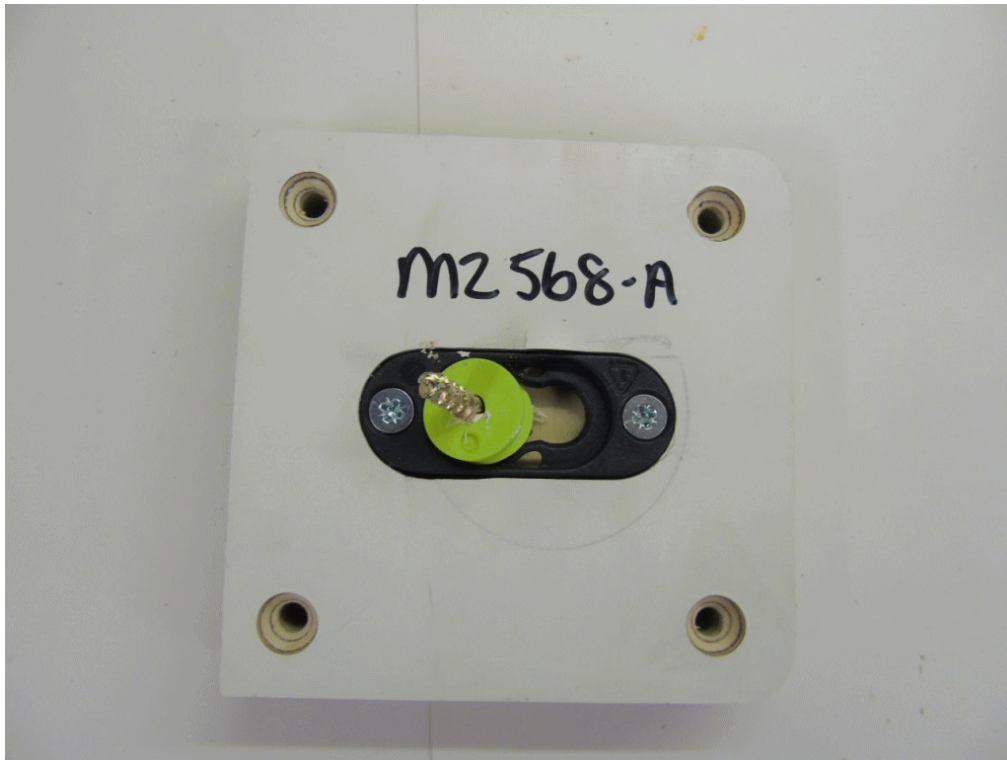
Photograph 3 A view showing the general condition of the fixing after a horizontal shear test on a type 1 - nylon fixing.

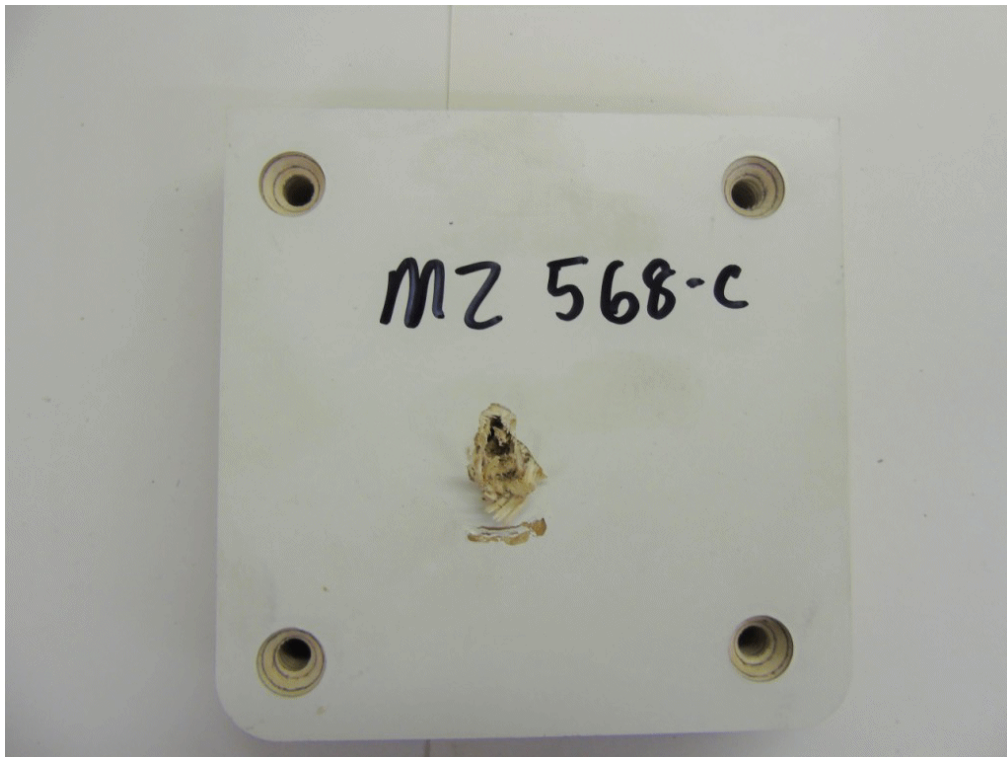
Photograph 4 A view showing the general condition of the button fixing location after a horizontal shear test on a type 1 - nylon fixing.

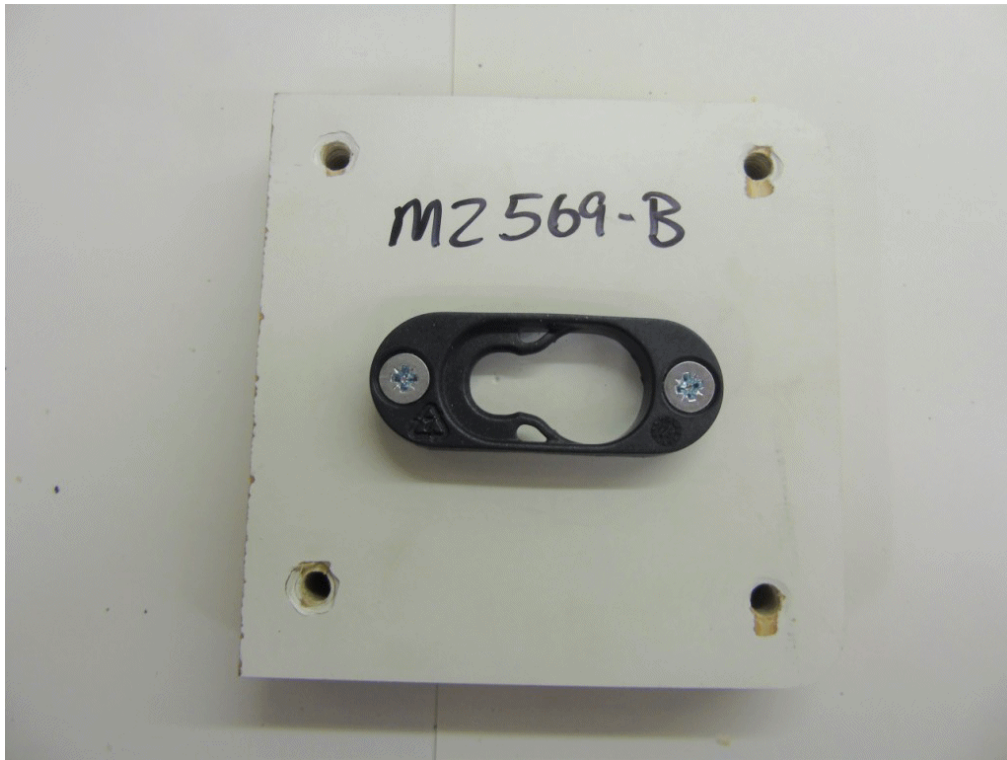
Photograph 5 A view showing the general condition of the fixing after a pull apart test on a type 1 - nylon fixing.

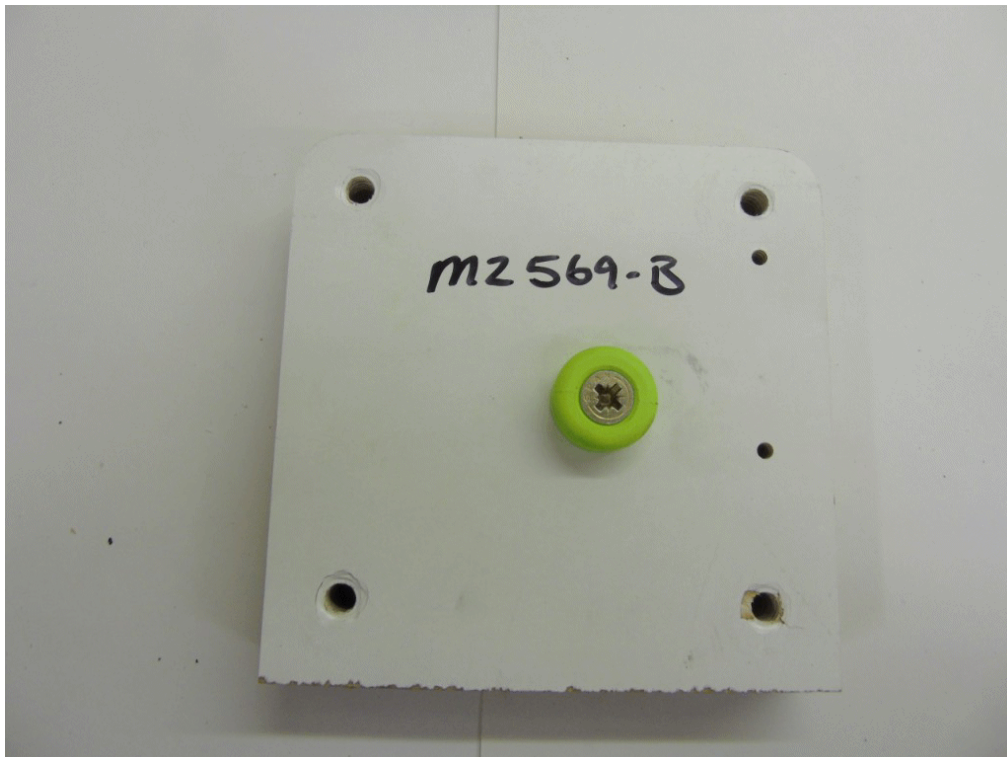
Photograph 6 A view showing the general condition of the button after a pull apart test on a type 1 - nylon fixing.
