Yeager Airport RSS Failure Case History

Ryan Berg, P.E., D.GE., F. ASCE

Jim Collin, Ph.D., P.E., D.GE., F. ASCE

- Purpose – Share lessons learned from the forensic evaluation of the largest RSS failure in North America
- The forensic analysis presented in the webinar was performed by The Collin Group and involved an extensive field exploration, and laboratory testing program to supplement the detailed engineering analysis – the entire process took over two years.
- Our client was the West Virginia Regional Airport Authority

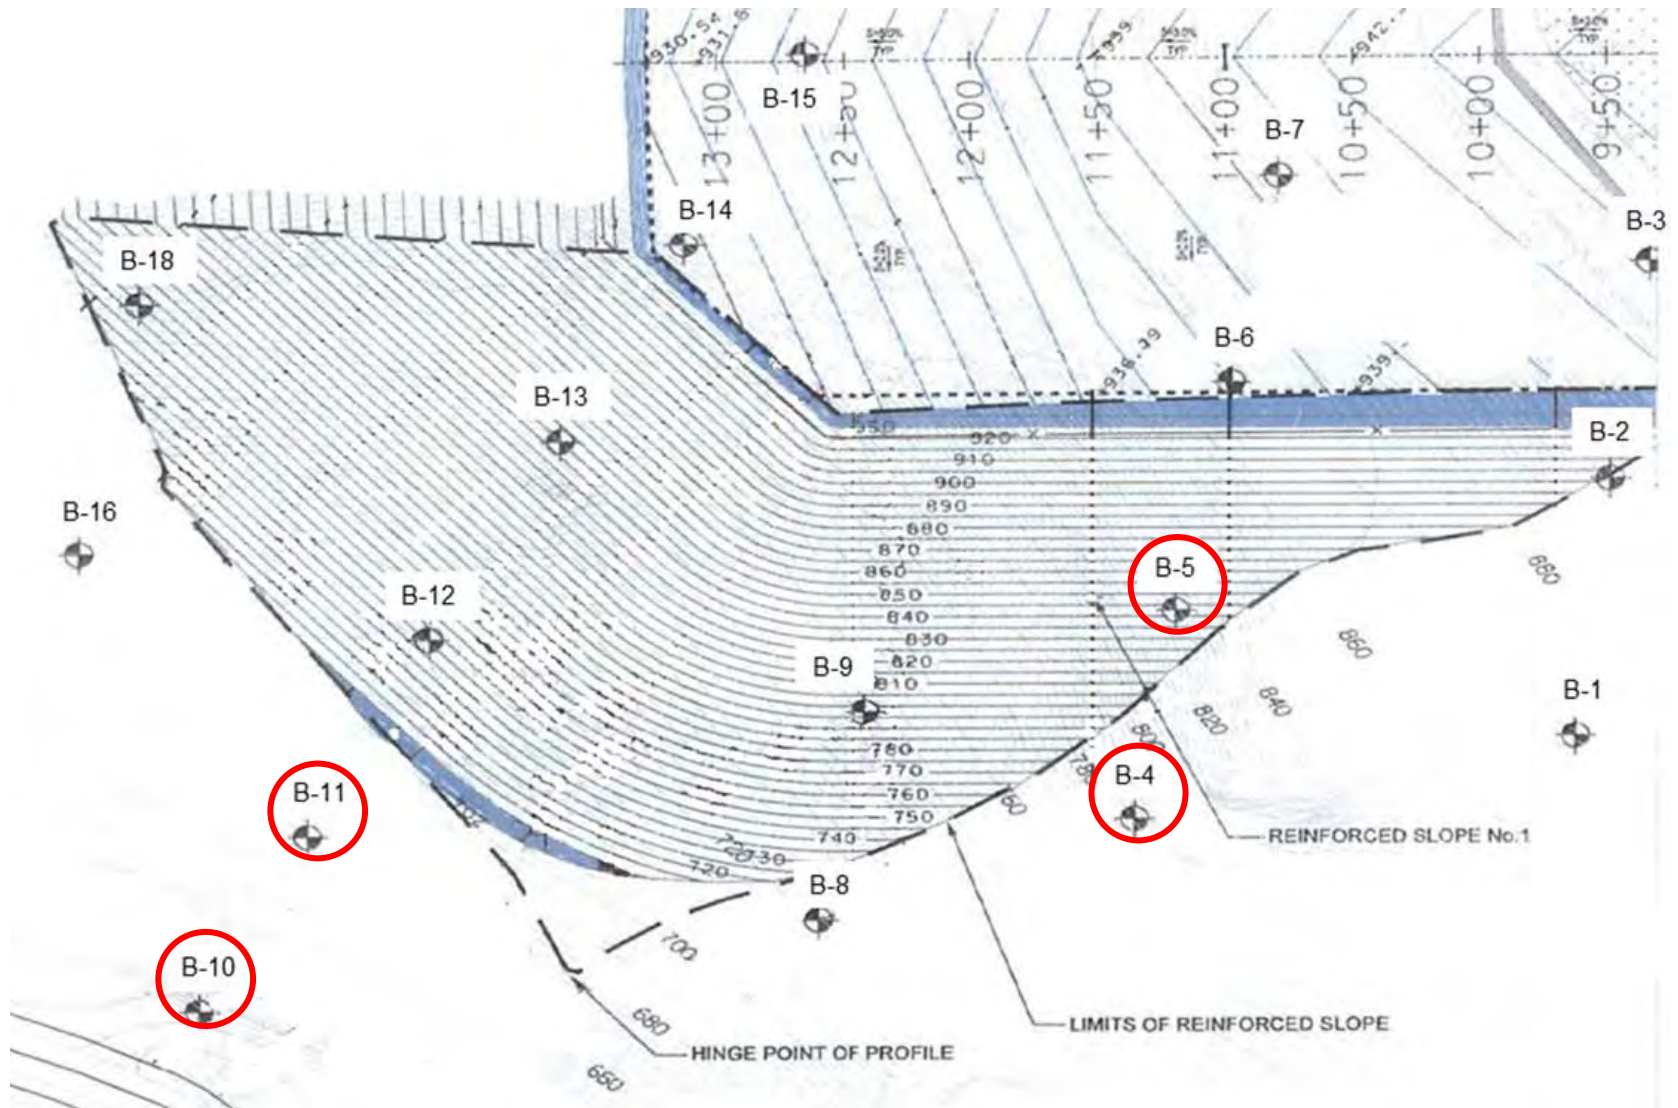
RSS Design – Subsurface Investigation Pre-Design

- No pre-design Geotechnical Investigation Report was prepared for the project.
- No borings in slope below proposed toe of RSS
- Groundwater found in three borings – warranted further investigation or inclusion of drainage in design of RSS
- Shale (fissile) identified in several borings – ranging in strength from very soft, to soft, and to medium hard was not investigated with regards to stability
- Coal seams identified – but not investigated with regards to extent, effect on drainage, etc.

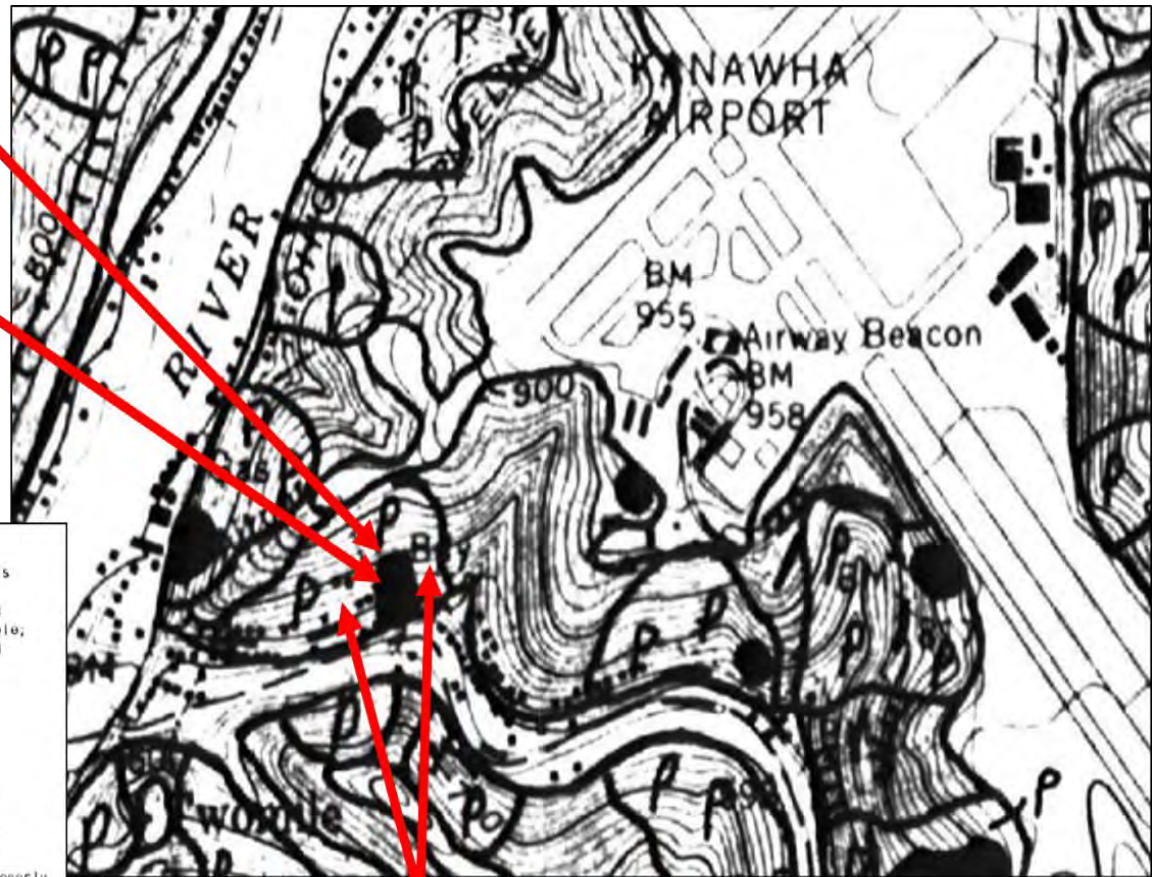
USGS Landslide Map

YEAGER RSS FAILURE, 2015

ACTIVE OR RECENTLY ACTIVE
LANDSLIDE, 1983

OLD LANDSLIDE, 1983

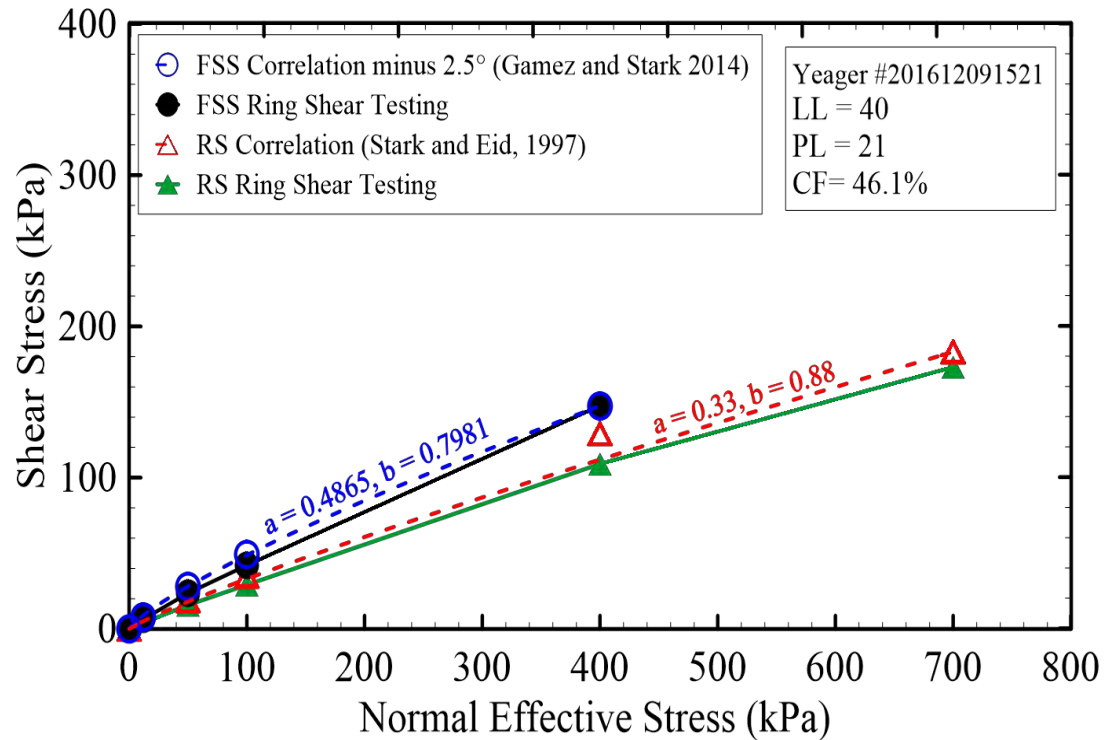
Soil-Rock Interface Fully Softened and Residual Strength

FSS strength $19.7^\circ - 25.8^\circ$

RSS $14.3^\circ - 20.2^\circ$

Normal Stress Range 50 to
 400 kN/m^2 (1050 – 8350 psf)

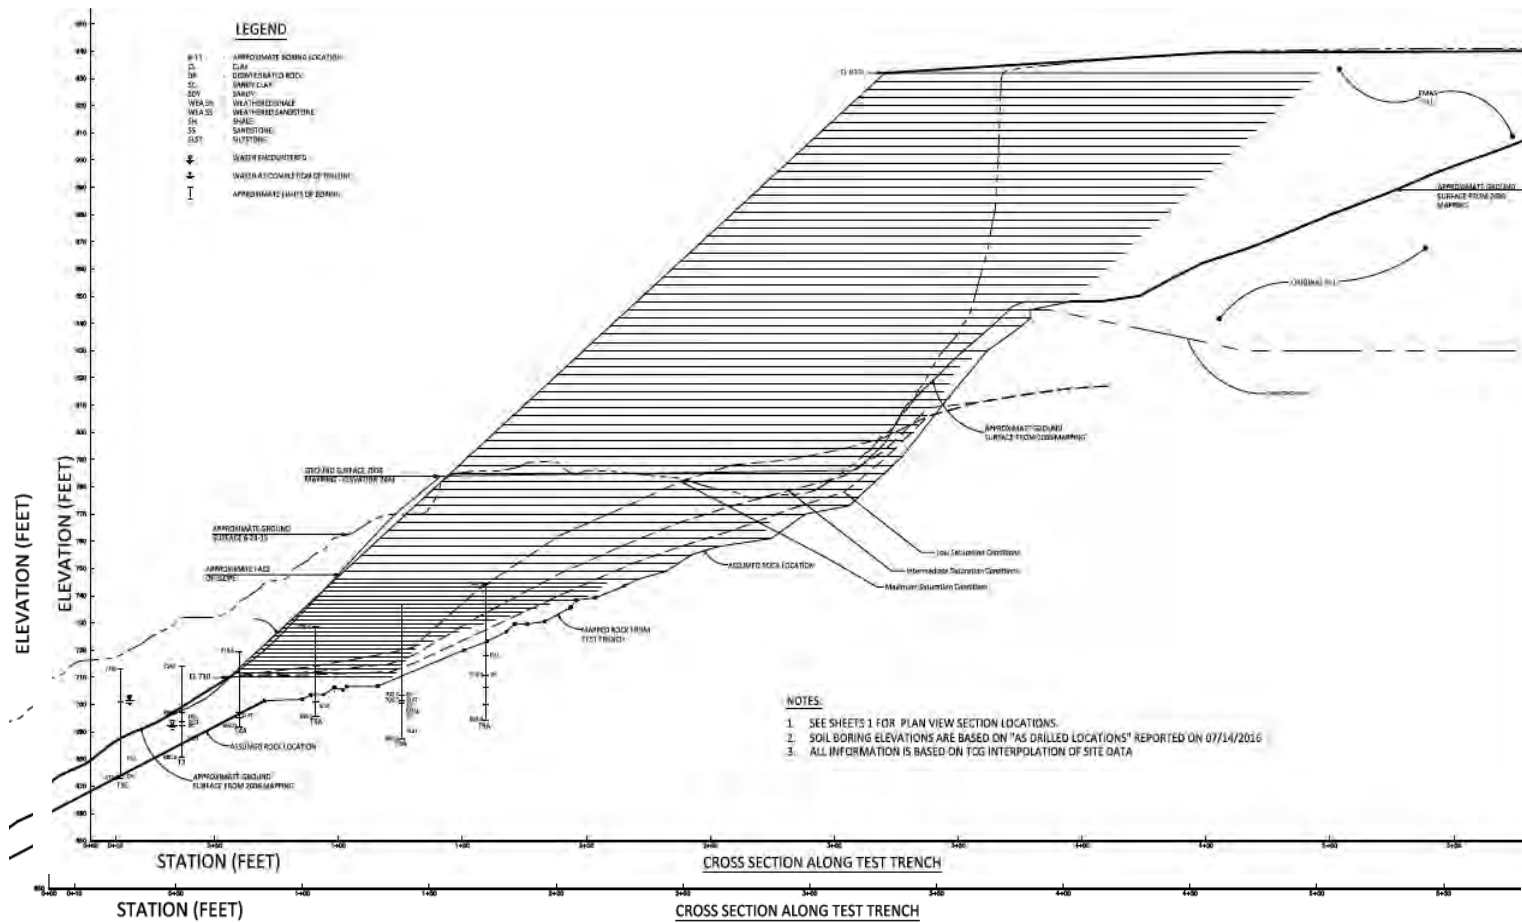
Groundwater Parametric Evaluation

Our estimate for a maximum groundwater potentiometric surface (groundwater table) is based on Chapter Four of Hoek and Bray.

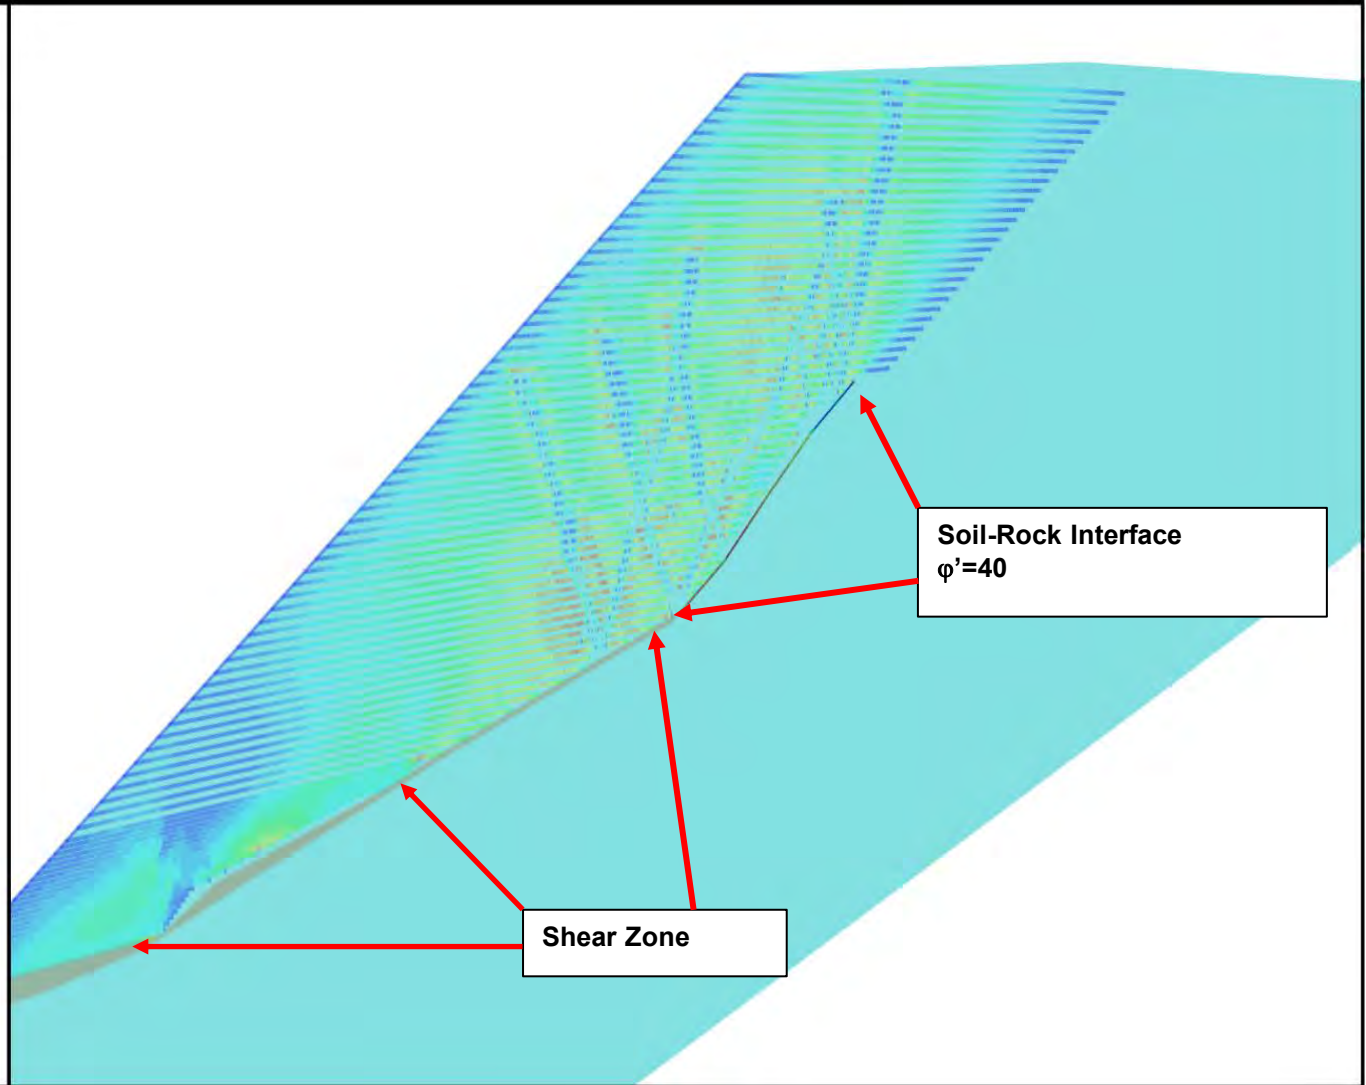
Soil-Rock interface

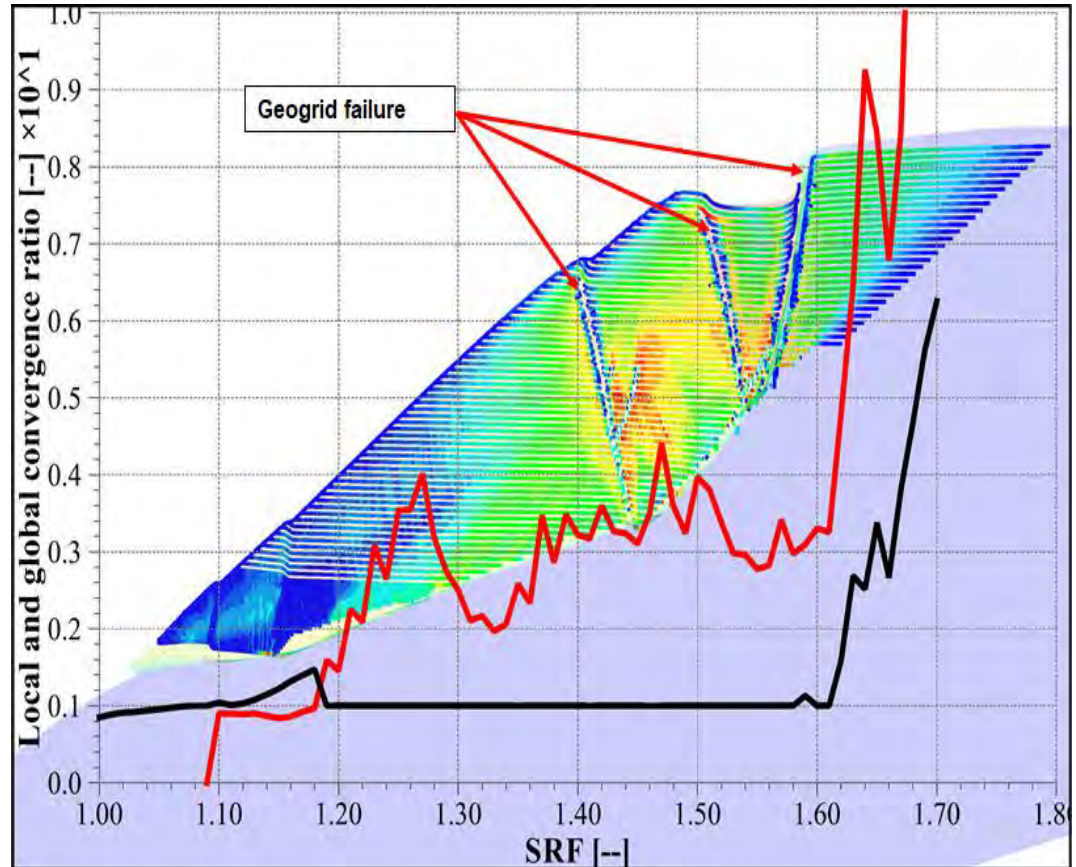
Failure Mechanism

- Geogrid failure in head scarp and two downslope areas
- Movement occurring behind and below the geogrids in lower portion of RSS where field changes were made to shorten the geogrids
- Deformation analysis results consistent with field observations

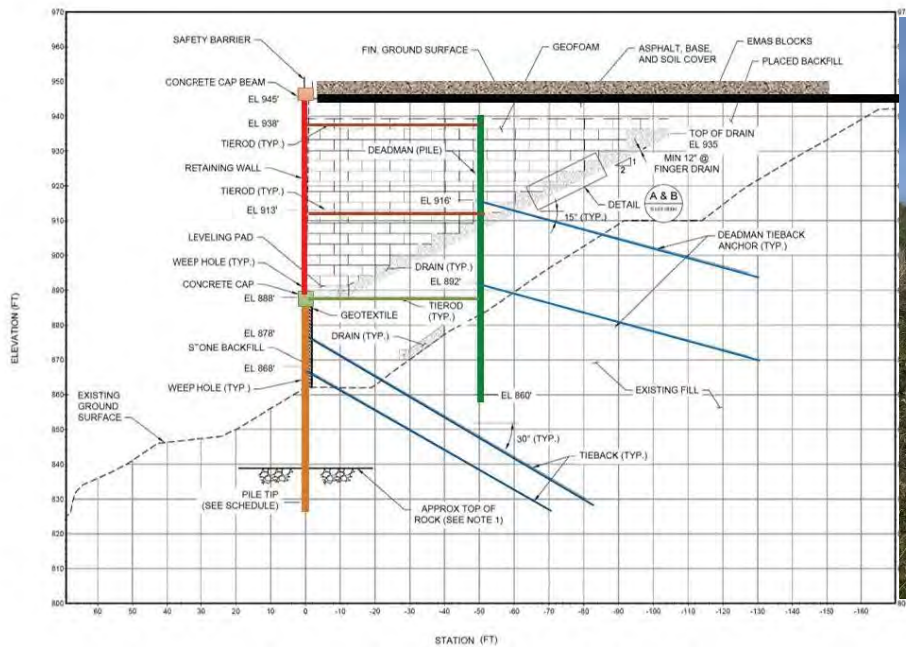
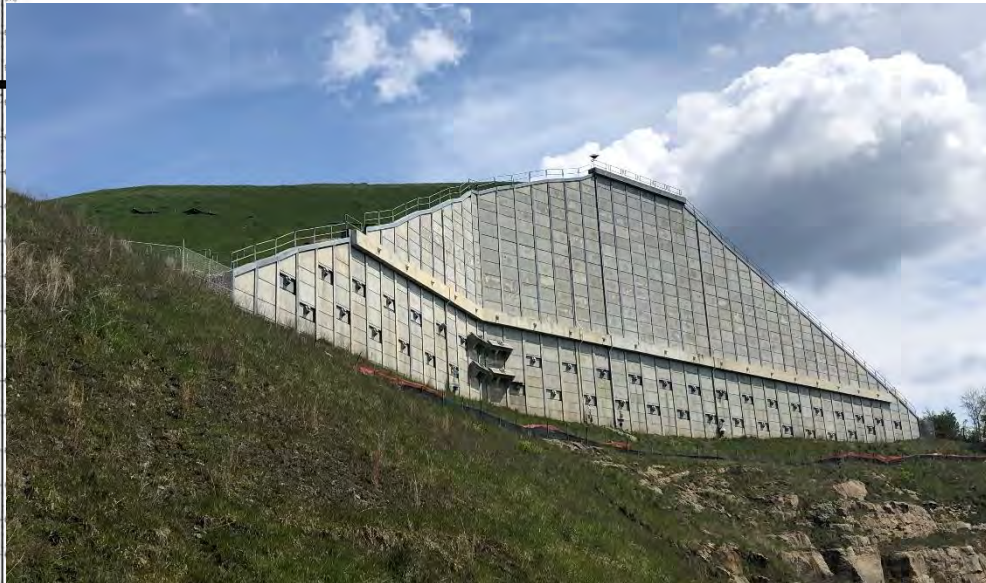
Summary

- The results of the 2D limit equilibrium analyses and the 3D permanent deformation analyses are consistent with the failure mechanism identified in the post forensic subsurface investigation
- Finite difference deformation analyses confirmed that a reduction in strength occurred along the soil-rock interface during the eight (8) year service life of the RSS due to deformations induced by the applied shear stresses and available groundwater.
- The deformation analyses also identified that the failure surface propagated from below the reinforced zone near the slope toe, behind the geogrids in the lower portion of the slope, and through the geogrids in the upper portion of the slope.

- Tension cracks observed approximately two (2) years before the failure also appeared in the stress-deformation analyses when the tensile geogrid strains reached about 2%. This analysis suggests that stress-deformation analyses can be used to predict the applied shear stresses and strains and possible development of a failure surface through an RSS for future projects.
- As the shear strength of the soil-rock interface decreased from the peak strength towards the FSS, the lower portion of the slope underwent shear deformations, which transferred the shear stresses to the geogrid reinforcement, which resulted in its deformation and creep strength reduction resulting in the failure of this RSS.
