Hispanic Carpenter Killed When Struck by Piece of Concrete That Fell From Rigging Device During Hoist in Highway Work Zone

Nebraska Case Report: 05NE028

Report Release Date: May 19, 2006

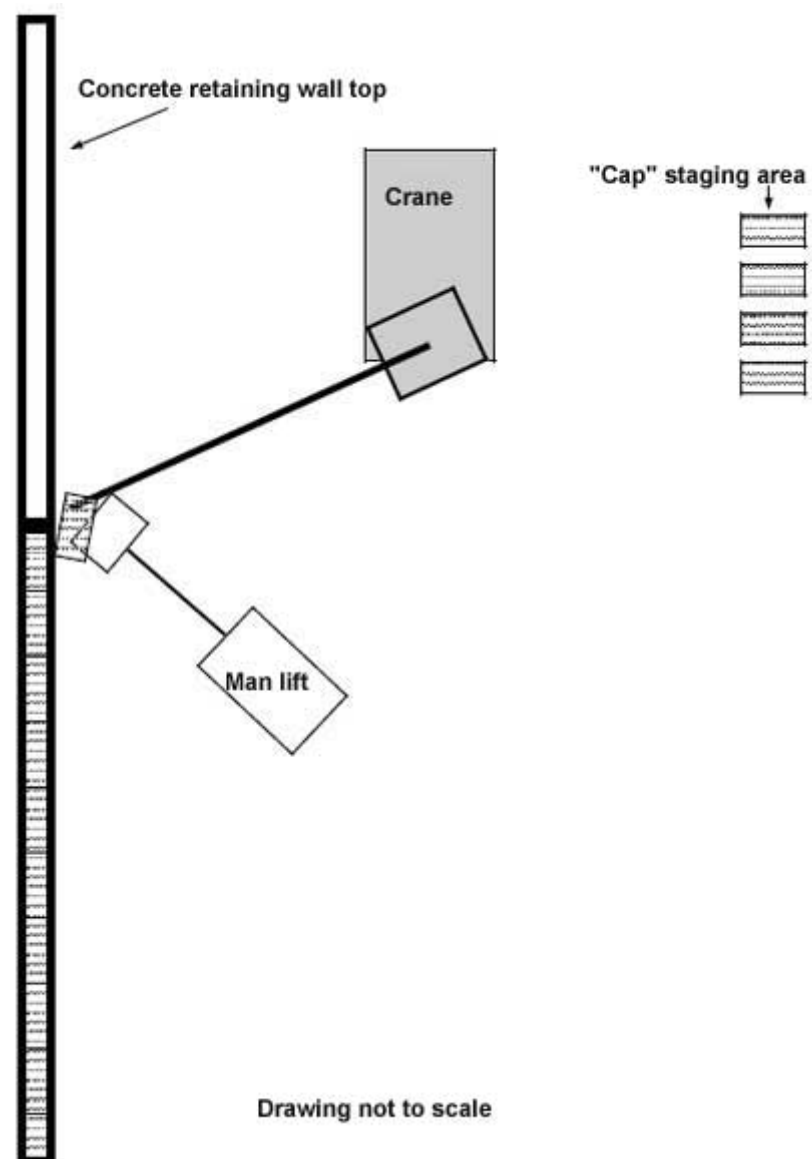
Attachment 1. Site diagram (Diagram not to scale)

Workers #2 & #4 screwed the bolts into the threaded insert and tightened them snug. Worker #2 raised the “cap” into the air and swung it toward the retaining wall, causing it to be swung over worker #4. It stopped above the victim and worker #7 in the man lift basket. As the “cap” was being raised (somewhere between 10 and 30 feet high) one of the bolts pulled out of the threaded insert. This caused the “cap” to swing towards the opposite side. The weight and pressure applied to the remaining bolt caused it to fail, and it pulled out of the threaded insert. The “cap” fell, striking the victim on his hard hat and body. The “cap” hit the man lift basket with sufficient force to cause it to jerk sideways with enough force into worker #7’s body, breaking several ribs.
