BRAKE TORQUE VARIATION DUE TO CALIPER MACHINING QUALITY

¹Toyota Motor Europe

ABSTRACT: One of the major concerns of brake NVH is Brake judder coming from Brake Torque Variation (BTV). This is a vibration that occurs during braking and can be felt by the driver through the steering, brake pedal or vehicle body. This can create a feeling of discomfort for the vehicle occupants.

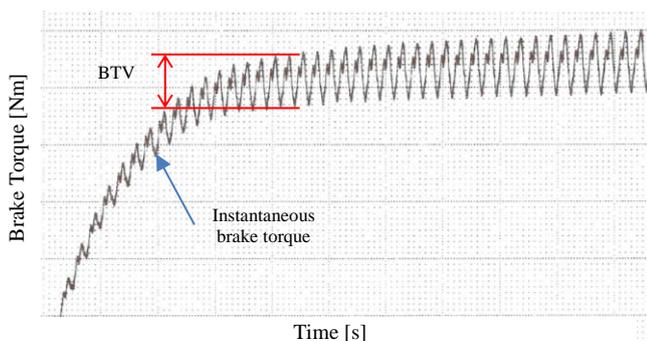
The cause of judder is a variation of the brake torque (Brake Torque Variation, or BTV), which is also linked with a variation of brake pressure. BTV is the difference of max and min torque values during a brake application. This is demonstrated in Figure 1 where the braking torque is seen to oscillate around the nominal brake torque value.

Figure 1: Brake torque during a brake application

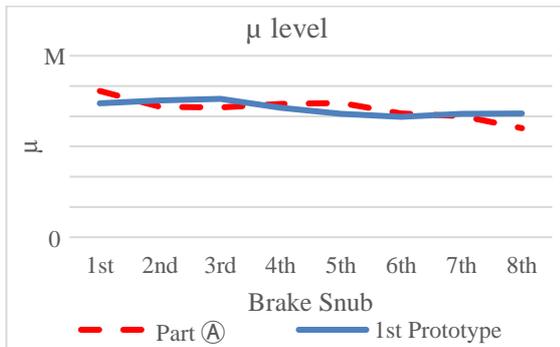
Taking Part (A), the fundamental items that influence BTV were investigated to confirm if it was within drawing specifications, as well as to confirm correlation with the theoretical calculation. The caliper stiffness was checked by scanning the components and measuring its deformation under pressure; no difference was found when comparing to the first prototype parts and expected design values. The disc thickness variation (DTV) had the same value as the first prototype parts. Examination of the μ level, Figure 3, showed the same values for Part (A) and the first prototype parts.

Figure 3: μ level – First prototype vs Part (A) comparison

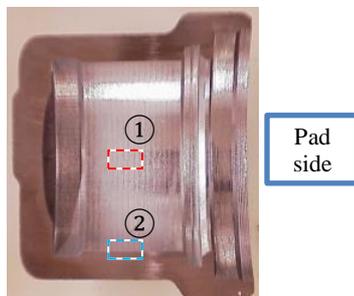
In parallel to the above investigation, the surface condition of the piston bore of Part ① was analysed in more detail. The piston bore was cut open and the investigation areas are illustrated in Figure 9.

Figure 9: Caliper housing piston bore cross section

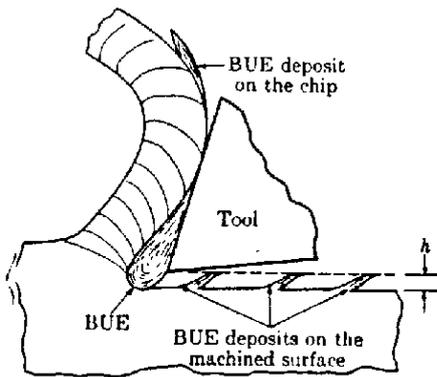
At this point, it is useful to know how BUE deposits form on the surface of the caliper housing piston bore. An illustration of BUE formation is shown in Figure 14 [8]. Some material, from the material being cut, accumulates on the cutting edge of the tool. This accumulated material work-hardens and becomes part of the tool itself. This then forms part of the cutting edge and, as it builds up, it cuts deeper into the material creating surface anomalies. At a certain point, the build-up detaches from the tool tip and deposits into the machined surface. This deposit is shown in Figure 14 and is the same phenomenon as found on the piston bore in Figure 13. These BUE deposits, or spikes, were found to play a significant role in the sensitivity of BTV which can be seen in the following section.

Figure 14: Generation of built-up edge [8]
