## Section Summary

Number of sections	3
Total length of sewer network	566.75 ft
Inspected length of sewer network	566.75 ft
Not inspected length of sewer network	0.00 ft
Total abandoned inspections	1
Number of section inspection photos	25
Number of section inspection videos	3
Number of section inspection scans	0
Number of section inclination measurements	0

## Inspection report

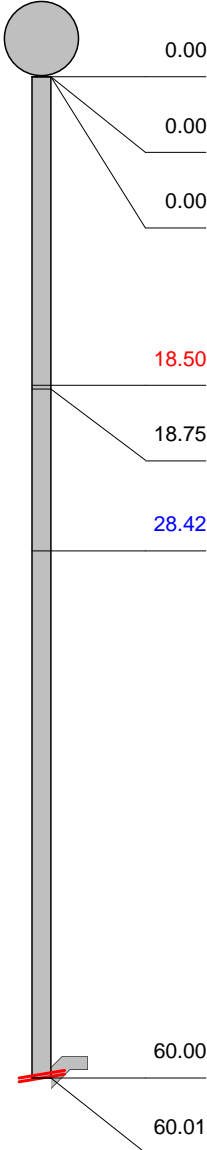
1:453	Distance	Code	Observation	Counter	Photo	Grade		
AA18018

0.00	AMH	Manhole / AA18018					
	0.00	MWL	Water Level, 10% of the vertical dimension	00:00:54				
	0.00	MMC	Material Change / UNKNOWN	00:01:01				
	18.50	FC	Fracture Circumferential from 10 o'clock to 4 o'clock, within 8 inch	00:03:50	5c6b0456-86b4-4a46-bfb7-c0ec	S2		
	18.75	ISZ	Intruding Sealing Other, 5% of cross sectional area from 12 o'clock to 2 o'clock	00:04:02	064060e0-ac33-4e4d-9616-a37	M2		
	28.42	MWLS	Water Level, Sag in pipe, 10% of the vertical dimension	00:04:48	6607f3b2-b39a-4d0a-9e67-3f0f	S2		
	60.00	TFA	Tap Factory Made Active at 7 o'clock, 8inch dim	00:07:16	79d0968e-8e48-4028-9614-d1d			
	60.01	MSA	Survey Abandoned / UNABLE TO PROCEED	00:07:27	45976fa0-d858-4d87-a220-c49			
QSR	QMR	QOR	SPR	MPR	OPR	SPRI	MPRI	OPRI
2200	2100	2300	4.0	2.0	6.0	2.0	2.0	2.0

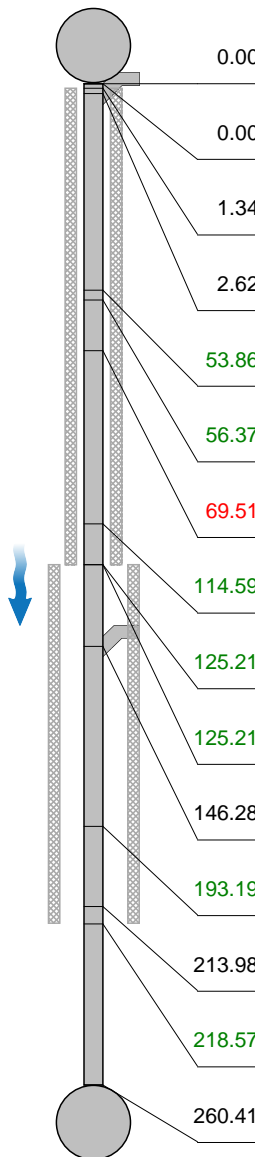
1:1966	Distance	Code	Observation	Counter	Photo	Grade		
AA18042

0.00	AMH	Manhole / AA18042	00:00:08				
	0.00	MWL	Water Level, 15% of the vertical dimension	00:00:20

1.34	S01	DAGS Deposits Attached Grease, 5% of cross sectional area from 7 o'clock to 5 o'clock, within 8 inch, Start	00:00:37				
	2.62	TFA	Tap Factory Made Active at 9 o'clock, 8inch dim	00:00:56	626b4da8-a746-4bd2-a730-537
